**COMPREHENSIVE
BUILDING
INSPECTIONS**

VISUAL VENDOR MAINTENANCE BUILDING INSPECTION REPORT **33108-2017**

Date Inspection carried out: Wednesday, 09th AUGUST 2017

**10 Springvale Avenue,
FRENCHS FOREST NSW 2086
9453 5024 - 0410 529 347**

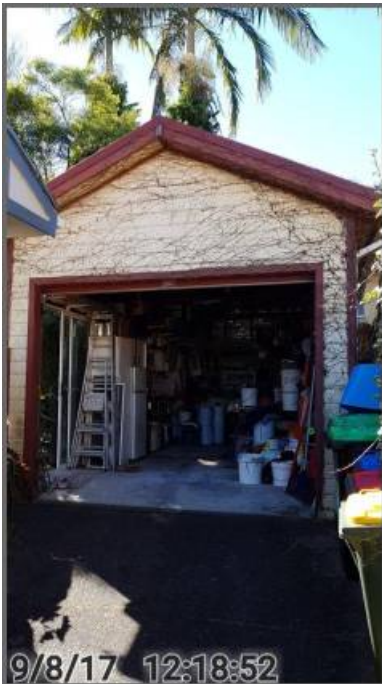
Garage Location:

To the rear of the main building.

Stored items restricted inspection to the interior. Garage was partially lined.
