Building Inspection Report

Inspection Date: Mon, 5 Jun 2023

Property Address: 8 Cotswold Cl, Belrose NSW 2085, Australia

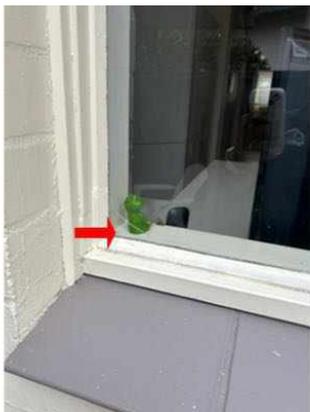
Defects 1.02

Building:	Building 1
Location:	All Areas
Finding:	Window - Cracked
Information:	A crack was identified in the window in this area. Cracking in windows is generally the

result of impact damage, and is likely to develop further when left unmanaged.

The likelihood of this windowpane further cracking and shattering is increased exponentially, providing a safety hazard in the area. The cracked window also impairs the weather tightness of the building, creating potential for minor water leaks.

A qualified glazier is required to repair the window as soon as possible. Depending on the extent of the cracking, replacement of the window may be required. Please be advised that any persons coming into contact with the cracked window should do so with due caution to avoid any personal injury that may ensue.

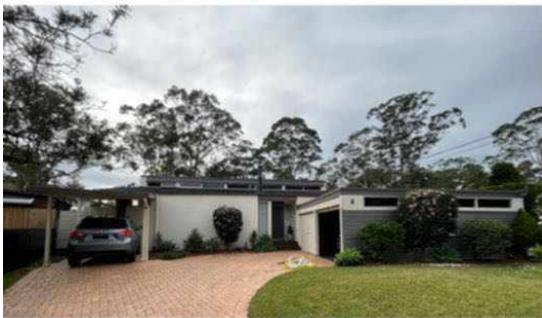
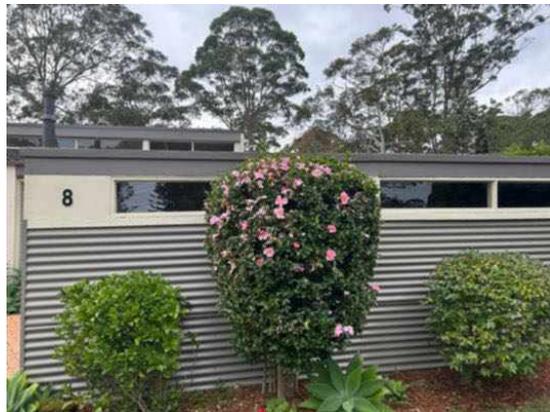
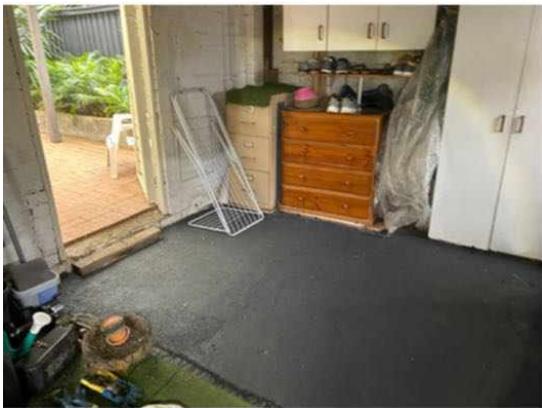
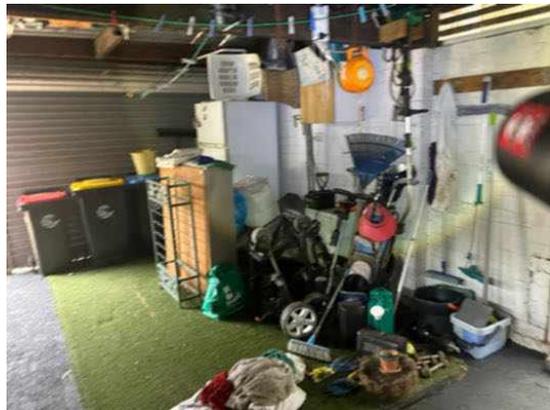
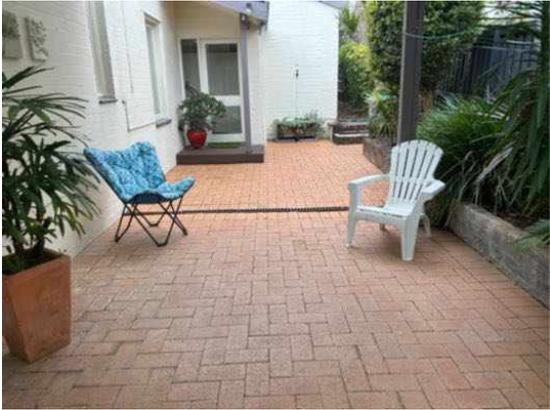
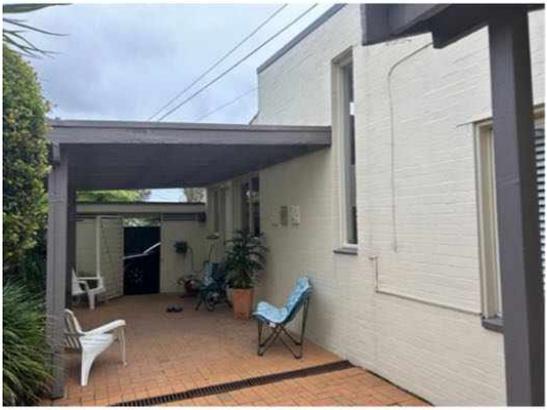
Noted Item

Building: Building 1
Location: All Areas
Finding: Additional Photos - Obstructions and Limitations
Information: These photographs are an indication of the obstructions and limitations which impeded full inspection of the property at the time of inspection. These obstructions can hide an array of defects and should be removed to allow full inspection to be carried out. A re-inspection is recommended once the areas are made accessible.

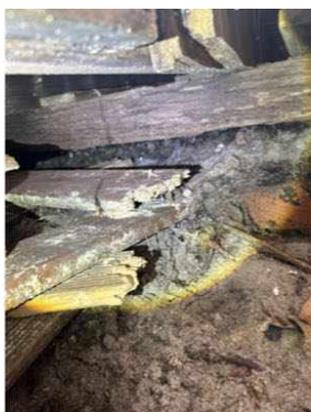
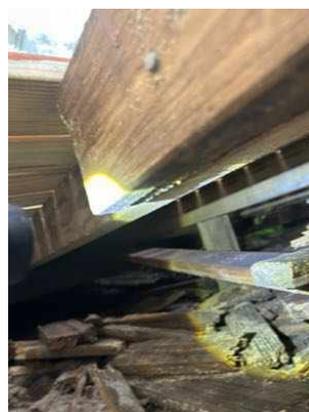
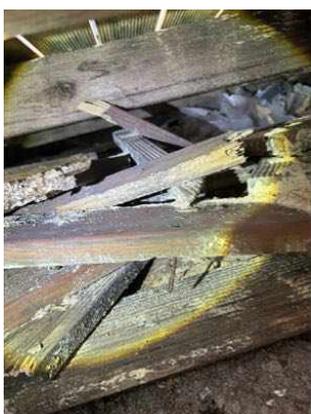
An array of debris was found in the subfloor area at the time of inspection. Debris in this area restricts subfloor ventilation and creates potential for concealed pest entry. Stored timbers and other materials may also make the area susceptible to termite activity and wood rot.

A clear and empty subfloor will be better ventilated and easier to maintain in a dry condition. The removal of any timber debris is vital in minimising the risk of termite or wood borer activity.

Debris in the subfloor should be removed as soon as possible. Depending on the location and amount of debris and stored items, the homeowner may elect to undertake this task. Alternatively there are a large number of rubbish removal subcontractors that could undertake these works.

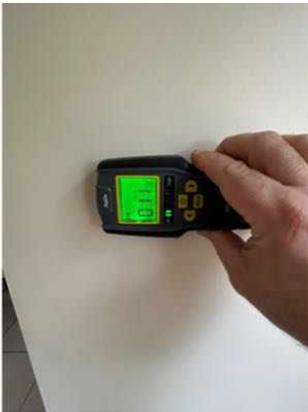
Building: Building 1
Location: All Areas
Finding: Moisture meter readings - low
Information: The moisture meter result for the areas inspected.

The moisture reading of 0-15% is quite normal and gives no cause for concern. However, moisture readings in excess of 15% indicate the need for further inspection.

Levels between 25-30% indicate that there may be water ingress, meaning that remedial work could be required.
