Building Inspection Report

Inspection Date: Wed, 28 Sep 2022

Property Address: 6 Ocean View Way, Belrose NSW 2085,
Australia

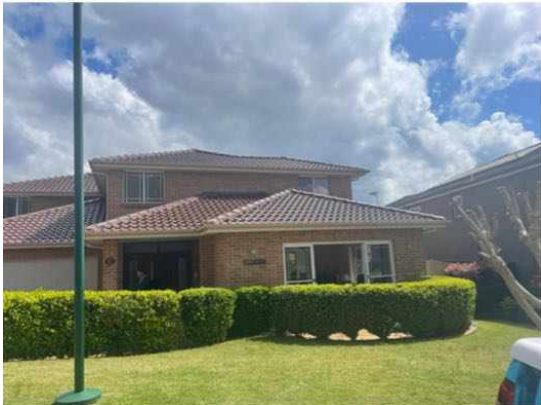
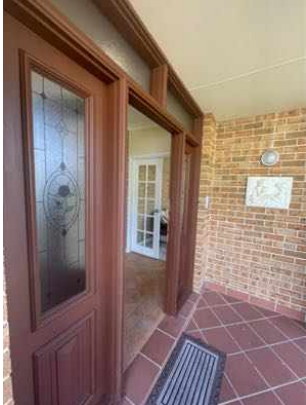
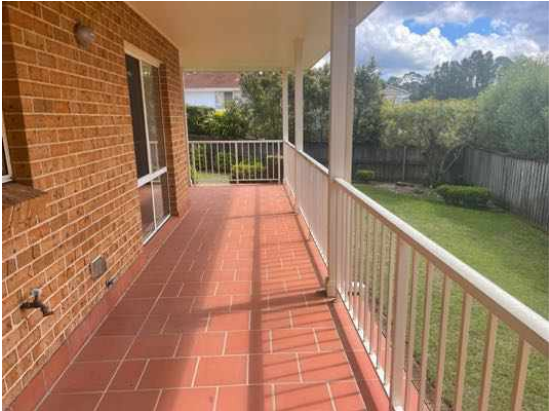
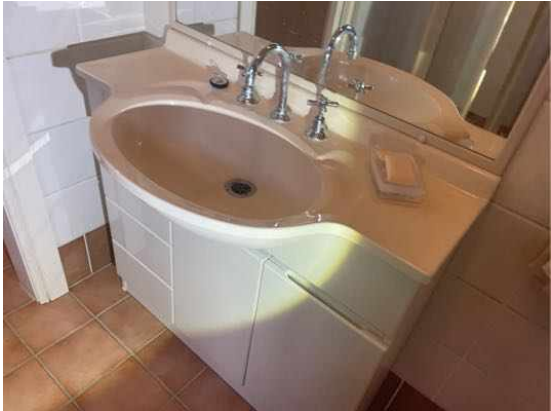
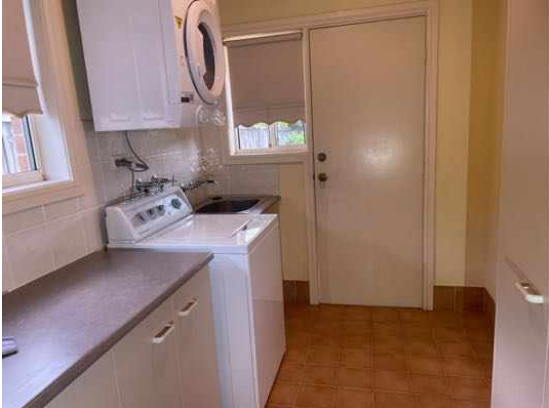
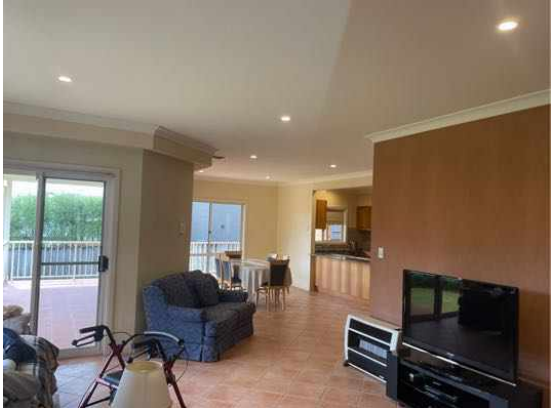
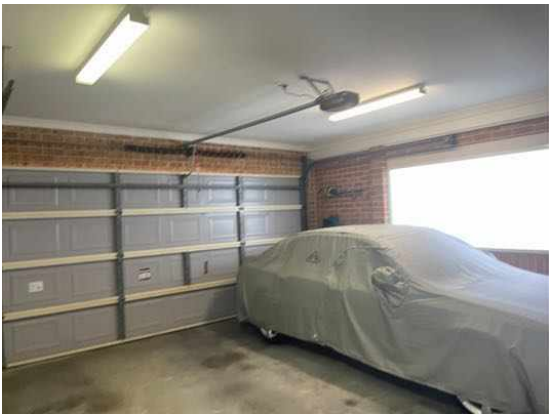
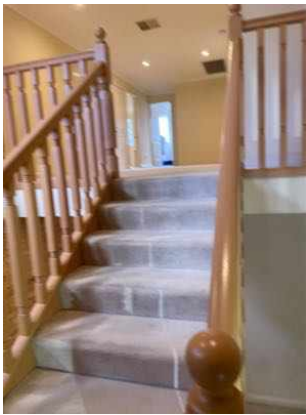
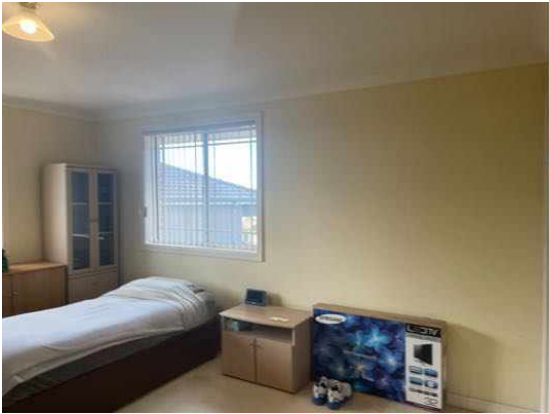
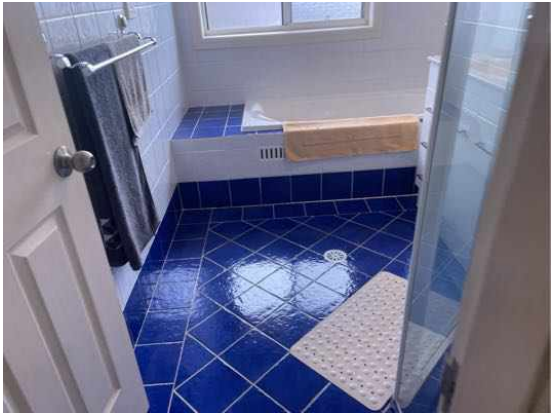
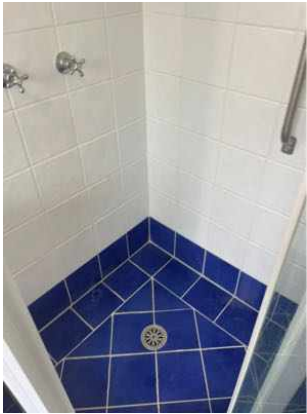
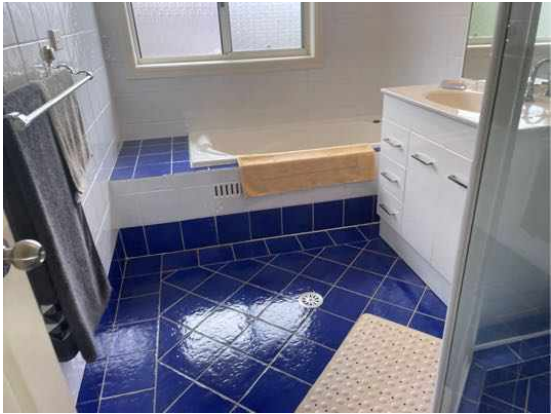
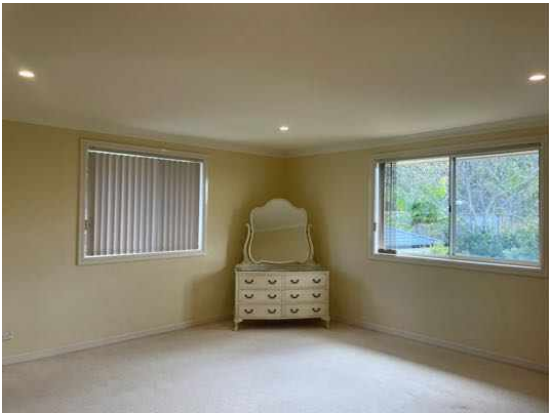
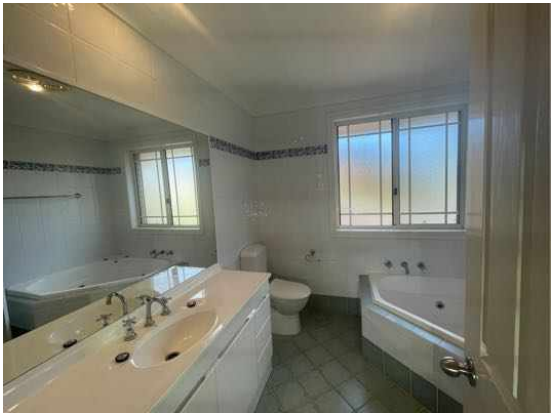
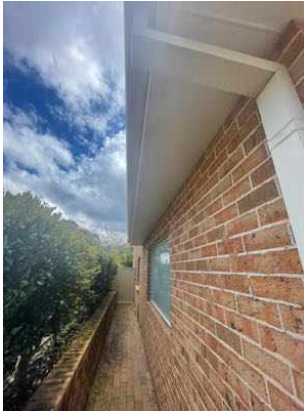
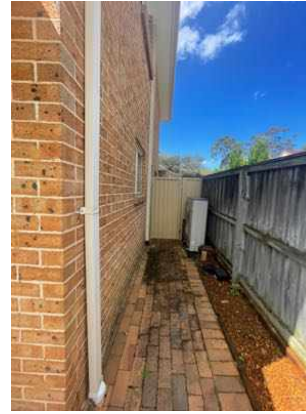
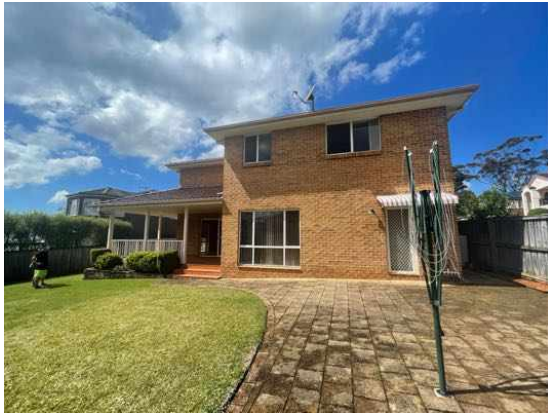
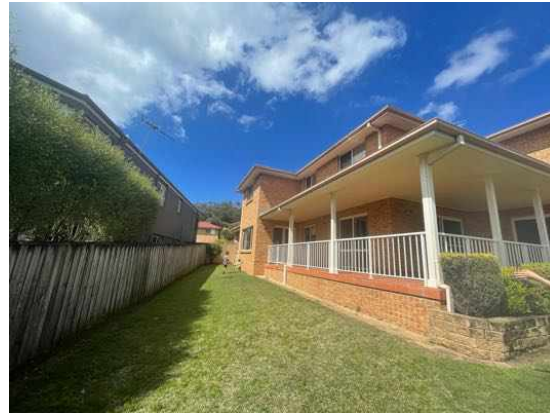
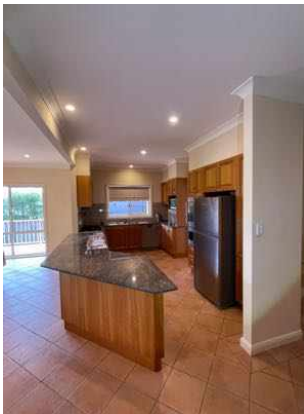
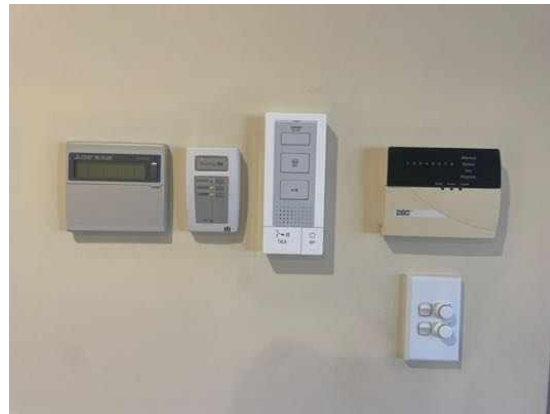
Building: Building 1
Location: All Areas
Finding: Additional Photos
Information: Additional photos are provided for your general reference.
