Building and Timber Pest Inspection Report

Inspection Date: Wed, 10 Feb 2021

Property Address: 34 Romford Rd, Frenchs Forest NSW 2086, Australia

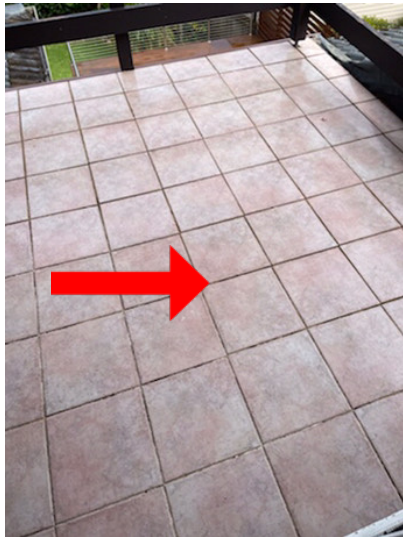
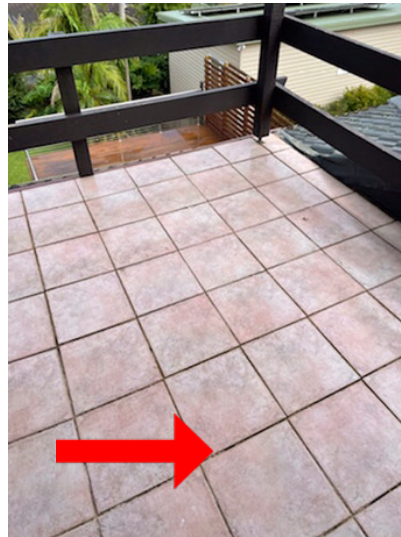
Regular maintenance and replacement of damage or missing or damaged sealant and grout is recommended , as this is a regular wear and tear defect. Sealant and grouting in areas that come into regular contact with water should be maintained for the long term care of your property.

A sealant specialist or tiling contractor should be appointed to complete these works.

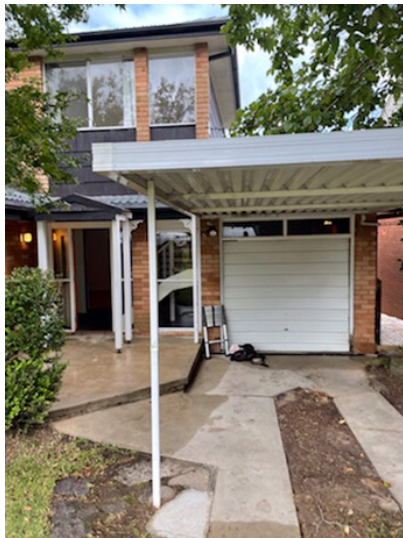
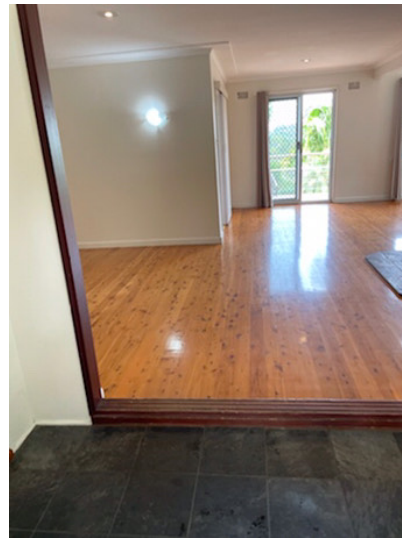
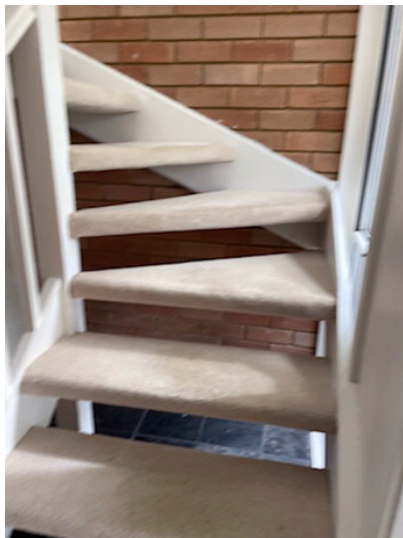
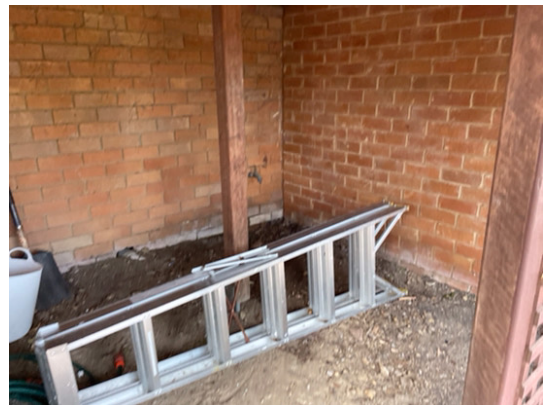
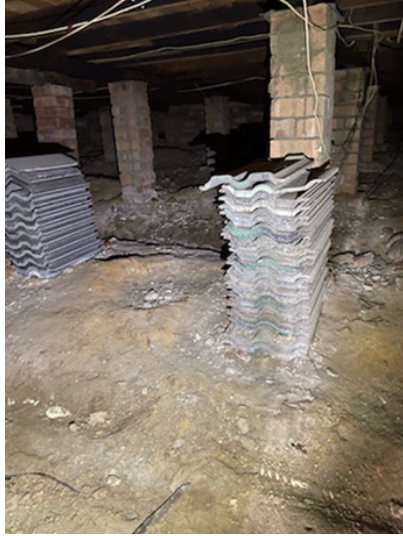
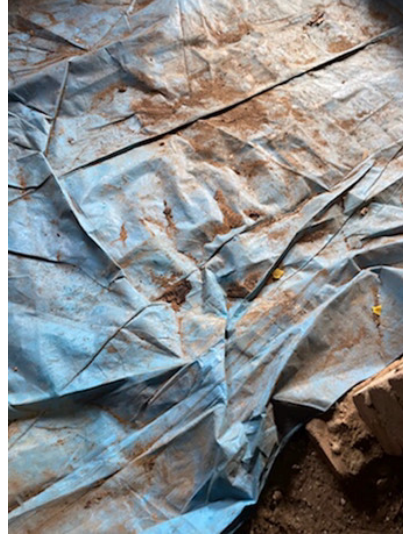
Finding 3.09

Finding: Additional Photos - Obstructions and Limitations

Information: These photographs are an indication of the obstructions and limitations which impeded full inspection of the property at the time of inspection. These obstructions can hide an array of defects and should be removed to allow full inspection to be carried out.

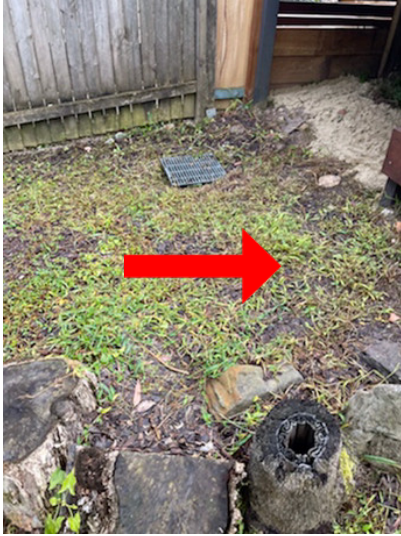
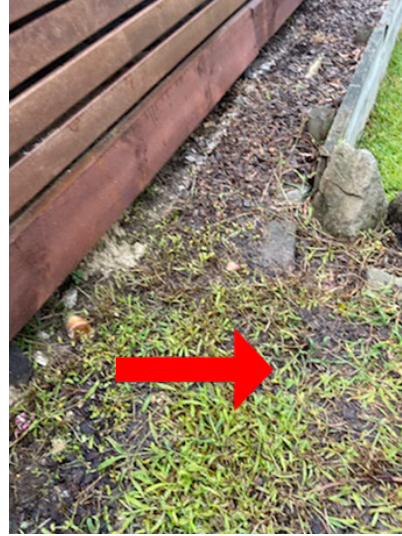
Finding 6.05

Building: Building 1

The client may consider gaining further advice from a pest controller as to the costs and procedures involved with this application. It is recommended that obtaining such advice be a short-term priority.
