# Building and Timber Pest Inspection Report

Inspection Date: Thu, 12 Sep 2024

Property Address: 16 Gozo St, Schofields NSW 2762, Australia

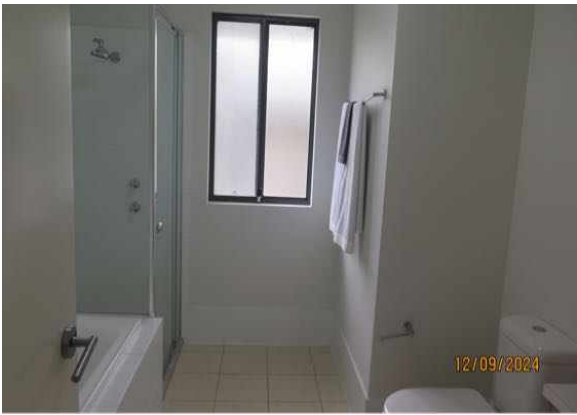
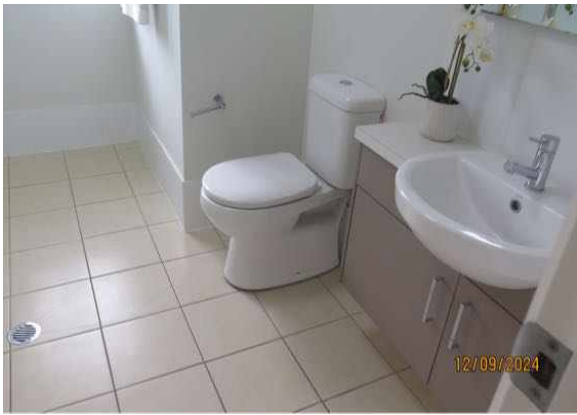
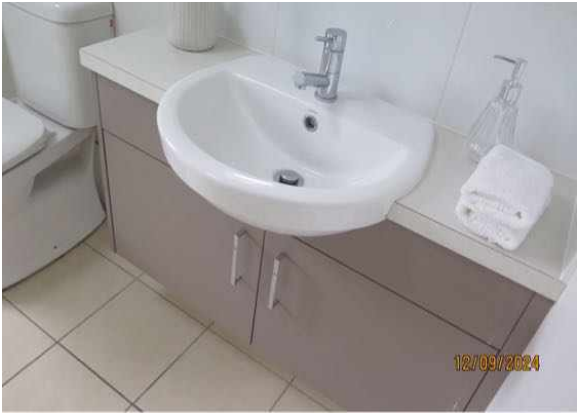
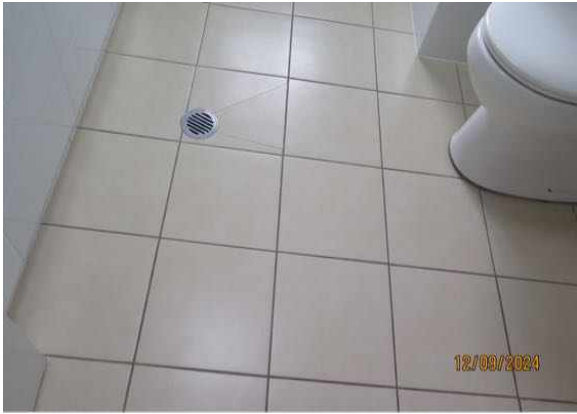
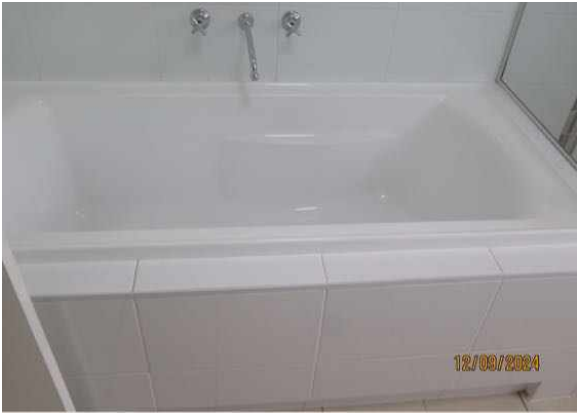
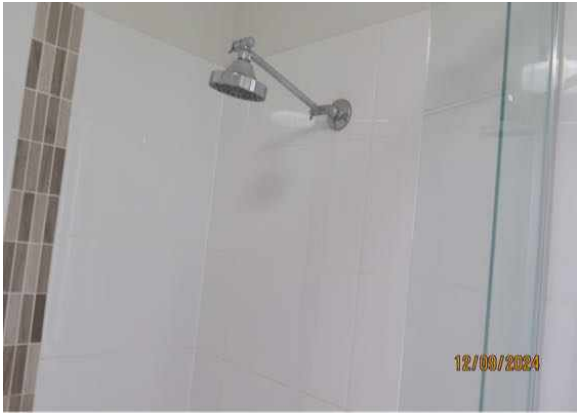
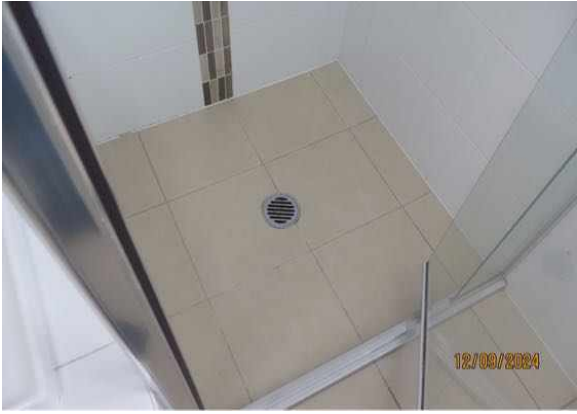
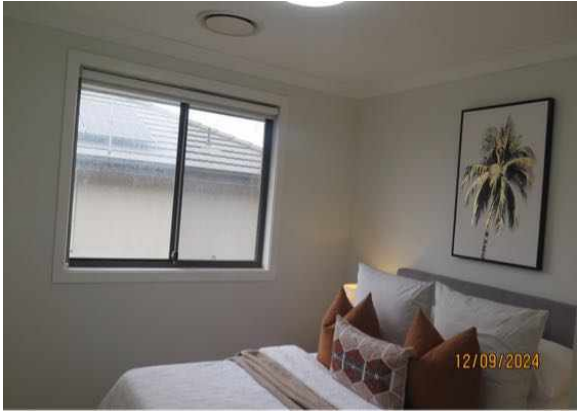
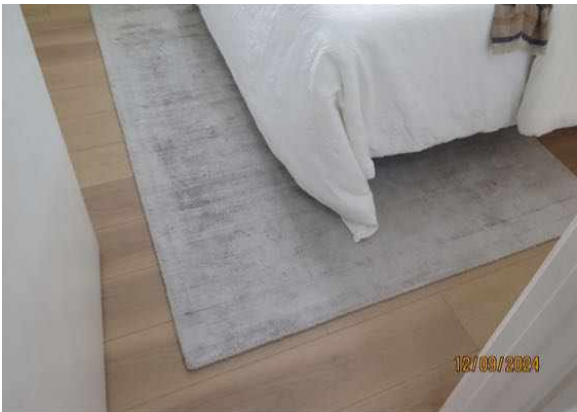
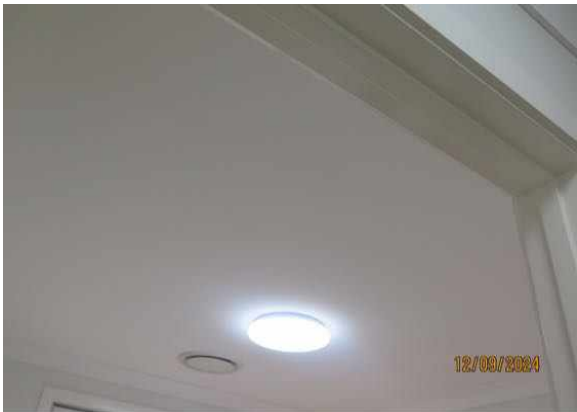
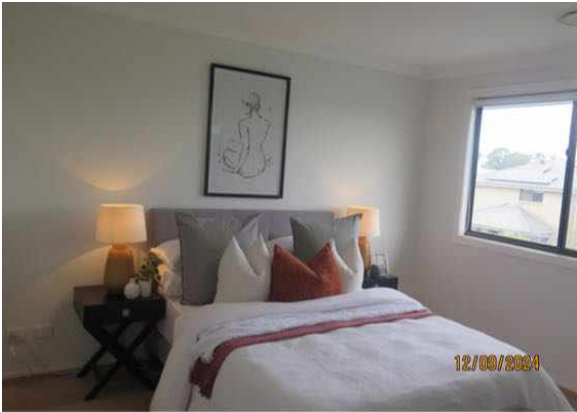
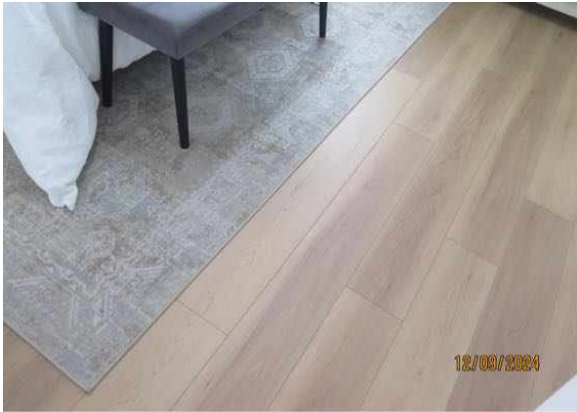
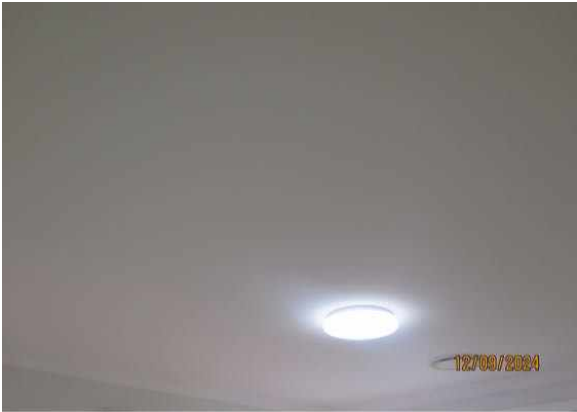
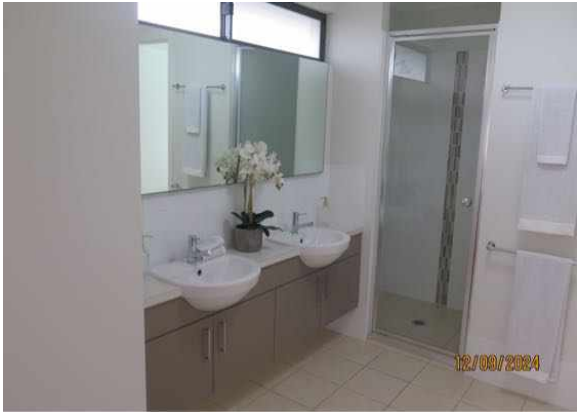
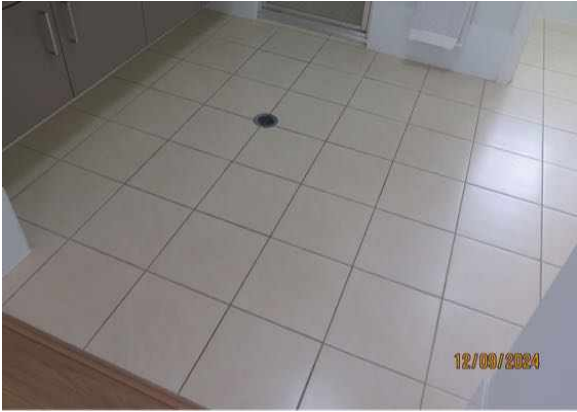
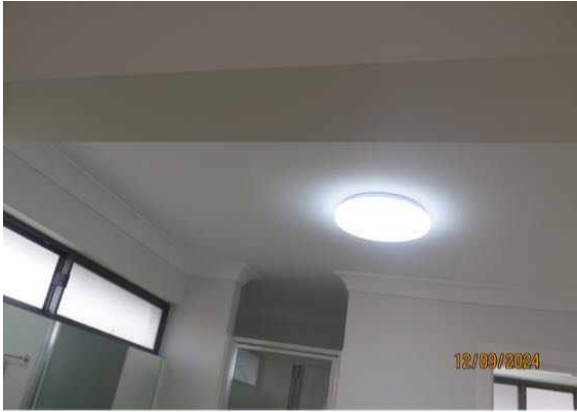
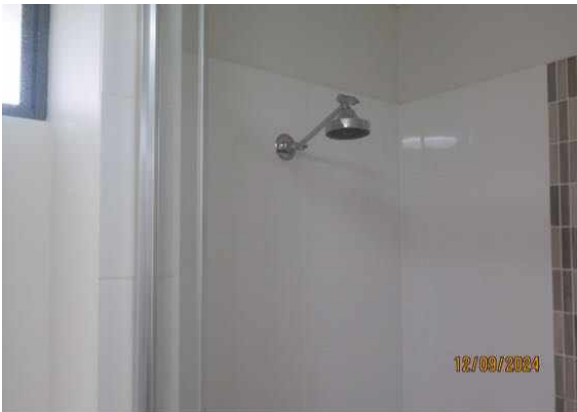
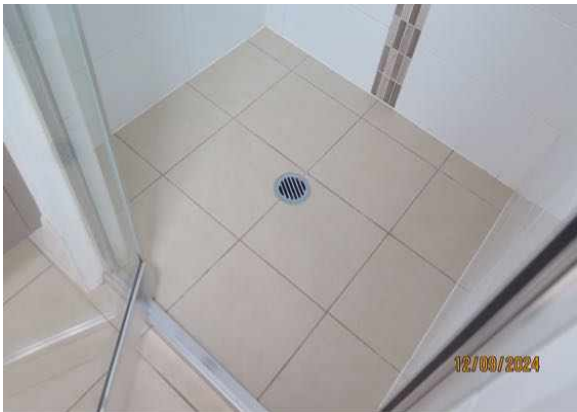
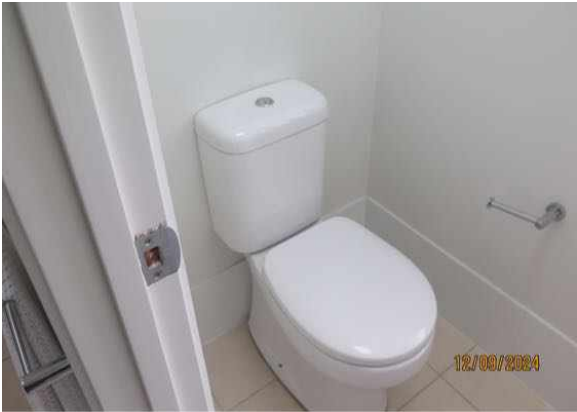
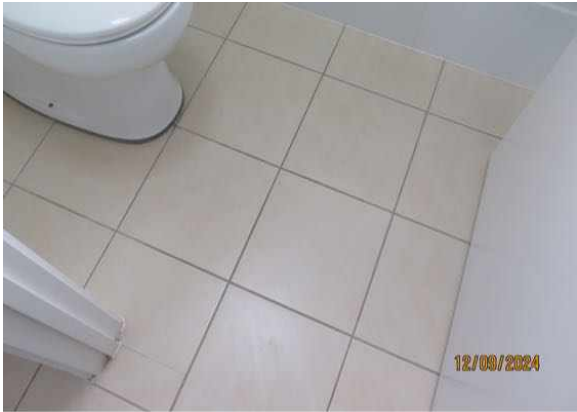
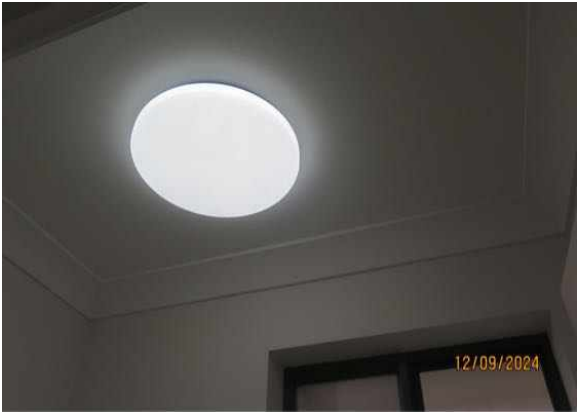
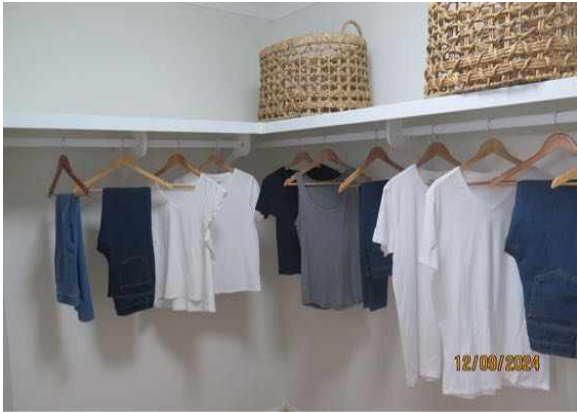
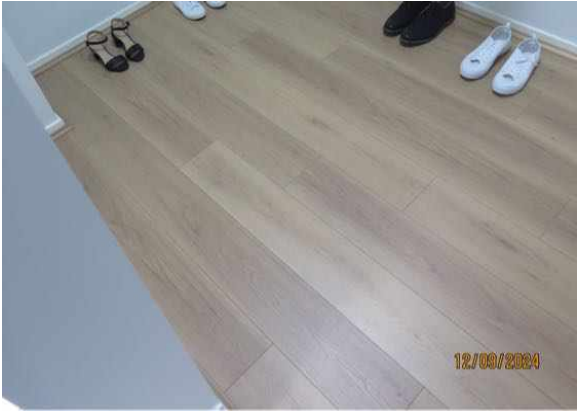
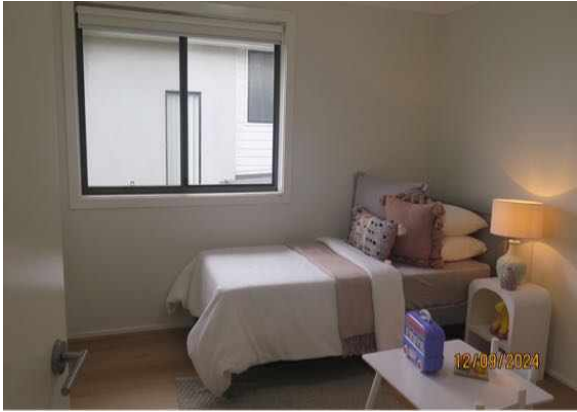
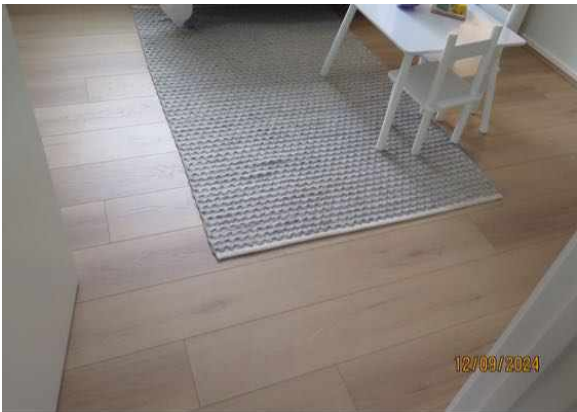
Building: Main Building  
Location: All Internal Areas  
Finding: Additional Photos  
Information: Additional photos are provided for your general reference

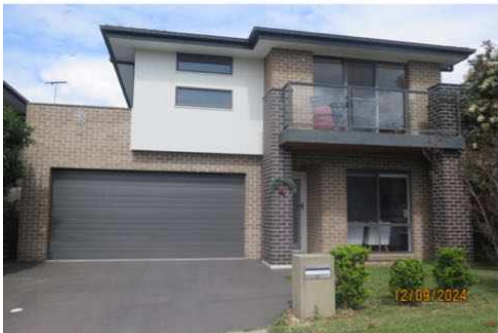
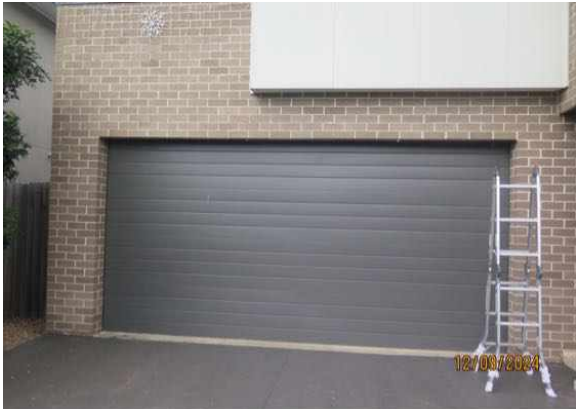
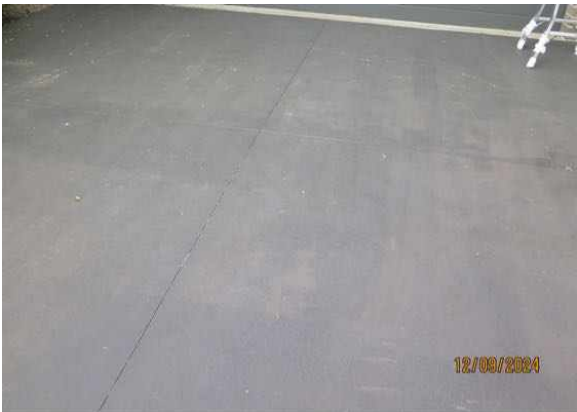
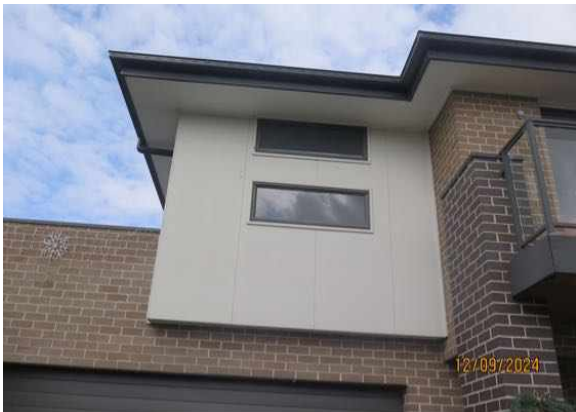
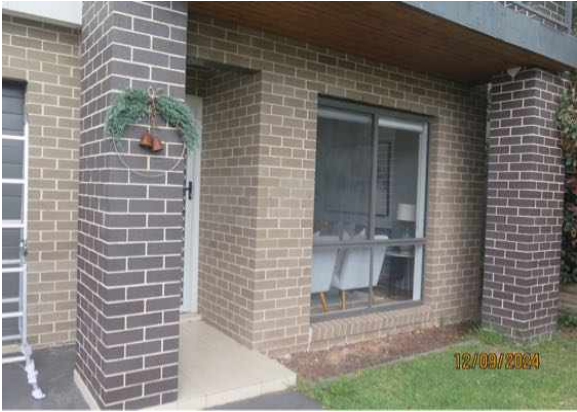
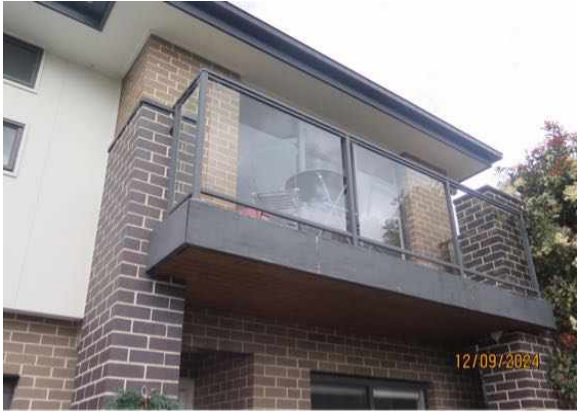
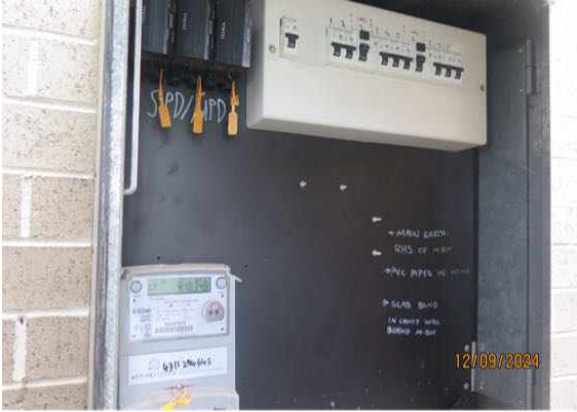
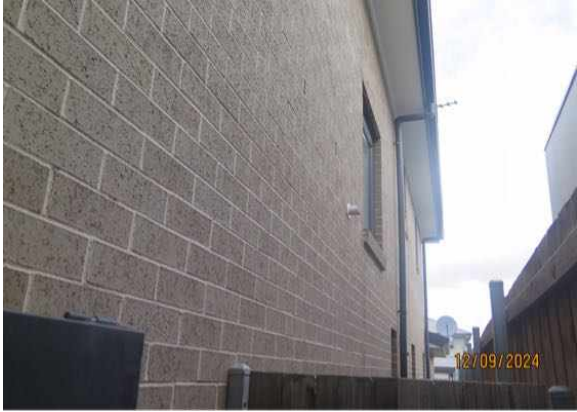
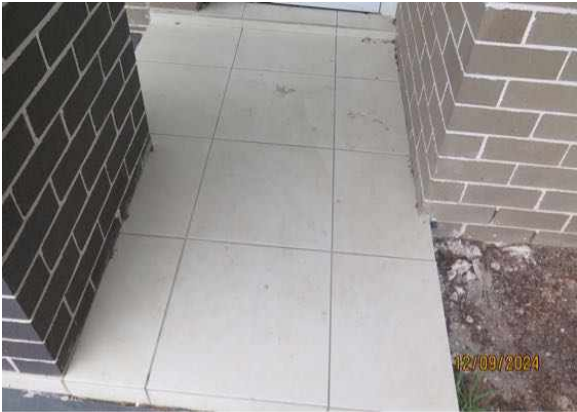
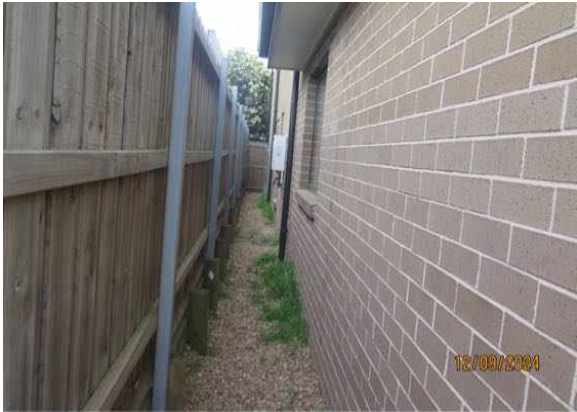
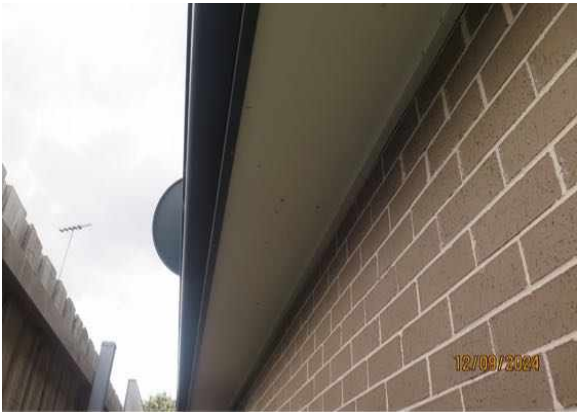
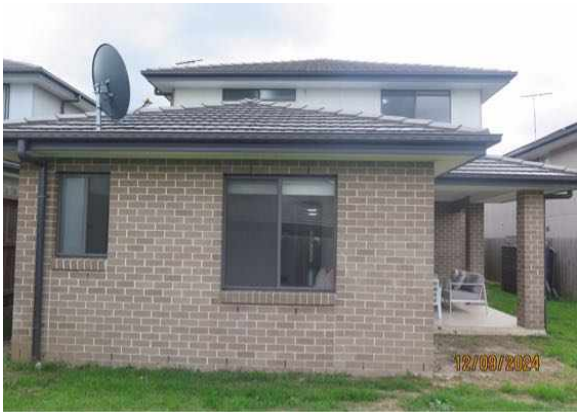
Building: Main Building  
Location: All External Areas  
Finding: Additional Photos  
Information: Additional photos are provided for your general reference
