## Building Inspection Report

Inspection Date: Thu, 25 May 2023

Property Address: 8 Dresden Ave, Beacon Hill NSW 2100,  
Australia

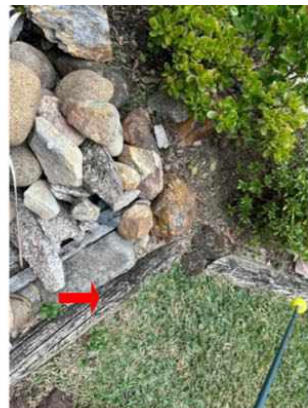
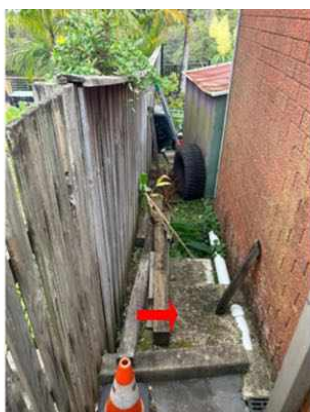
### Defects 3.01

Building:	Building 1
Location:	All Areas
Finding:	Evidence of excessive moisture was present at the time of inspection
Information:	Excessive moisture can attract termites and produce conditions that promote termite attack fungal growth and wood decay.

Excessive moisture is generally caused by deteriorated inadequate or missing roof drainage leaking plumbing pipes or fixtures poorly plumbed HWS overflows or condenser units and poor site drainage.

It is recommended that all plumbing and drainage fixtures and fittings be maintained regularly in order to prevent excessive moisture being present in the external / internal property.

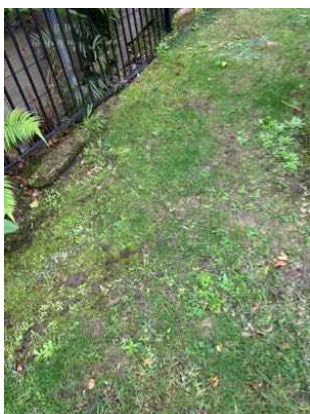
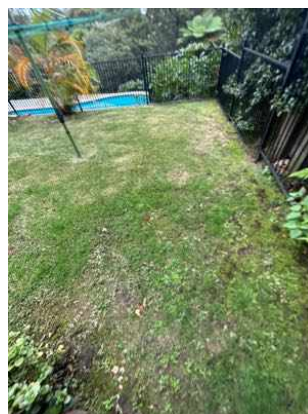
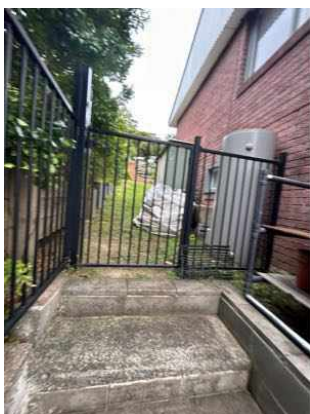
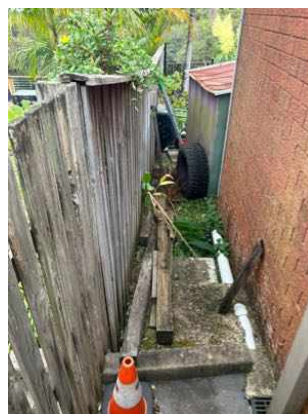
### Defects 3.02

Building:	Building 1
Location:	All External Areas
Finding:	Site drainage - suspected Inadequate
Information:	The site drainage in this area was found to be inadequate at the time of inspection, creating potential for subsequent water damage to associated building elements.

It is important that water does not lie against the base of walls; surrounding paths and ground levels should be sloped to drain water away from walls. Downpipes should not disgorge stormwater onto lower walls or plinths. Stormwater should be carried away by large, regularly cleaned drains. Ground levels may need to be lowered to expose a buried DPC.

Where site drainage is inadequate, installation of an Agricultural (Aggie) Drain may be required. A qualified plumber should be appointed to further inspect the property and perform any remedial works as necessary. Water damage and secondary defects are likely to occur if left unmanaged.

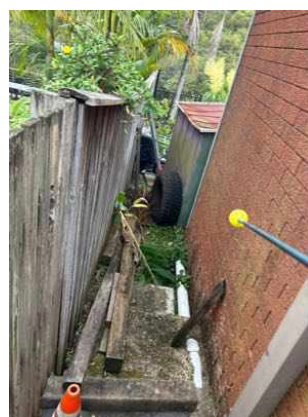
### Defects 3.03

Building:	Building 1
Location:	All Areas
Finding:	Fencing - Deteriorated
Information:	It was noted at the time of inspection that sections of the fencing throughout the

property have deteriorated. Typically fencing deteriorates due to age and or wear, rot and or rust which is generally expected for a structure of this age, due to prolonged exposure to weather conditions. Sometimes inadequate installation or maintenance can be to blame.

If left unattended, it is likely that further damage will occur. It is suspected that repair of several elements of the fencing may be required however replacement may be a consideration of the client also.

A licensed fencing contractor should be appointed to provide further advice and perform rectification works as necessary.

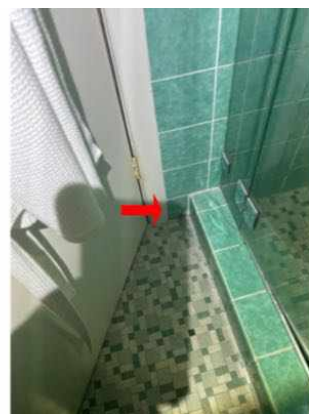
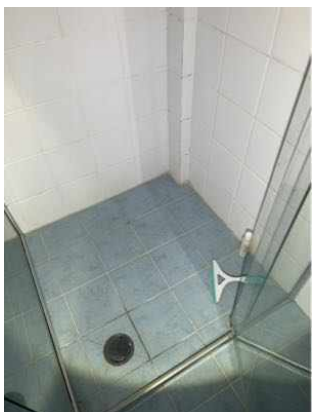
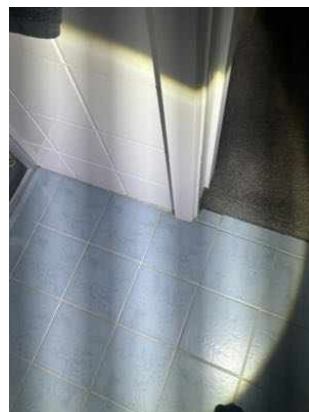
### Defects 3.04

Building:	Building 1
Location:	Bathroom
Finding:	Sealant - missing/ deteriorated
Information:	Flexible and mould resistant materials should be applied to affected areas to prevent any subsequent water damage that is likely to occur. Regular maintenance and replacement of damage or missing or damaged sealant and grout is highly recommended to the wet areas, as this is a regular wear and tear defect.

Sealant and grouting in areas that come into regular contact with water should be maintained for the long term care of your property. A sealant specialist or tiling contractor should be appointed to complete these works as soon as possible

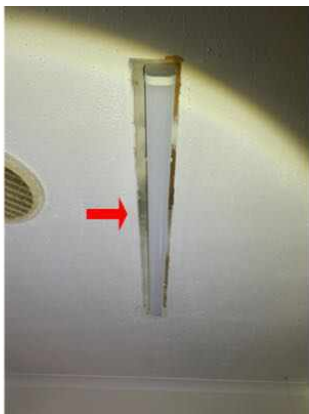
### Defects 3.05

Building:	Building 1
Location:	All Areas
Finding:	Paint finish - Incomplete
Information:	The paint finish in this area was identified as being incomplete at the time of inspection.

Whilst incomplete or missing paint finish is generally an appearance defect, it can also lead to the development of secondary building defects over time. Incomplete areas of paint finish expose the area to moisture, potentially accelerating the deterioration of underlying building materials.

Incomplete paint finishes should be sanded back, filled, leveled and painted, as applicable. Where inadequate or missing paint protection has led to the deterioration of the associated building element, repair and/or replacement of this building element may be required.

A painting contractor should be appointed as soon as possible to perform necessary works to aid the appearance of the affected area and to ensure the area is protected against further deterioration. Alternatively, the homeowner following manufacturer instructions may perform these works.

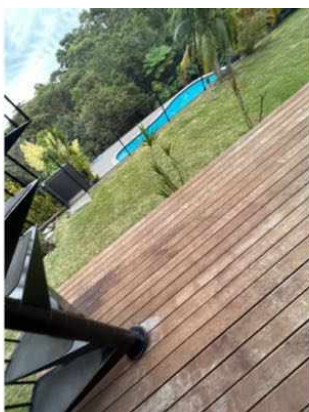
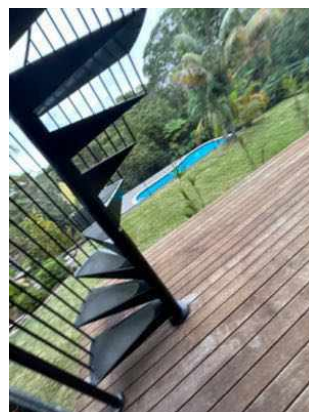
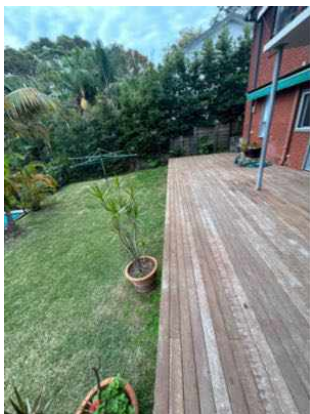
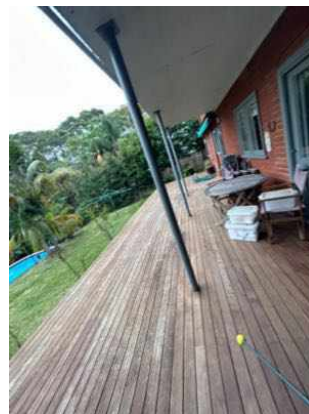
### Defects 3.06

Building:	Building 1
Location:	All Areas
Finding:	External painting deteriorated- deck
Information:	Some of the external paintwork has been neglected and require attention to prepare and re-paint.

Degraded paint finishes should be sanded back, filled, leveled and painted, as applicable. Where inadequate or missing paint protection has led to the deterioration of the associated building element, repair and/or replacement of this building element may be required.

A painting contractor should be appointed as soon as possible to perform necessary works to aid the appearance of the affected area and to ensure the area is protected against further deterioration. Alternatively, the homeowner following manufacturer instructions may perform these works.

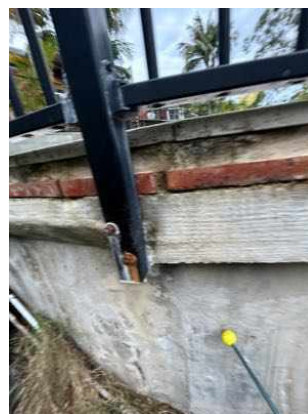
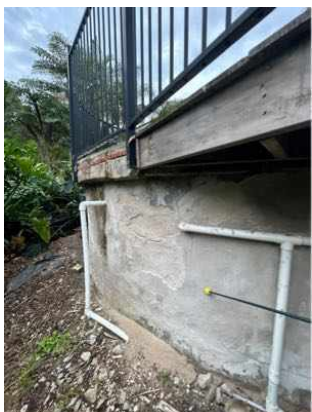
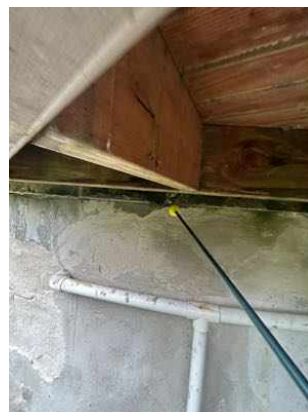
### Defects 3.07

Building:	Building 1
Location:	Pool Area
Finding:	Render - Drummy
Information:	<p>Drummy rendered areas were identified at the time of inspection. The term 'drummy' refers to render that has become detached from its fixing, despite it still being solid. Such defects are generally caused by physical or moisture damage to the area. Drummy render may also be a direct result of poor workmanship during the construction process.</p>

Render may swell and shrink with changes in air humidity if the area has sustained moisture damage. Any exposure to moisture is capable of causing rendered areas to become drummy and/or cracked over a prolonged period of time. Drummy render generally requires chipping off and re-rendering or painting.

Specialist trades are available for these types of services. A builder may be required to undertake works if damage is extensive, or if secondary building defects have resulted. Immediate action is recommended to ensure that no further damage is sustained in the affected area.

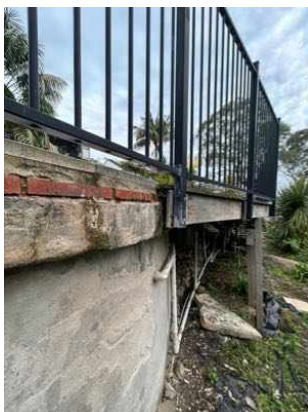
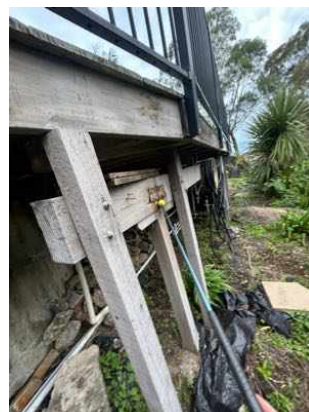
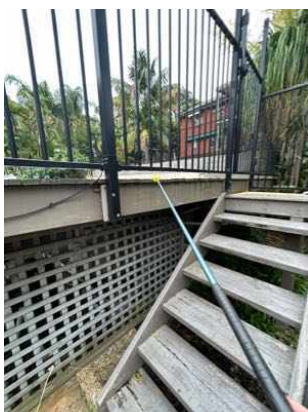
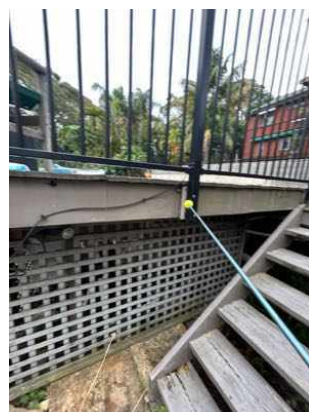
### Defects 3.08

Finding: Wood rot

Information: This building element shows evidence of wood rot. Wood rot, also known as Fungal Decay, occurs when timbers and other cellulose building materials are exposed to damp conditions on an ongoing basis. This could be the result of exposure to weathering over a prolonged period of time, or the attraction of excessive moisture from other abutting building materials. Contributing factors also include poor air ventilation in the area.

Prior to any works being performed, the cause of the moisture that has created the visible wood rot should be identified and addressed in a suitable manner. Replacement of affected timbers may then be a necessary step in protecting surrounding building elements from such deterioration.

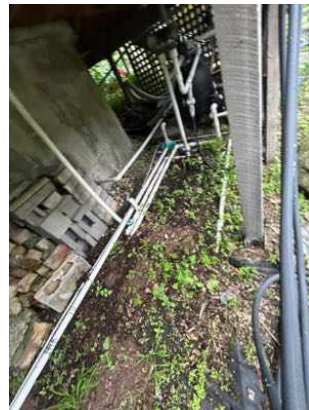
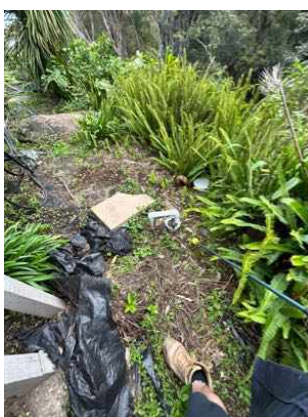
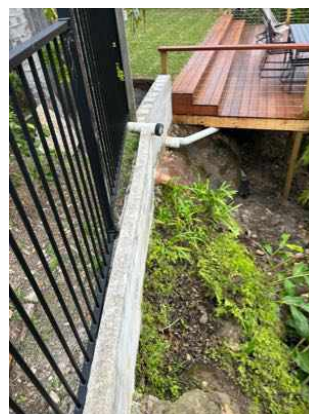
### Defects 3.09

Building:	Building 1
Location:	Pool Area
Finding:	Evidence of excessive moisture was present at the time of inspection
Information:	Excessive moisture can attract termites and produce conditions that promote termite attack fungal growth and wood decay.

Excessive moisture is generally caused by deteriorated inadequate or missing roof drainage leaking plumbing pipes or fixtures poorly plumbed HWS overflows or condenser units and poor site drainage.

It is highly recommended that all plumbing and drainage fixtures and fittings be

maintained regularly in order to prevent excessive moisture being present in the external / internal property.

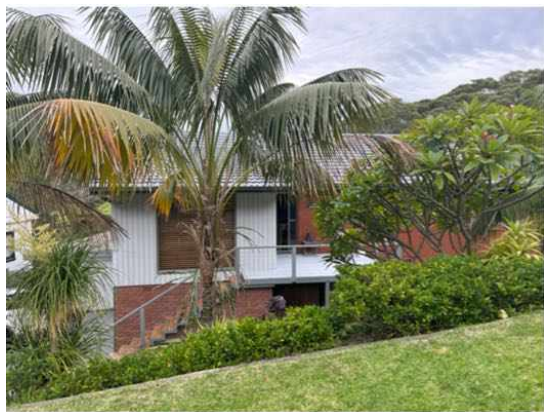
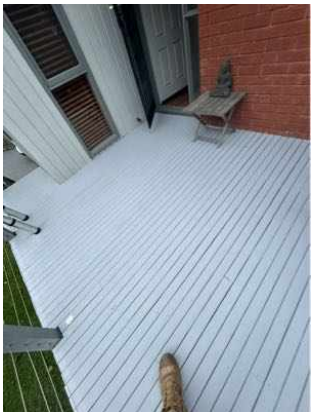
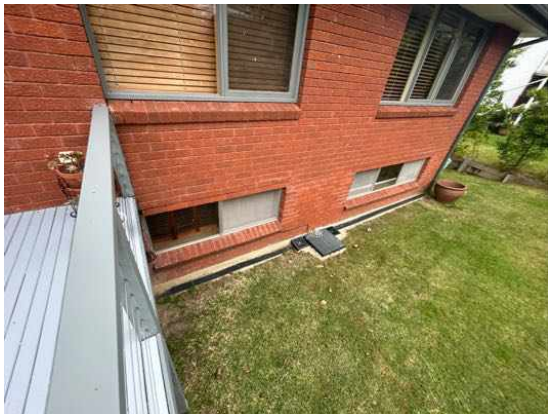
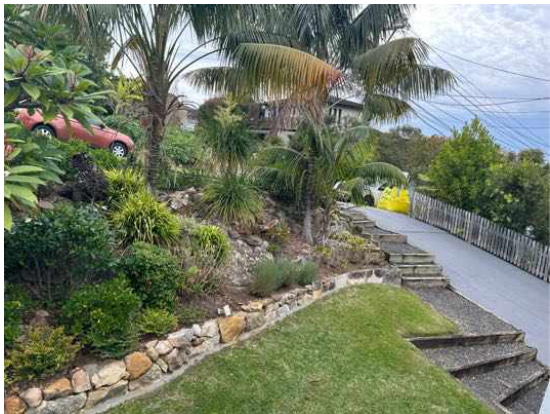
Noted Item

Building: Building 1  
Location: All Areas  
Finding: Additional Photos - Obstructions and Limitations  
Information: These photographs are an indication of the obstructions and limitations which impeded full inspection of the property at the time of inspection. These obstructions can hide an array of defects and should be removed to allow full inspection to be carried out. A re-inspection is recommended once the areas are made accessible.

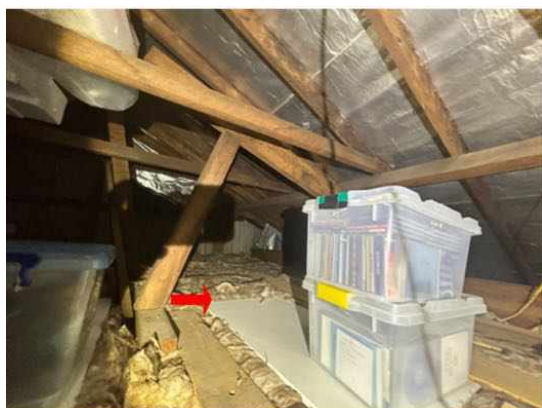
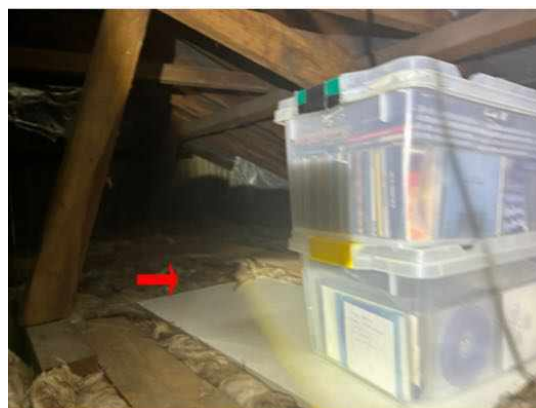
Building: Building 1  
 Location: Roof Void  
 Finding: Insulation - present  
 Information: Upon inspection of the roof void it was noted that there is insulation.

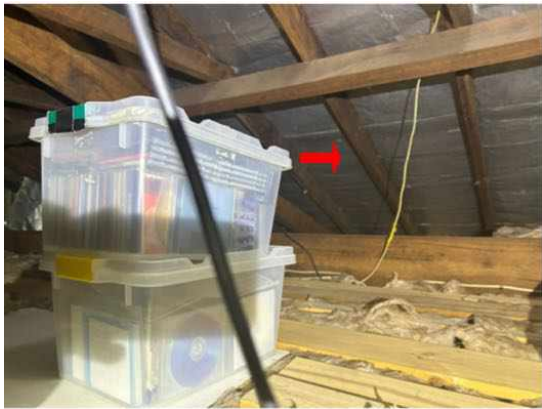
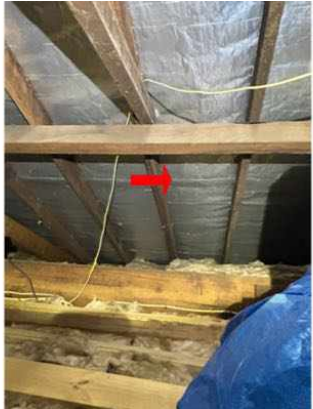
Building: Building 1  
 Location: Roof Void  
 Finding: Sarking - installed  
 Information: Sarking is under the roof sheeting. Sarking acts as an insulator that helps with noise reduction and protects against water penetration. Sarking plays a key role in the operation and function of the overall roofing structure and its performance.

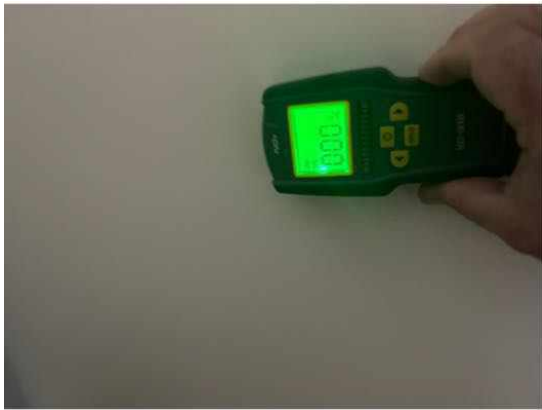
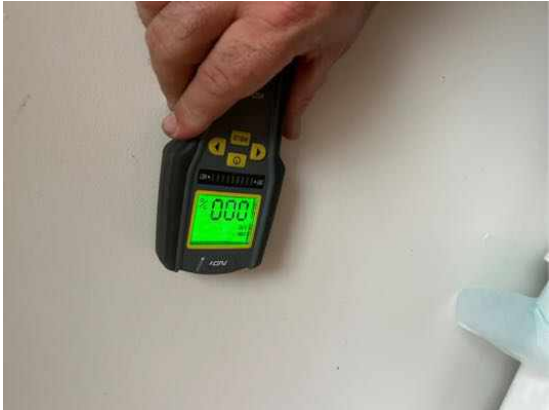
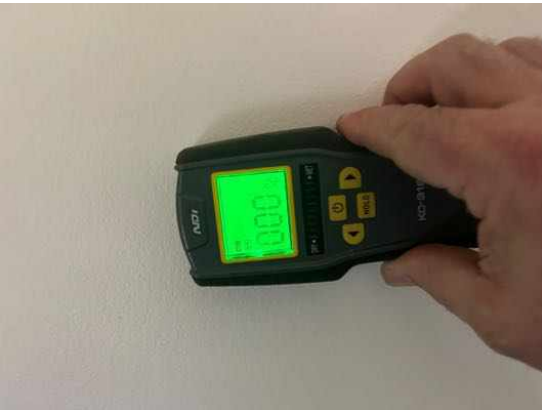
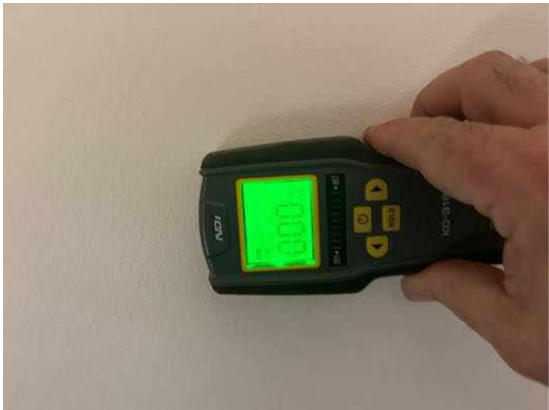
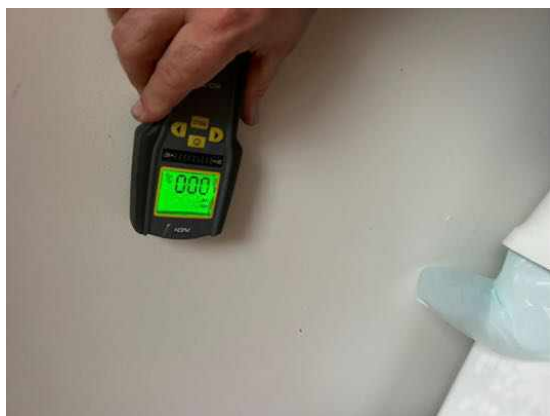
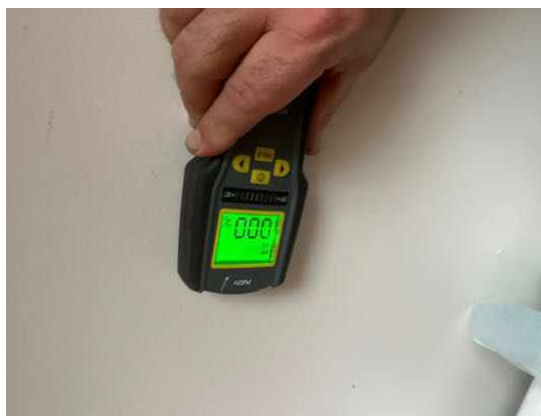
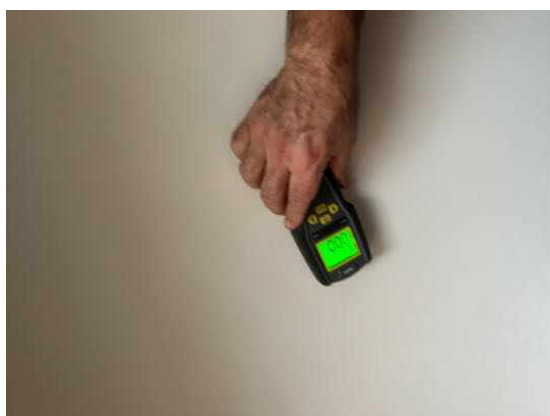
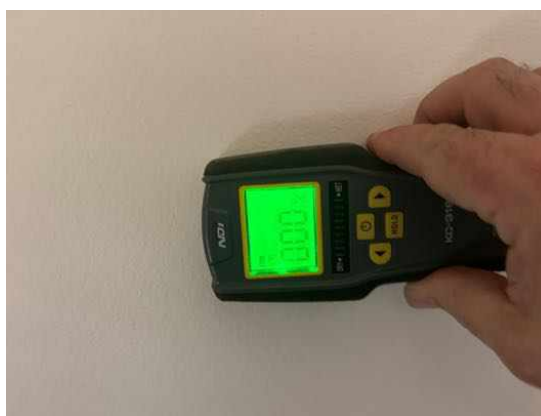
Building: Building 1  
Location: All Areas  
Finding: Moisture meter readings - low  
Information: The moisture meter result for the areas inspected.

The moisture reading of 0-15% is quite normal and gives no cause for concern. However, moisture readings in excess of 15% indicate the need for further inspection.

Levels between 25-30% indicate that there may be water ingress, meaning that remedial work could be required.

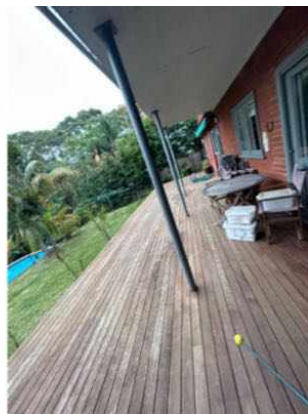
Building: Building 1  
 Location: All External Areas  
 Finding: External Timber Balcony or Deck - Structural Stability  
 Information: The load capacity of the external balcony or deck could not be verified during the inspection.

External timber structures are also constantly exposed to weather elements and can deteriorate in an accelerated manner, ongoing assessments are required.

It is highly recommended that a Structural Engineer further assess the external timber balcony or deck to inform the client of its load capacity. Regular maintenance inspections by competent practitioners is needed.

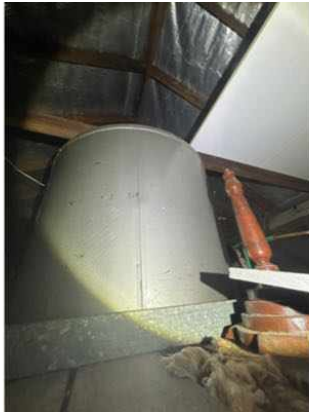
Building: Building 1  
 Location: Roof Void  
 Finding: Gravity-Fed HWS - Disconnected  
 Information: It was noted at the time of inspection that a disconnected gravity-fed hot water system (HWS) remains in this area.

Despite this plumbing structure being unused, it is likely to be storing residual water, and is therefore susceptible to rust and corrosion. If allowed to continue, rust and corrosion is likely to lead to damage to adjoining building elements, and may also make the area susceptible to termite or timber pest activity.

While it is a costly exercise to remove the disused gravity-fed HWS, it is advisable in the short-term future to prevent any further damage to the area. Further consultation with a licensed plumber is required to gain further advice on removal of the structure.
