Building Inspection Report

Inspection Date: Tue, 26 Nov 2019

Property Address: 7 Stirling Pl, Belrose NSW 2085, Australia

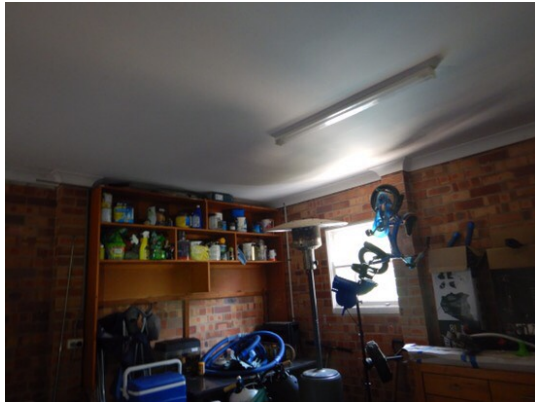
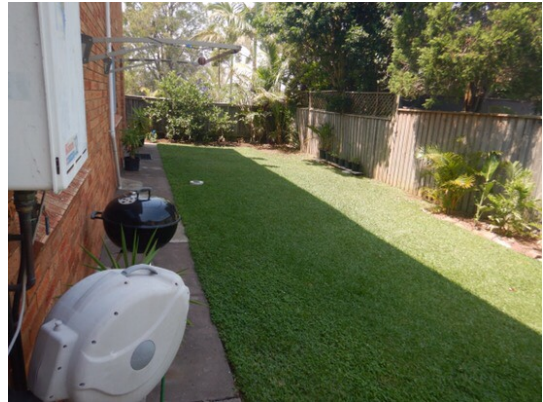
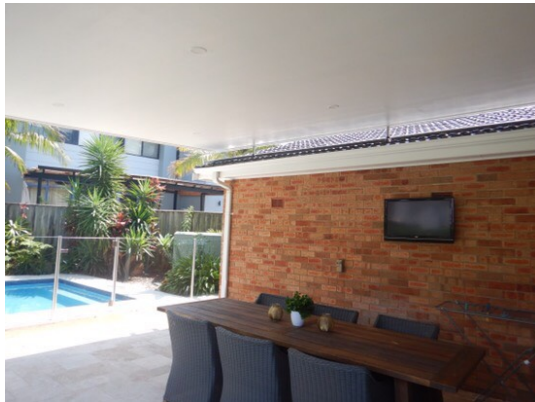
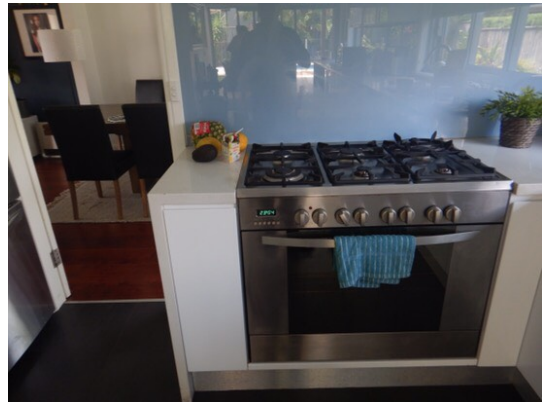
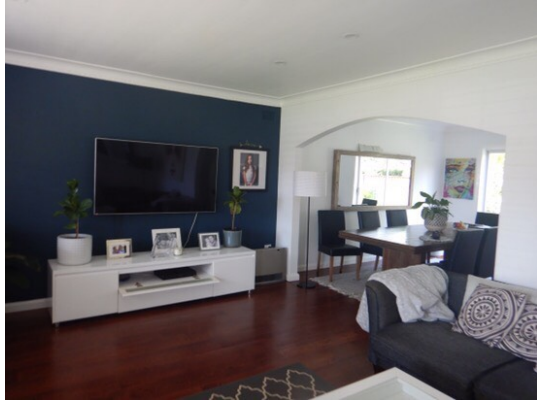
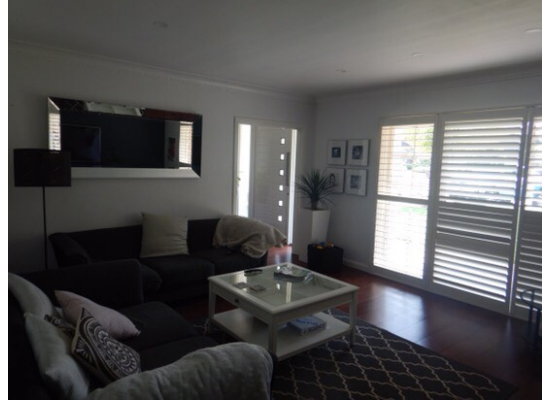
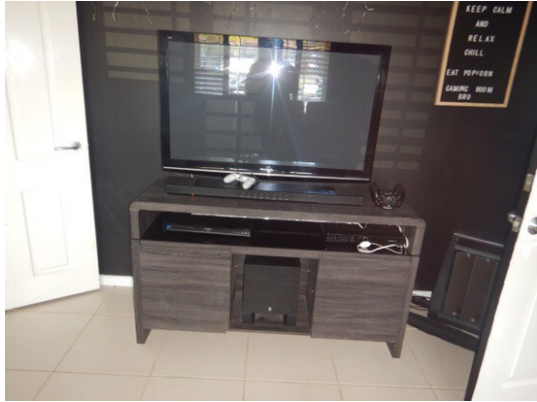
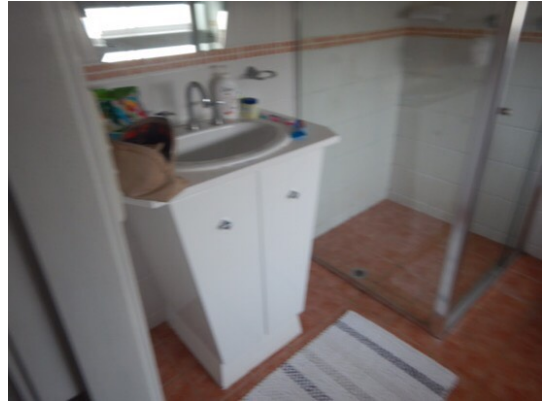
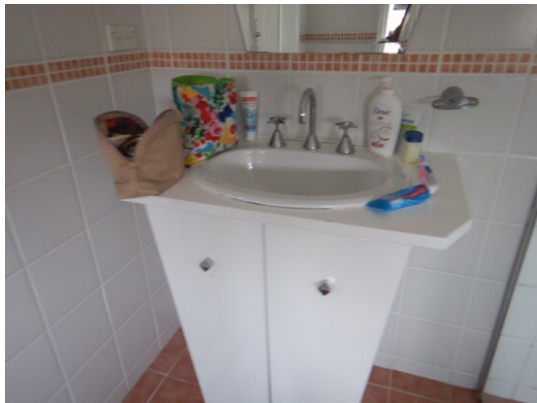
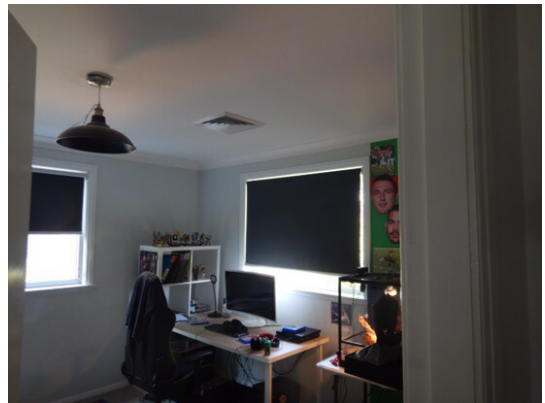
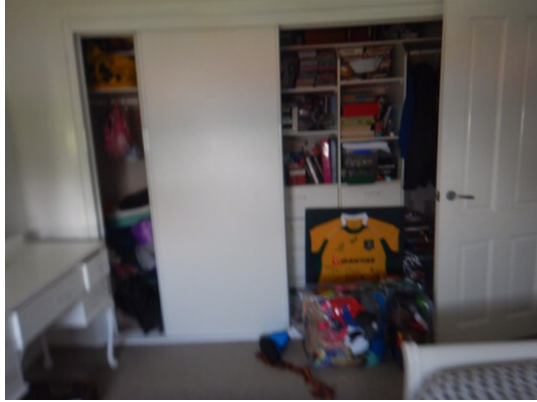
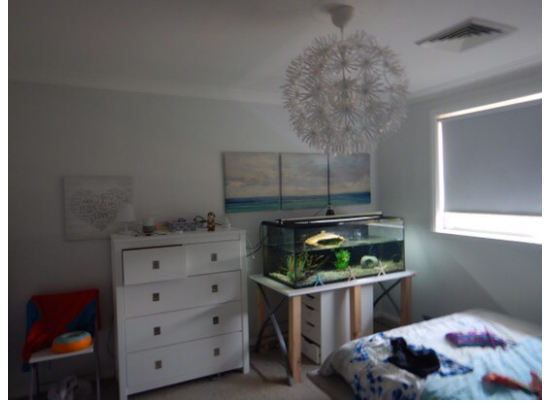
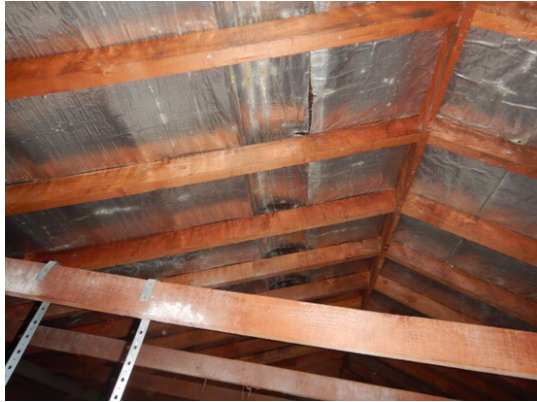
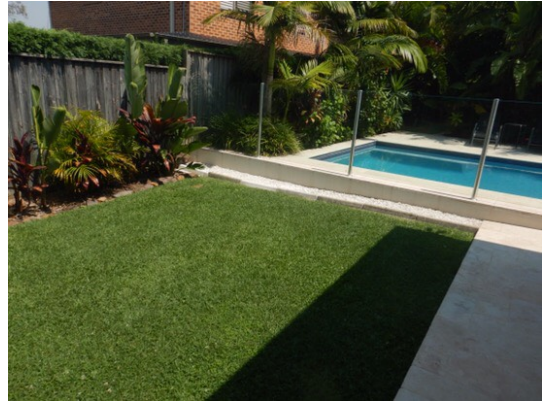
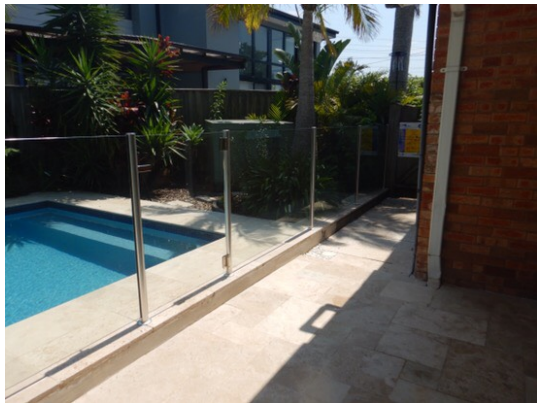
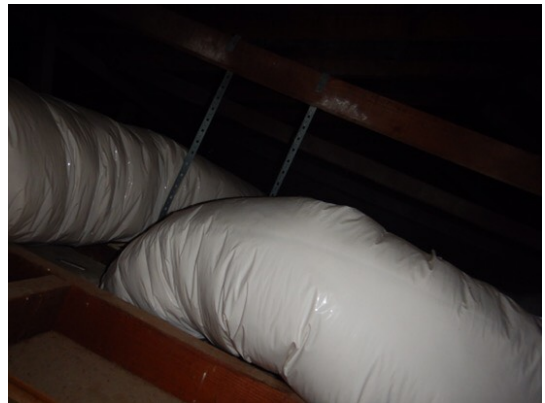
Building: Main Building
Location: All Areas
Finding: Additional Photos - Obstructions and Limitations
Information: These photographs are an indication of the obstructions and limitations which impeded full inspection of the property at the time of inspection.
