Building Inspection Report

Inspection Date: Tue, 27 Aug 2019

Property Address: 3 Tisane Avenue, Frenchs Forest NSW, Australia

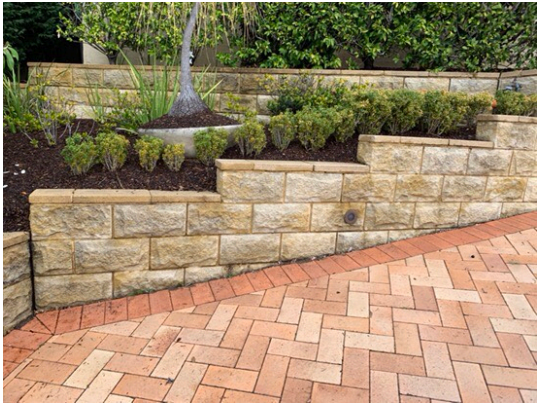
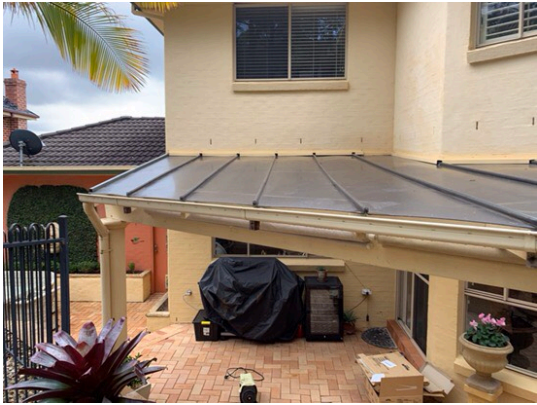
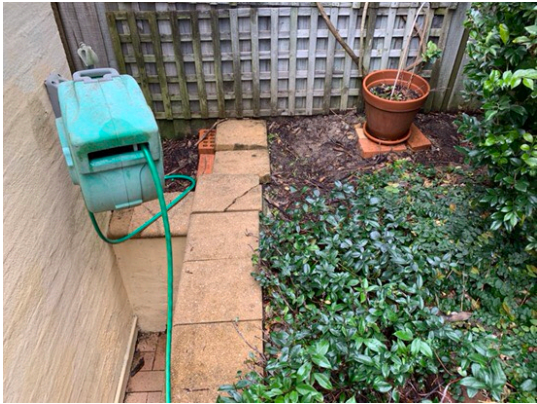
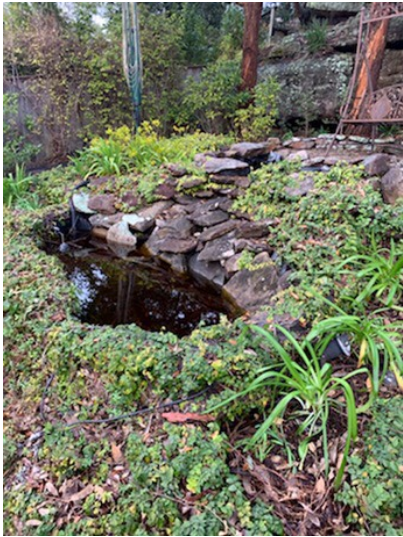
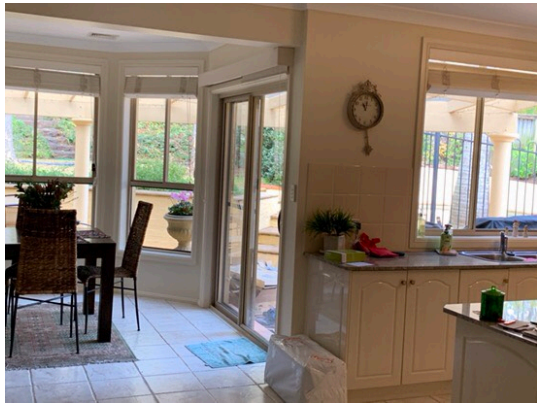
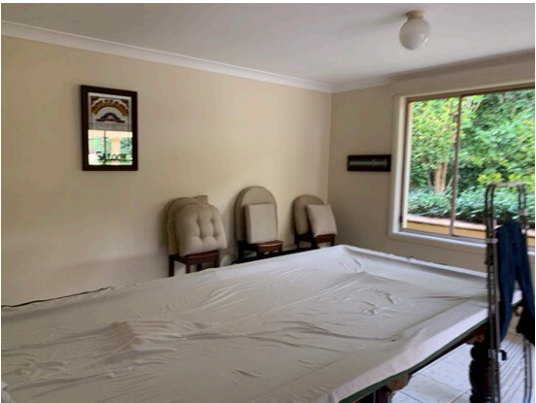
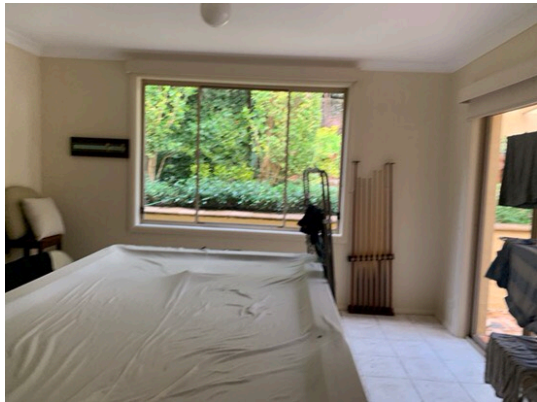
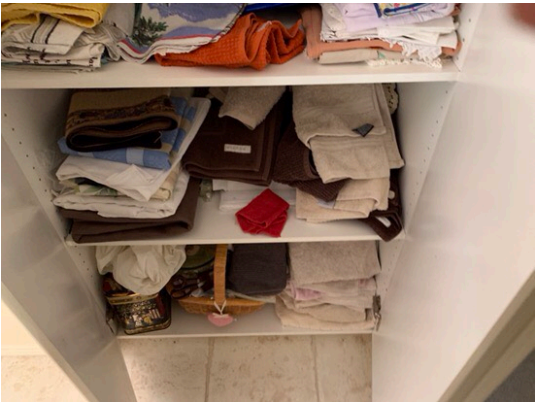
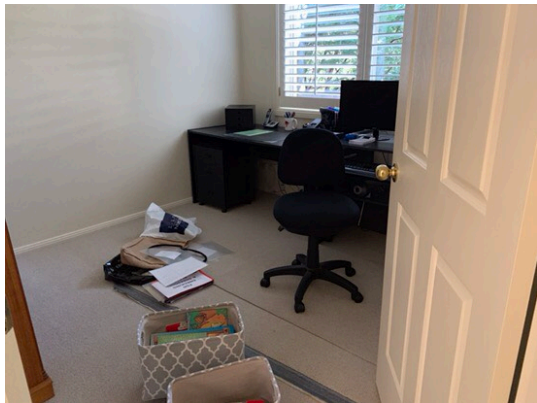
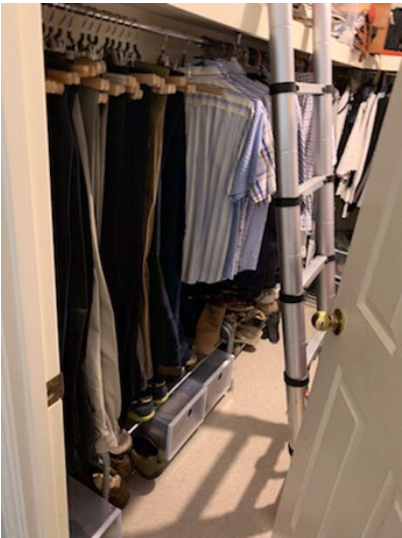
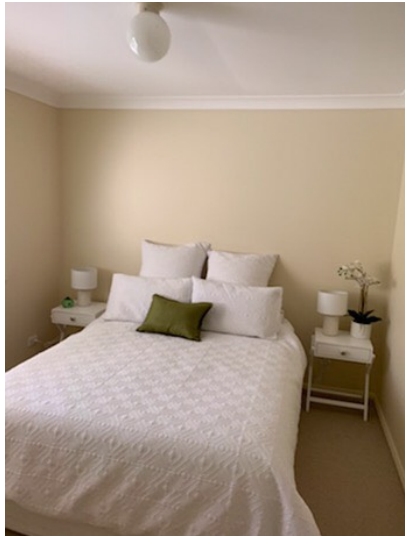
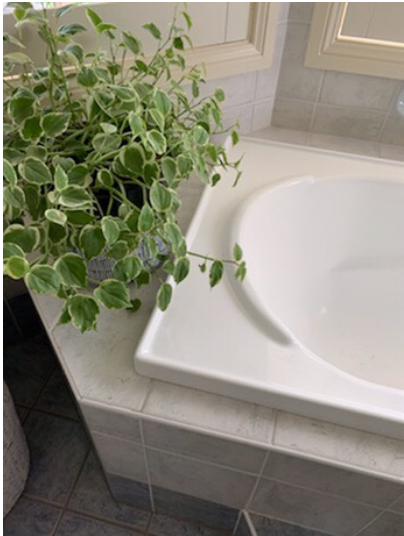
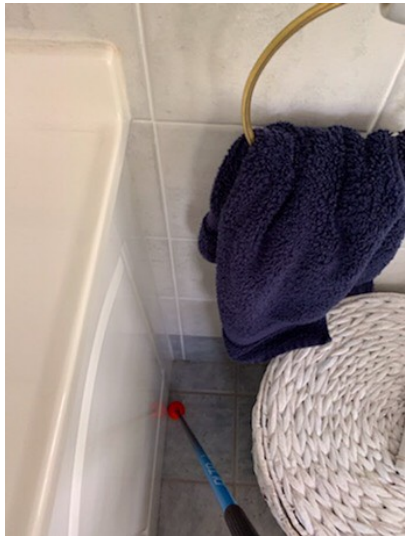
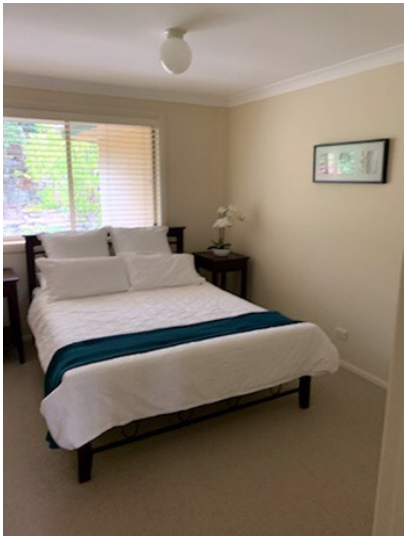
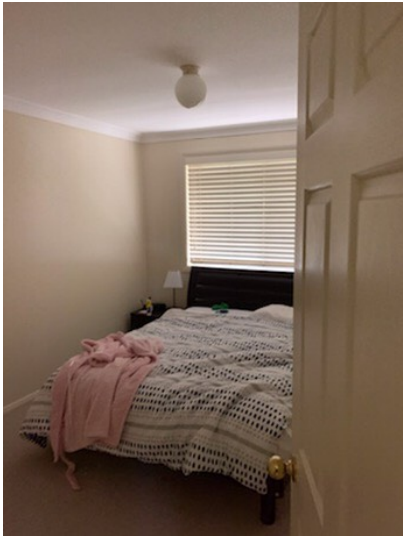
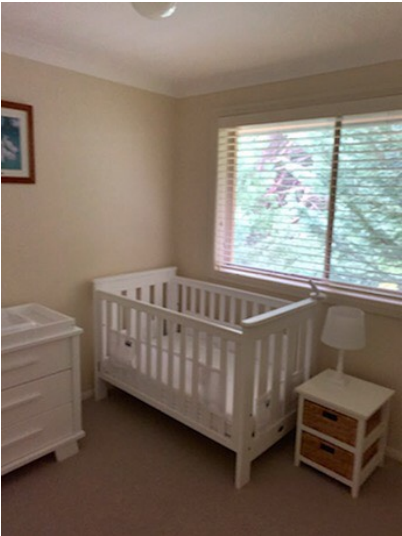
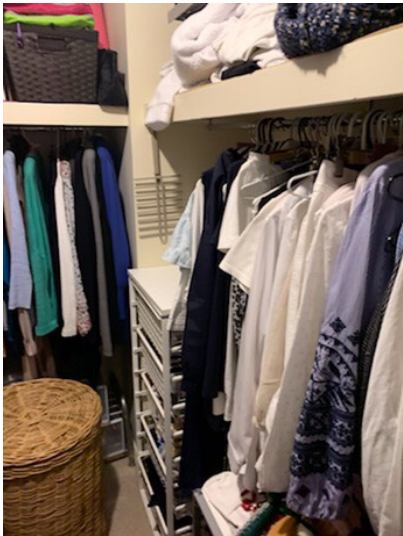
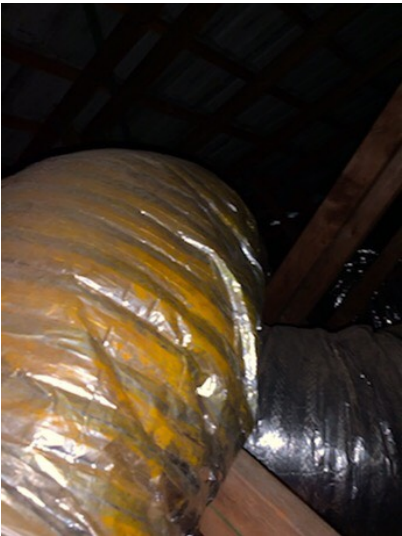
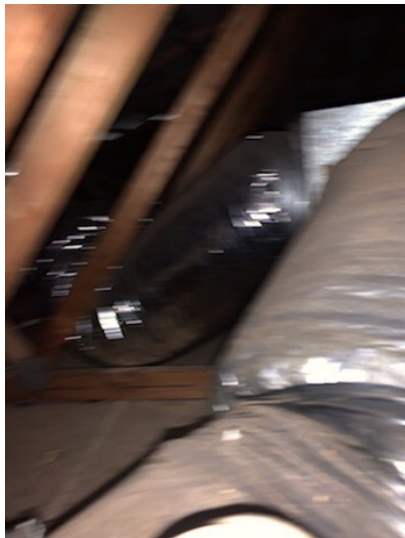
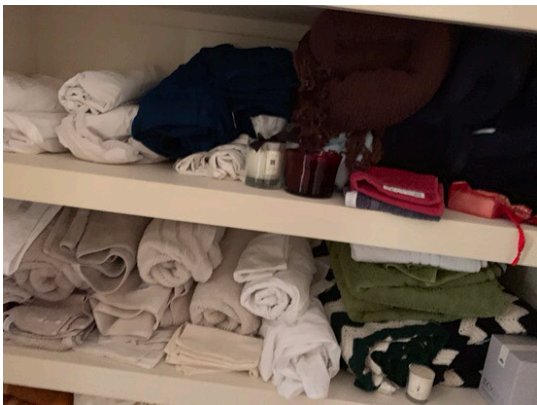
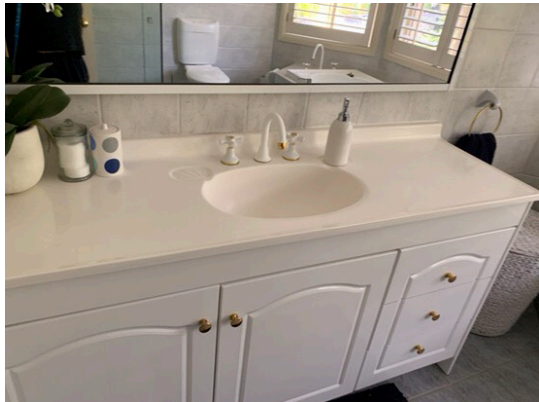
Noted Item

Building:
Location:
Finding: Additional Photos - Obstructions and Limitations
Information: These photographs are an indication of the obstructions and limitations which impeded full inspection of the property at the time of inspection.
