Building and Timber Pest Inspection Report

Inspection Date: Wed, 14 Apr 2021

Property Address: 65a Dareen st, Frenches Forest

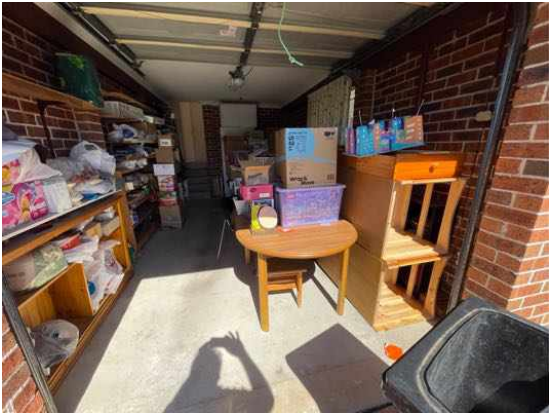
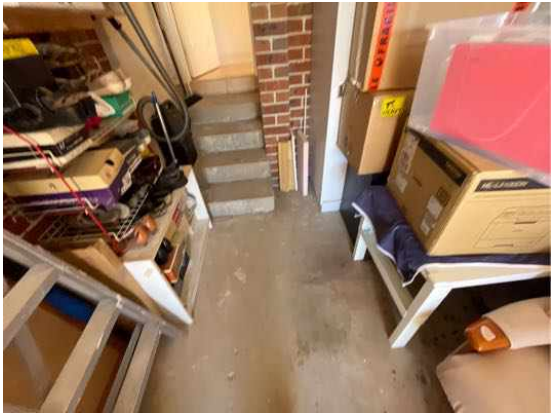
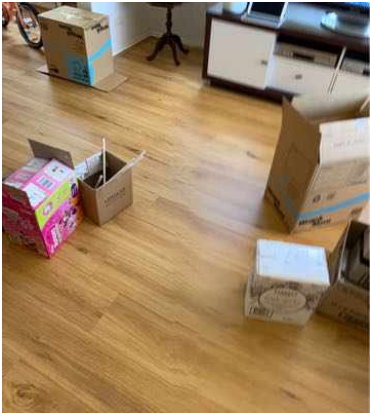
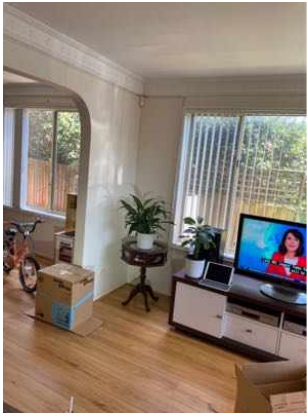
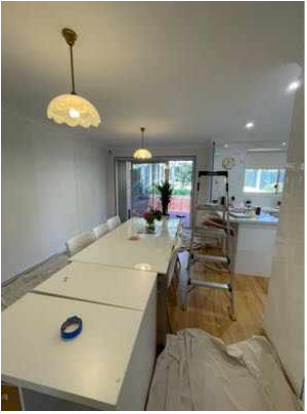
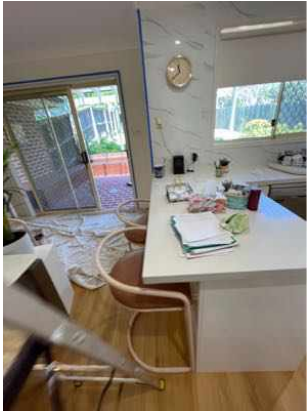
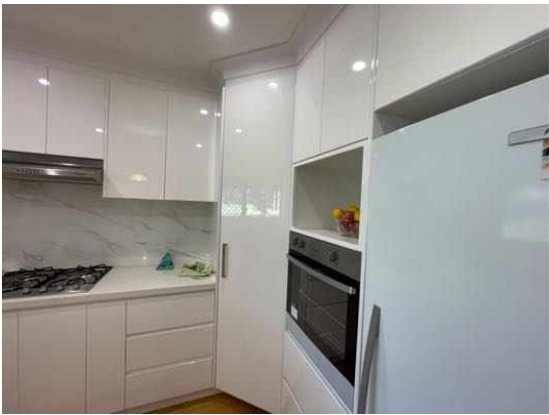
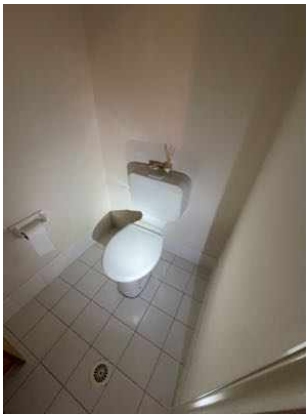
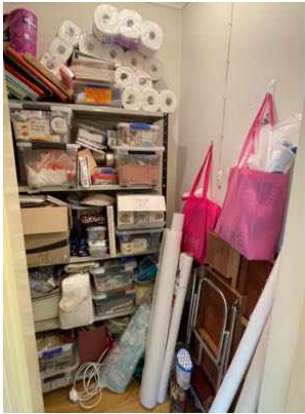
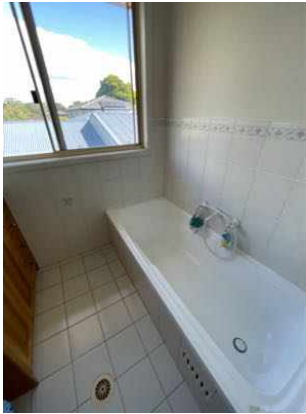
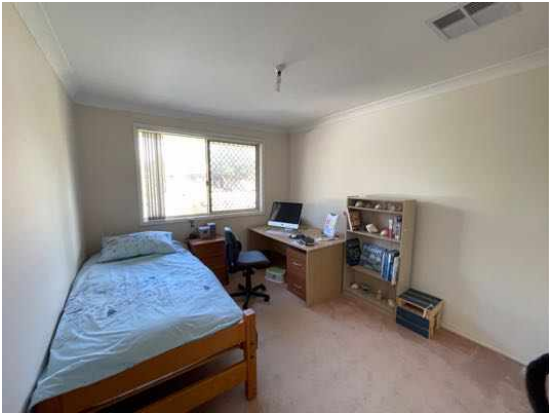
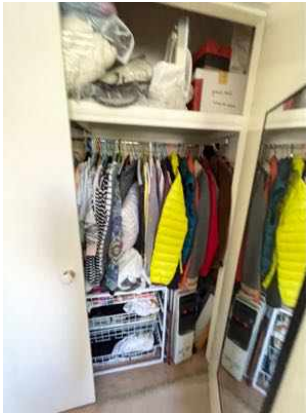
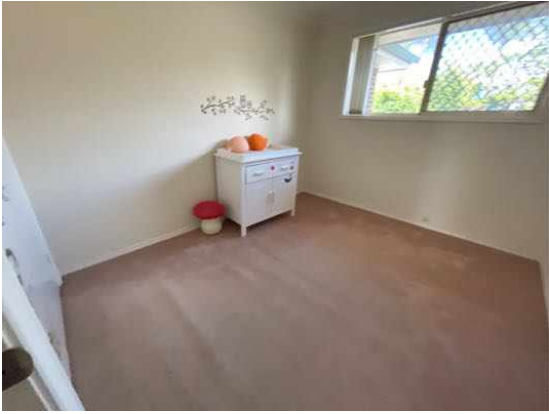
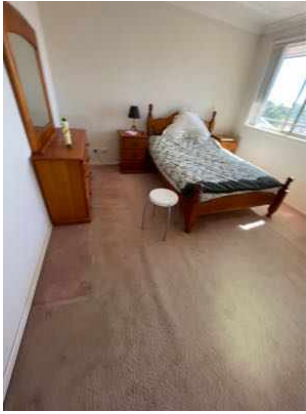
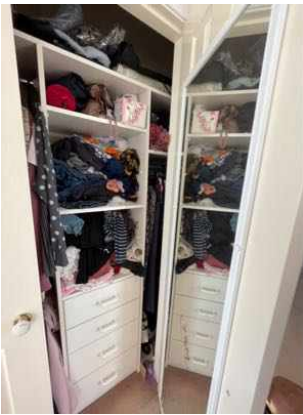
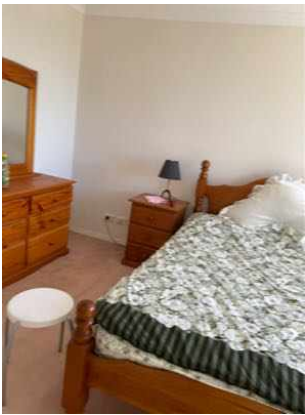
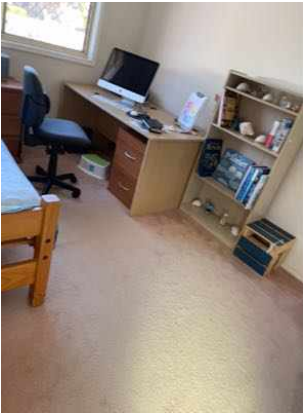
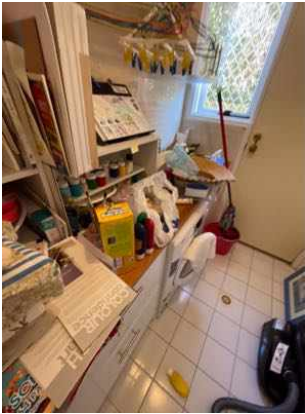
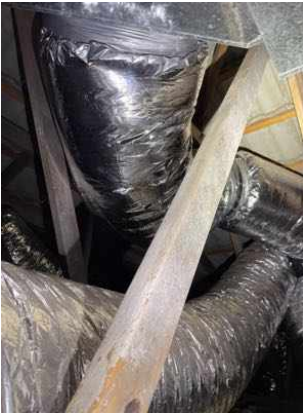
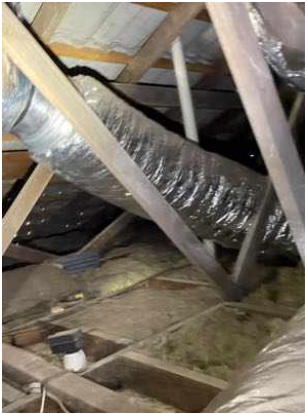
Building: Building 1
Location: All Areas
Finding: Additional Photos - Obstructions and Limitations
Information: These photographs are an indication of the obstructions and limitations which impeded full inspection of the property at the time of inspection. These obstructions can hide an array of defects and should be removed to allow full inspection to be carried out. A re-inspection is recommended once the areas are made accessible.
