## Section D Significant Items

### Defects 3.1

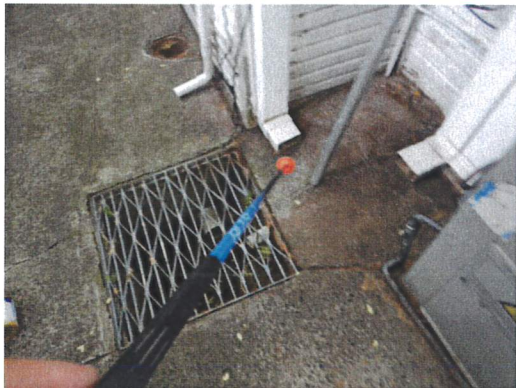
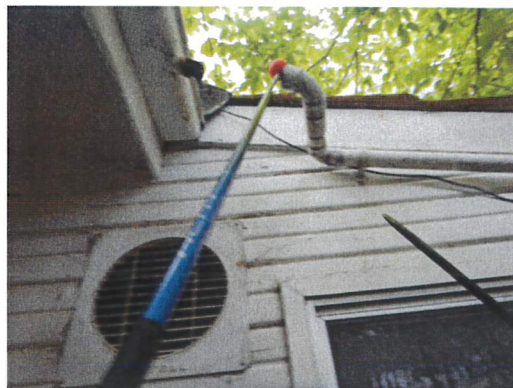
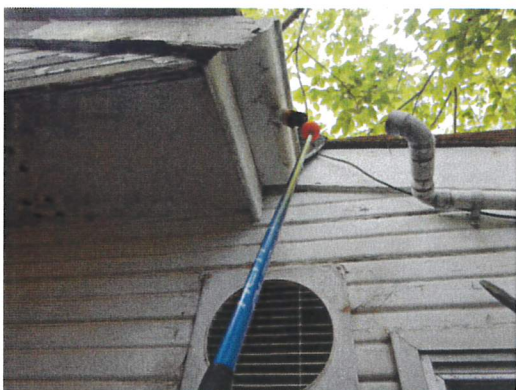
These damp conditions can lead to secondary defects such as rot, rust or corrosion of associated building elements, the formation of fungal decay, or even the creation of potential slip hazards. When coupled with poor site drainage, pooling of water may also attract termite activity to this area.

It is recommended that a qualified plumber be appointed to install adequate drainage to the overflow. These works will ensure that the area remains dry and free of any secondary defects.
