## Building Inspection Report

Inspection Date: Tue, 15 Nov 2022

Property Address: 7 Romford Rd, Frenchs Forest NSW 2086,  
Australia

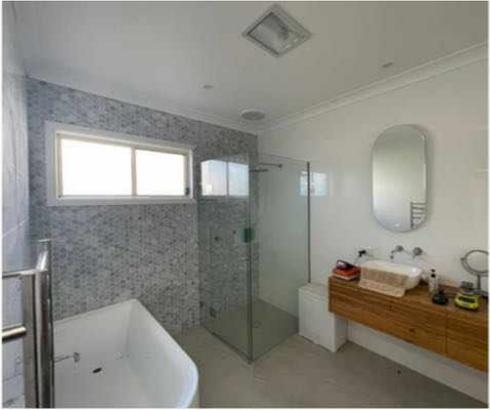
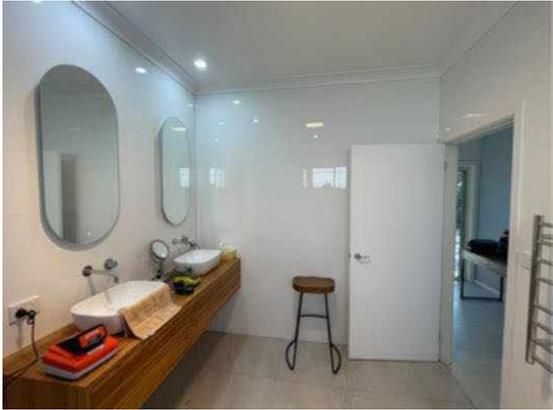
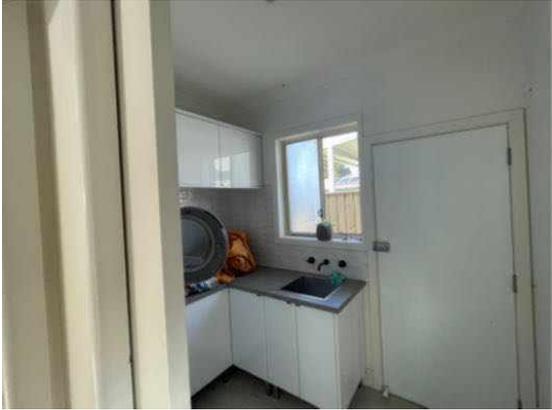
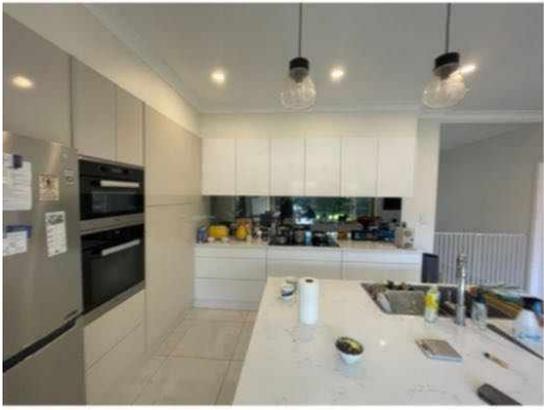
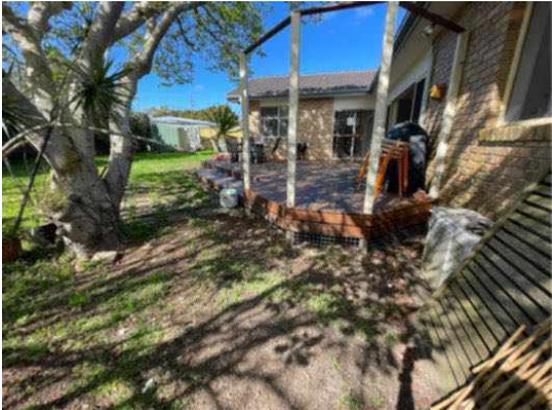
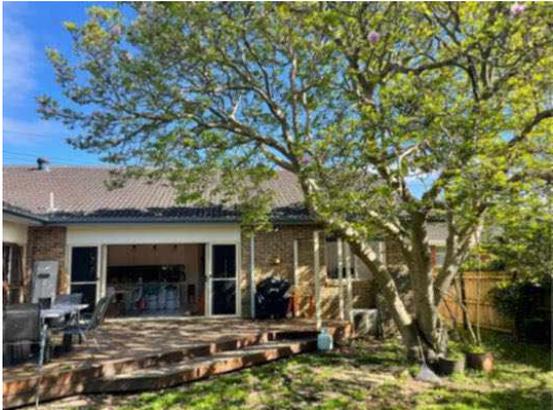
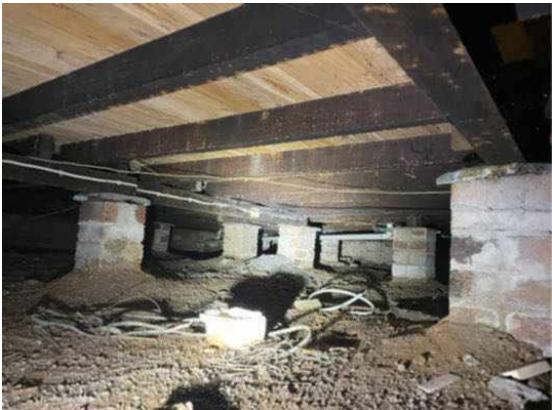
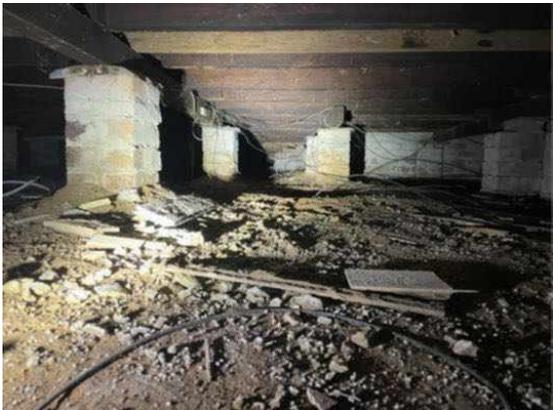
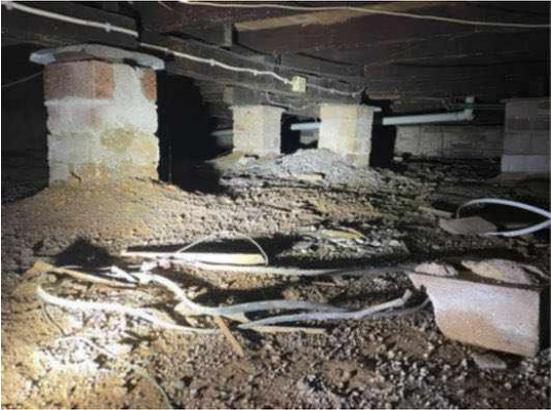
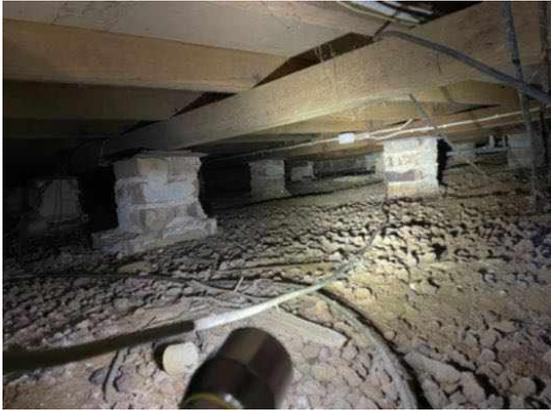
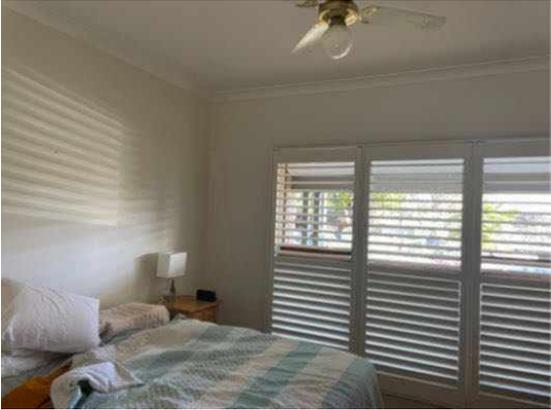
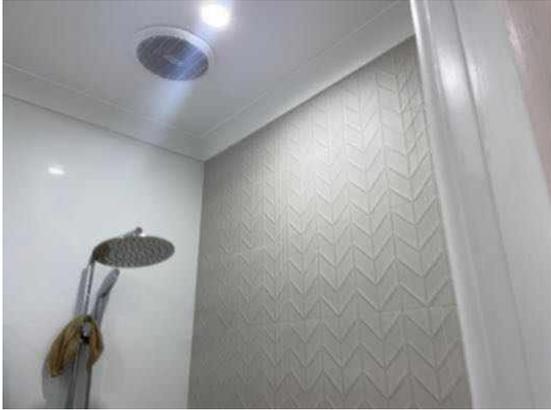
Building: Building 1  
Location: All Areas  
Finding: Additional Photos  
Information: Additional photos are provided for your general reference.
