## Building Inspection Report

Inspection Date: Tue, 23 Jul 2024

Property Address: 19 Elliot St, Beacon Hill NSW 2100,  
Australia

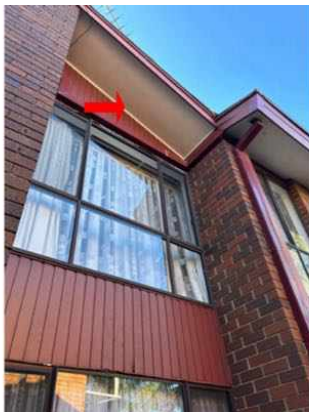
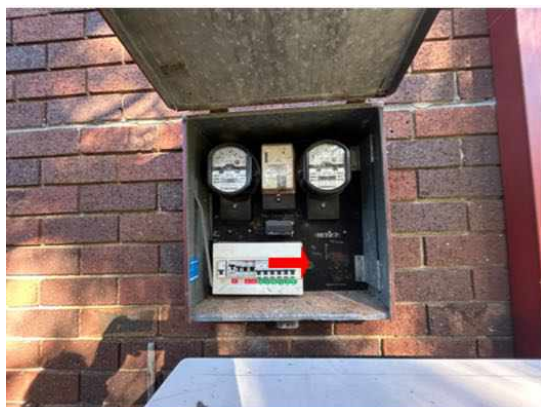
#### Defects 1.01

Building:	Building 1
Location:	All Areas
Finding:	Asbestos - Suspected ACM Identified on Site
Information:	Reporting on Asbestos is outside the Scope of this Report. This suspected defect is highlighted as a caution only. We suspect, based on our experience in the building industry, that there is a higher risk of the identified building element containing asbestos.

As Asbestos Reporting is outside the scope of this report, we advise that you consider a separate Asbestos Inspection and Condition Audit, which can include the taking of samples for definitive confirmation of the presence of Asbestos.

In the interim, the client is advised to act with caution, especially when considering any damage to building materials general wear and tear renovations extensions demolition and general maintenance activities due to the suspected presence of Asbestos.

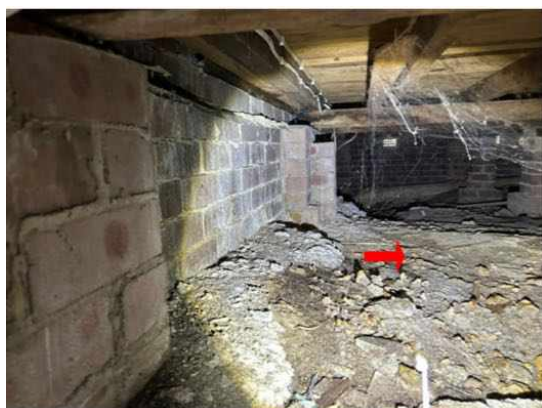
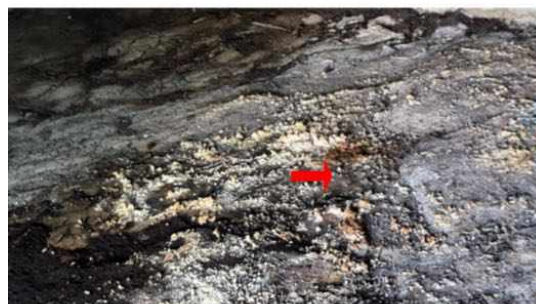
#### Defects 1.02

Building:	Building 1
Location:	Subfloor
Finding:	Mould - visually identified
Information:	Where evidence of growth was noted, there may be environmental, biological or health issues associated with the area. A specialist inspection by a suitably qualified environmental health inspector is warranted, where mould is extensive or where any queries regarding air quality spores or other related issues apply.

Generally, the client is advised to ensure that the general environment is free of moisture and humidity to aid in the prevention of mould formation and development. Any mould found during the inspection should be cleaned immediately by a cleaning contractor or the homeowner as applicable.

Please note that severely affected building elements may require replacement by a registered builder or qualified carpenter.

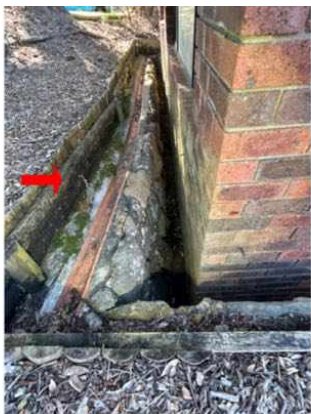
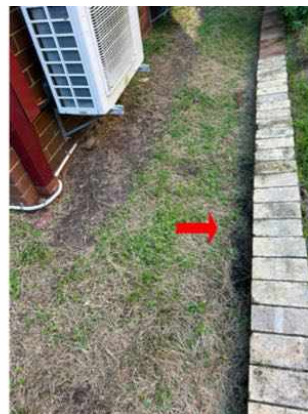
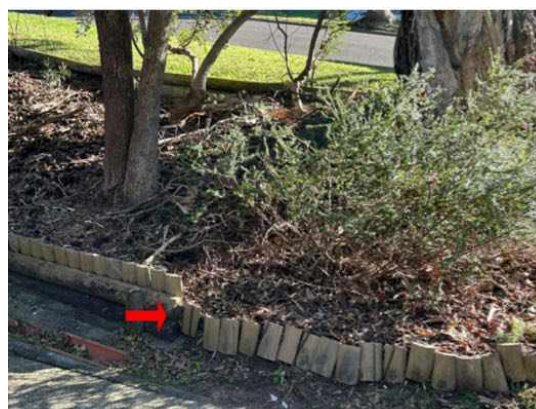
### Defects 3.01

Building:	Building 1
Location:	Yard - Back
Finding:	Retaining wall - Defective
Information:	The retaining wall in this area was found to be defective at the time of inspection. Generally, defective retaining walls are caused by poor original design or material use. However, deteriorated retaining walls may also be a result of substandard construction, poor site drainage or unmanaged stormwater flows.

If left unmanaged, the retaining wall may become a safety hazard if it continues to

destabilise.

Where retaining walls are considered structural walls, a structural engineer / surveyor should be consulted regarding required remedial works. Otherwise, a landscaper or retaining wall installer may be appointed to repair or replace the wall, at the discretion of the client.

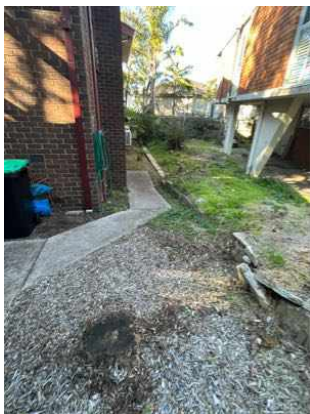
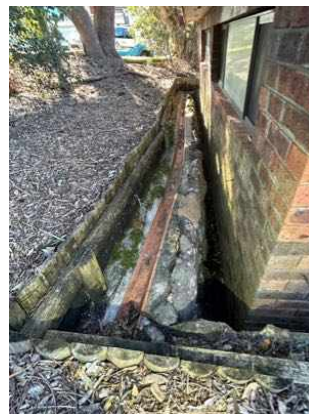
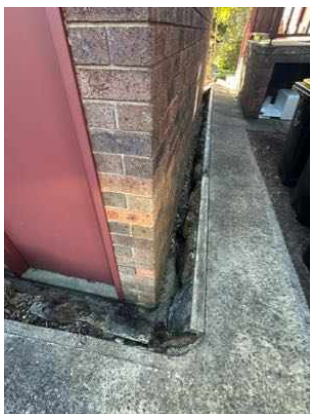
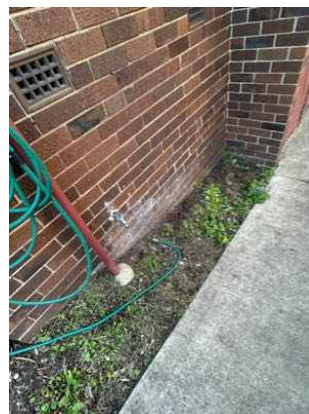
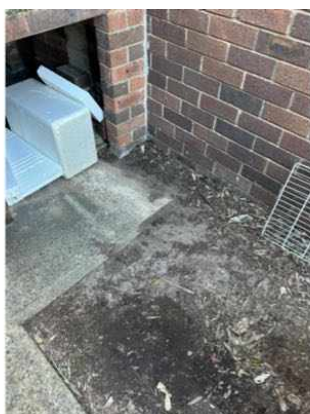
### Defects 3.02

Building:	Building 1
Location:	All Areas
Finding:	Evidence of excessive moisture was present at the time of inspection
Information:	Excessive moisture is generally caused by deteriorated inadequate or missing roof drainage leaking plumbing pipes or fixtures poorly plumbed HWS overflows or condenser units and poor site drainage.

Excessive moisture can attract termites and produce conditions that promote termite attack fungal growth and wood decay.

It is recommended that all plumbing and drainage fixtures and fittings be maintained regularly in order to prevent excessive moisture being present in the external / internal property.

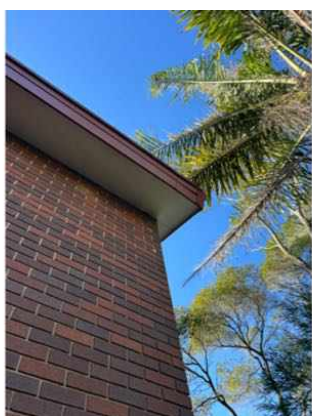
### Defects 3.03

Building: Building 1  
 Location: Yard - Back  
 Finding: Trees - Overhanging and filling gutters  
 Information: Overhanging trees often result in excessive amounts of leaf debris accumulating in gutters.

Gutters are a critical part of the building's management of storm water and rain. It is therefore important that they be kept clear to prevent secondary damage to associated building elements, including exterior and interior walls, ceiling linings and any adjoining building elements. Where gutters are blocked, pooling of rainwater is likely to occur, fast-tracking rust and corrosion of the roof plumbing elements.

It is highly advised that all overhanging tree branches be removed as soon as possible to prevent any further damage. Repair and/or replacement of sections of damaged guttering may also be required where the extent of the damage necessitates.

Such works should be performed by the homeowner; however, appointment of a landscape contractor or an arborist may be required. Consultation with a licensed roof plumber is required where guttering has been damaged.

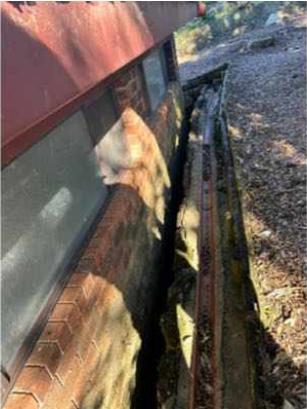
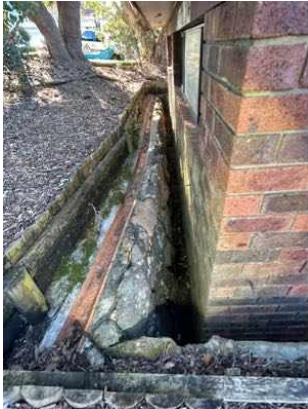
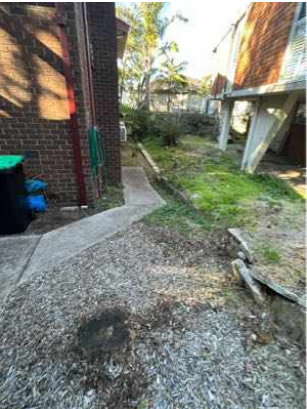
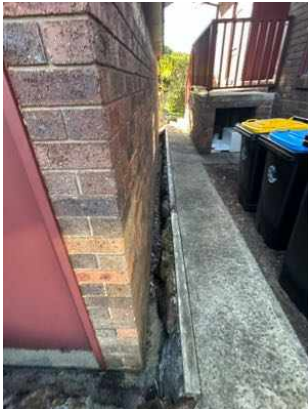
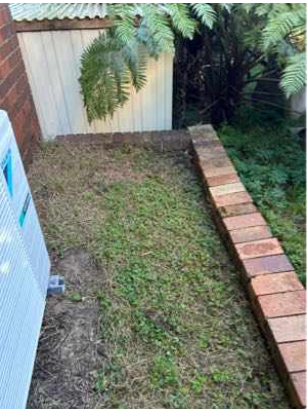
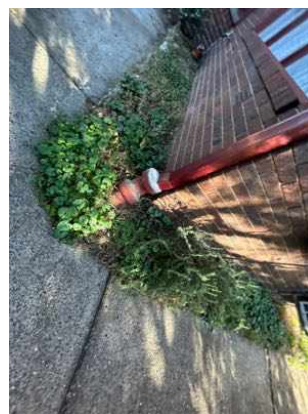
### Defects 3.04

Building:	Building 1
Location:	All Areas
Finding:	Site drainage - suspected Inadequate
Information:	The site drainage in this area was found to be inadequate at the time of inspection, creating potential for subsequent water damage to associated building elements.

Where site drainage is inadequate, installation of an Agricultural (Aggie) Drain may be

required. A qualified plumber should be appointed to further inspect the property and perform any remedial works as necessary. Water damage and secondary defects are likely to occur if left unmanaged.

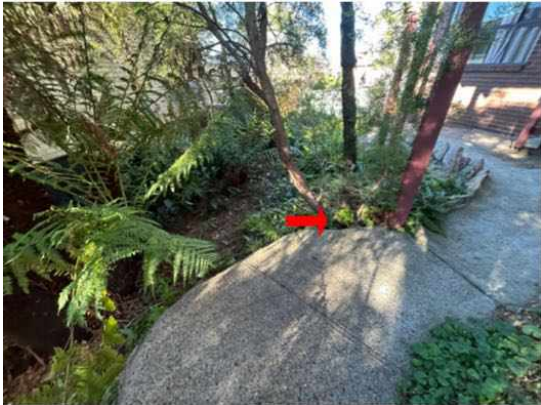
### Defects 3.05

Building:	Building 1
Location:	All Areas
Finding:	Subsidence - Local trees and vegetation
Information:	Trees and other vegetation can have a significant local effect on drying of soils. Over a number of years, especially during drought conditions, adjacent trees and vegetation may draw excessive moisture from the soils. The opposite may also occur, where swelling of the soil results when the trees decline or are removed.

As the cumulative moisture deficient is reversed, the surface level around the tree (and adjoining subfloor) will rise and expand laterally. This is often damaging to buildings unless the foundations have been strengthened or designed to cope with the effect.

Subsidence can have complex and varying causes, which will influence the required remedial works. It is advised to begin by consulting a structural engineer to determine the required scope of works. This generally includes some form of underpinning, as well as addressing the underlying cause. Consultation with a geotechnical engineer may also be necessary.

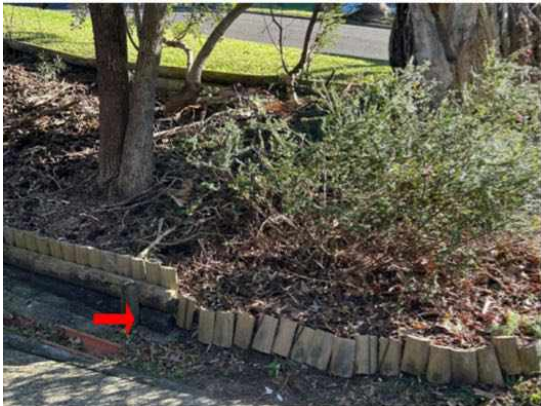
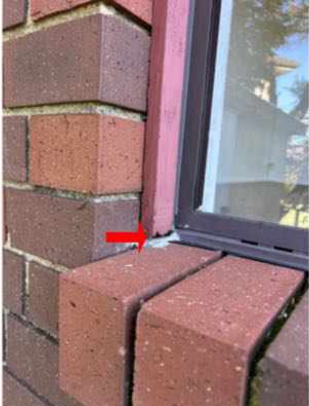
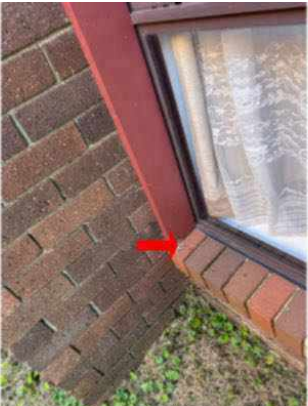
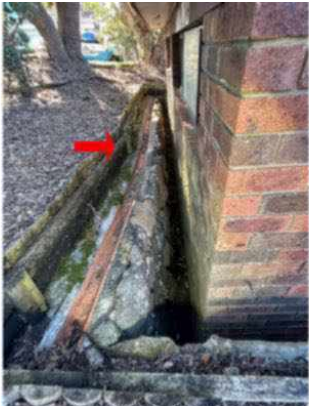
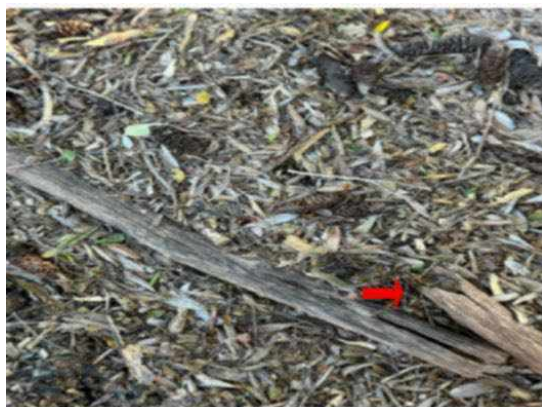
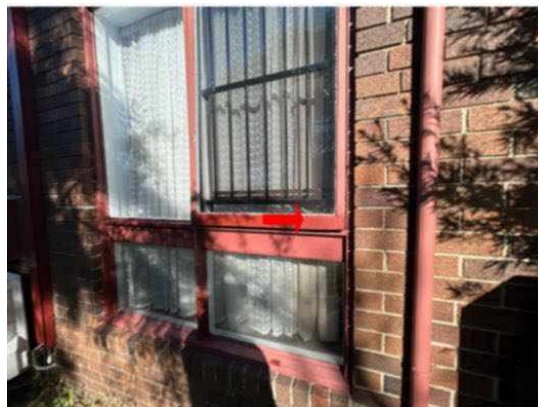
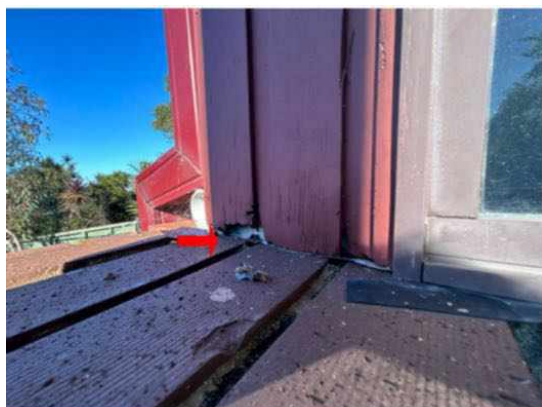
**Defects 3.06**

Finding: Wood rot

Information: This building element shows evidence of wood rot. Wood rot, also known as Fungal Decay, occurs when timbers and other cellulose building materials are exposed to damp conditions on an ongoing basis.

This could be the result of exposure to weathering over a prolonged period of time, or the attraction of excessive moisture from other abutting building materials. Contributing factors also include poor air ventilation in the area.

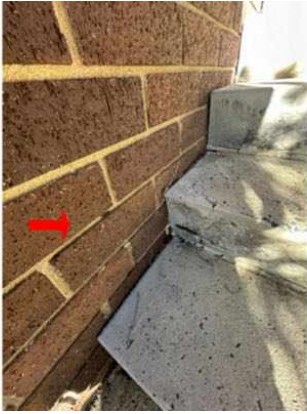
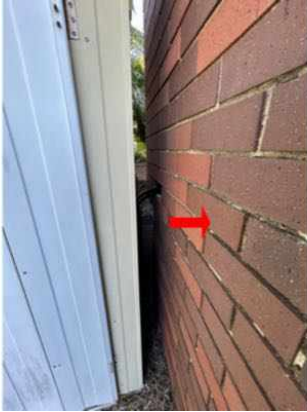
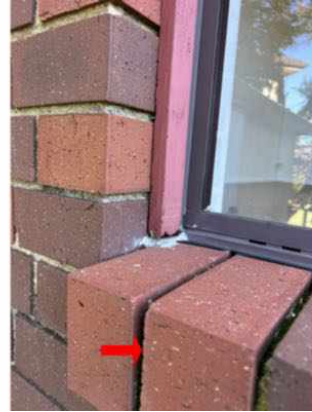
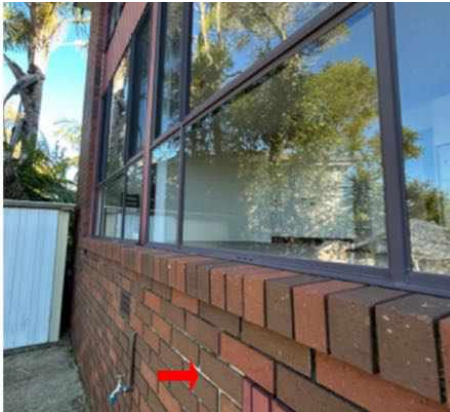
### Defects 3.07

Building:	Building 1
Location:	All Areas
Finding:	Mortar - Deterioration
Information:	Mortar, or 'bedding', is the material which fills joins and intersections between tiles and other building elements on the exterior roof covering, such as gable ends, hip capping and valleys. Upon inspection of the exterior roof, it was noted that sections of the mortar show varying levels of deterioration.

Mortar generally deteriorates as a result of frequent exposure to weather conditions over a prolonged period of time. Mortar that is deteriorating may allow water ingress into the roof void, putting associated building elements and roofing structures at risk of water damage. Deteriorated mortar also detracts from the functionality of roof tiles and other roofing elements, potentially decreasing weather tightness and roof drainage.

Mortar deterioration can be attended to by a handyman where areas of deterioration are localised and easily accessible. Otherwise, consultation with a roofing contractor is advised where greater works are required.

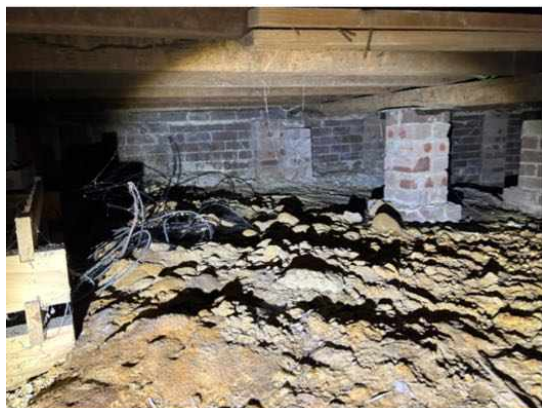
### Defects 3.08

Building:	Building 1
Location:	Subfloor
Finding:	Evidence of excessive moisture was present at the time of inspection
Information:	Excessive moisture can attract termites and produce conditions that promote termite attack, fungal growth and wood decay. Excessive moisture is generally caused by deteriorated, inadequate or missing roof drainage, leaking plumbing pipes or fixtures, poorly plumbed HWS overflows or condenser units and poor site drainage.
	It is recommended that all plumbing and drainage fixtures and fittings be maintained regularly to prevent excessive moisture from being present in the external / internal property.

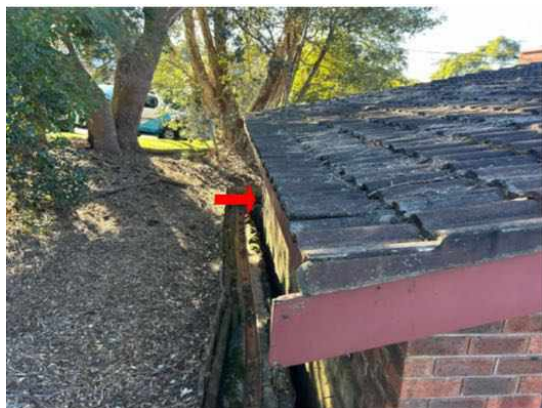
### Defects 3.09

Building:	Building 1
Location:	Garage
Finding:	Roof plumbing- Not plumbed for drainage
Information:	The roof plumbing is not plumbed or connected to suitable drainage, which has resulted in the surrounding area becoming excessively damp.

These damp conditions can lead to secondary defects such as rot, rust or corrosion of associated building elements, the formation of fungal decay, or even the creation of potential slip hazards.

When coupled with poor site drainage, pooling of water may also attract termite activity to this area. It is highly recommended that a qualified plumber be appointed to install adequate drainage to the overflow. These works will ensure that the area remains dry and free of any secondary defects.

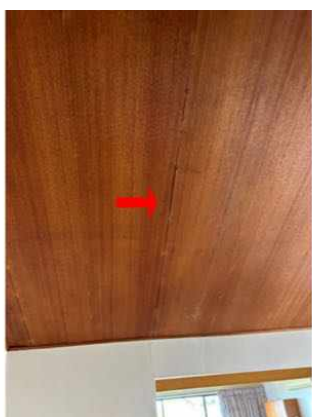
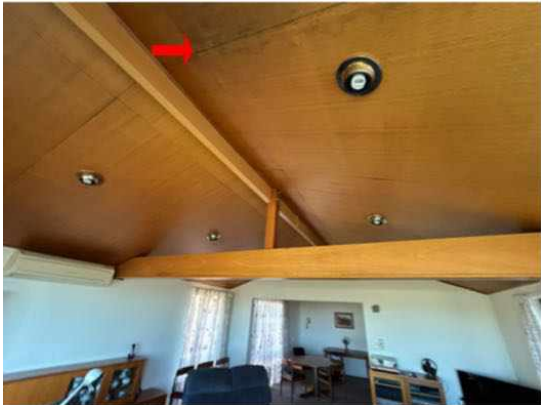
### Defects 3.10

Building:	Building 1
Location:	All Areas
Finding:	Ceiling - Water stained
Information:	Water staining to ceiling linings in this area was evident at the time of inspection. Water staining indicates that surfaces have been exposed to excessive moisture over time. The minerals and other elements in the water lead to staining, which may graduate to corrosion and deterioration if left unmanaged.

While mostly an appearance defect, water staining can be indicative of more serious defects, which may be currently concealed by interior ceilings.

Where water staining is active, a licensed plumber must be consulted to identify the cause of the staining and to provide advice on any reparation works that may be required. Replacement or repair of any damaged structures is advised.

Conversely, where water staining is old and inactive, affected building materials may be repaired or replaced at client discretion.

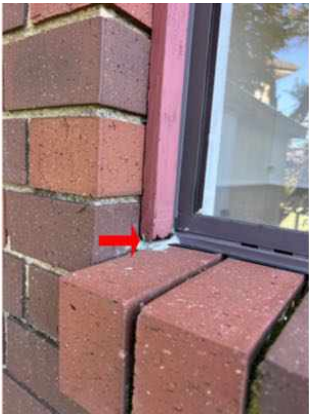
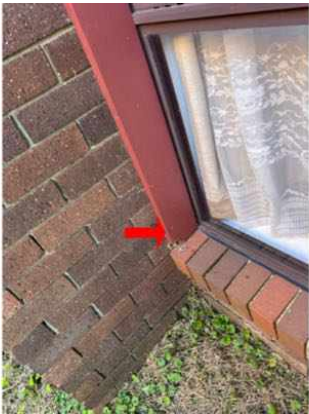
**Defects 3.11**

Building: Building 1  
Location: All Areas  
Finding: Window Evidence of deterioration  
Information: Rectification works may include repair or replacement depending on the extent of damage.

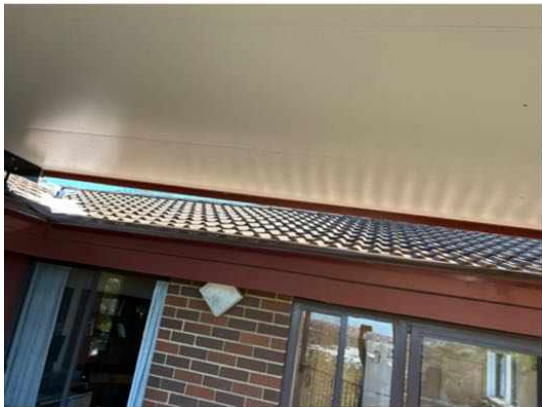
**Defects 3.12**

Information: Upon the inspection of the exterior roofing, the majority of roof tiles were considered to be in a fair condition. While the weathering of the tiles is consistent with the age of the property, maintenance works are required.

Where left unmanaged, deteriorating roof tiles are likely to lead to a number of secondary defects, including minor water leaks and weather exposure to internal roofing structures.

Consultation with a roofing contractor is highly advised to gain advice on cost of remedial works that may be required in the short to medium term. Remedial works are likely to increase the longevity of the exterior roofing structure.

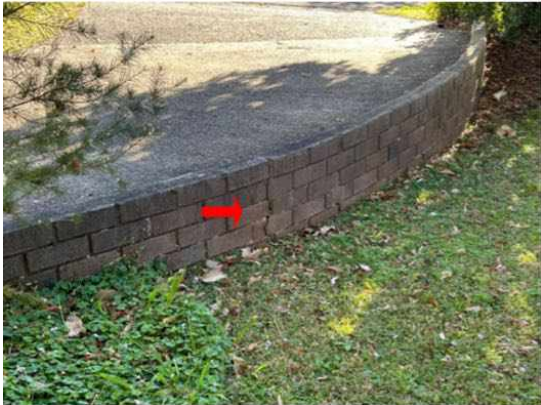
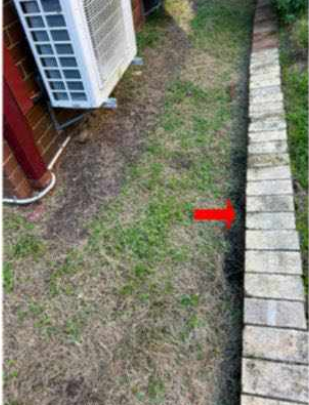
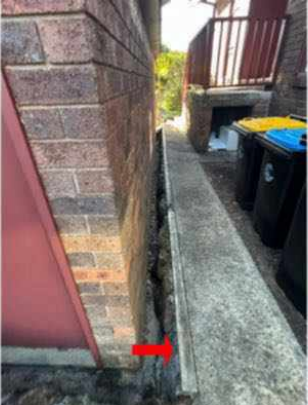
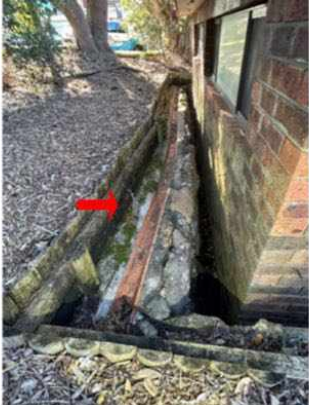
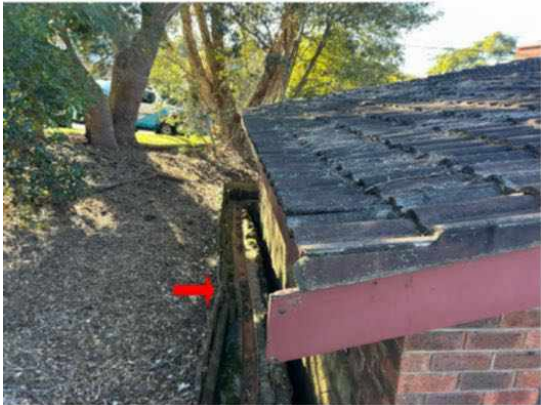
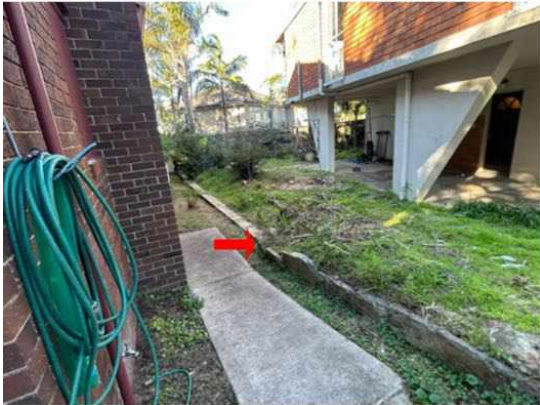
### Defects 3.13

Building: Building 1  
Location: All External Areas  
Finding: Retaining wall - Defective  
Information: The retaining wall in this are was found to be defective at the time of inspection. Generally, defective retaining walls are caused by poor original design or material use. However, deteriorated retaining walls may also be a result of substandard construction, poor site drainage or unmanaged stormwater flows.

If left unmanaged, the retaining wall may become a safety hazard if it continues to destabilise. Where retaining walls further rot and decay, an environment is created that is conducive to termite and pest infestation.

Where retaining walls are considered structural walls, a structural engineer / surveyor should be consulted regarding required remedial works. Otherwise, a landscaper or retaining wall installer may be appointed to repair or replace the wall, at the discretion of the client.

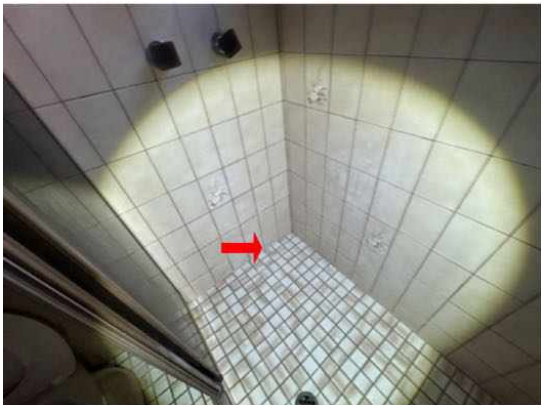
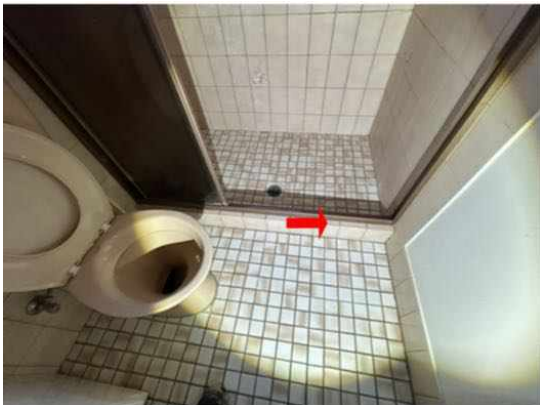
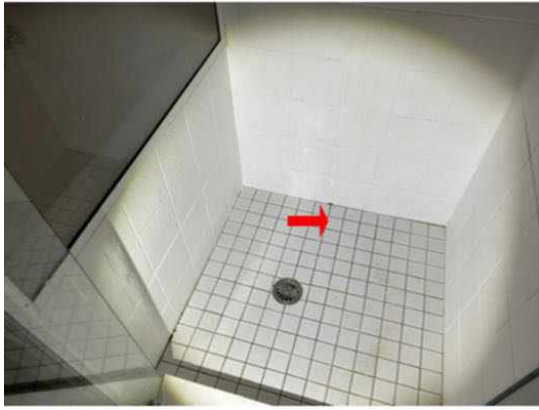
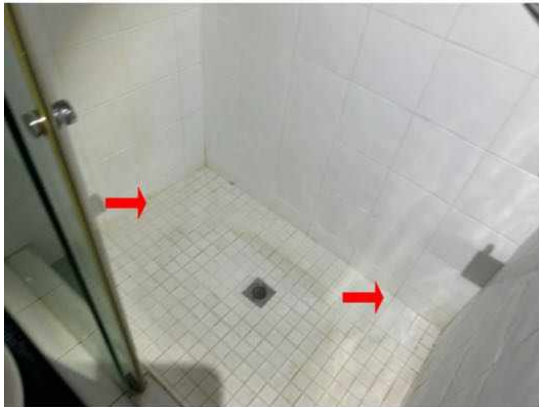
**Defects 3.14**

Building: Building 1  
Location: Bathrooms/ showers  
Finding: Sealant - Deterioration in areas/Missing in areas  
Information: It was noted on inspection that sealant is missing in areas & deteriorated in areas to the tiled wet areas. Grouting was identified in areas however grout can crack and allow water entry. A flexible sealant should be applied to affected areas to prevent any subsequent water damage that is likely to occur.

Regular maintenance and replacement of damage or missing sealant & grout is highly recommended for the wet areas as this is a regular wear and tear defect. Sealant and grouting in areas that come into regular contact with water should be maintained for the long term care of

A licensed sealant specialist can be appointed to complete these works.

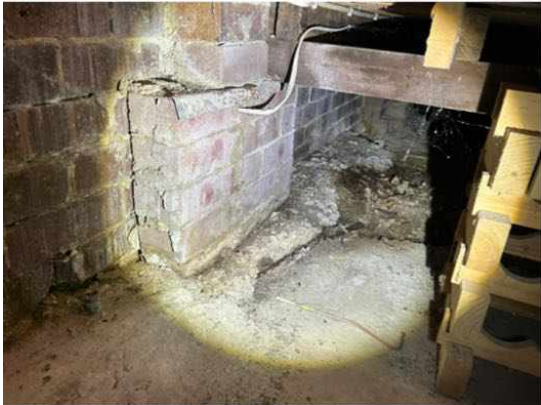
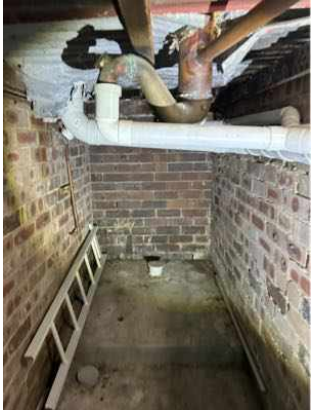
### Defects 3.15

Building:	Building 1
Location:	Subfloor
Finding:	Evidence of excessive moisture was present at the time of inspection
Information:	Excessive moisture can attract termites and produce conditions that promote termite attack, fungal growth and wood decay. Excessive moisture is generally caused by deteriorated, inadequate or missing roof drainage, leaking plumbing pipes or fixtures, poorly plumbed HWS overflows or condenser units and poor site drainage.

It is recommended that all plumbing and drainage fixtures and fittings be maintained regularly to prevent excessive moisture from being present in the external / internal property.

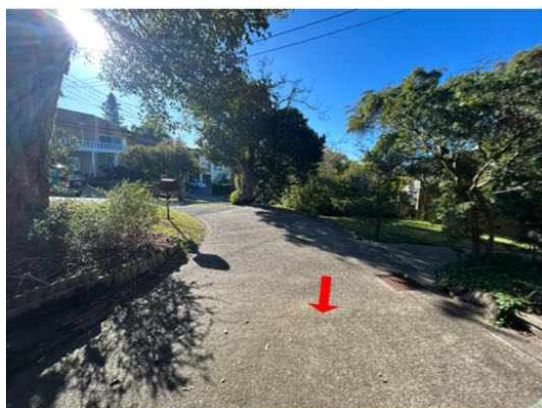
**Defects 3.16**

Building: Building 1  
 Location: Driveway  
 Finding: Cracking - External Concrete Paving Damage Category 1 - Fine (less than 2mm)  
 Information: Fine cracks were identified in external concrete paving. Although fine cracks are quite noticeable, they are often only considered to be an appearance defect, and usually do not indicate any structural damage. To be considered a Category 1 or fine crack, the crack is found to be less than 2mm in width.

Generally the cause of a hairline crack in existing concrete paving such as driveways and pathways is indicative of the expansion and contraction of the concrete. Such causes are generally due to environmental factors, such as moisture levels, weather

conditions, root systems of nearby trees or the soil types on which they are laid.

Fine cracks may also be due to poor original installation of the concrete. Factors such as poor compaction of the sub-surface and/or inadequate reinforcing of the slab may create cracking and other secondary defects.

Monitoring of all cracking should be conducted frequently. Always contact a building inspector should cracks widen, lengthen, or become more numerous.

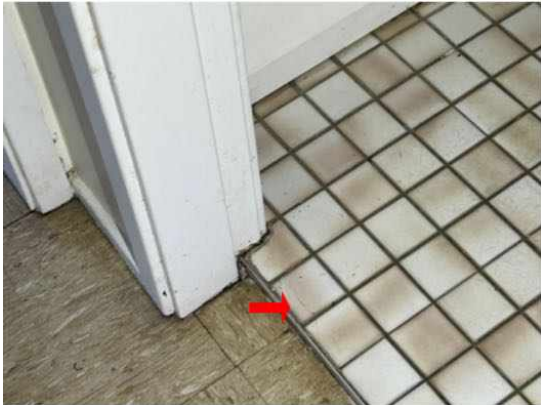
### Defects 3.17

Building:	Building 1
Location:	Bathroom > Lower-Ground Level
Finding:	Tiles - Cracked or damaged
Information:	Cracking was evident to the tiling in this area at the time of inspection. While the cracking appears to be minor, this area is frequently exposed to water, allowing potential for water penetration into adjoining sections of walls or flooring.

If left unmanaged, water penetration to these areas may lead to subsequent water damage, which is likely necessitate repair work to affected building elements.

A tiling contractor should be appointed to ensure that no further water damage occurs. The re-application of silicone and grouting throughout remaining tile work is also advised, to further protect the area against water penetration.

Where water penetration has led to water damage, appointment of a relevant tradesperson may be required to repair damaged building elements.

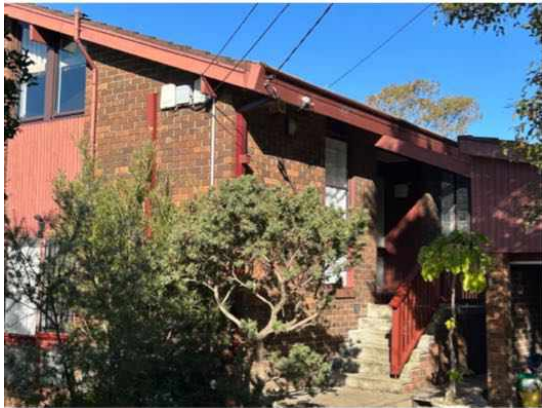
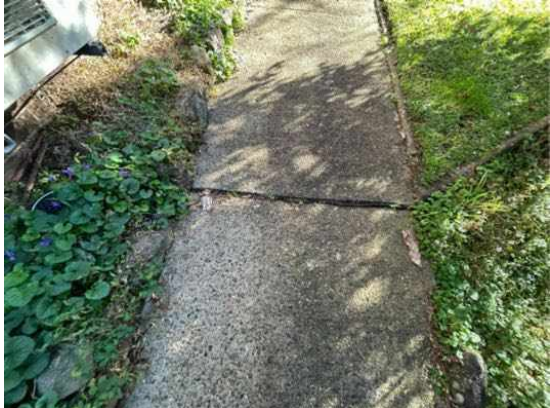
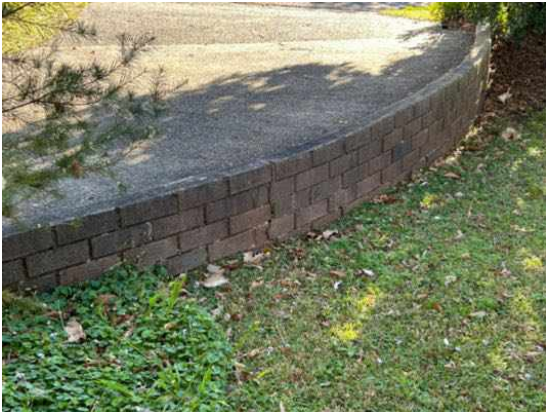
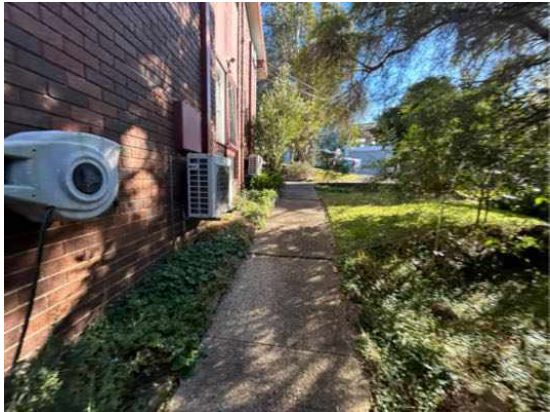
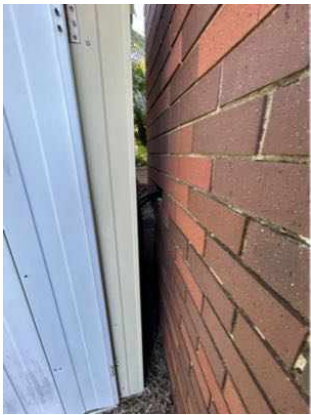
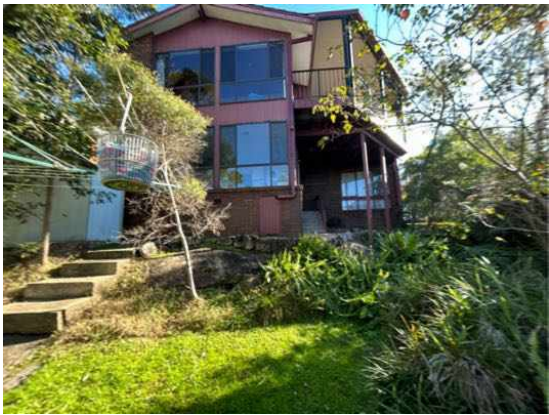
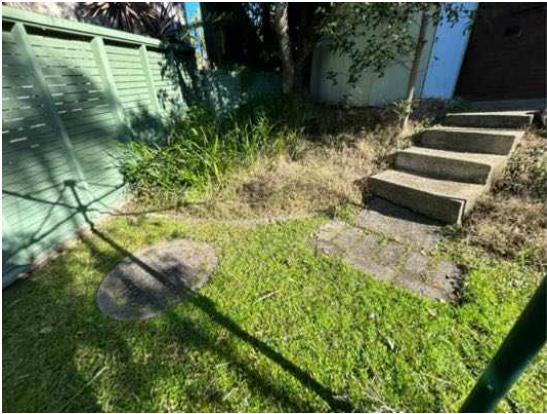
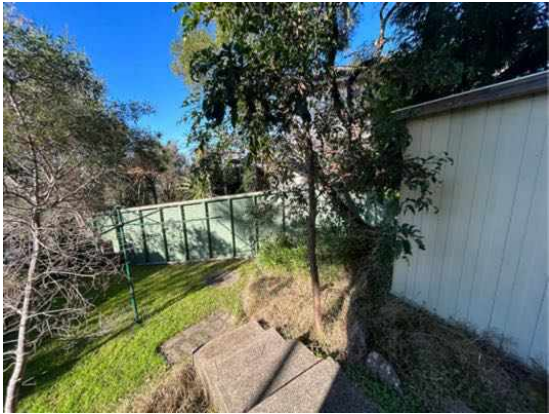
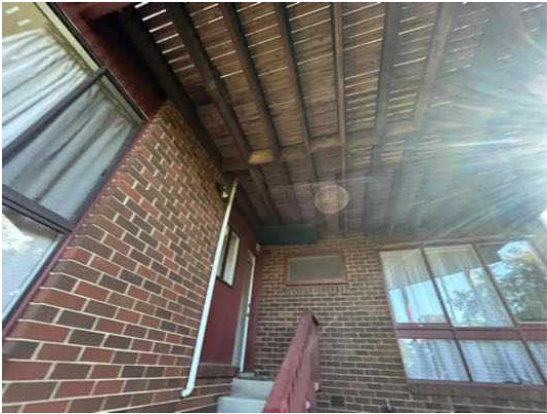
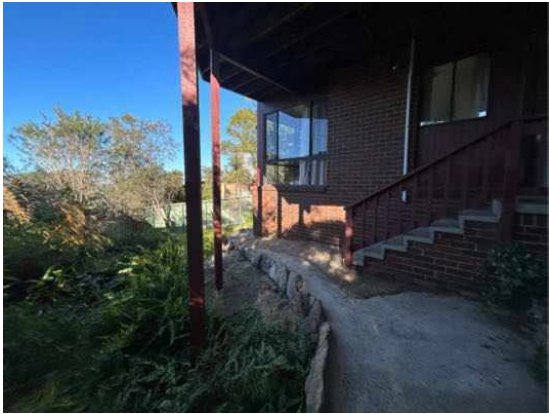
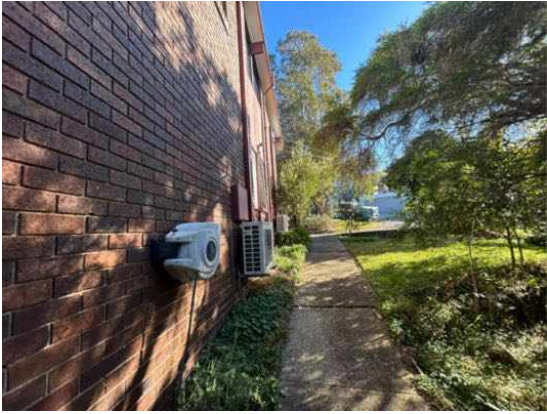
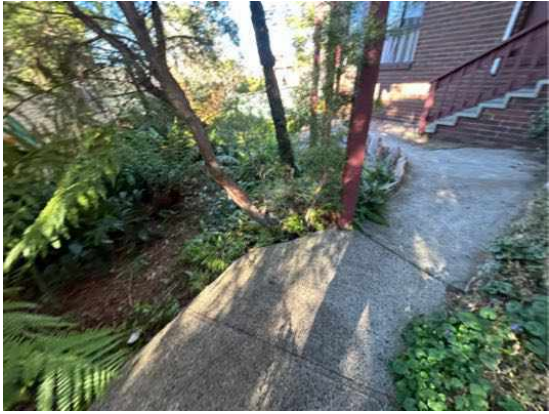
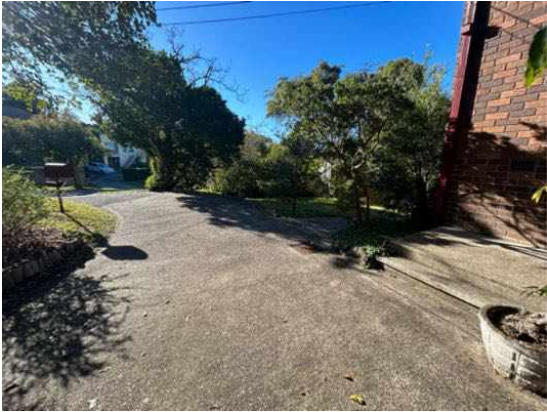
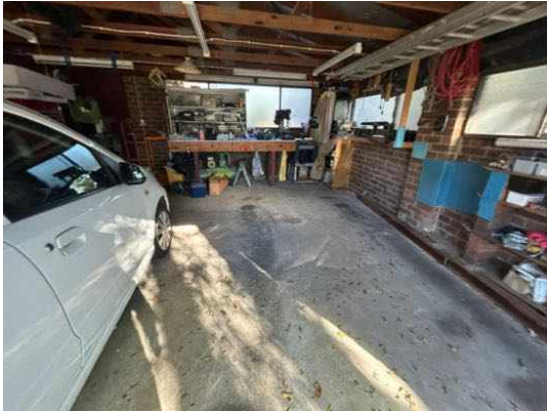
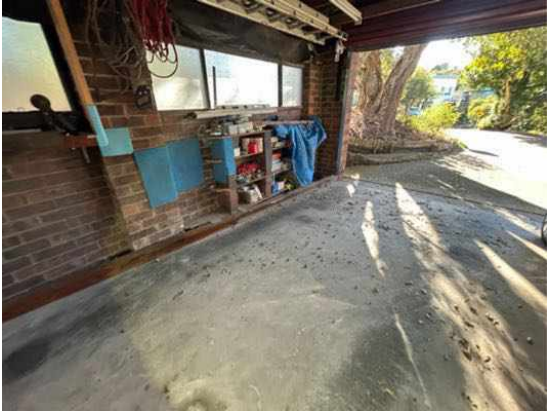
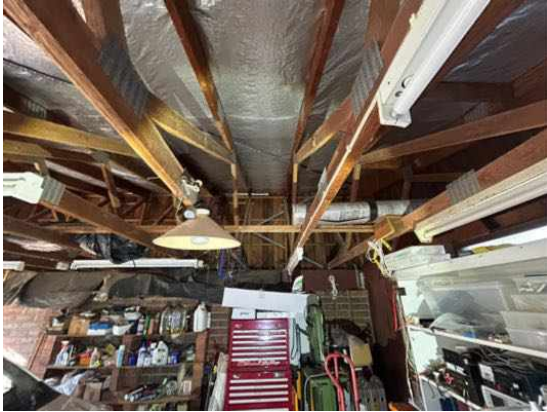
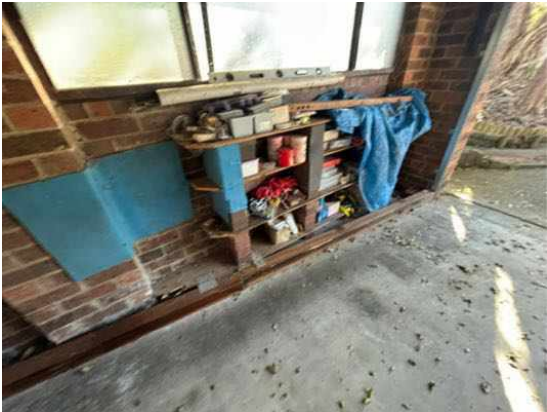
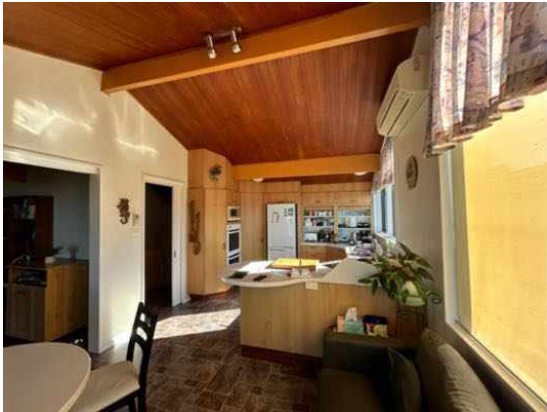
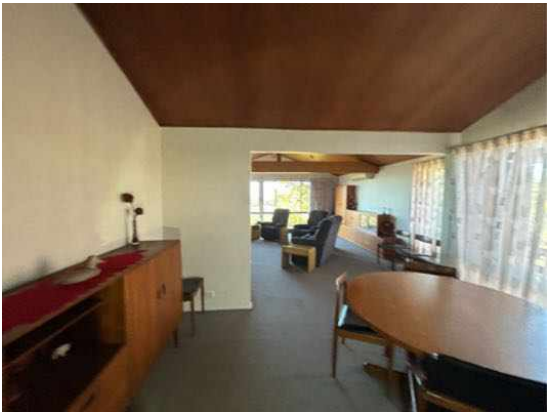
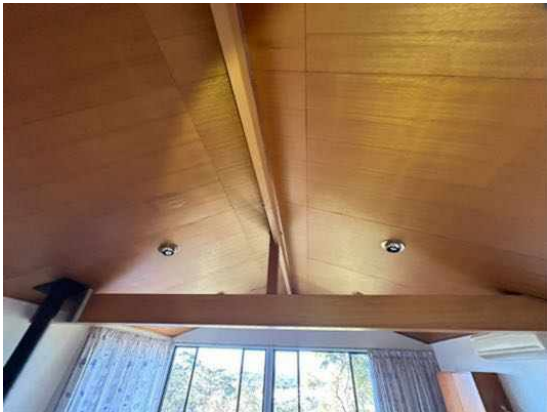
#### Noted Item

Building: Building 1  
Location: All Areas  
Finding: Additional Photos - Obstructions and Limitations  
Information: These photographs are an indication of the obstructions and limitations which impeded full inspection of the property at the time of inspection. These obstructions can hide an array of defects and should be removed to allow full inspection to be carried out.

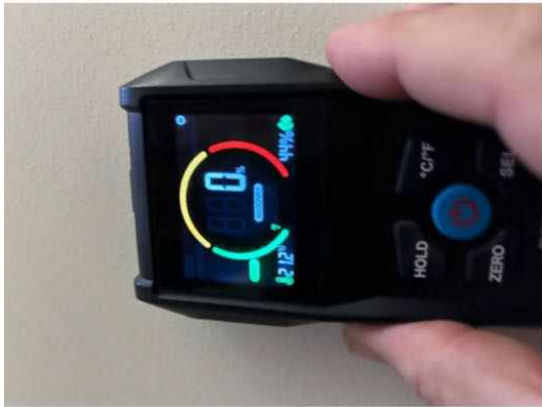
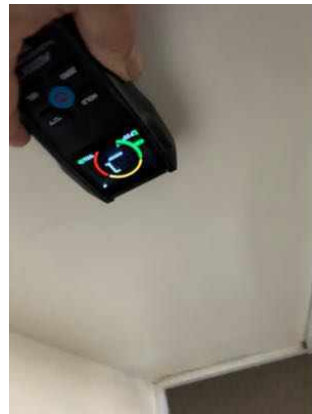
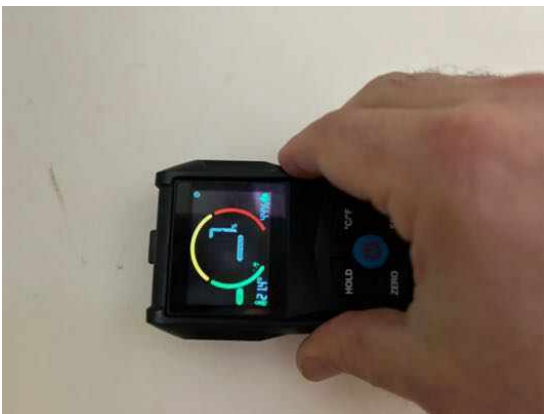
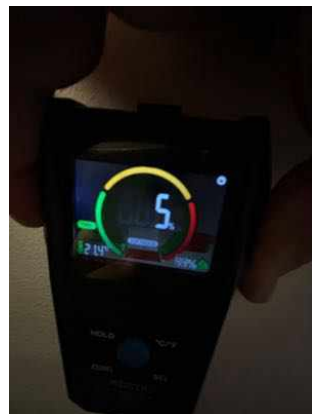
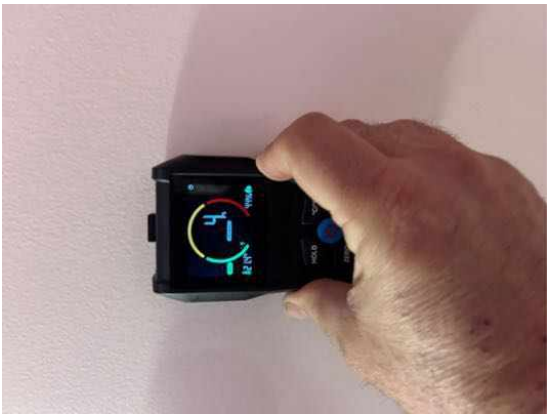
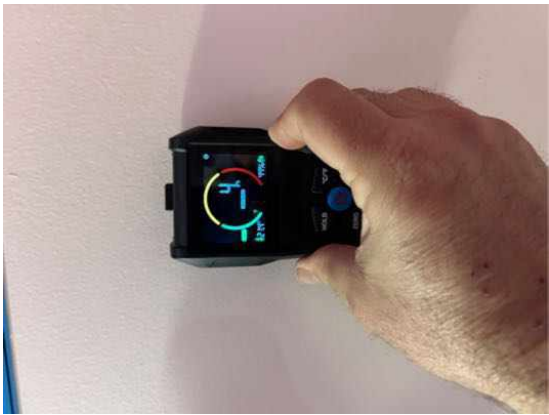
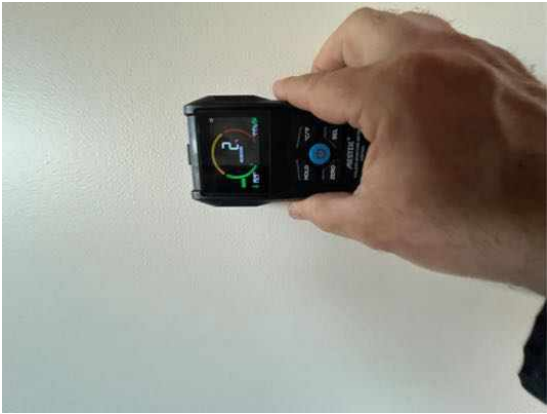
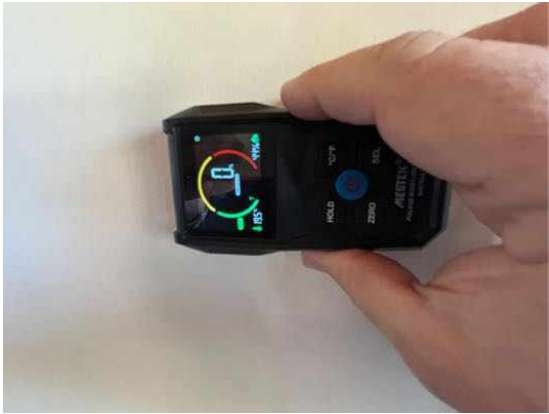
Building: Building 1  
 Location: All Areas  
 Finding: Moisture meter readings - low  
 Information: The moisture meter result for the areas inspected.

The moisture reading of 0-15% is quite normal and gives no cause for concern. However, moisture readings in excess of 15% indicate the need for further inspection.

Levels between 25-30% indicate that there may be water ingress, meaning that remedial work could be required.

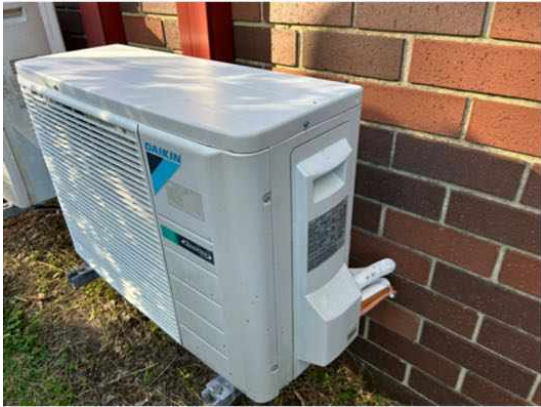
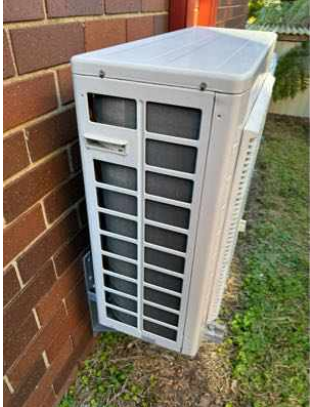
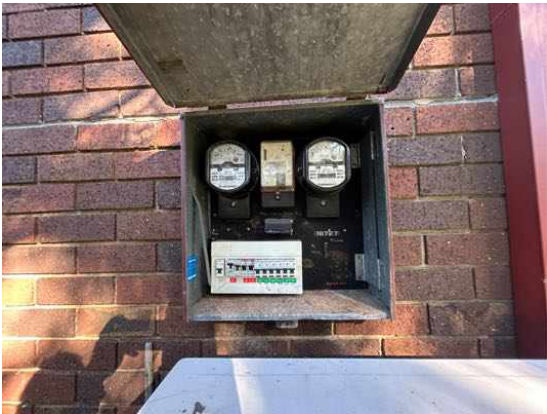
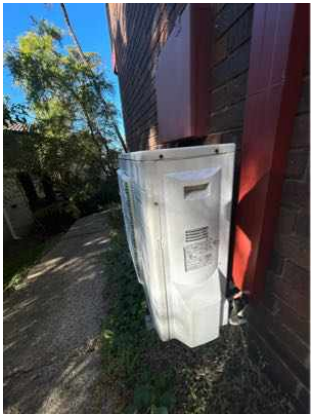
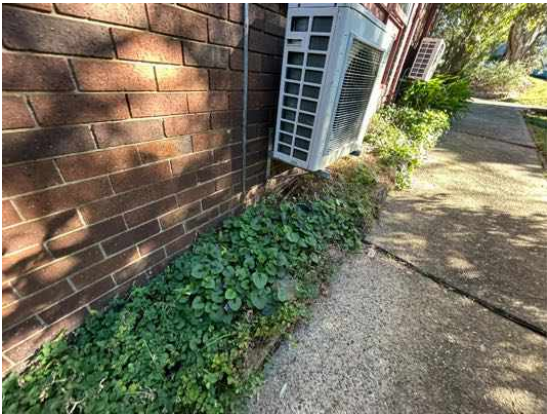
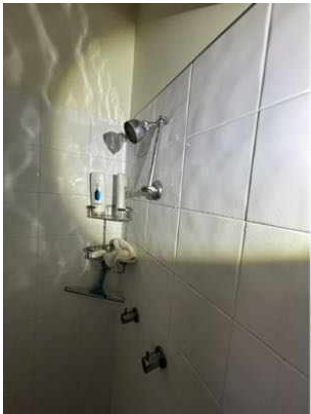
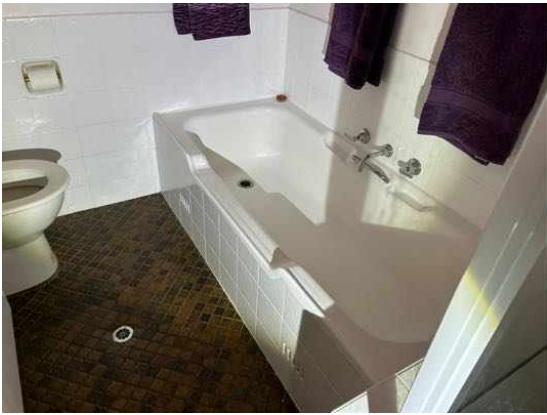
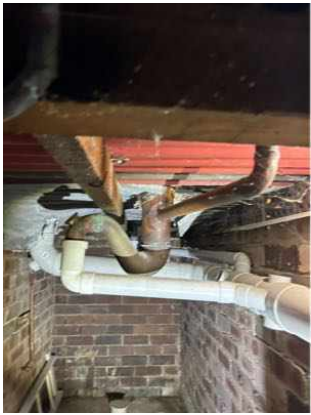
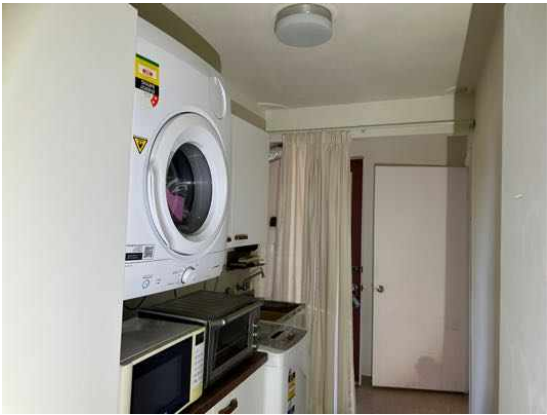
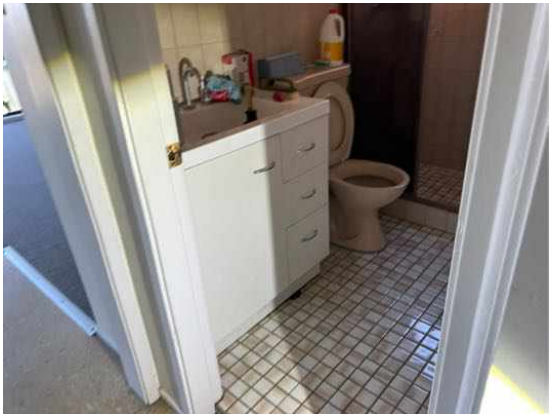
Building: Building 1  
 Location: All Areas  
 Finding: Plumbing and Electrical  
 Information: Plumbing and electrical inspections are outside the scope of the building inspection and must be conducted by a Licensed and registered Trades person.

Whilst we note and comment of visually apparent defects that present during the building inspection, legislation requires the checking and documenting of compliance for plumbing and electrical requirements be done by licensed electrician and plumbers respectively to ensure they are functioning correctly.
