Building and Timber Pest Inspection Report

Inspection Date: Sun, 12 Sep 2021

Property Address: 2-10 Lochview Ct, Tamborine QLD 4270,
Australia

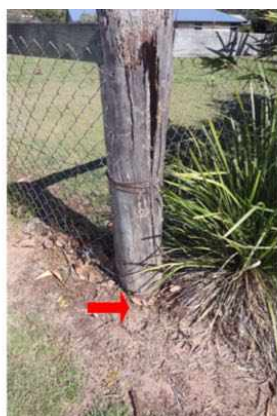
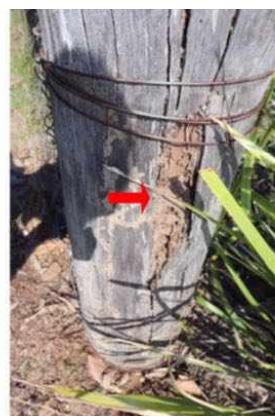
Building:	Yard
Location:	Fencing > Front Left
Finding:	Evidence of termite damage - minor
Information:	Despite no live termite or timber pest activity being indicated, previous termite damage was found to have affected this area. This damage is considered to be inactive and is minor in nature.

It is advised that the area be visually inspected frequently to ensure that the condition of affected building materials does not worsen. At the time of inspection, damage is not structural and is only considered to be superficial.

A building contractor may be appointed to provide a further invasive inspection if further damage is evident.

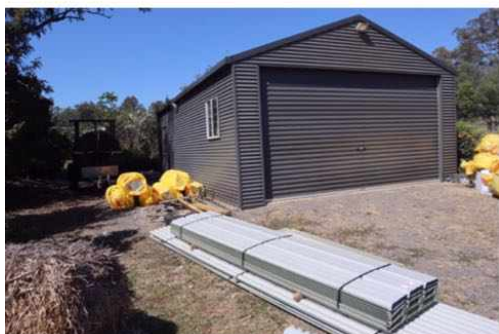
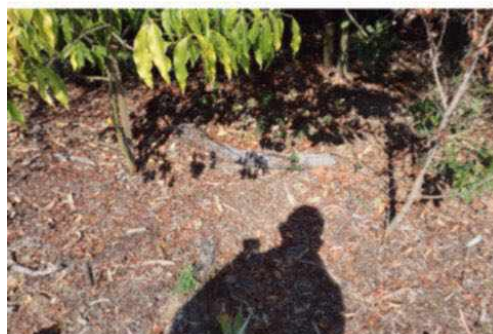
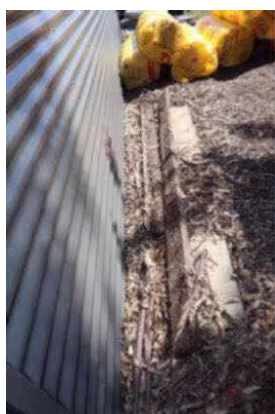
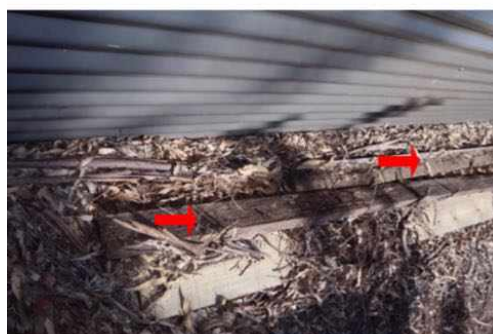
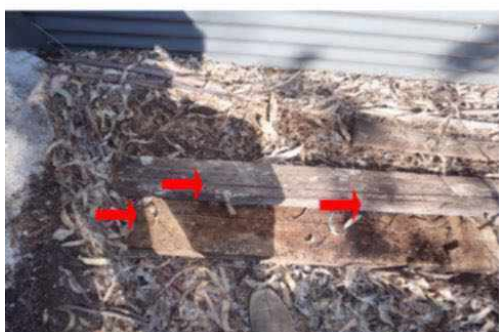
Finding 3.02

Building:	Shed
Location:	Exterior walls - right side > Centre
Finding:	Evidence of termite damage - minor
Information:	Despite no live termite or timber pest activity being indicated, previous termite damage

was found to have affected this area. This damage is considered to be inactive and is minor in nature.

It is advised that the area be visually inspected frequently to ensure that the condition of affected building materials does not worsen. At the time of inspection, damage is not structural and is only considered to be superficial.

A building contractor may be appointed to provide a further invasive inspection if further damage is evident.

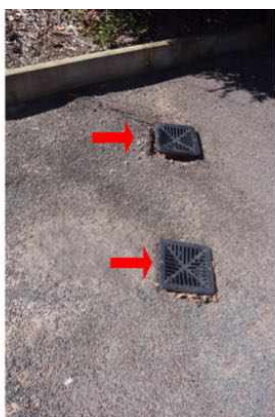
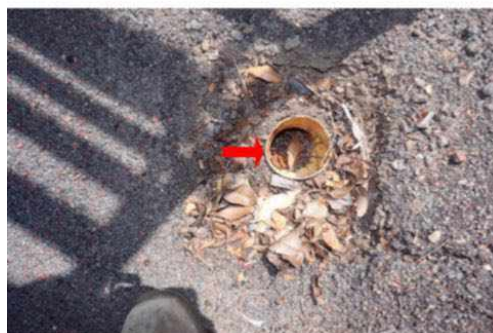
Finding 3.03

Building: Main Building

Location: Driveway > Front Right
 Finding: Storm water drainage blocked
 Information: At time of inspection it was noted that the yard drain to side garage was partially blocked This maybe due to minor subsidence to this area.

A qualified plumber may be required to rectify this issue.

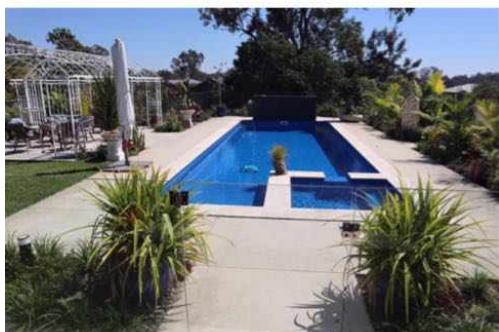
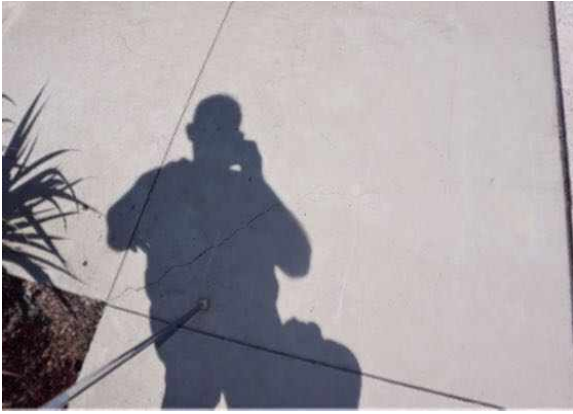
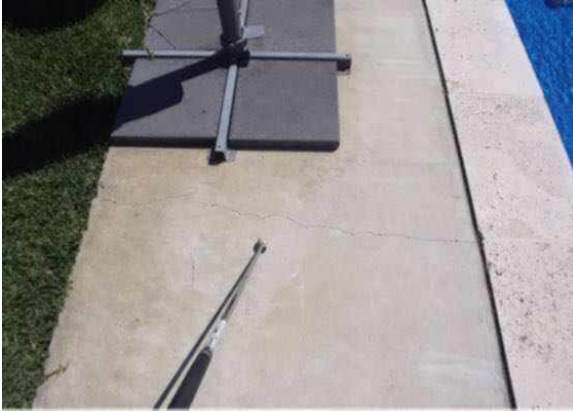
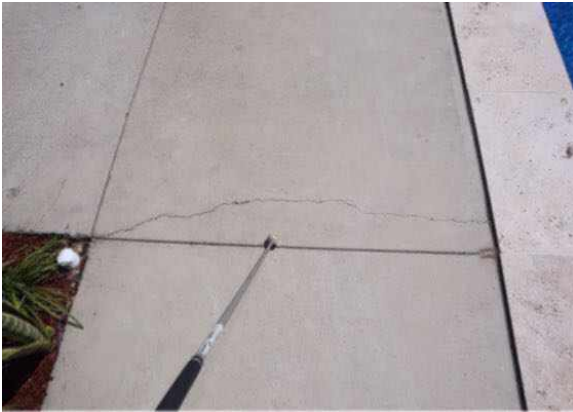
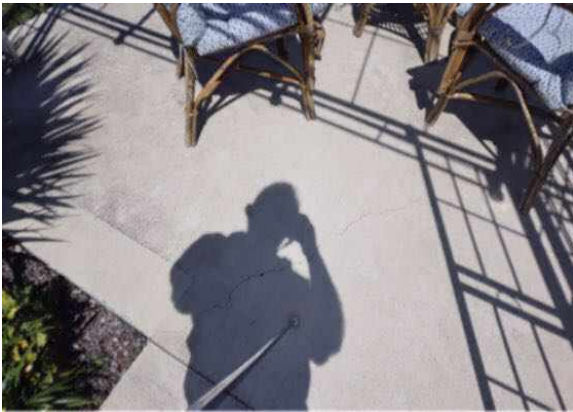
Finding 3.04

Building: Yard
 Location: Pool Area > Existing
 Finding: Crack in concrete slab - Category 0
 Information: A crack coded as Category 0 was identified in the slab. A Category 0 crack is described as a hairline crack, representing insignificant movement of slab from level.

The approximate width of the crack to be considered Category 0 is 0.3mm, or change in offset of less than 8mm when a 3m straight edge is placed over the defect.

No rectification is required at this time. However, all cracking should be monitored over a 12 month period to identify any further damage in the area.

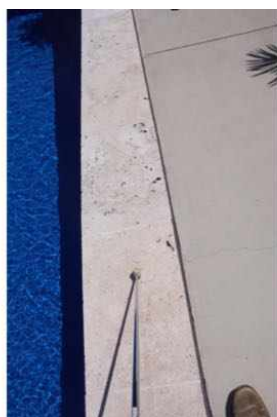
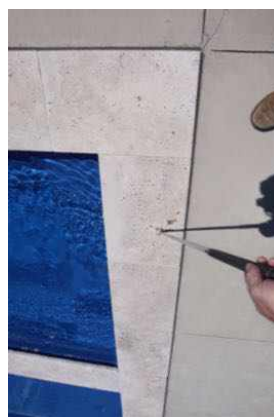
Finding 3.05

Building:	Yard
Location:	Pool Area > Existing
Finding:	Tiles - Drummy
Information:	Drummy tiled areas were identified at the time of inspection. The term 'drummy' refers to tiles that have become detached from their fixing, despite otherwise being in relatively good condition. Such defects are generally caused by physical or moisture damage to the area. Drummy tiled areas may also be a direct result of poor workmanship during the construction process.

Tiled areas may swell and shrink with changes in air humidity if the area has sustained moisture damage. Any exposure to moisture is capable of causing tiled areas to become drummy and/or cracked over a prolonged period of time. Drummy tiled areas generally require removal and replacement of affected tiles, with adequate sealant and grouting.

Specialist trades are available for these types of services. A registered builder may be required to undertake works if damage is extensive or if secondary building defects have resulted. Otherwise, it is advised that a tiling contractor be appointed to perform works as necessary. Immediate action is recommended to ensure that no further damage is sustained in the affected area.

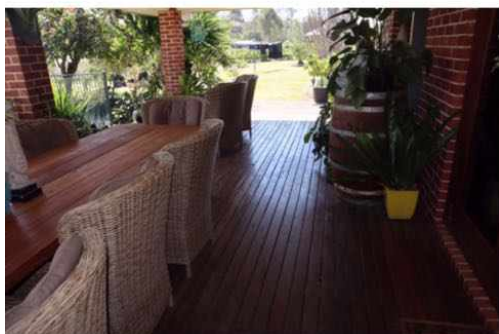
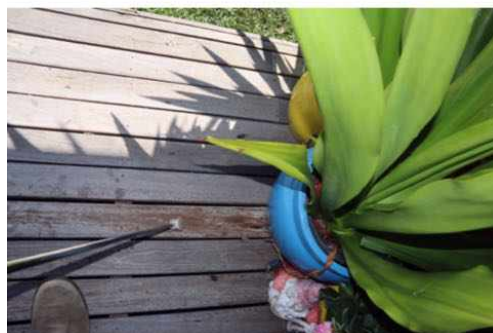
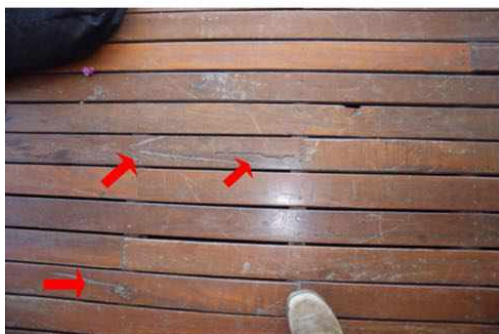
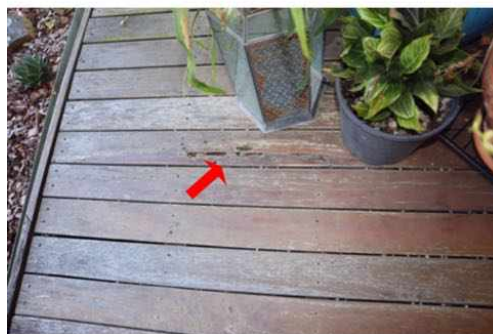
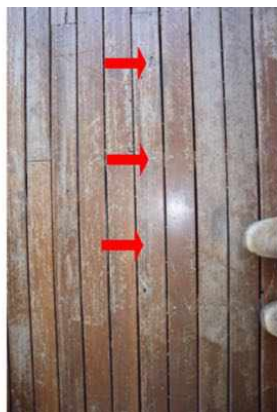
Finding 3.06

Building: Main Building
Location: Deck > Rear
Finding: Evidence of termite damage - minor
Information: Despite no live termite or timber pest activity being indicated, previous termite damage was found to have affected this timber deck members. This damage is considered to be inactive and is minor in nature.

It is advised that the area be visually inspected frequently to ensure that the condition of affected building materials does not worsen. At the time of inspection, damage is not structural and is only considered to be superficial.

A building contractor may be appointed to provide a further invasive inspection if further damage is evident.

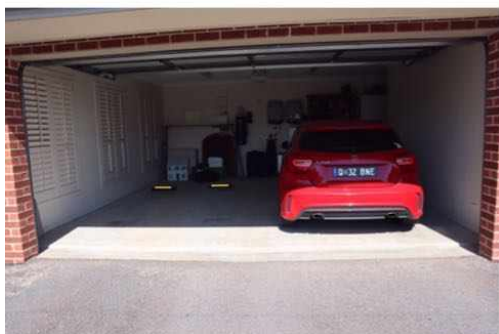
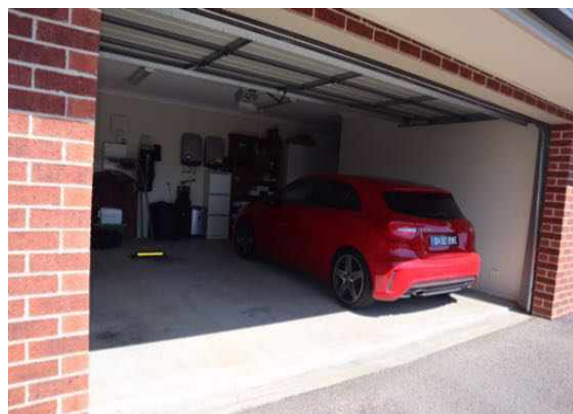
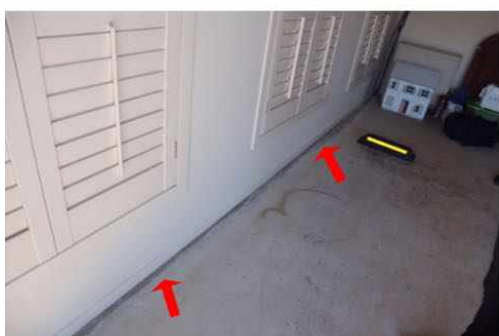
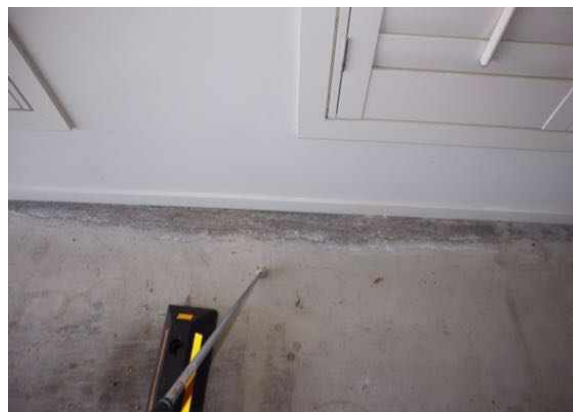
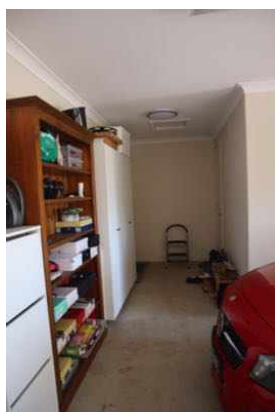
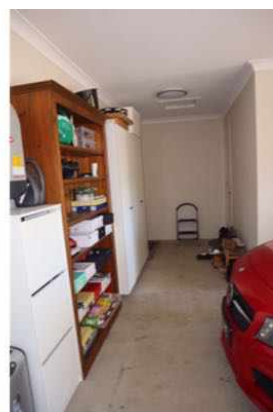
Finding 3.07

Building:	Main Building
Location:	Garage > Centre Left
Finding:	Slab - Efflorescence garage
Information:	Efflorescence appears to be affecting the concrete in garage. Efflorescence typically occurs when excess salts within the concrete or cement is leached to the surface due to water transfer.

It is typically seen as white salt deposits on the surfaces of concrete pavement or mortar between bricks or tiles. While detracting from the overall appearance of the affected area, efflorescence is not likely to develop into secondary damage if left unmanaged.

Generally, soluble salt deposits can be removed by dry brushing with a stiff-bristled brush. Repeated dry brushing is an ideal treatment for eliminating this forming of efflorescence. A cleaning contractor or general handyperson may be appointed to perform these works at the discretion of the client.

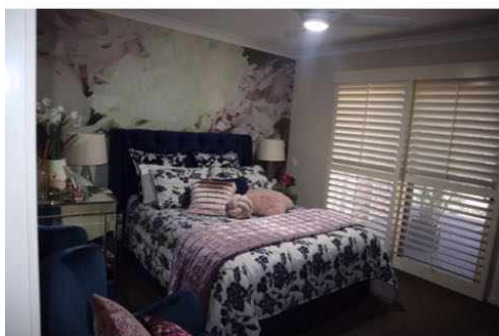
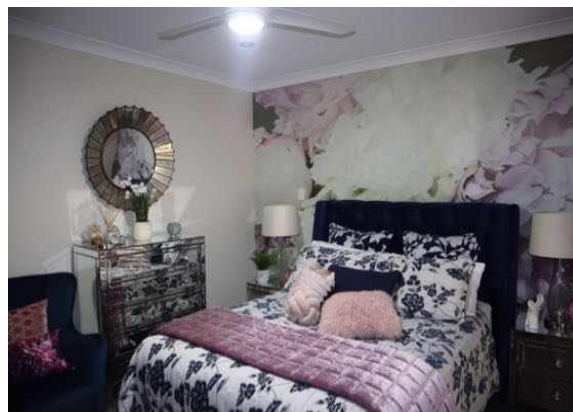
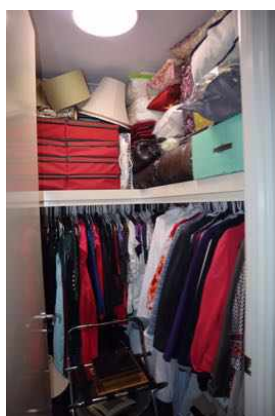
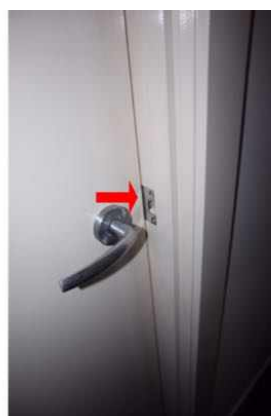
Finding 3.08

Building:	Main Building
Location:	Bedroom 3 > Existing
Finding:	Door - Binding/jamming
Information:	Binding and/or jamming of this door is evident during standard operation. This defect inhibits the functionality of the affected door as well as creating potential for secondary defects to associated building elements, such as damage to the floor covering.

A door that binds to flooring or to the associated door frame may have several causes, ranging from minor defects, such as poor installation of the door or deteriorated hinges, through to major structural issues, such as damage to subfloor structures.

Where door binding/jamming appears to indicate major structural issues, a registered builder specialising in re-stumping should be appointed to provide an estimate on the cost of rectification.

For minor causes, a qualified carpenter or general handyperson should be appointed to perform minor rectification works at client discretion.

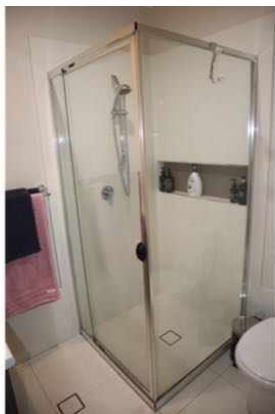
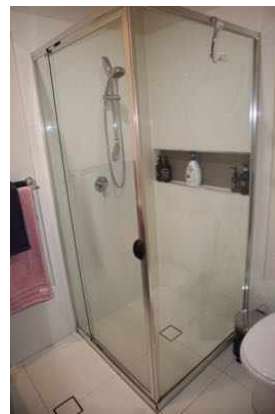
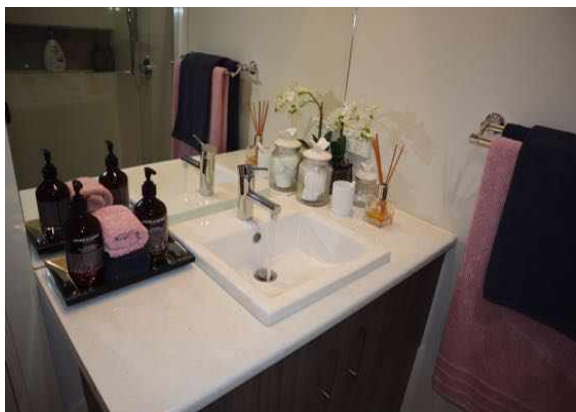
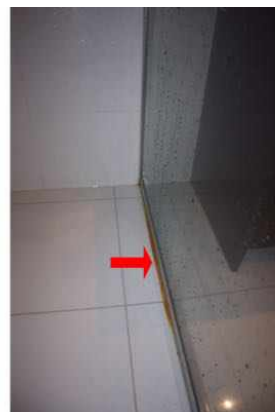
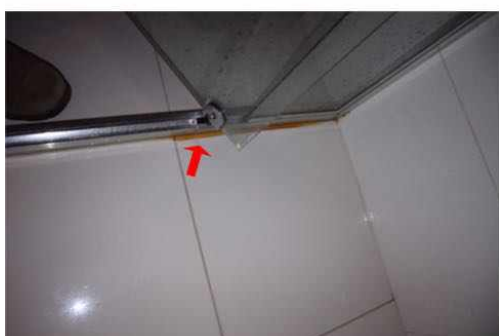
Finding 3.09

Building:	Main Building
Location:	Ensuite 3 > Front
Finding:	Silicone stain
Information:	At the time of inspection the silicone to shower screen is stained.

This maybe due to age or water damage.

A handyman maybe required to rectify this condition.

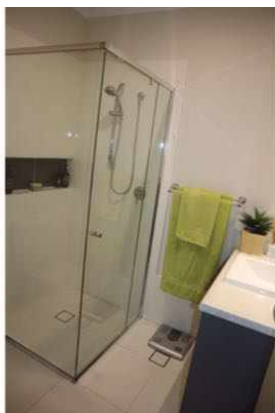
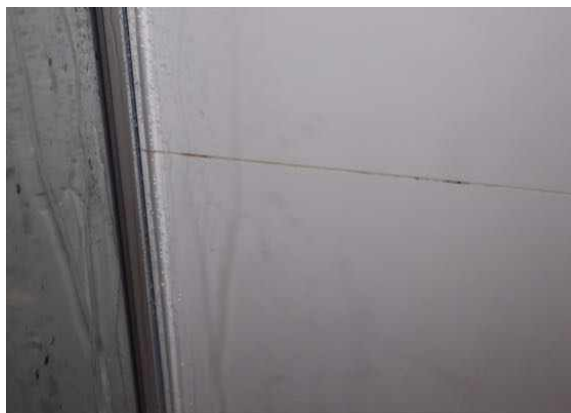
Finding 3.10

Building:	Main Building
Location:	Ensuite 2 > Centre
Finding:	Mould - Present minor
Information:	Where evidence of mould growth was noted, there may be environmental, biological or health issues associated with the report. A specialist inspection by a suitably qualified environmental health inspector is warranted, where mould is extensive or where any queries regarding air quality spores or other related issues apply.

Generally, the client is advised to ensure that the general environment is free of moisture and humidity to aid in the prevention of mould formation and development. Any mould found during the inspection should be cleaned immediately by a cleaning

contractor or the homeowner as applicable.

Please note that severely affected building elements may require replacement by a registered builder or qualified carpenter.

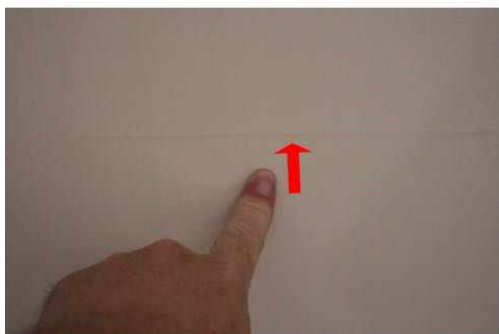
Building:	Main Building
Location:	Ensuite2 > Centre Left
Finding:	Cracks to internal plaster render - Category 0
Information:	It has been observed that cracking to internal plaster rendered surfaces has occurred. The degree of damage falls within Category 0, and is described as hairline cracking, which is less than 0.1mm in width. Damage of this category is not considered a defect for rectification.

No rectification is required at this time. Always contact your building inspector should cracks widen, lengthen, or become more numerous.

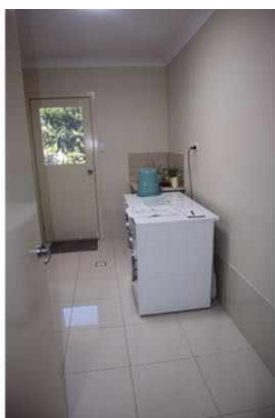
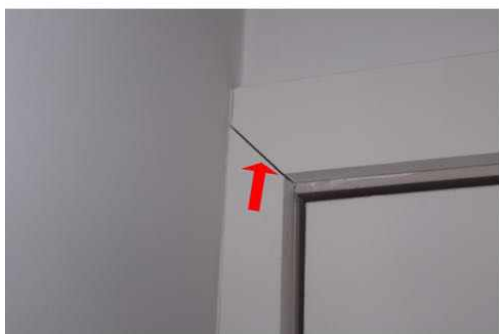
Finding 3.12

Building: Main Building
 Location: Laundry > Centre Left
 Finding: Gaps in architrave joints
 Information: At the time of inspection it was noted that there were gaps in the joints in the architrave.

Although this has no structural integrity this may take away the aesthetic look of the overall appearance.

A handyman or painter maybe required to rectify this issue.

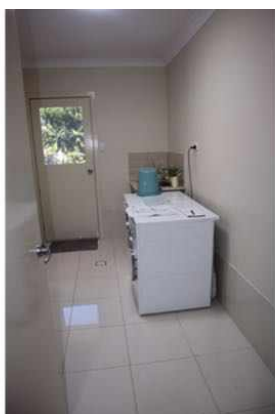
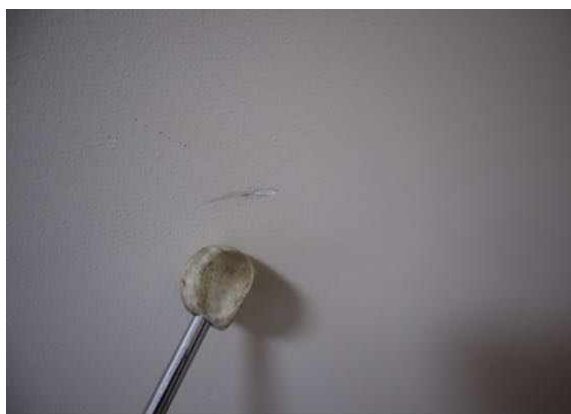
Finding 3.13

Building:	Main Building
Location:	Laundry > Centre Right
Finding:	Walls - Scuffed
Information:	Superficial scuff marks were noted to the internal walls in this area at the time of inspection. Marked and scuffed surfaces, while detracting from the overall appearance of the affected building element, do not indicate any operational or structural damage. This degree of surface damage is consistent with general wear and tear.

Marked surfaces may be left at client discretion, as no repair/replacement is necessarily required. Marked surfaces are unlikely to result in the development of secondary damage; however, the client may wish to seek quotations for the cost to refurbish or replace the affected wall linings.

A general handyperson or cleaning contractor may be appointed to rectify marked or scuffed surfaces at the client's discretion.

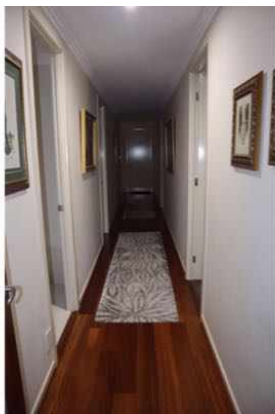
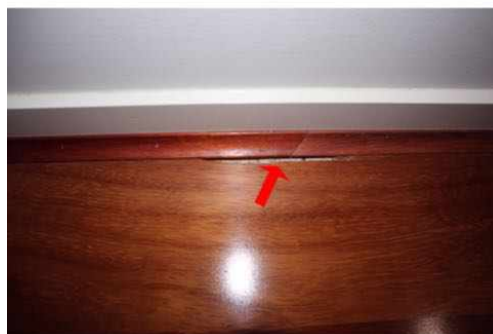
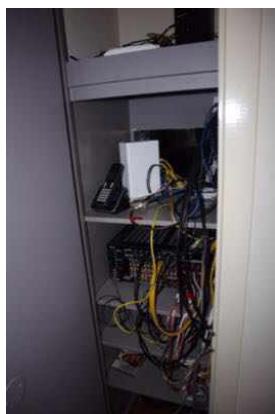
Finding 3.14

Building:	Main Building
Location:	Hallway > Centre Left
Finding:	Timber flooring - Gap edge gap

Information: At the time of inspection it was noted that there was a gap in timber floor edge hallway.

This maybe due to accidental damage.

A carpenter or handyman maybe required to rectify this condition.

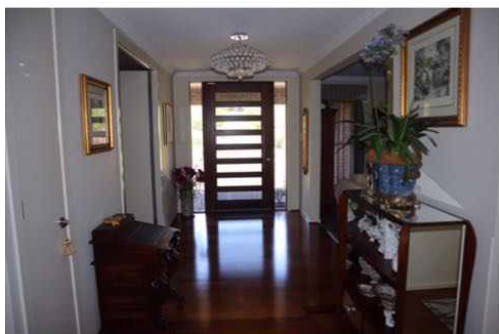
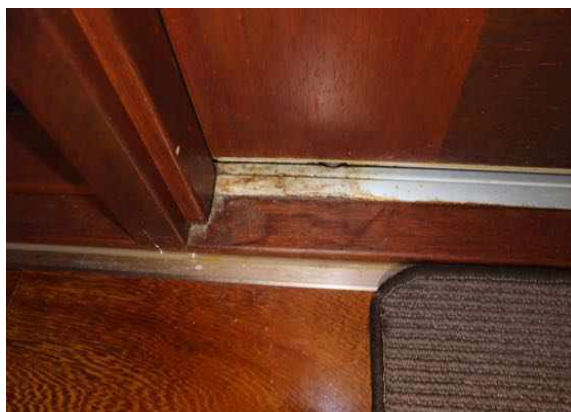
Finding 3.15

Finding: Door stain run marks

Information: At the time of inspection it was noted that the door stain had ran onto door seal.

This maybe due to age or accidental damage.

A handyman or general clean maybe required to rectify this issue.

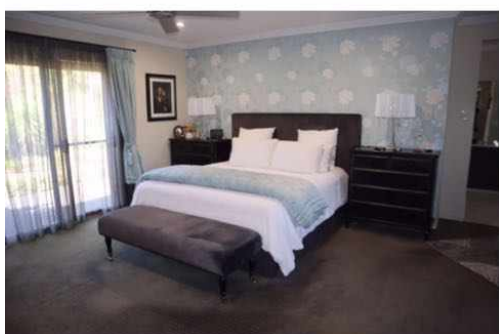
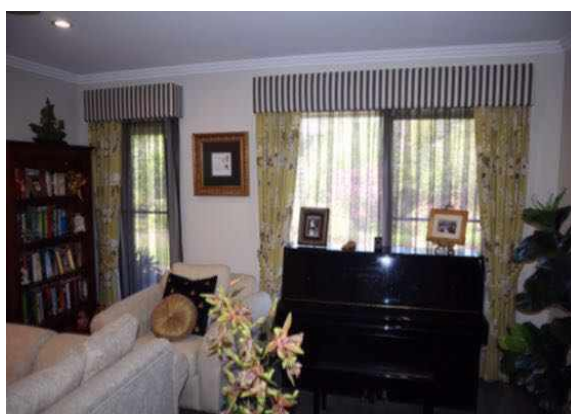
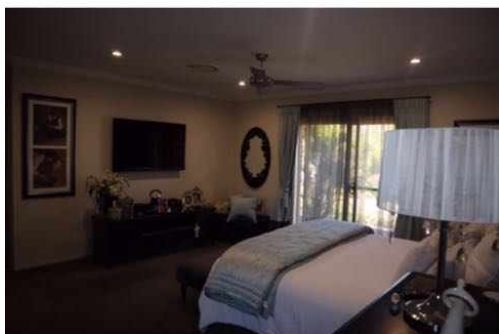
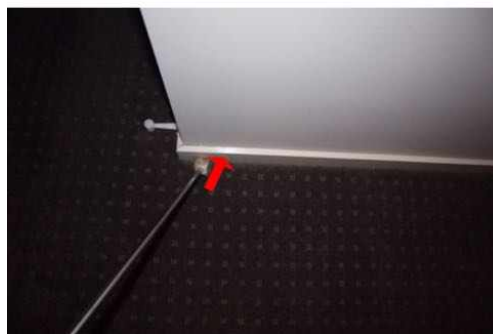
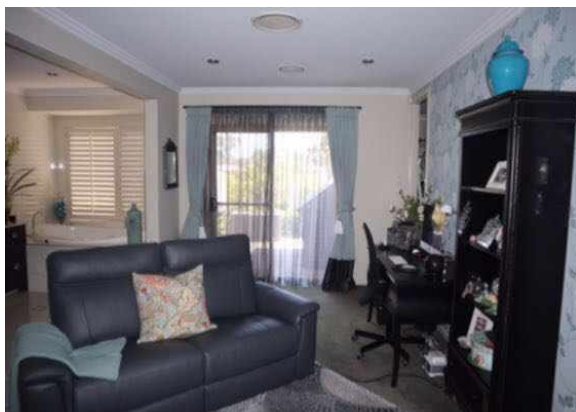
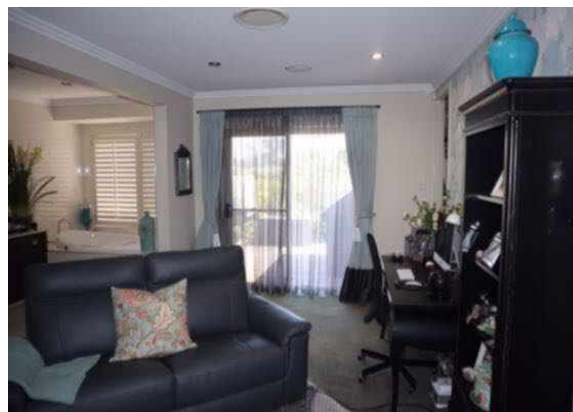
Finding 3.16

Finding: Beads - Damaged

Information: Beading acts (like cornice or skirtings) to cover the intersection or joins of building materials. It was noted at the time of inspection that beading in this area has deteriorated. This deterioration is suspected to have been caused by general ageing and frequent exposure to weather, which is expected in a building of this age and condition.

Repair or replacement of the beading is advised to ensure the protection and longevity of any associated building elements. Such works may be performed by a general handyperson or qualified carpenter.

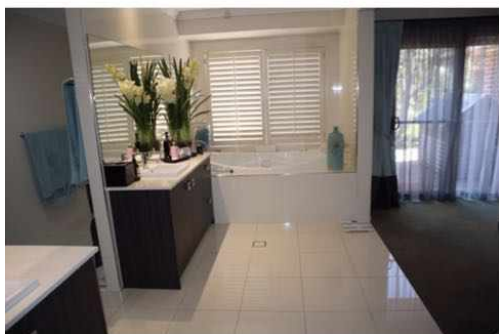
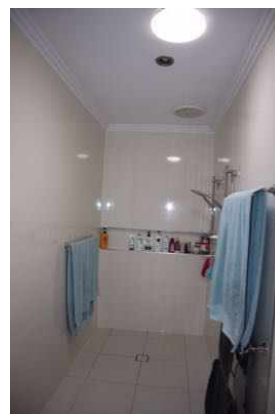
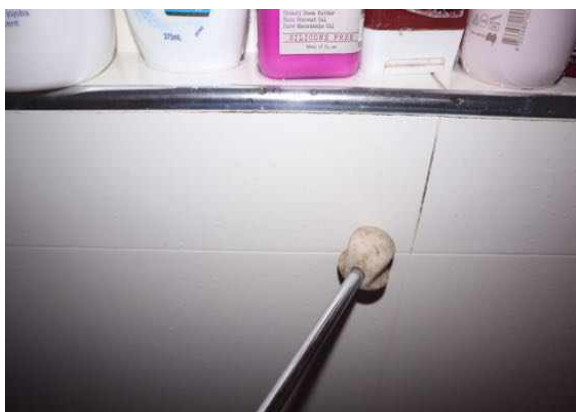
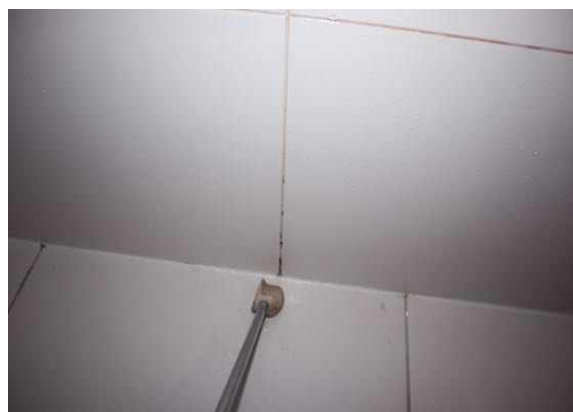
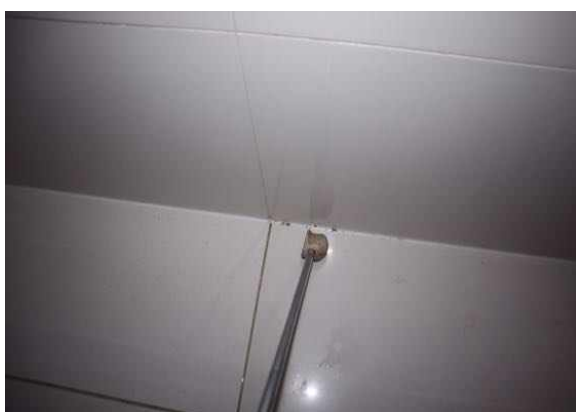
Finding 3.17

Building:	Main Building
Location:	Ensuite - Master > Centre
Finding:	Mould - Present minor
Information:	Where evidence of mould growth was noted, there may be environmental, biological or health issues associated with the report. A specialist inspection by a suitably qualified environmental health inspector is warranted, where mould is extensive or where any queries regarding air quality spores or other related issues apply.

Generally, the client is advised to ensure that the general environment is free of moisture and humidity to aid in the prevention of mould formation and development. Any mould found during the inspection should be cleaned immediately by a cleaning contractor or the homeowner as applicable.

Please note that severely affected building elements may require replacement by a registered builder or qualified carpenter.

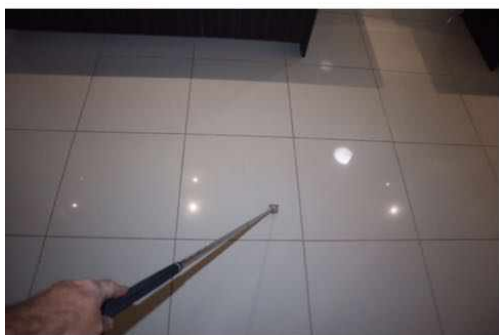
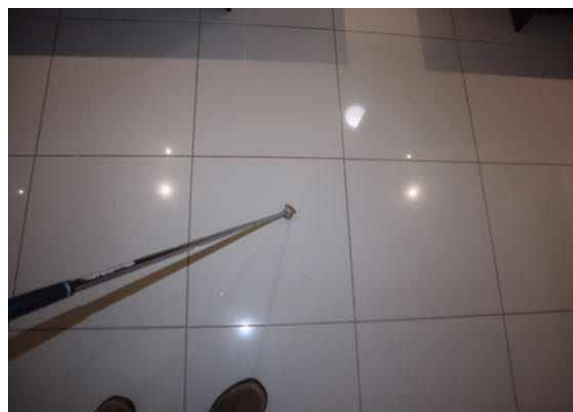
Finding 3.18

Building:	Main Building
Location:	Ensuite - Master > Existing
Finding:	Tiles - Drummy
Information:	<p>Drummy tiled areas were identified at the time of inspection. The term 'drummy' refers to tiles that have become detached from their fixing, despite otherwise being in relatively good condition. Such defects are generally caused by physical or moisture damage to the area. Drummy tiled areas may also be a direct result of poor workmanship during the construction process.</p>

Tiled areas may swell and shrink with changes in air humidity if the area has sustained moisture damage. Any exposure to moisture is capable of causing tiled areas to

become drummy and/or cracked over a prolonged period of time. Drummy tiled areas generally require removal and replacement of affected tiles, with adequate sealant and grouting.

Specialist trades are available for these types of services. A registered builder may be required to undertake works if damage is extensive or if secondary building defects have resulted. Otherwise, it is advised that a tiling contractor be appointed to perform works as necessary. Immediate action is recommended to ensure that no further damage is sustained in the affected area.

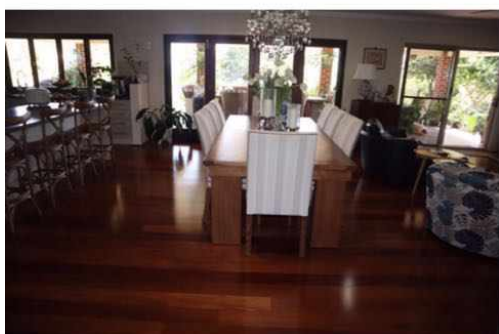
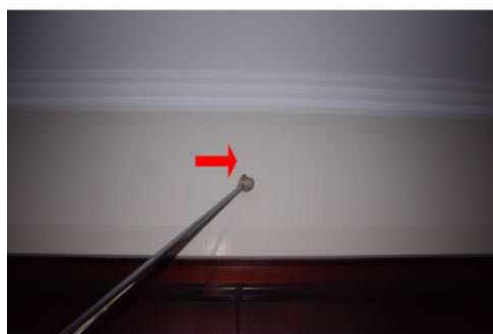
Finding 3.19

Building:	Main Building
Location:	Dining Room > Rear
Finding:	Cracks to internal plaster render - Category 0
Information:	It has been observed that cracking to internal plaster rendered surfaces has occurred. The degree of damage falls within Category 0, and is described as hairline cracking, which is less than 0.1mm in width. Damage of this category is not considered a defect for rectification.

No rectification is required at this time. Always contact your building inspector should cracks widen, lengthen, or become more numerous.

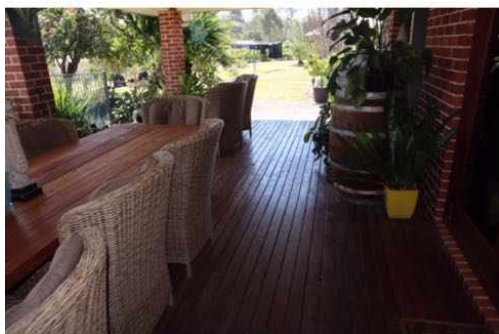
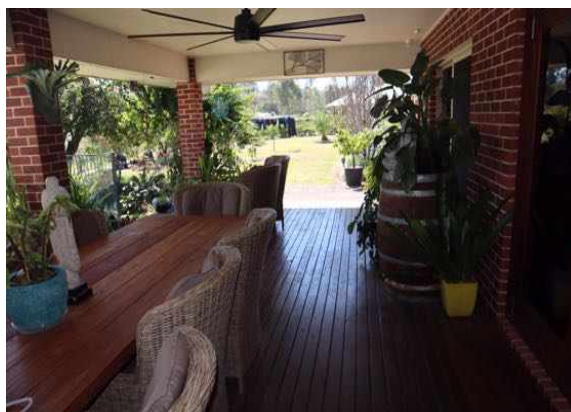
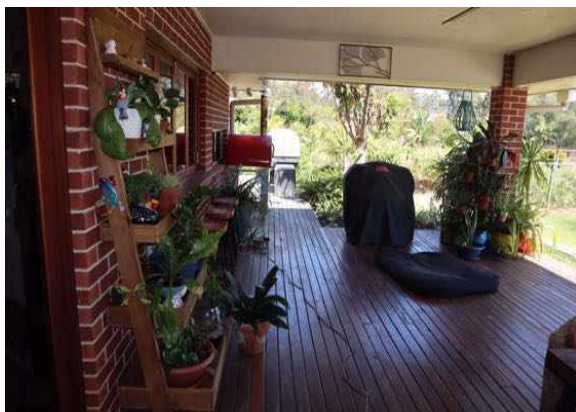
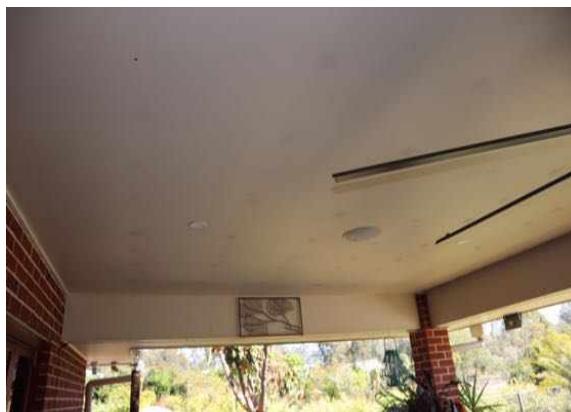
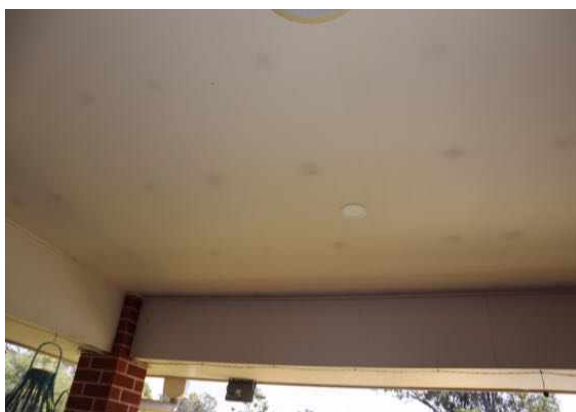
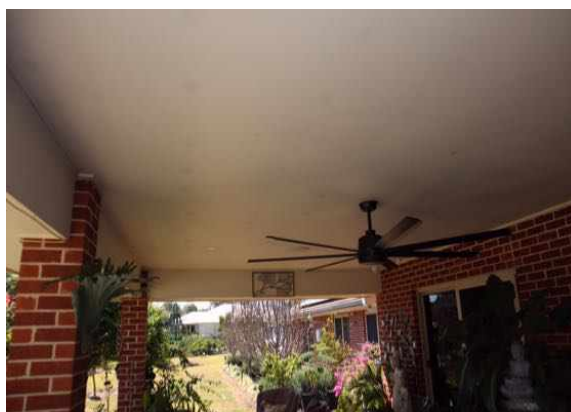
Finding 3.20

Building:	Main Building
Location:	Alfresco > Rear
Finding:	Ceiling - Water damaged
Information:	Water damage to the ceiling lining is generally an indication of excessive moisture being present in the roof void, usually via a leak to the roof covering.

Where water damage is evident to the ceiling, the primary requirement is to identify and rectify the source of the leak. A roofing plumber should be appointed as soon as possible to identify the leak and perform rectification works as necessary, ensuring the water damage is restricted.

Once the leak is repaired, consultation with relevant tradespeople, including plasterers and painters, is advised. Rectification works may include replacement of ceiling lining or minor repainting, depending on the extent of the damage.

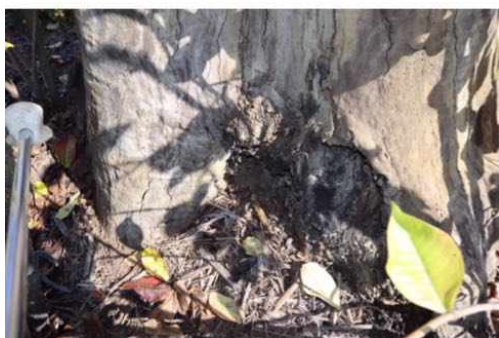
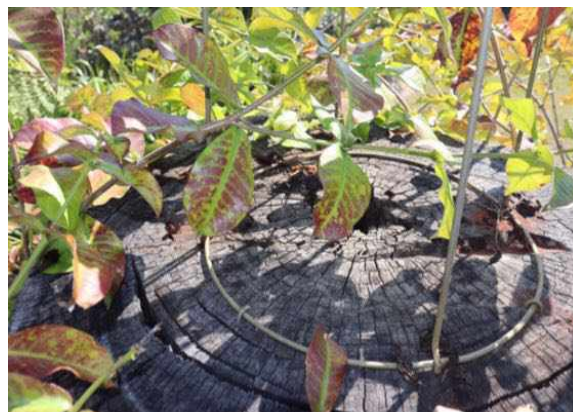
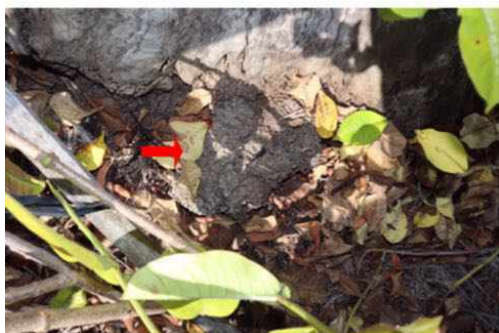
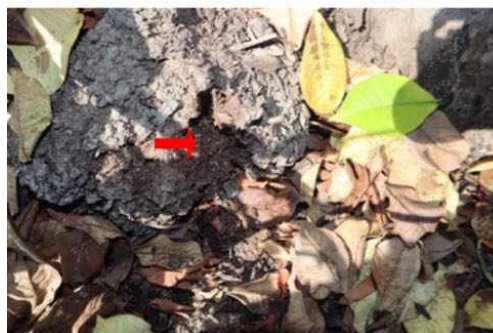
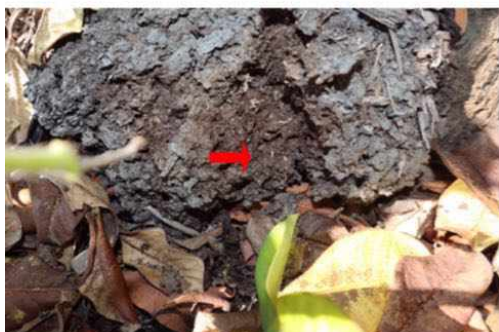
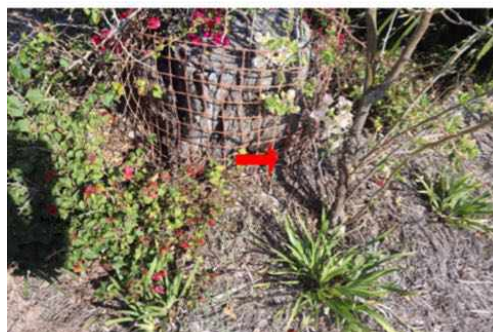
Finding 4.01

Building:	Yard
Location:	Yard - Front > Front
Finding:	Evidence of a termite nest was identified during the inspection
Information:	Termite nests require preliminary treatment as well as ideally manual removal. This may include destruction of the nest via drilling and injection of termiticide or direct removal of the nest site i.e. tree or tree stump. All related timbers should be removed from site.

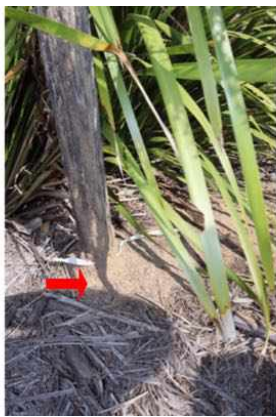
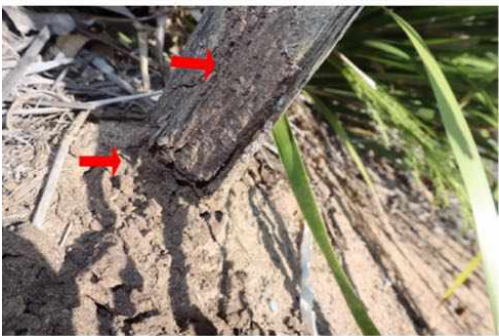
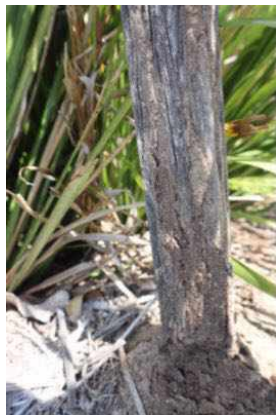
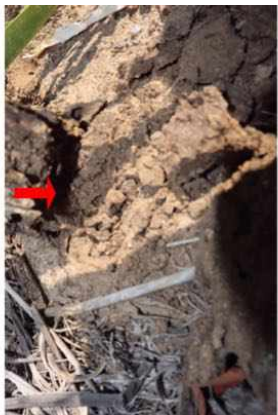
Finding 4.02

Building:	Yard
Location:	Yard - Side > Rear Right
Finding:	Evidence of a termite nest was identified during the inspection
Information:	Termite nests require preliminary treatment as well as ideally manual removal. This may include destruction of the nest via drilling and injection of termiticide or direct removal of the nest site i.e. tree or tree stump. All related timbers should be removed from site.

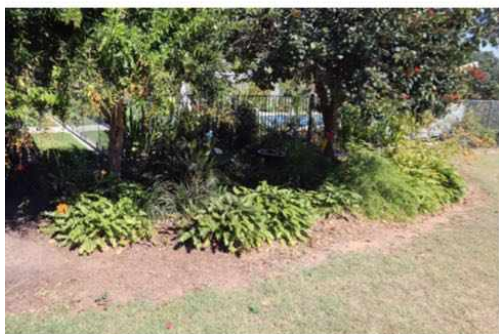
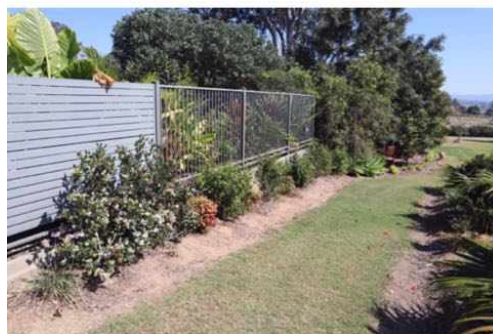
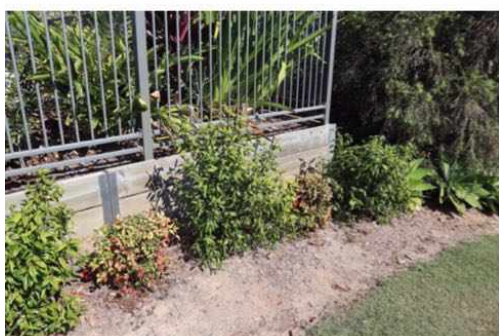
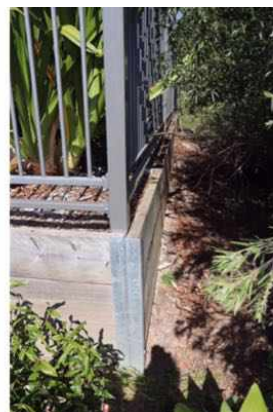
Finding 6.01

Building:	Yard
Location:	Yard - Back > Existing
Finding:	Garden Beds - Conditions Conducive to Termites
Information:	Garden beds were found to be evident in the garden area. These garden beds can include untreated timber, and with a combination of moisutre from watering hosing can make conditions conducive to termite activity and termite ingress.

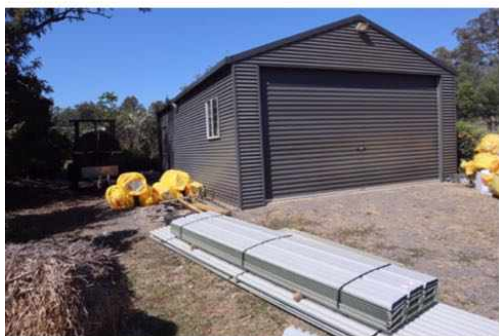
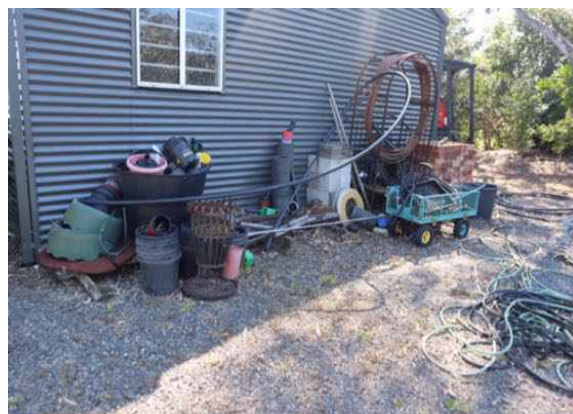
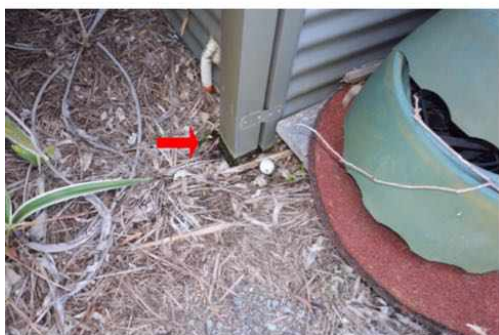
Finding 6.02

Building:	Shed
Location:	Exterior walls - rear > Existing
Finding:	Stormwater drain - Not connected
Information:	The roof plumbing is not adequately connected to stormwater drainage on the site. This disconnection negatively impacts the functional capacity of the roof plumbing.

Where roof plumbing doesn't drain adequately, the area at the base perimeter can become excessively damp, potentially creating an environment that is susceptible to rust and corrosion of surrounding building elements, as well as attracting termites and other pests.

It is highly recommended that a plumber be appointed to further inspect the area and to install adequate drainage equipment where necessary.

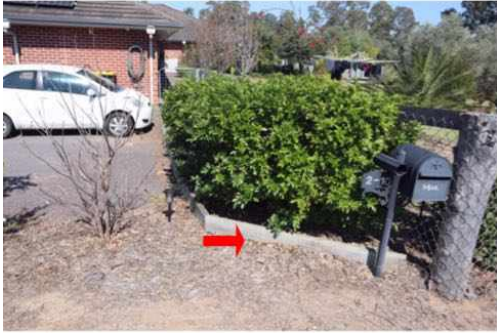
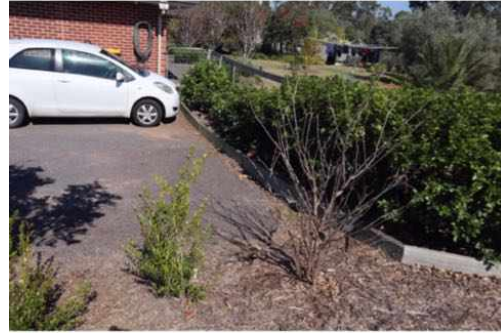
Finding 6.03

Building:	Yard
Location:	Garden > Rear Right
Finding:	In ground contact
Information:	Any timbers in direct ground contact provide opportunity for concealed termite entry and are likely to be subject to premature rot and decay as the soil retains moisture or damp conditions against the timbers.

Remove untreated timber that is in direct contact with external grounds. Consider replacement with more durable materials i.e. treated timber or non timber elements. Frequent pest inspections are advised to readily identify any termite activity in these areas.

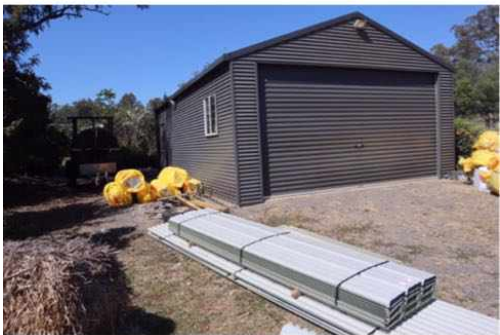
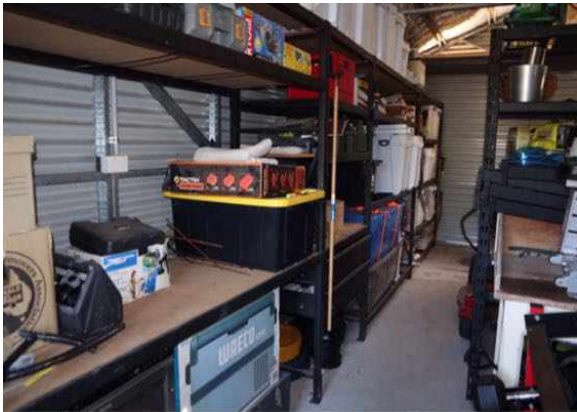
Building: Shed
Location: Yard - Back > Existing
Finding: Additional Photos
Information: Additional photos are provided for your general reference. Arrows have been included to highlight areas of importance. Please discuss these photos with your building consultant for clarification.

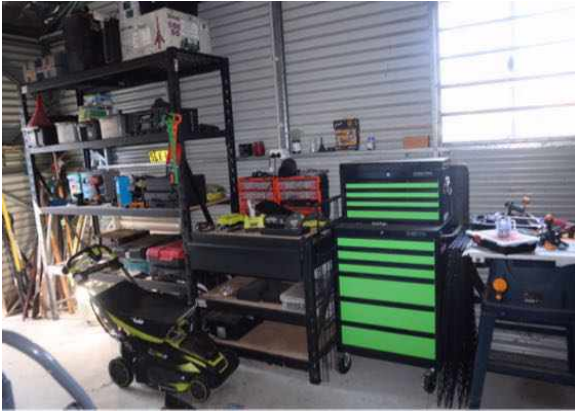
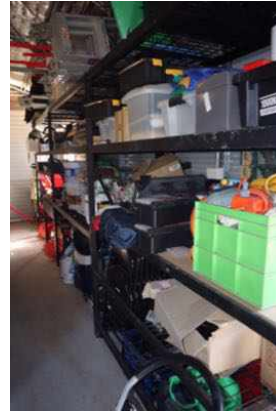
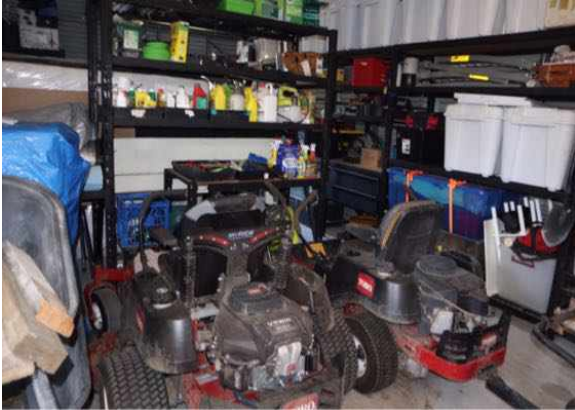
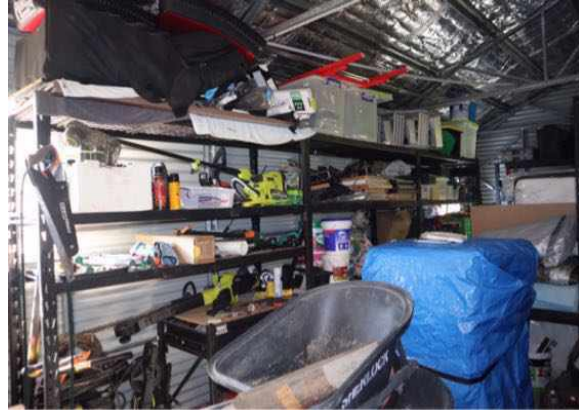
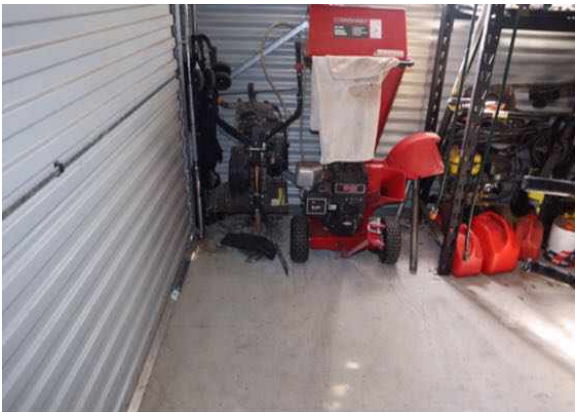
The shed at rear at of property has stored timbers which have evidence of timber pest damage, there is no evidence of timber pest activity at the time of inspection.

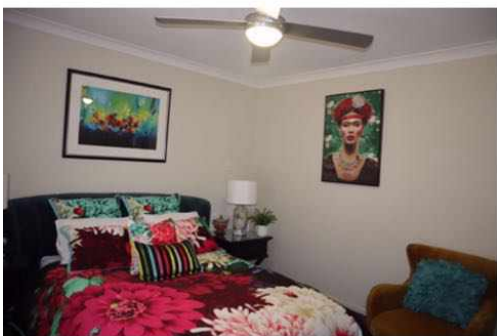
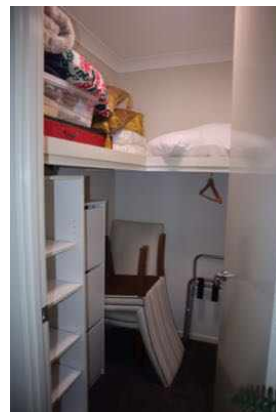
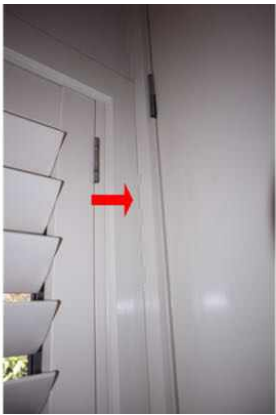
Building: Main Building
Location: Bedroom 2 > Existing
Finding: Gaps on window architrave minor
Information: At the time of inspection it was noted that there was minor cracks in window architraves.

This maybe from minor movement.

A handyman maybe required to rectify this issue.

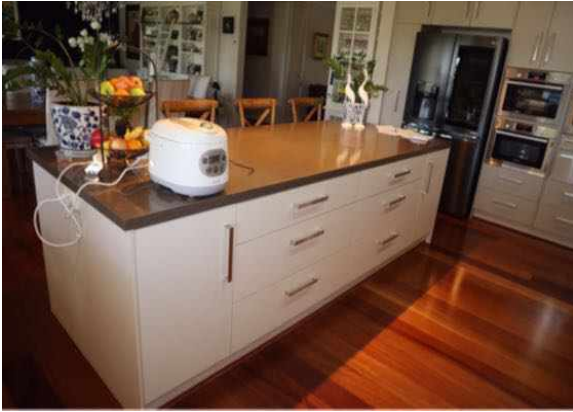
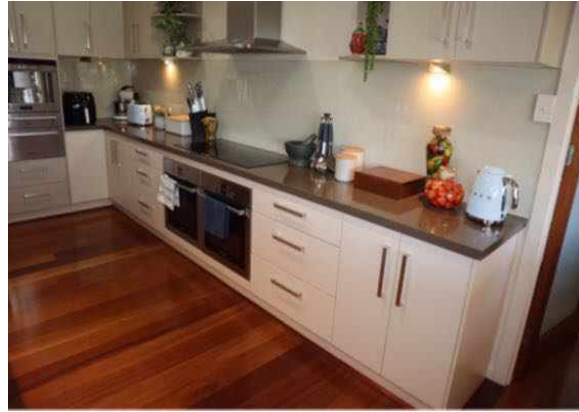
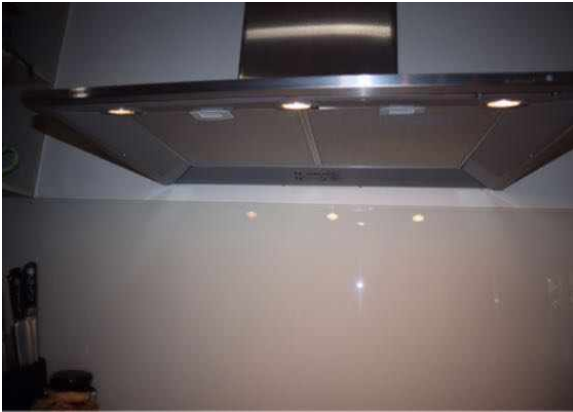
Building: Main Building
Location: Kitchen > Existing
Finding: Photos Added
Information: Additional photos are provided for your general reference.
