Building and Timber Pest Inspection Report

Inspection Date: Sun, 12 Sep 2021

Property Address: 2-10 Lochview Ct, Tamborine QLD 4270,
Australia

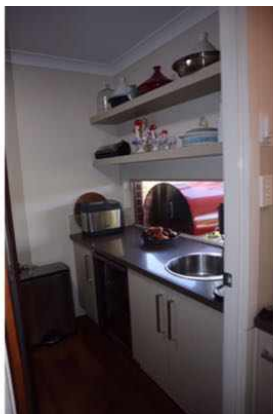
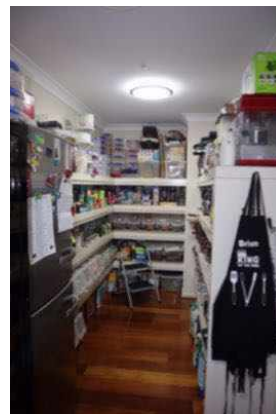
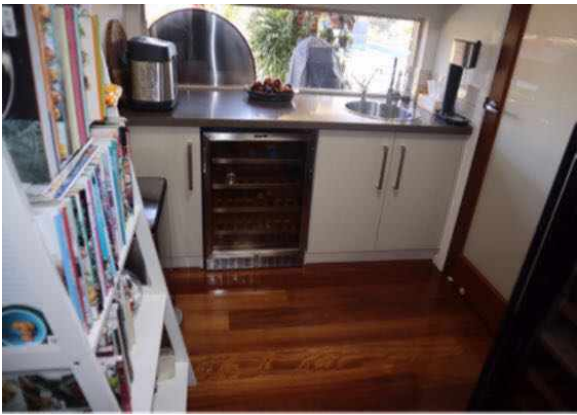
Building: Main Building
 Location: Butters pantry > Existing
 Finding: Photos Added
 Information: Additional photos are provided for your general reference.

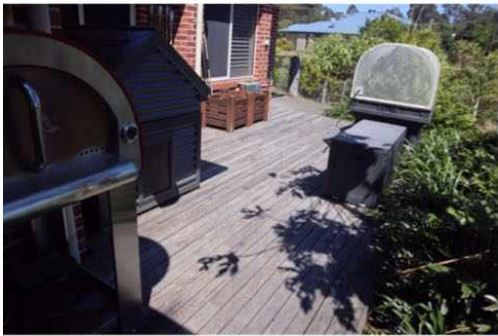
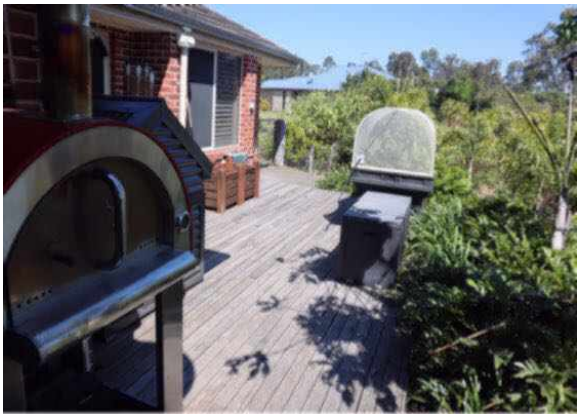
Building: Main Building
Location: Deck > Rear Left
Finding: Photos Added
Information: Additional photos are provided for your general reference.

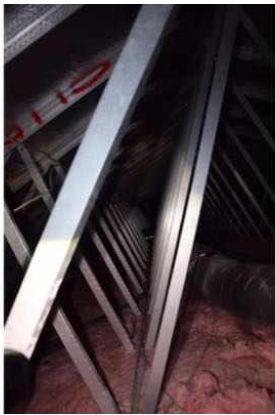
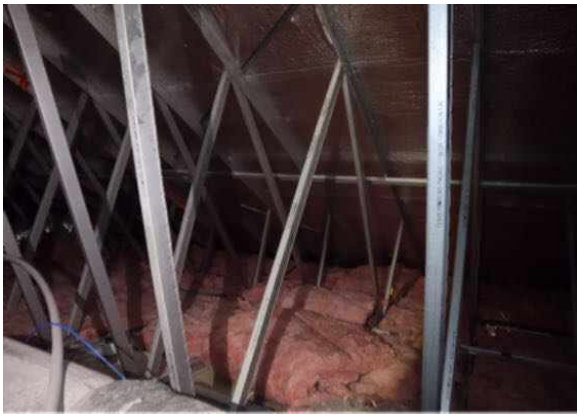
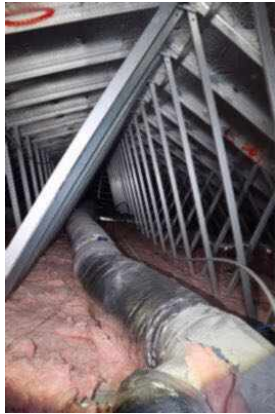
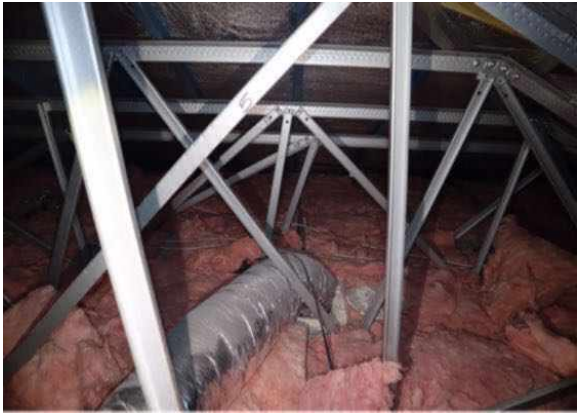
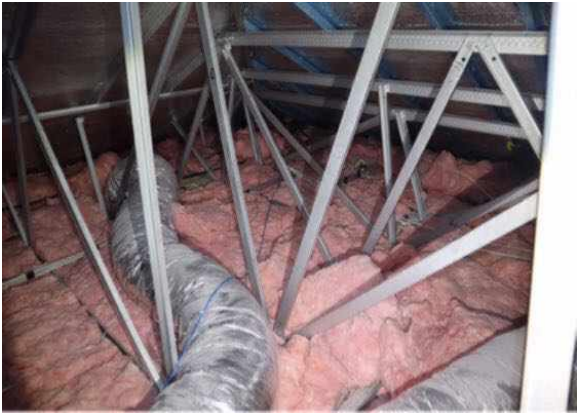
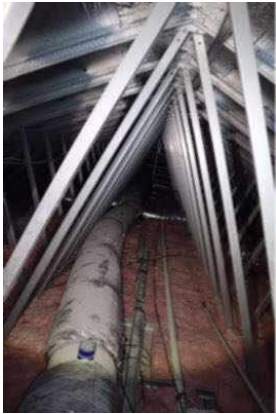
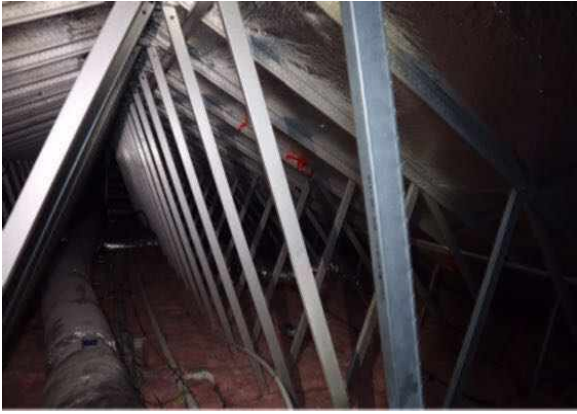
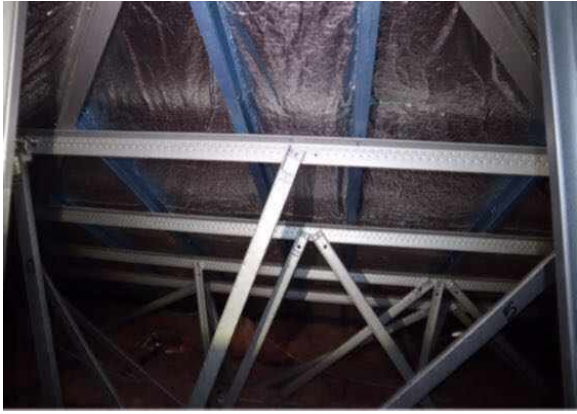
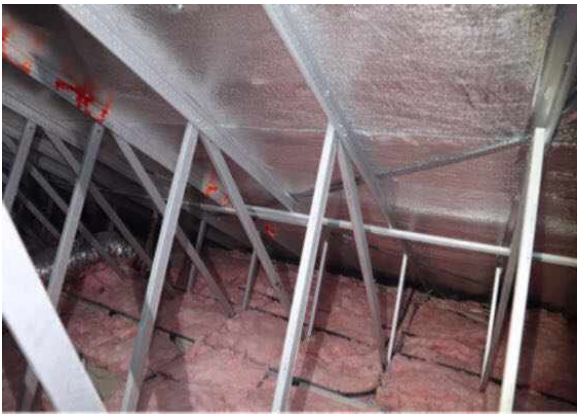
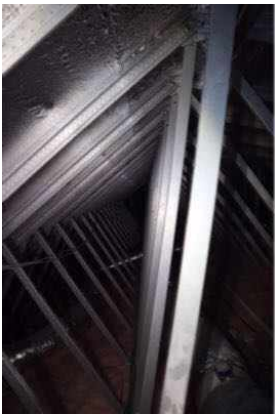
Building: Main Building
Location: All Areas > Existing
Finding: Photos Added
Information: Additional photos are provided for your general reference.

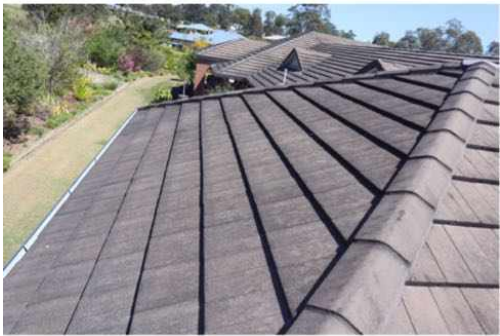
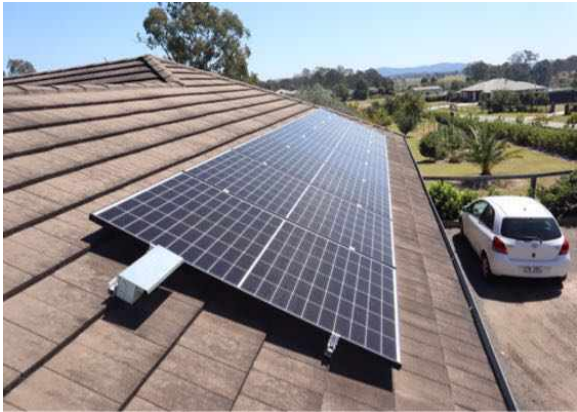
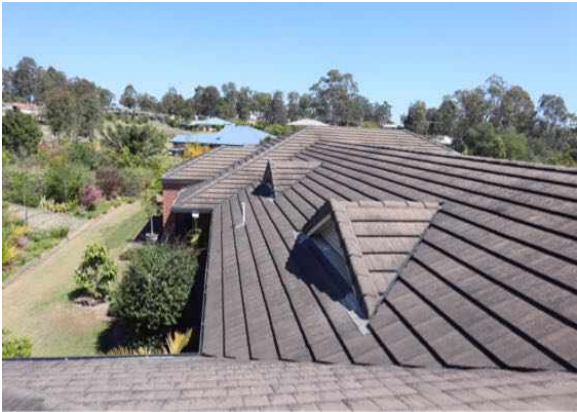
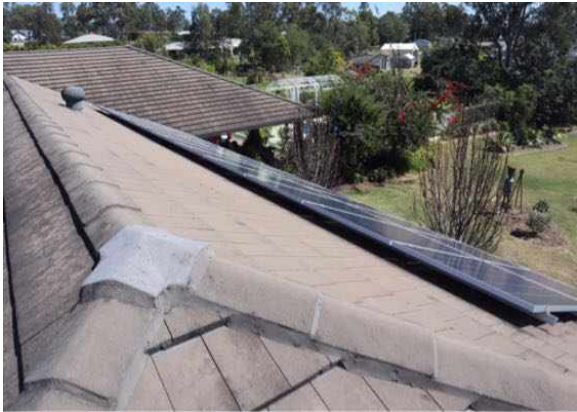
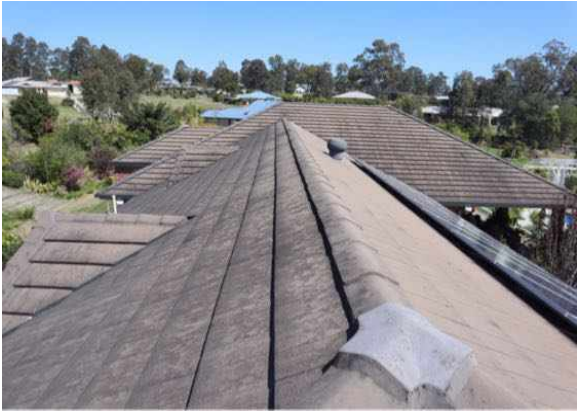
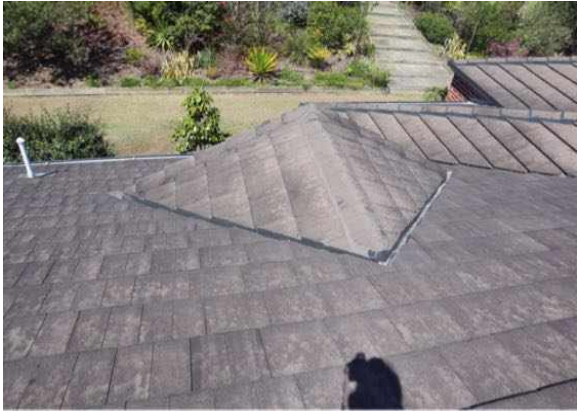
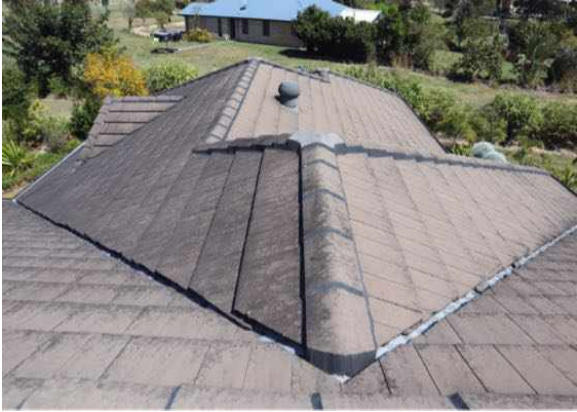
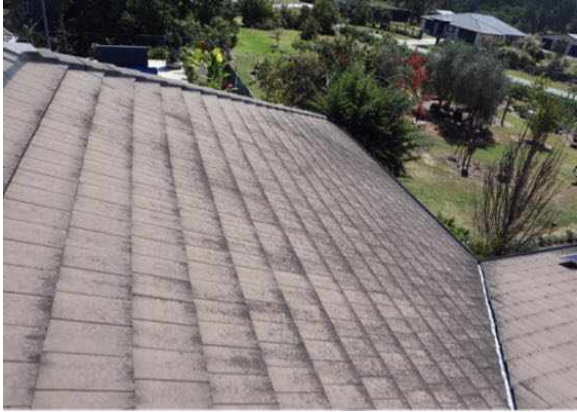
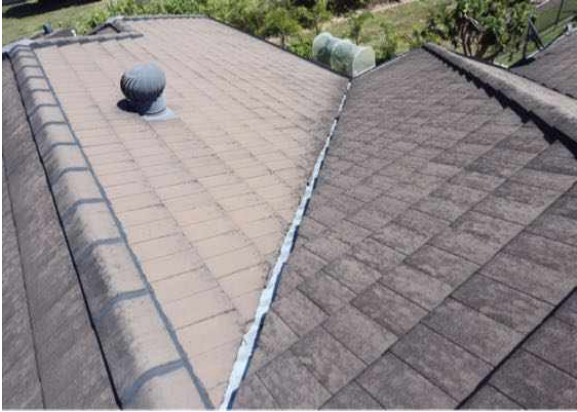
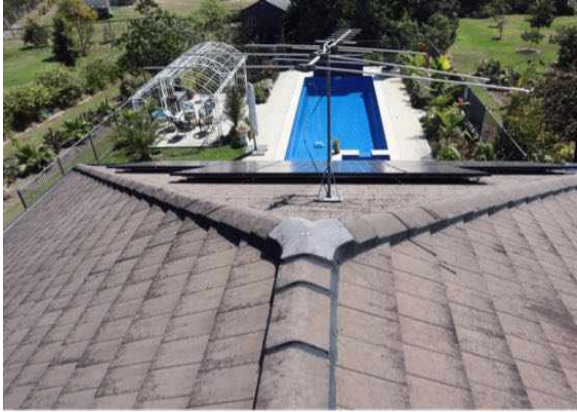
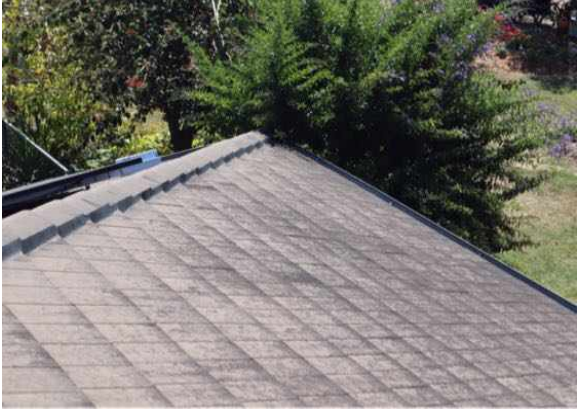
Building: Main Building
Location: All Areas > Existing
Finding: Photos Added
Information: Additional photos are provided for your general reference.

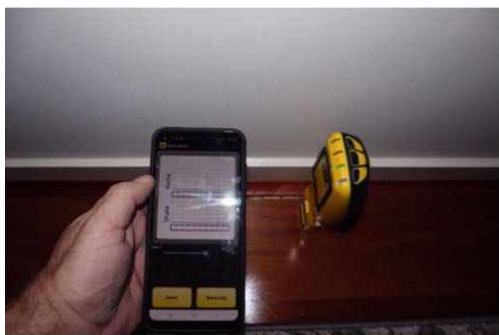
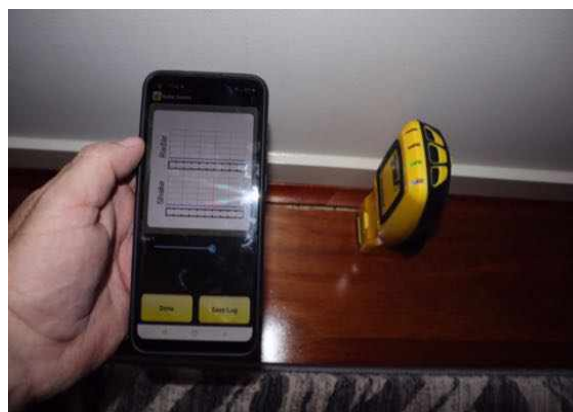
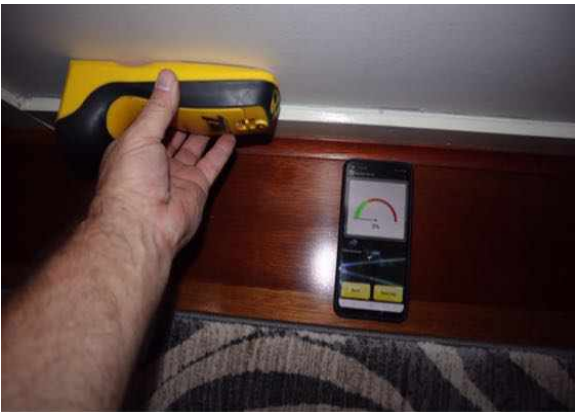
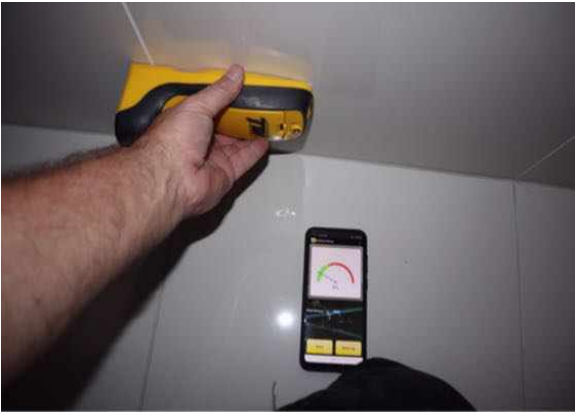
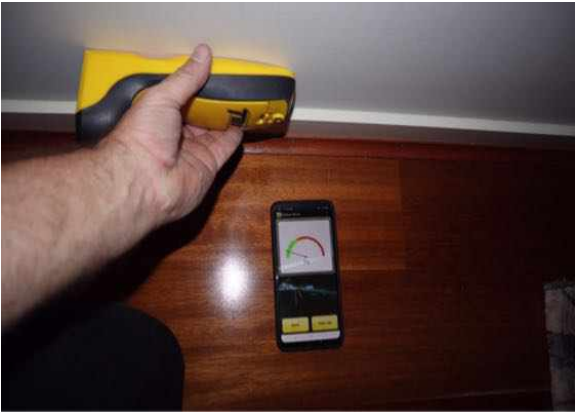
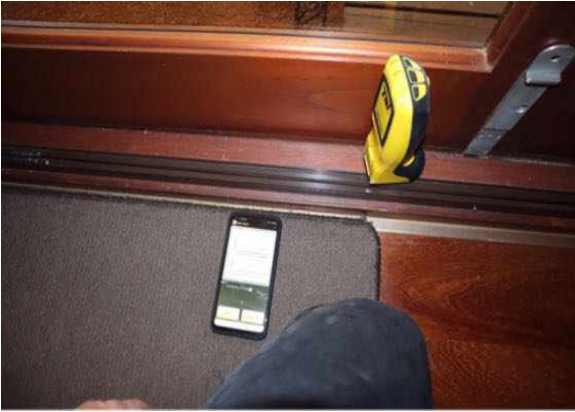
Building: Main Building
Location: All Areas > Existing
Finding: Termite Techniques
Information: All areas of the dwelling are checked with particular attention paid to wet areas which were closely assessed to check for excessive levels of moisture and temperature anomalies.

No evidence of termite activity was found inside the house at the time of the inspection.

High readings for moisture was found in the lower walls of the wet areas which warrants further invasive investigation.
