## Building and Timber Pest Inspection Report

Inspection Date: Thu, 16 Dec 2021

Property Address: 62 The Esplanade, Frenchs Forest NSW  
2086, Australia

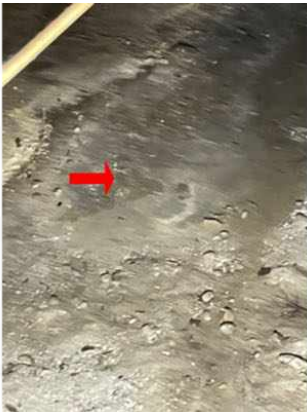
Excessive moisture is generally caused by deteriorated inadequate or missing roof drainage leaking plumbing pipes or fixtures poorly plumbed HWS overflows or condenser units and poor site drainage.

It is highly recommended that all plumbing and drainage fixtures and fittings be maintained regularly in order to prevent excessive moisture being present in the external / internal property.

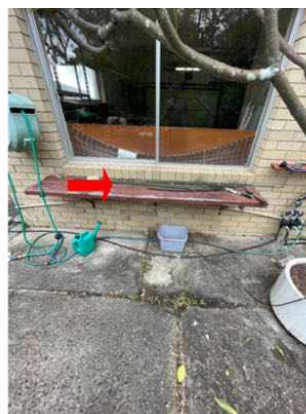
Building:	Building 1
Location:	All Areas
Finding:	painting deteriorated
Information:	Whilst incomplete or missing paint finish is generally an appearance defect, it can also lead to the development of secondary building defects over time. Incomplete areas of

paint finish exposes the area to moisture, potentially accelerating the deterioration of underlying building materials.

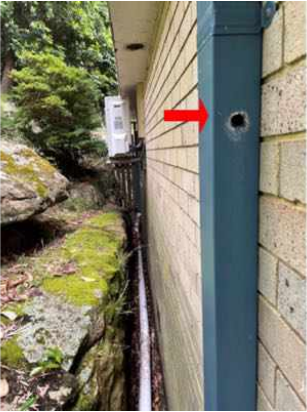
Where holes are apparent in the surface of a building material, the surface is no longer sealed against water penetration or further impact damage, which may lead to additional damage to the surrounding surface.

Repair or replacement of the affected building element is recommended as soon as possible to ensure that any secondary defects are minimised. A qualified carpenter or general handyperson should be appointed to perform these works.

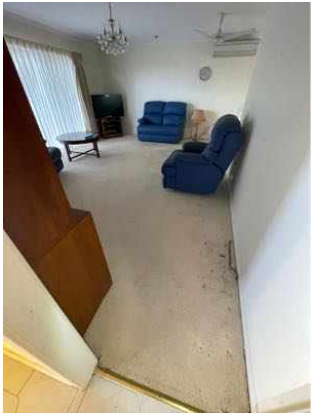
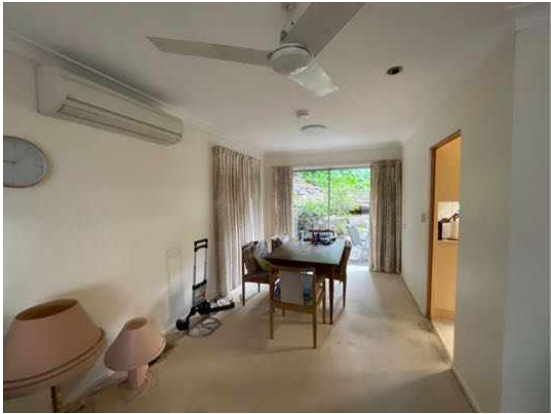
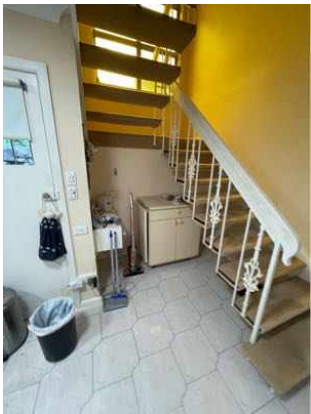
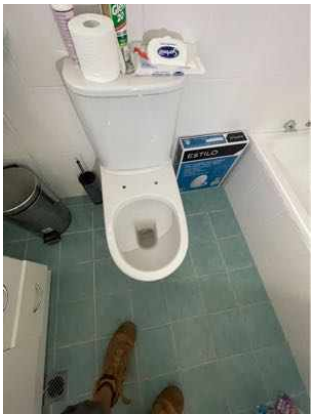
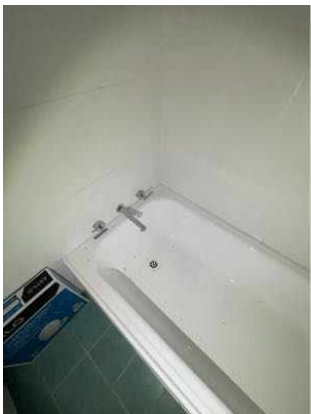
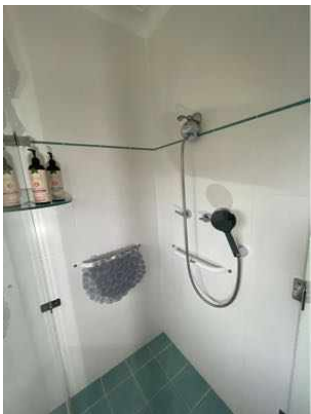
Building: Building 1  
Location: All Areas  
Finding: Additional Photos - Obstructions and Limitations  
Information: These photographs are an indication of the obstructions and limitations which impeded full inspection of the property at the time of inspection.

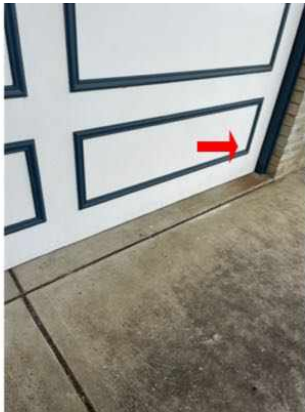
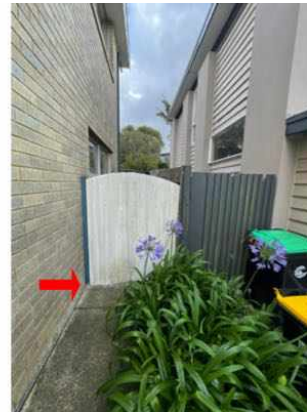
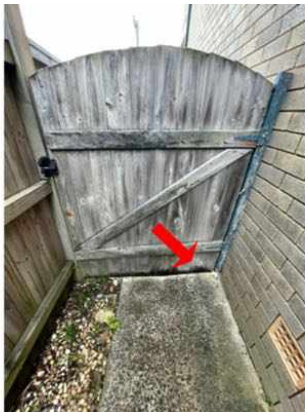
**Finding:** Building materials in direct ground contact - conducive to termites

**Information:** Where timber elements are in direct contact with the ground and consequently moisture or dampness they become conducive to termite activity. Whether timber is used as a building element part of a fencing structure or stored as an unused item they can provide an environment that is attractive to termite infestation. When met with excessive moisture timber begins to decay and develop wood rot. Any timbers that are in direct contact with external grounds especially if left untreated or non- durable also provide ingress for subterranean termites into that particular element. The removal of any such materials that may be conducive to termite activity should be removed as soon as possible to minimise the risk of termite attack.

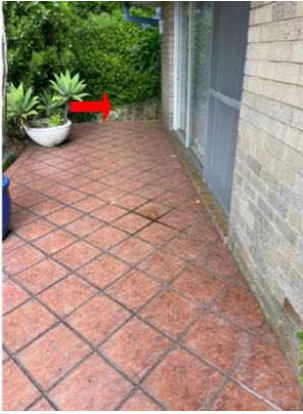
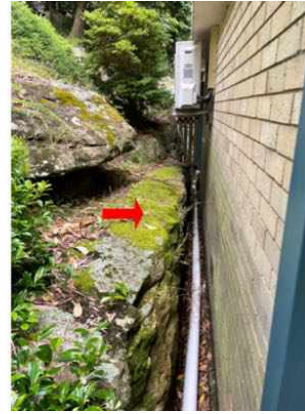
**Finding:** Garden Beds - Conditions Conducive to Termites

**Information:** Garden beds were found to be evident in the garden area. These garden beds can include untreated timber, and with a combination of moisture from watering hosing can make conditions conducive to termite activity and termite ingress.
