10 Rounce Ave, Forestville

Standard Termite Detection Report

18th Apr, 2021

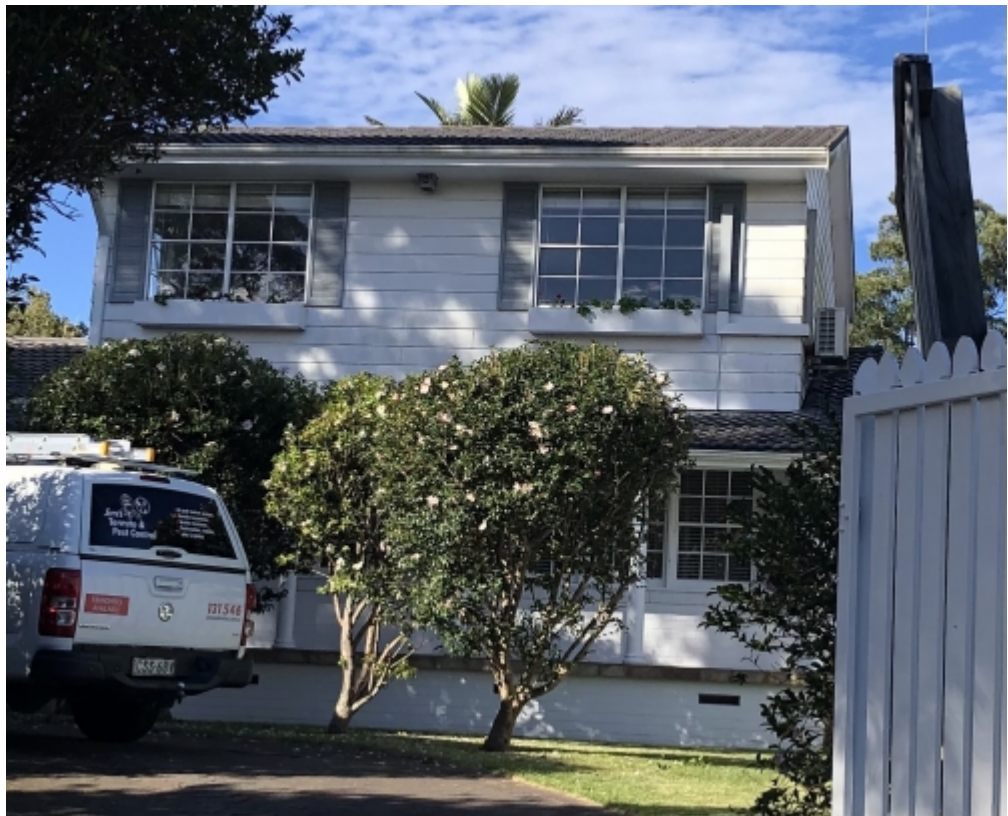
Working Or Damage Photos

Was evidence of termite workings or damage found?	Yes - see clauses A.4 and A.5
The extent of any visible damage appears:	Localised

Details - indicate the location of all accessible timbers and other materials showing signs of attack, and a description of any termite workings found:	Previous termite activity was found in a tree stump in front yard next to the carport. No live activity was found.
---	--

Additional Comments:	We recommend a termite management system to be installed around the building to detect/prevent termite activity before they enter the building
----------------------	--
