VISUAL BUILDING AND PEST INSPECTION REPORT

Complies with Australian Standard 4349.1 & 4349.3

7 Rangers Retreat Road, Frenchs Forest

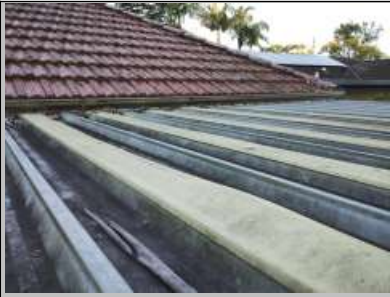
The roof is of skillion style construction.

Metal decking. Polycarbonate.

The overall condition of the roof coverings is fair.

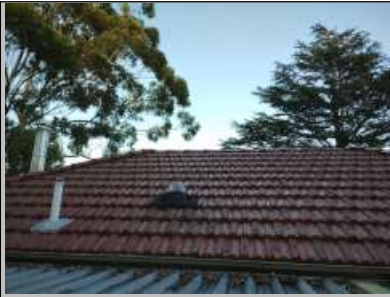
The roof is of pitched and skillion construction.

No access was possible to part of the external roof area due to the roof not being accessible from a 3.6 meter ladder.

The overall condition of the roof coverings is fair.

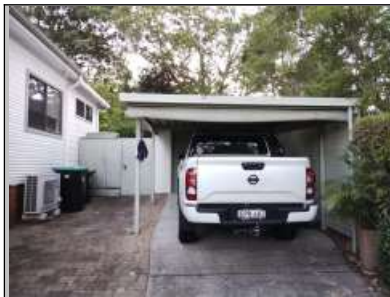
Carport.

Adjacent to the main building.

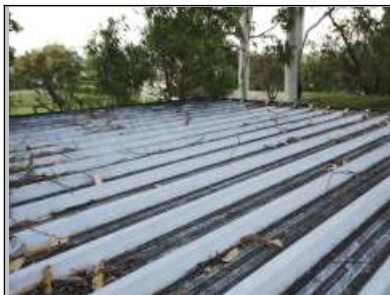
The roof is of skillion style construction.

The overall condition of the roof coverings is fair.

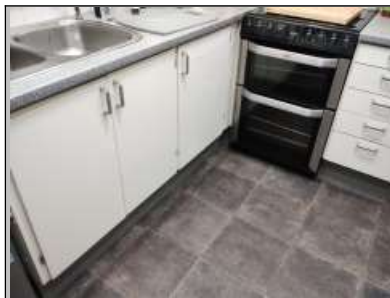
The condition of the fixtures is generally fair.

The condition of the tiles is generally fair.
