## Building Inspection Report

Inspection Date: Fri, 7 Jul 2023

Property Address: 81 Dareen St, Frenchs Forest NSW 2086,  
Australia

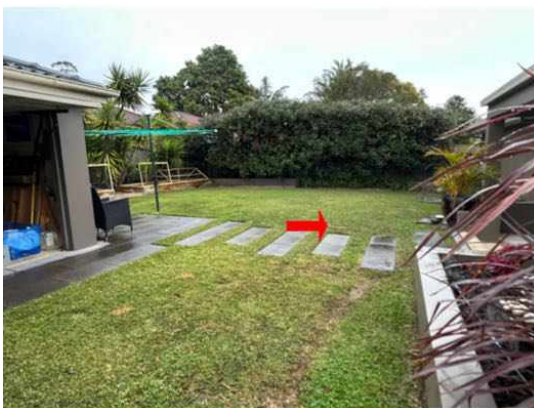
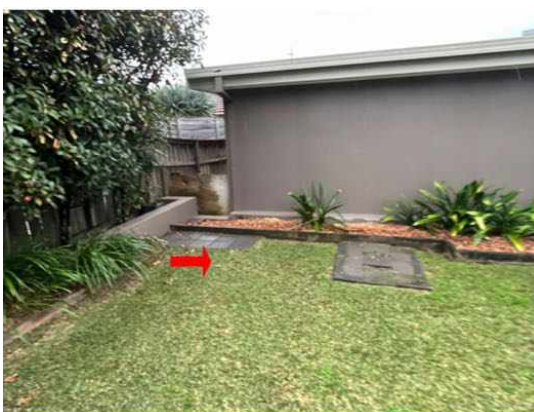
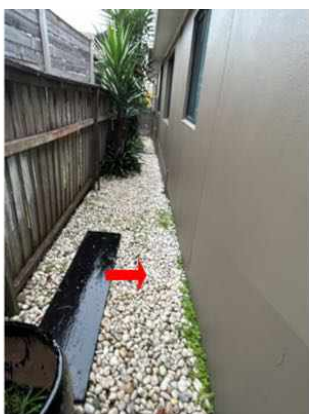
### Defects 3.01

Building:	Building 1
Location:	All External Areas
Finding:	Site drainage - suspected inadequate
Information:	The site drainage in this area was found to be inadequate at the time of inspection, creating potential for subsequent water damage to associated building elements.

It is important that water does not lie against the base of walls; surrounding paths and ground levels should be sloped to drain water away from walls. Downpipes should not disgorge stormwater onto lower walls or plinths. Stormwater should be carried away by large, regularly cleaned drains. Ground levels may need to be lowered to expose a buried DPC.

Where site drainage is inadequate, installation of an Agricultural (Aggie) Drain may be required. A qualified plumber should be appointed to further inspect the property and perform any remedial works as necessary. Water damage and secondary defects are likely to occur if left unmanaged.

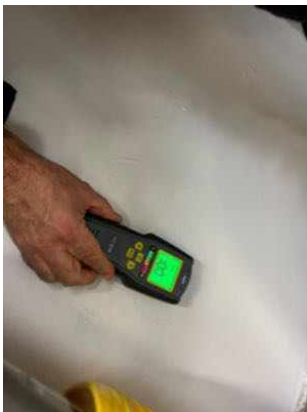
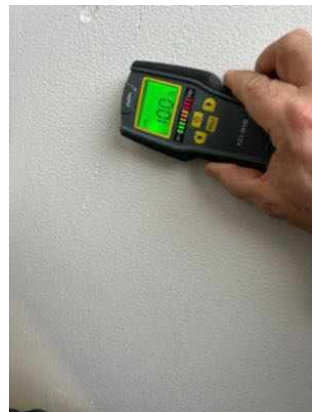
### Defects 3.03

Building:	Building 1
Location:	Garage
Finding:	Evidence of excessive moisture was present at the time of inspection
Information:	Excessive moisture can attract termites and produce conditions that promote termite attack fungal growth and wood decay.

Excessive moisture is generally caused by deteriorated inadequate or missing roof drainage leaking plumbing pipes or fixtures poorly plumbed HWS overflows or condenser units and poor site drainage.

It is highly recommended that all plumbing and drainage fixtures and fittings be maintained regularly in order to prevent excessive moisture being present in the external / internal property.

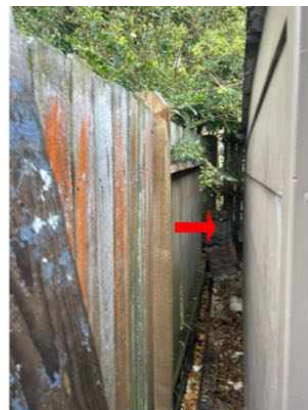
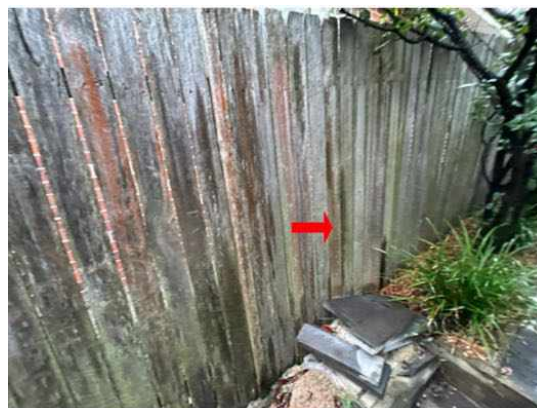
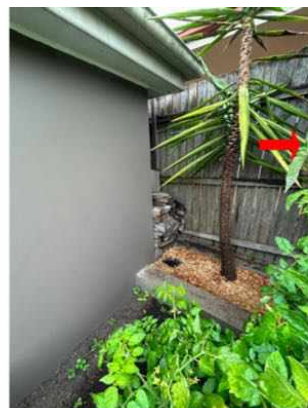
### Defects 3.06

Building:	Building 1
Location:	All External Areas
Finding:	Fencing - Deteriorated
Information:	It was noted at the time of inspection that sections of the fencing throughout the property have deteriorated. Typically fencing deteriorates due to age and or wear, rot and or rust which is generally expected for a structure of this age, due to prolonged exposure to weather conditions. Sometimes inadequate installation or maintenance can be to blame.

If left unattended, it is likely that further damage will occur. It is suspected that repair of several elements of the fencing may be required however replacement may be a consideration of the client also.

A licensed fencing contractor should be appointed to provide further advice and perform rectification works as necessary.

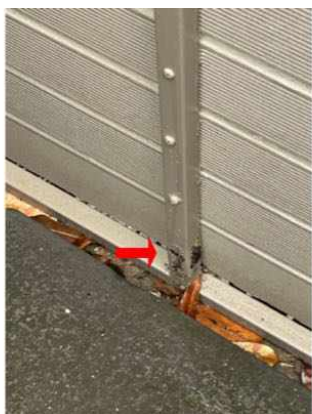
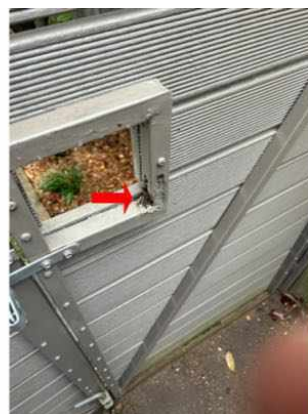
### Defects 3.07

Building:	Building 1
Location:	Yard - Side
Finding:	Building element - Rusted or corroded
Information:	This building element shows evidence of rusting and corrosion, which is likely to have developed as a result of excessive exposure to moisture and or inadequate coatings.

Rusting and corrosion should be managed by ideally removing or limiting the affected surface from exposure to moisture. A registered builder may be appointed to replace any building elements that have been severely affected by rust or water damage.

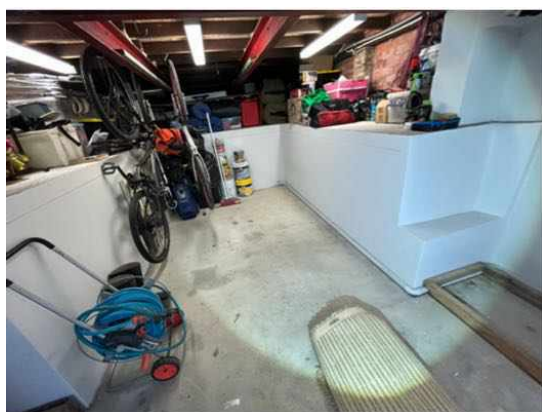
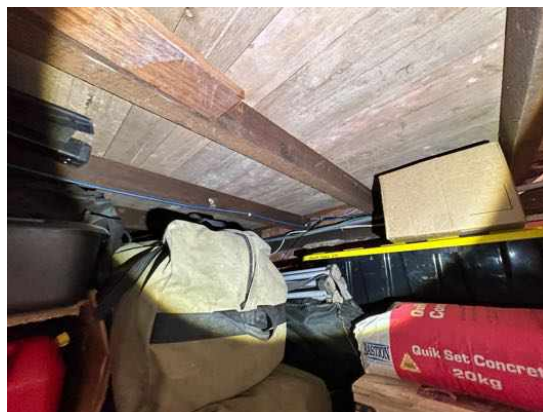
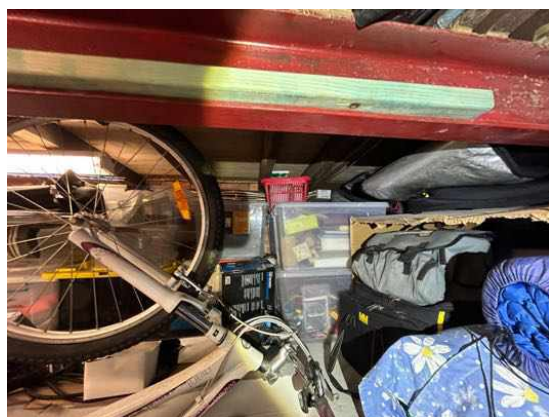
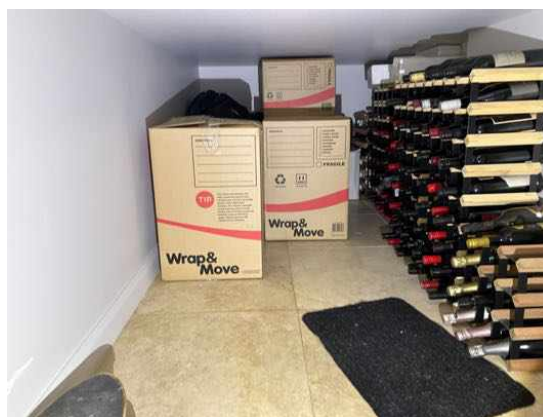
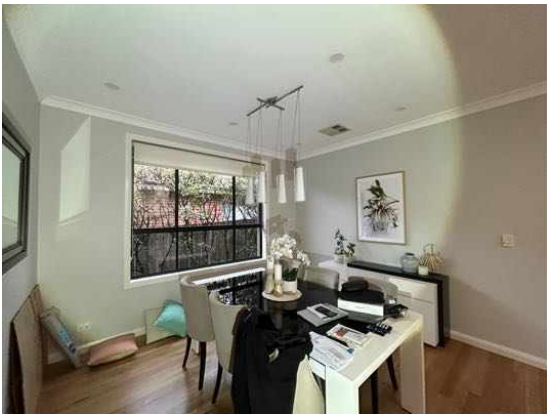
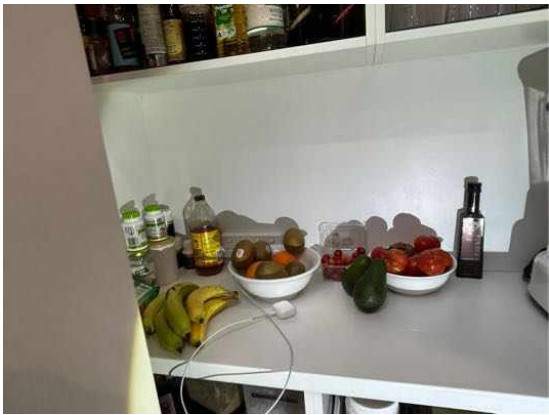
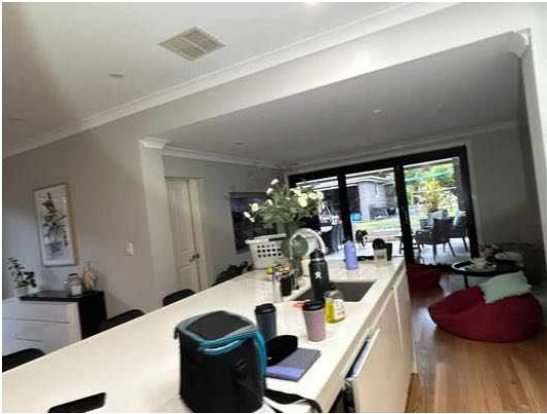
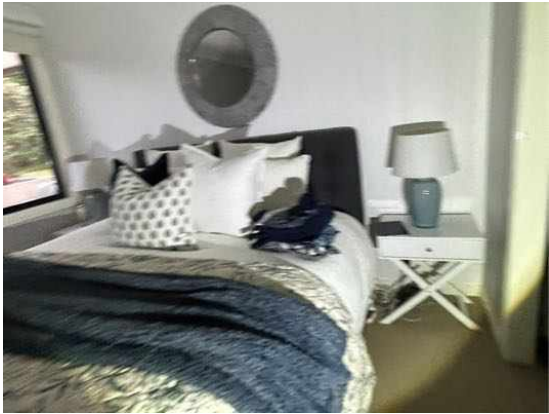
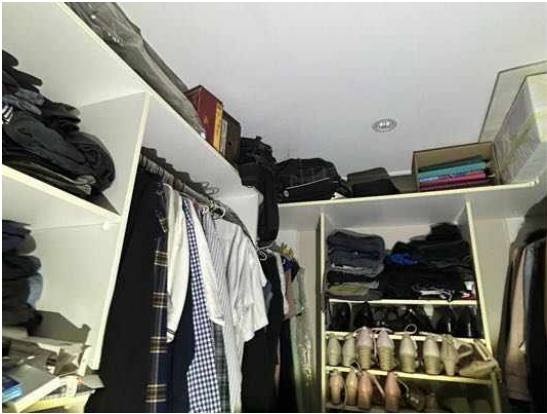
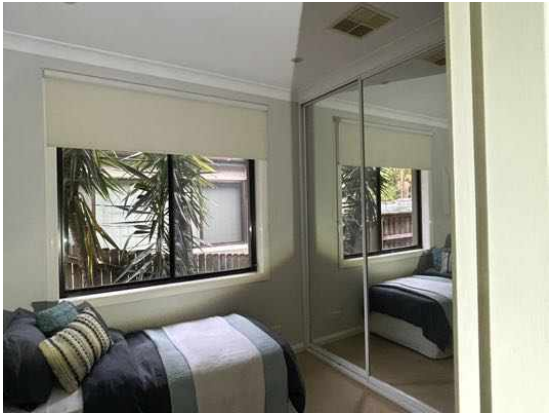
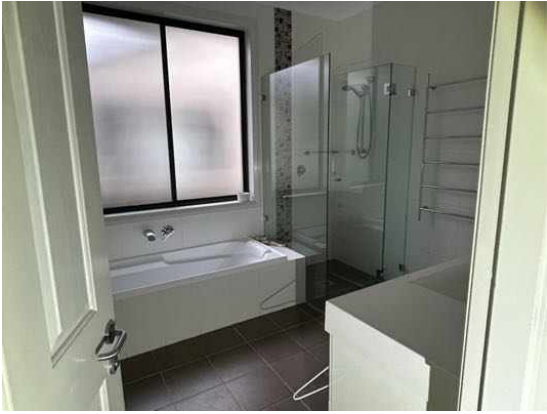
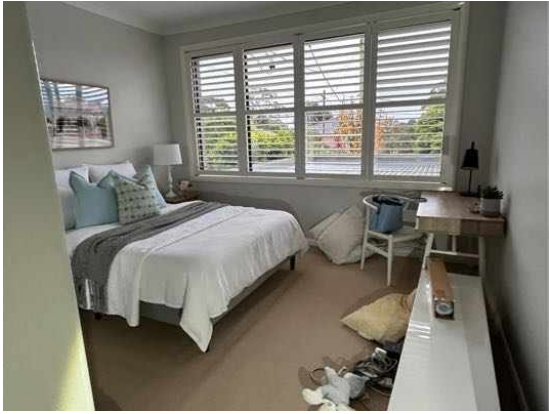
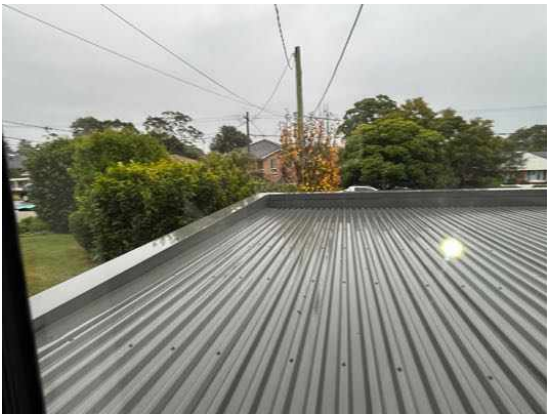
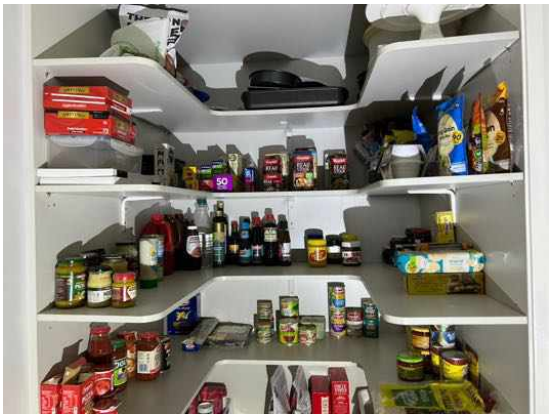
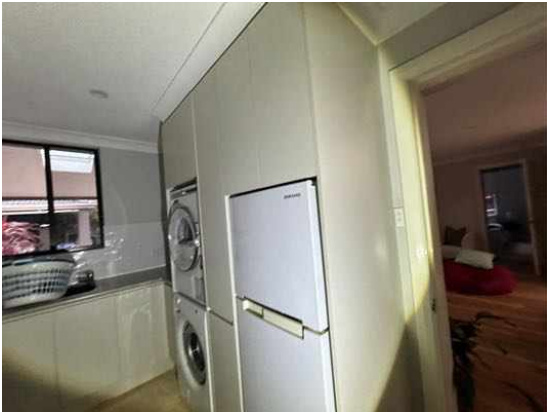
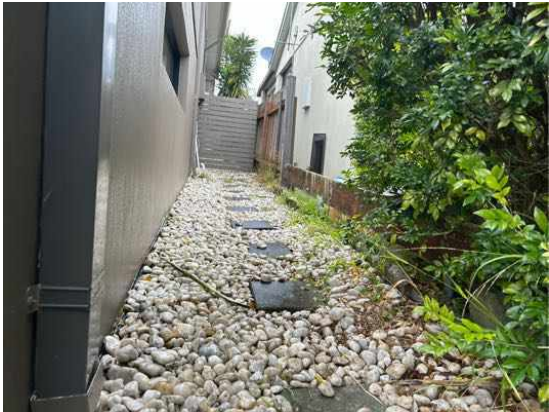
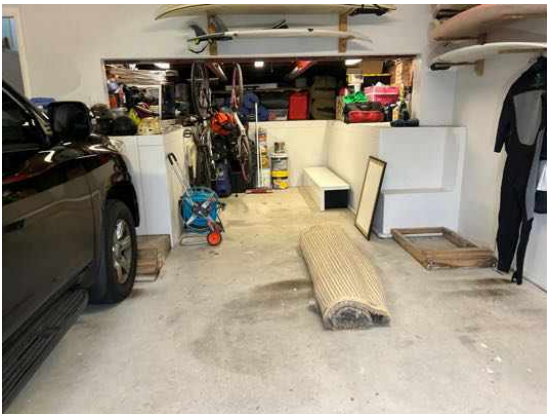
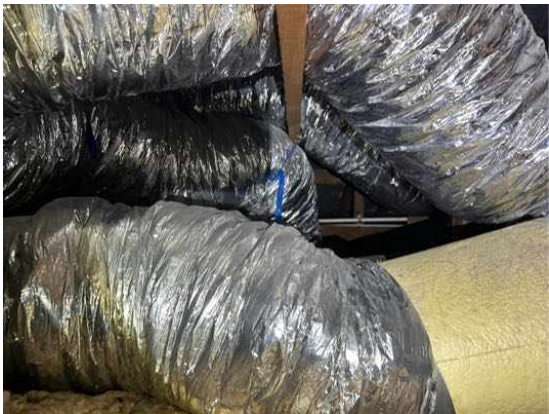
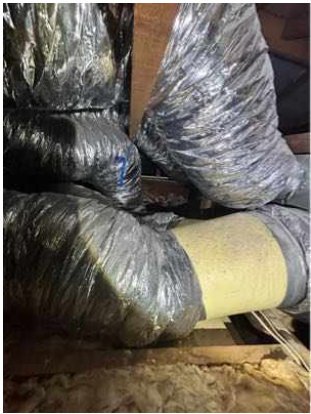
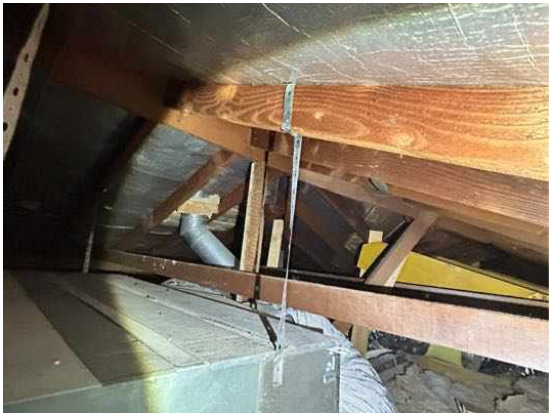
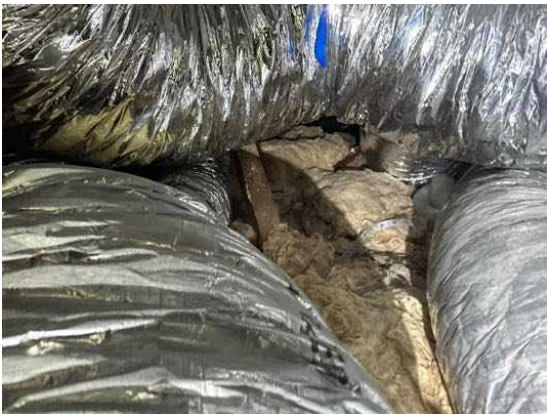
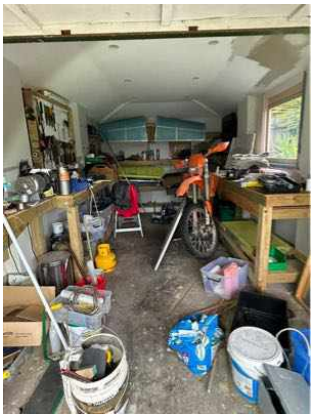
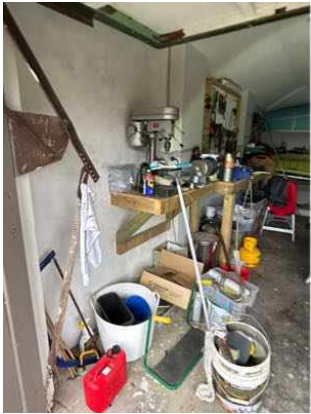
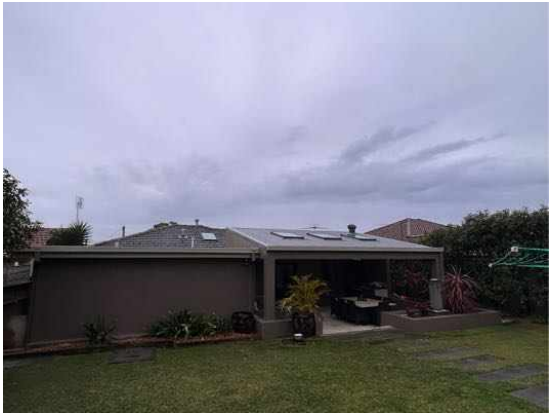
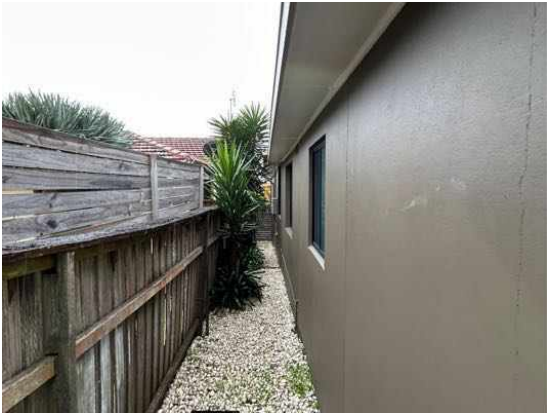
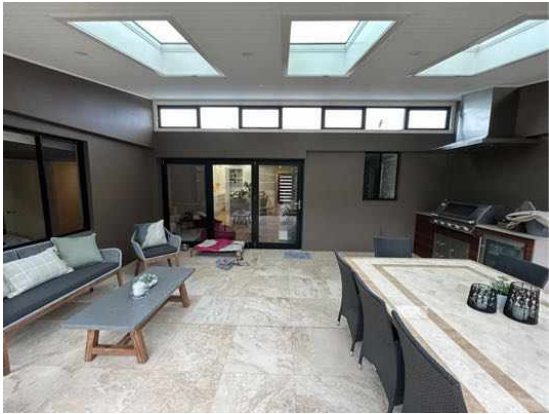
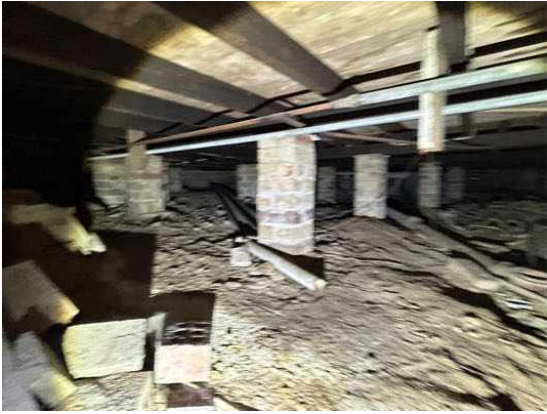
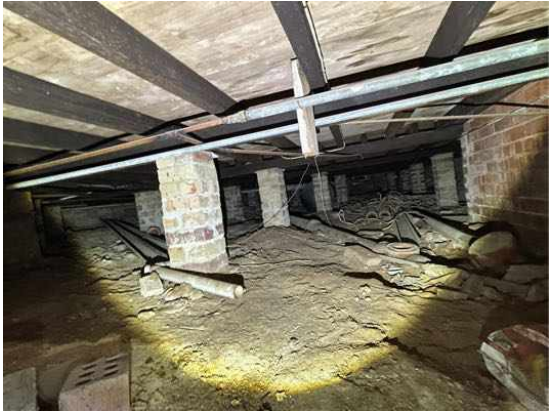
### Noted Item

Building: Building 1  
 Location: All Areas  
 Finding: Additional Photos - Obstructions and Limitations  
 Information: These photographs are an indication of the obstructions and limitations which impeded full inspection of the property at the time of inspection. These obstructions can hide an array of defects and should be removed to allow full inspection to be carried out. A re-inspection is recommended once the areas are made accessible.

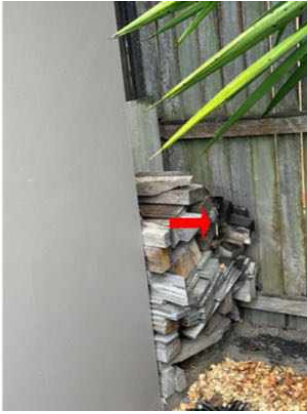
Building:	Building 1
Location:	Yard - Back
Finding:	Stored timbers - external area
Information:	<p>The storing of timbers around the external property increases the risk of termite activity being present. As they are likely to come into contact with weather conditions or excessive moisture wood rot is likely to develop on timbers that are not treated.</p> <p>It is highly recommended that any stored timbers be immediately removed from areas in which they may attract any termite / timber pest attack. Minimisation of risk / prevention of termite attack is far more adequate than dealing with the presence of termite activity.</p>

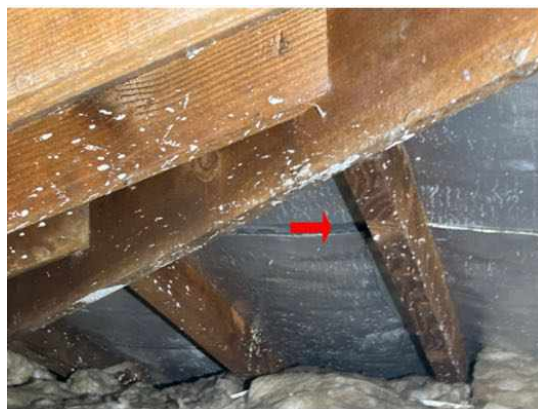
Building:	Building 1
Location:	Roof Void
Finding:	Sarking - installed
Information:	Sarking is under the roof sheeting. Sarking acts as an insulator that helps with noise reduction and protects against water penetration. Sarking plays a key role in the operation and function of the overall roofing structure and its performance.

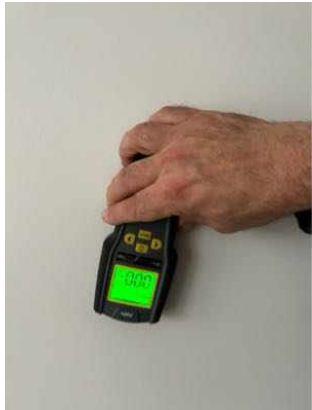
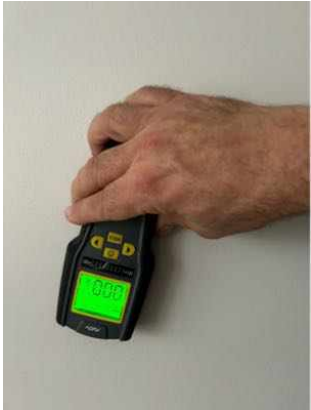
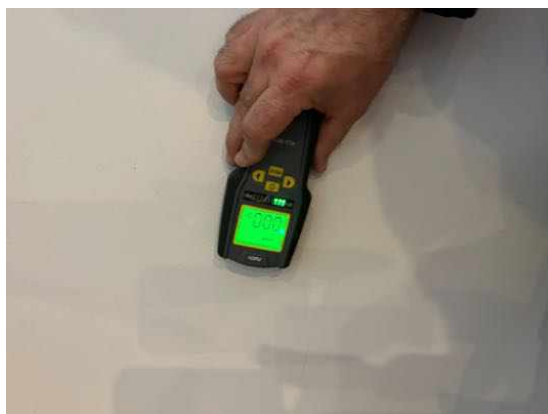
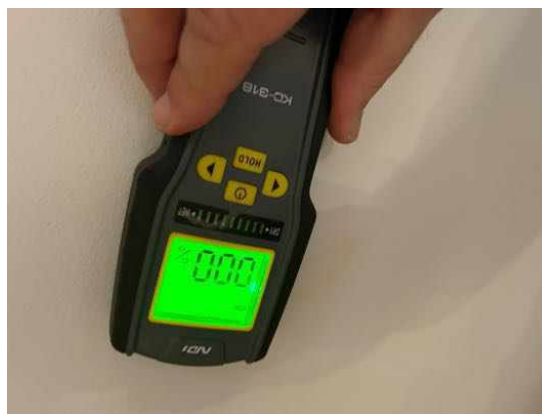
Building:	Building 1
Location:	All Areas
Finding:	Moisture meter readings - low
Information:	The moisture meter result for the areas inspected.

The moisture reading of 0-15% is quite normal and gives no cause for concern. However, moisture readings in excess of 15% indicate the need for further inspection.

Levels between 25-30% indicate that there may be water ingress, meaning that remedial work could be required.
