Building and Timber Pest Inspection Report

Property Address: 14 Tyalla Ave, Frenchs Forest NSW 2086,
Australia

Original Inspection Date: Thu, 8 Apr 2021

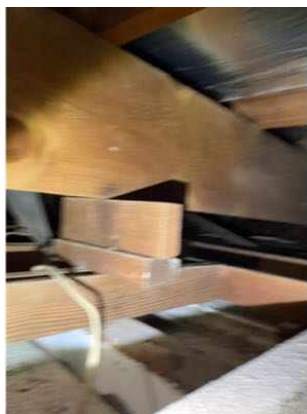
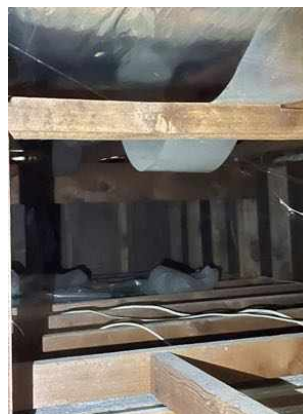
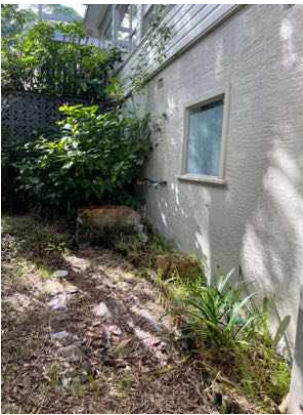
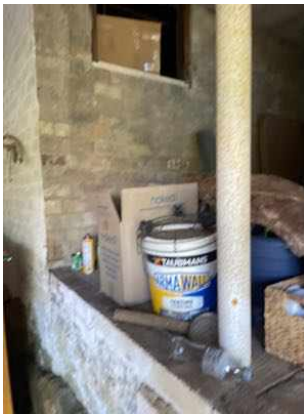
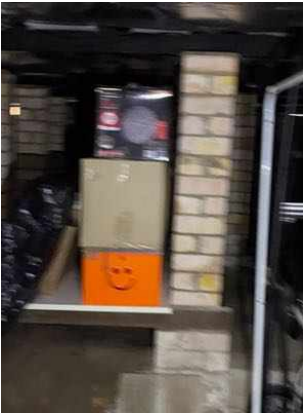
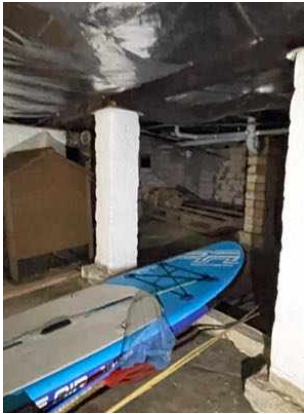
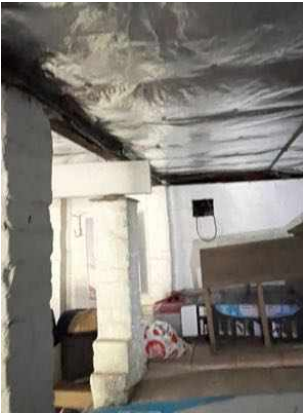
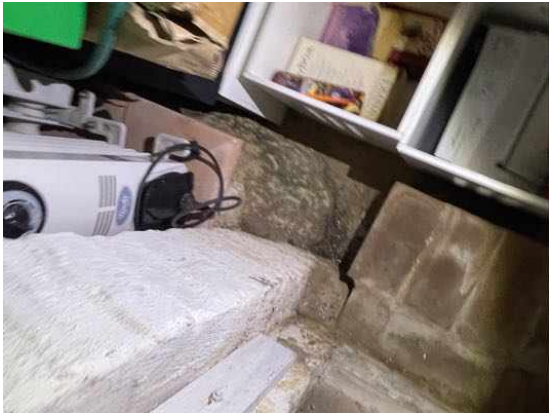
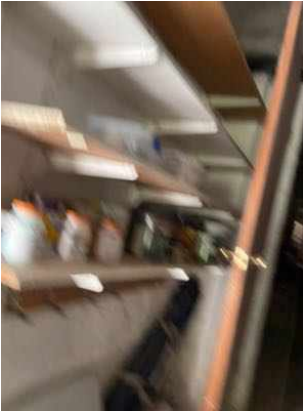
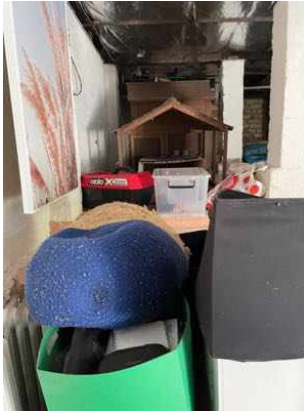
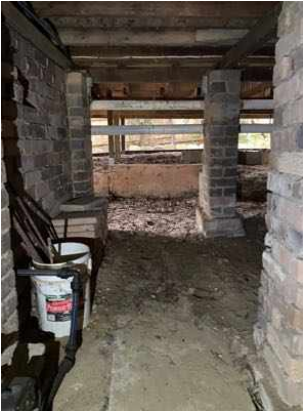
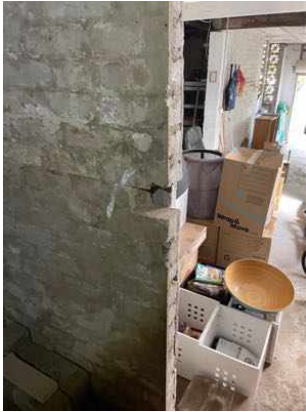
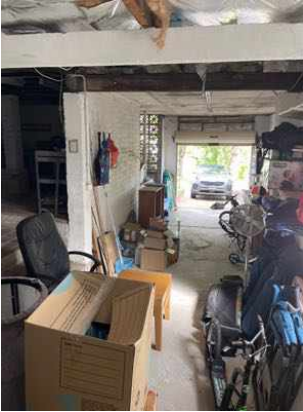
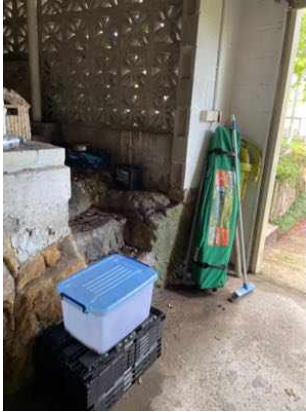
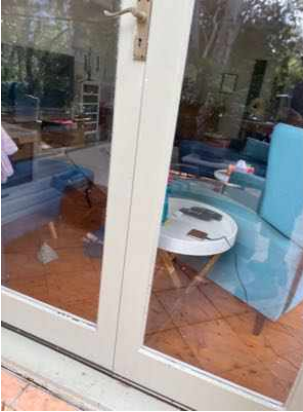
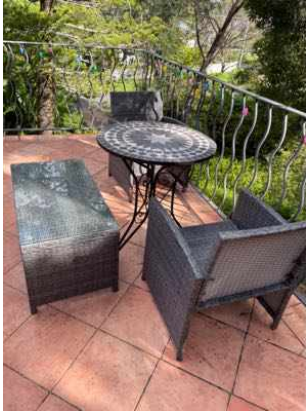
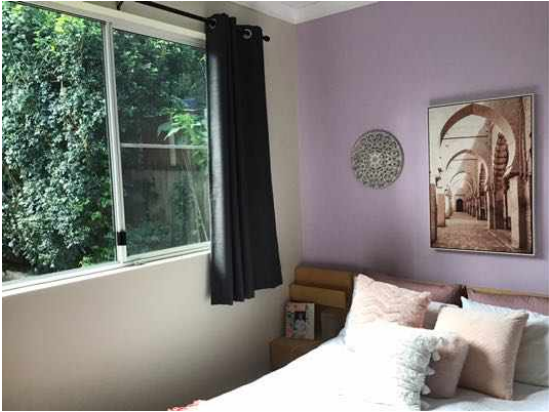
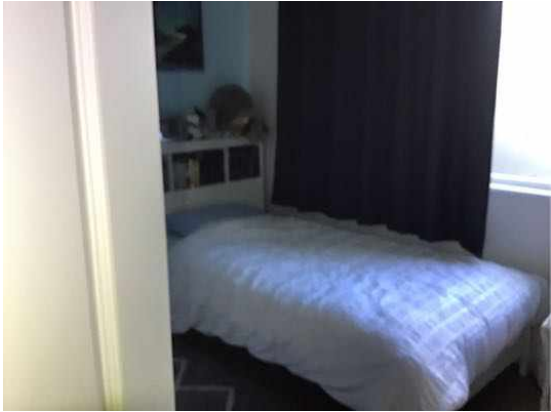
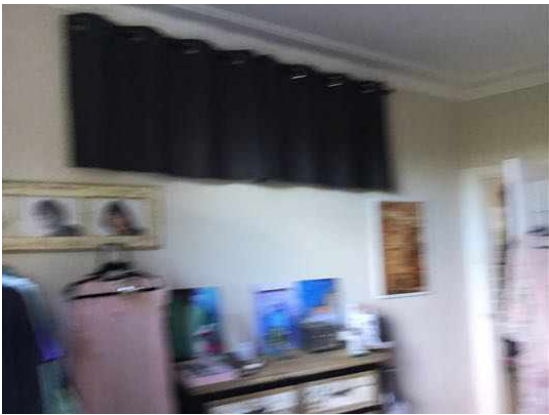
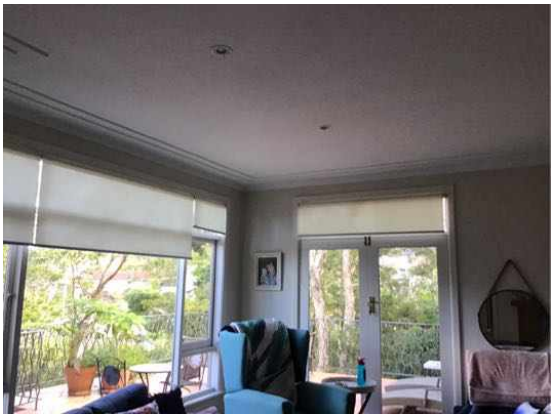
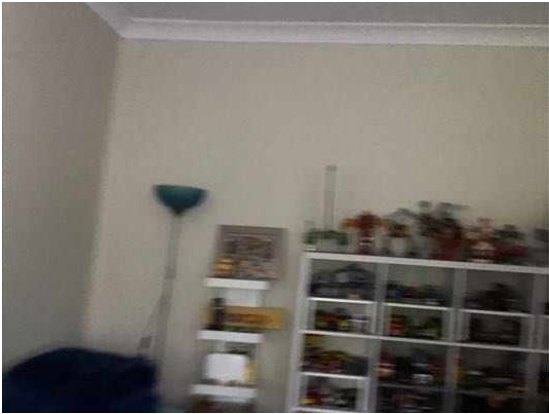
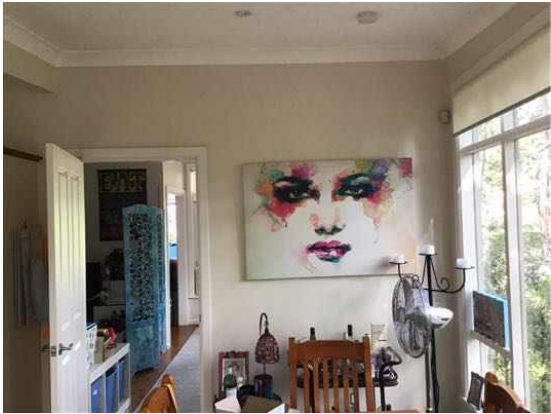
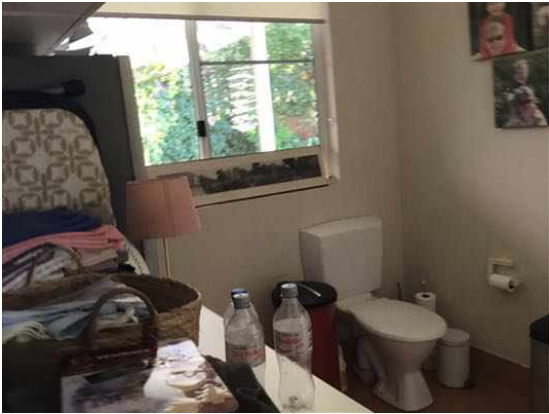
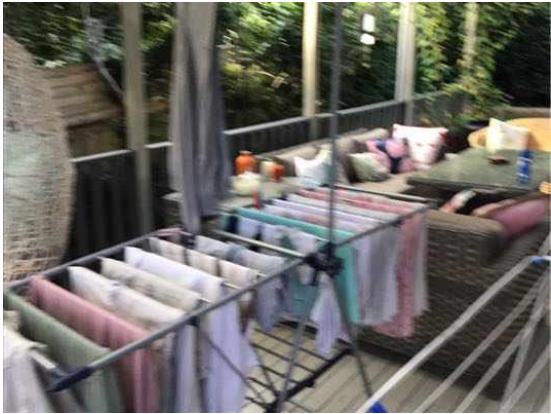
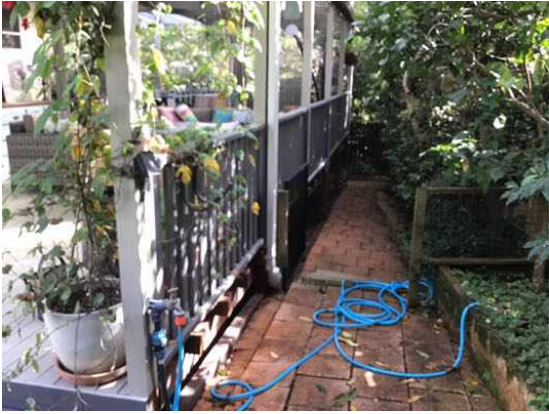
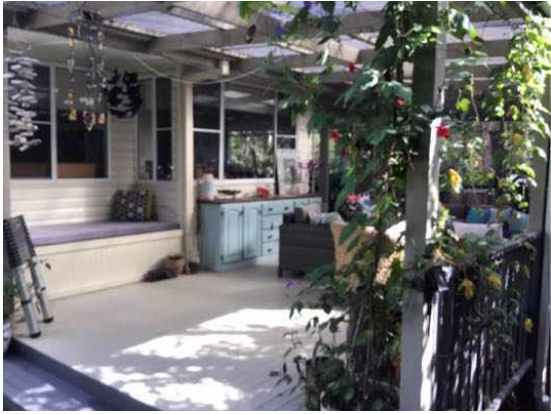
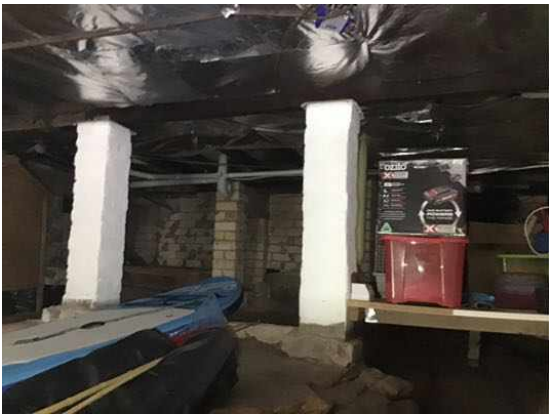
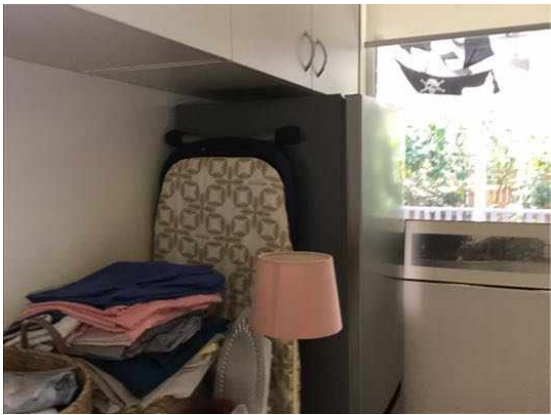
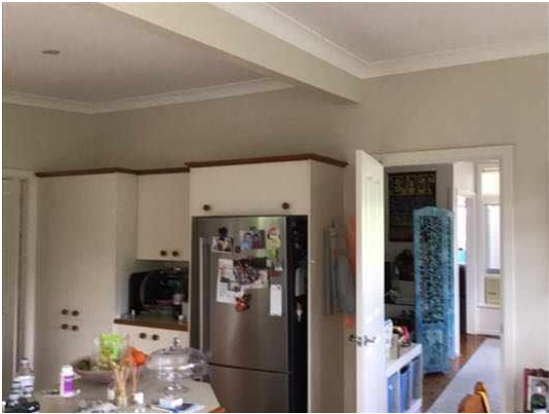
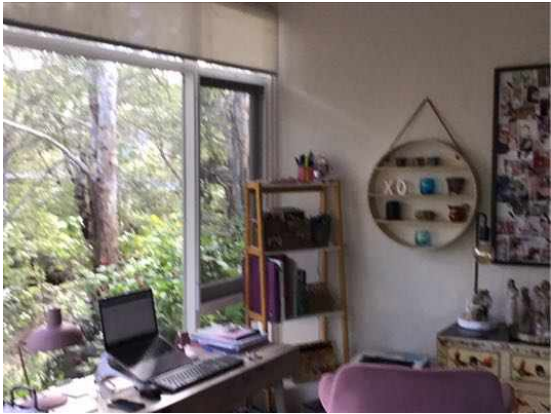
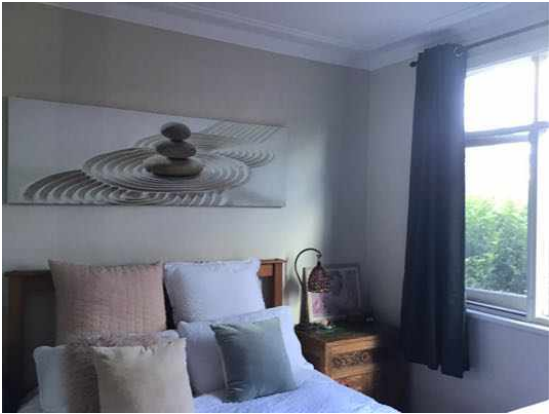
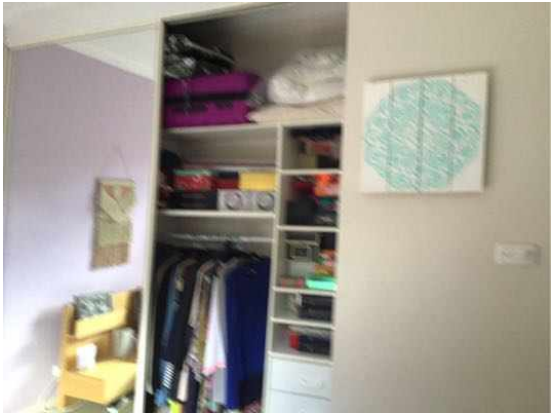
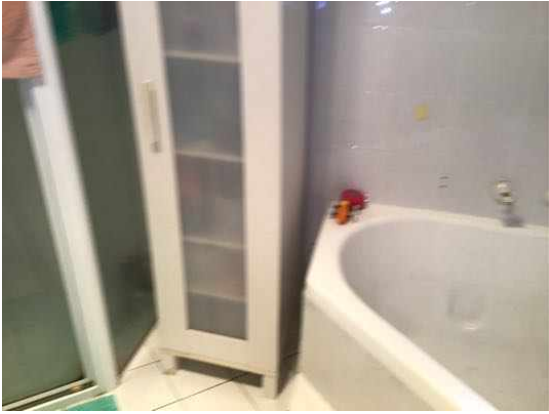
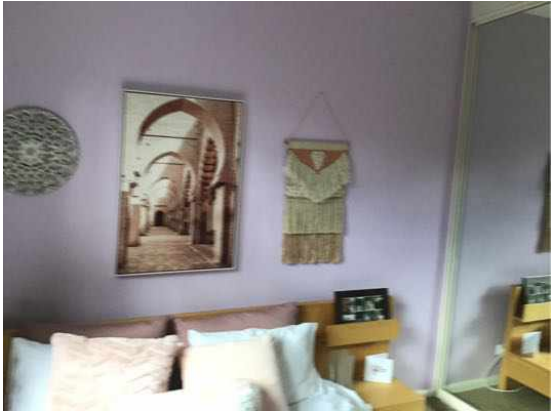
Noted Item

Building:	Building 1
Location:	
Finding:	Additional Photos - Obstructions and Limitations
Information:	These photographs are an indication of the obstructions and limitations which impeded full inspection of the property at the time of inspection. These obstructions can hide an array of defects and should be removed to allow full inspection to be carried out. A re-inspection is recommended once the areas are made accessible.
