# Building and Timber Pest Inspection Report VR

Inspection Date: Tue, 5 Nov 2024

Property Address: 2 Kenford Cct, Stanhope Gardens NSW  
2768, Australia

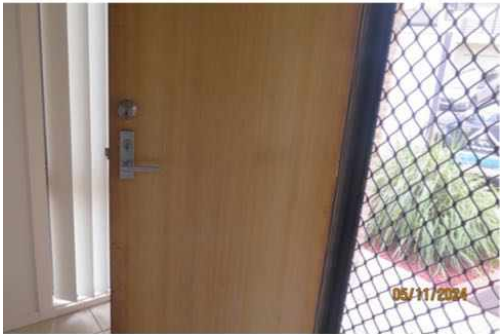
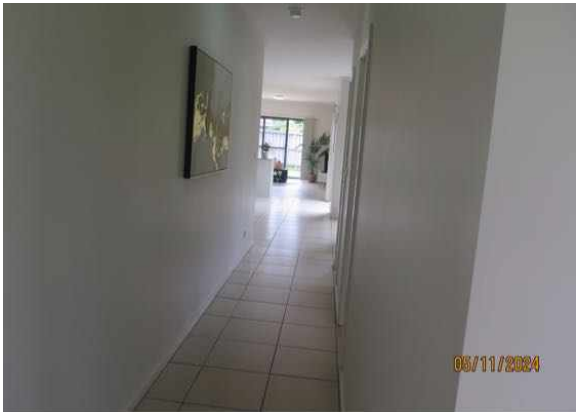
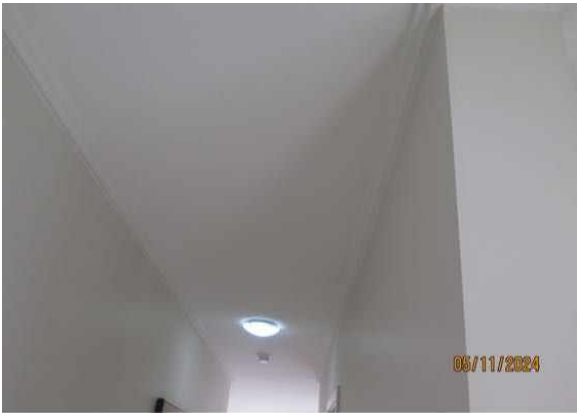
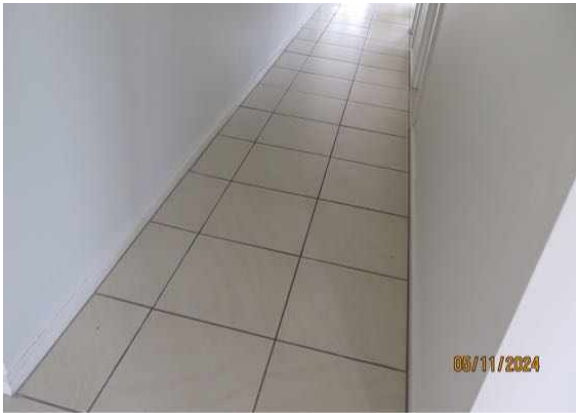
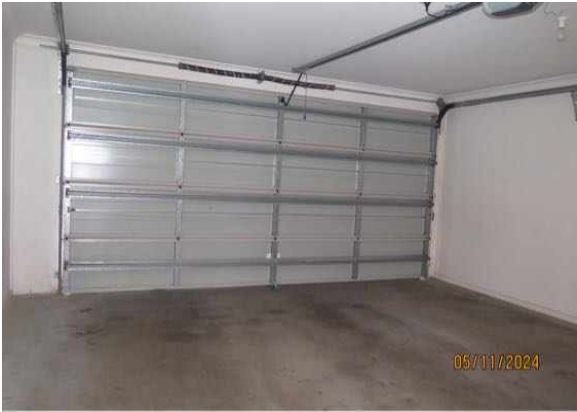
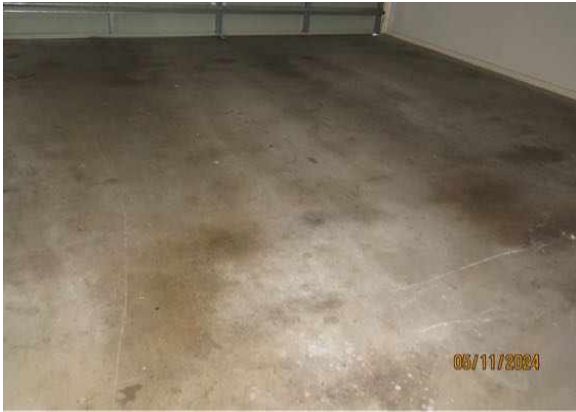
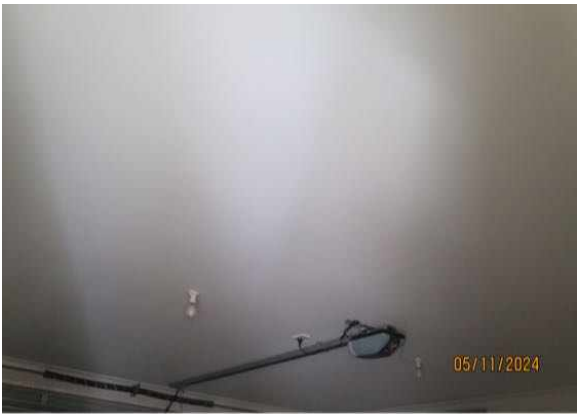
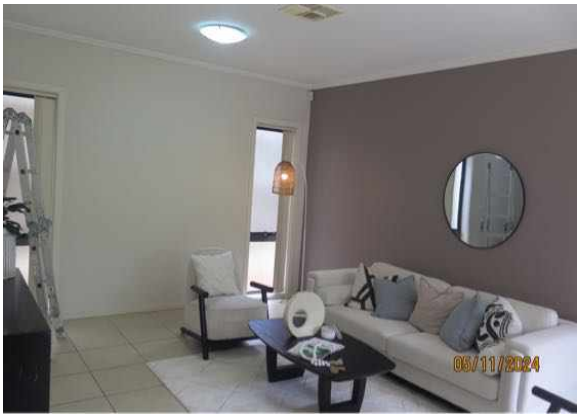
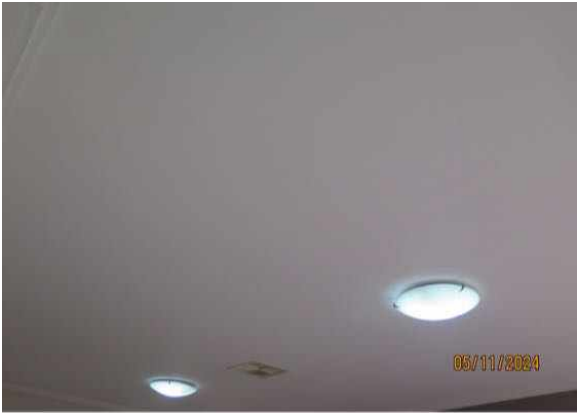
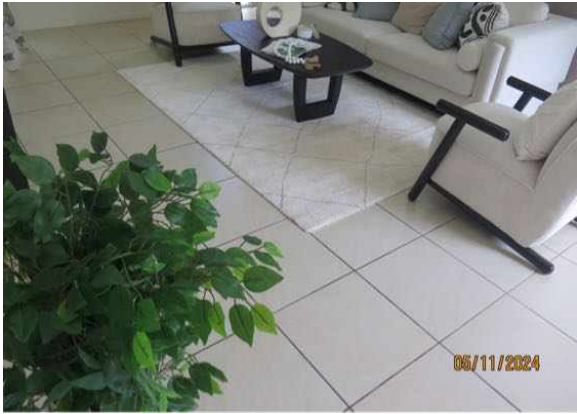
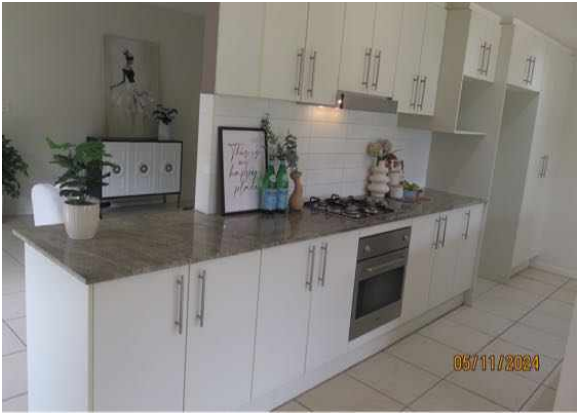
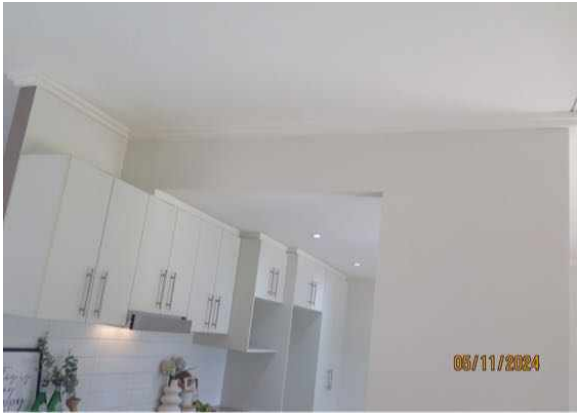
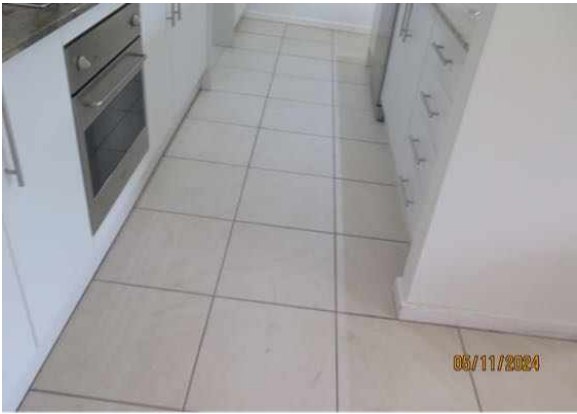
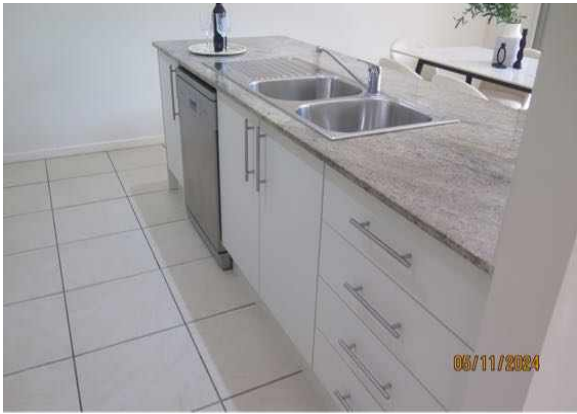
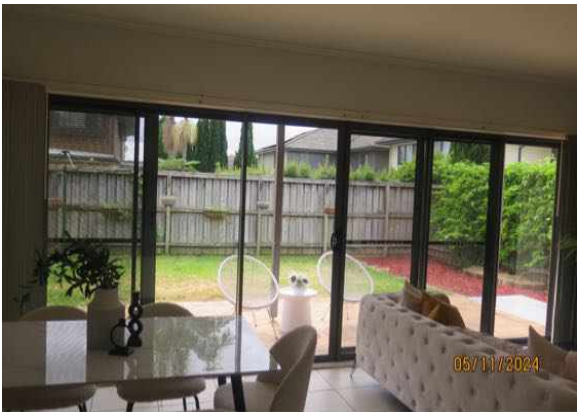
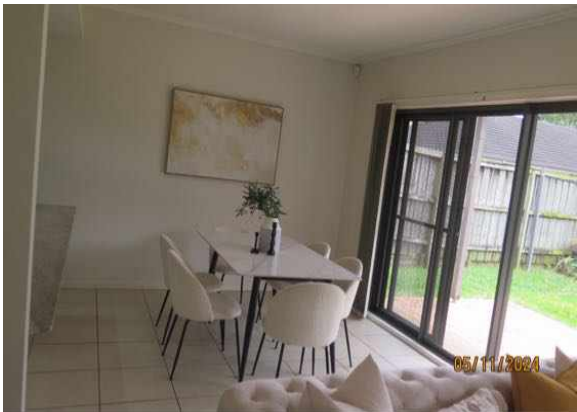
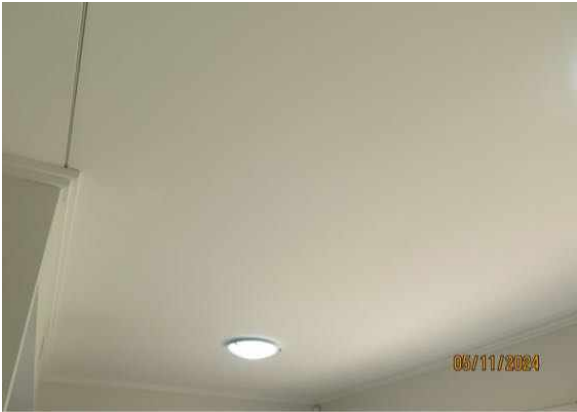
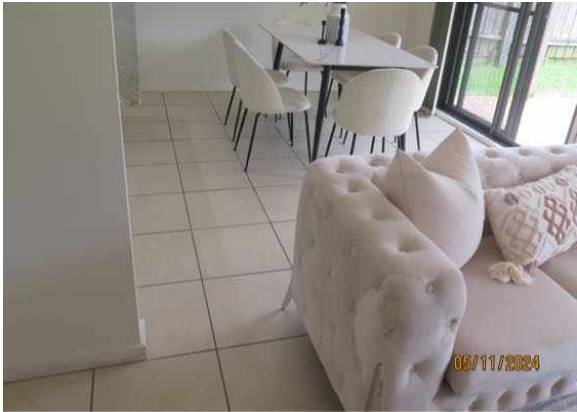
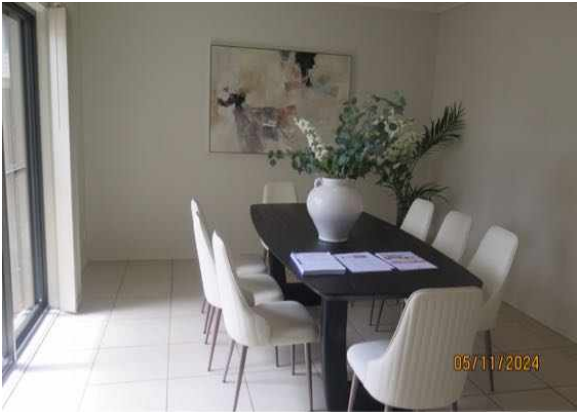
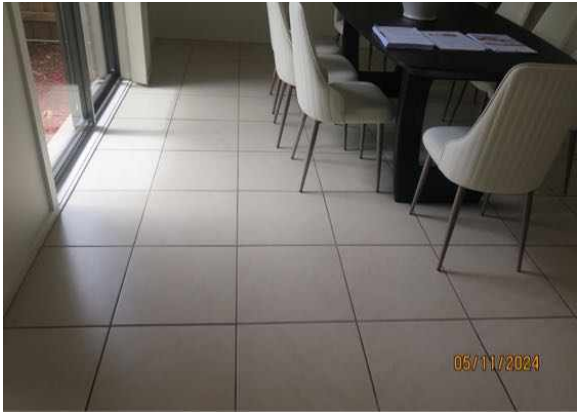
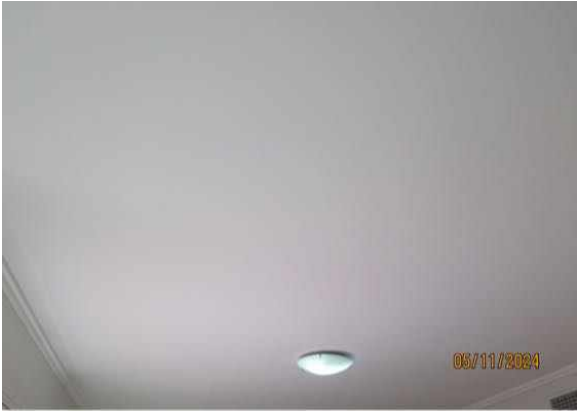
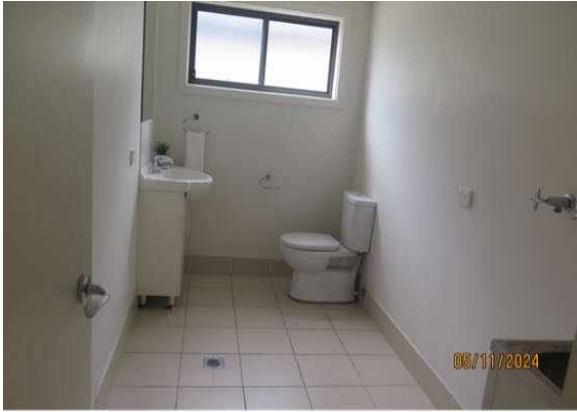
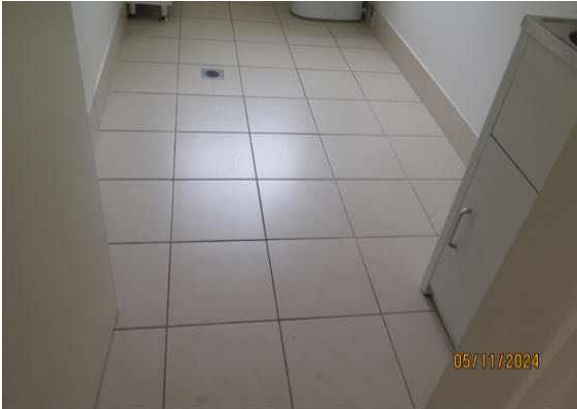
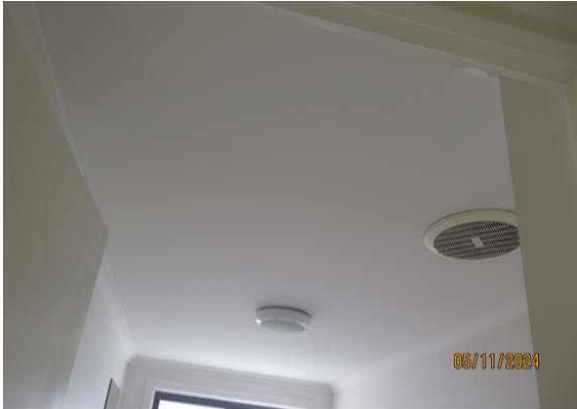
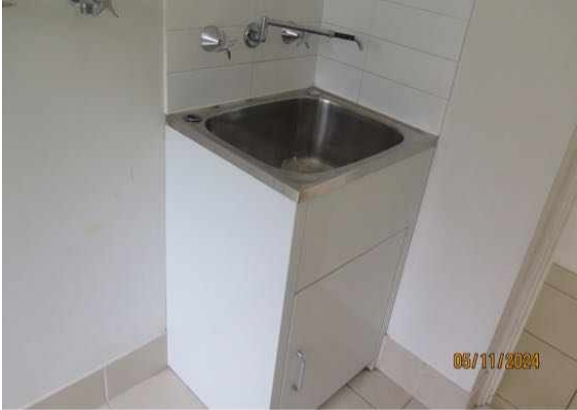
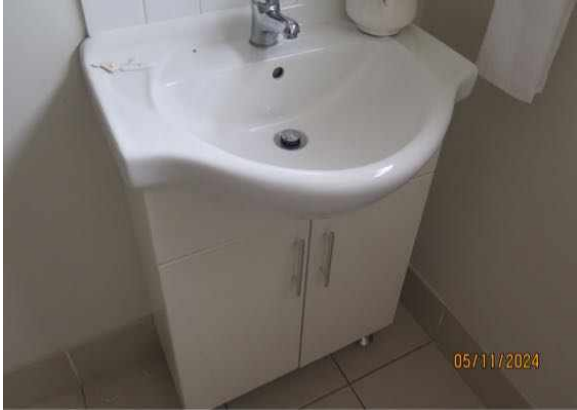
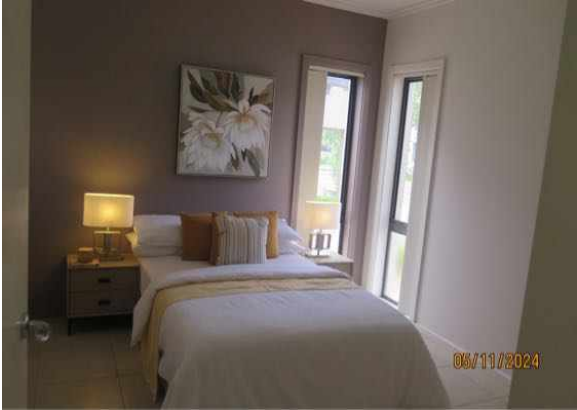
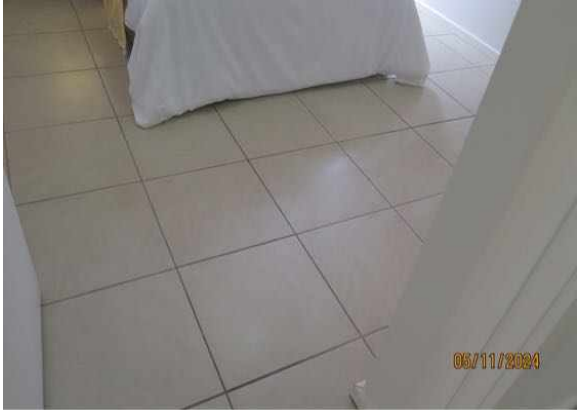
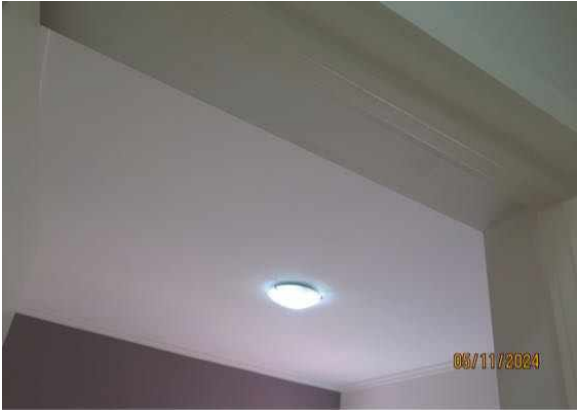
Building: Main Building  
Location: All Internal Areas  
Finding: Additional Photos  
Information: Additional photos are provided for your general reference

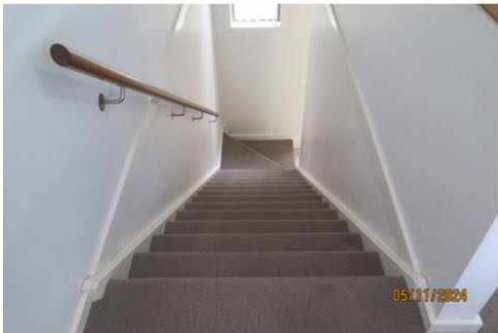
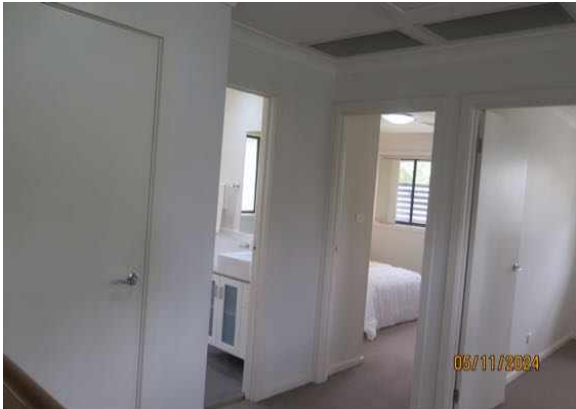
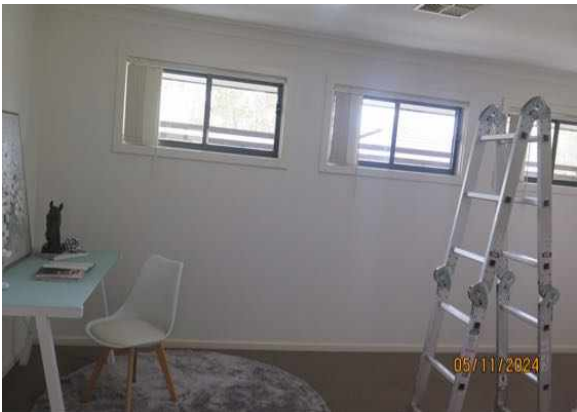
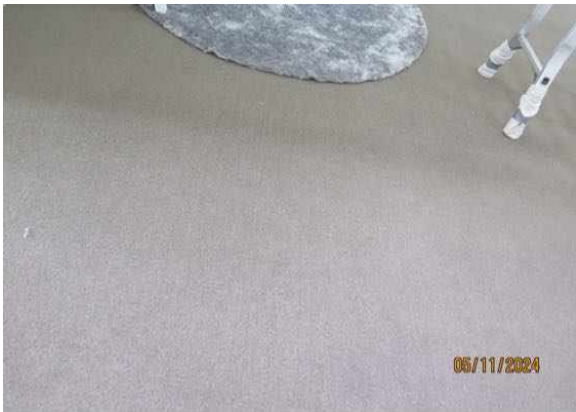
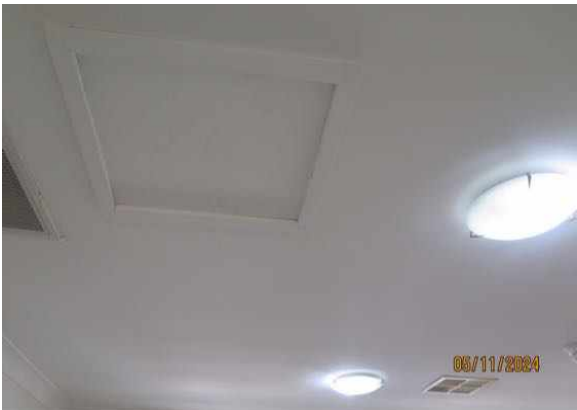
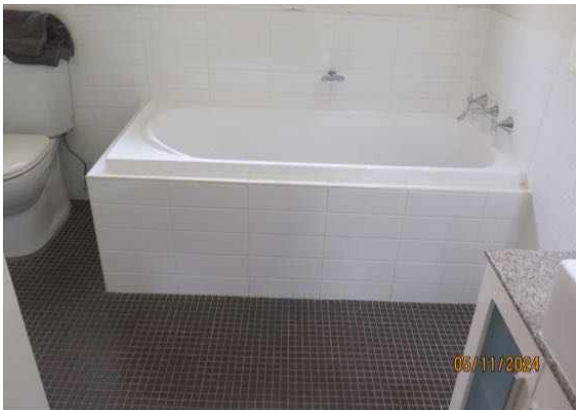
Building: Main Building  
Location: All Internal Areas  
Finding: Additional Photos  
Information: Additional photos are provided for your general reference

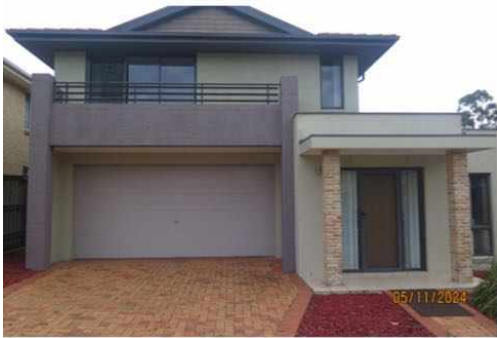
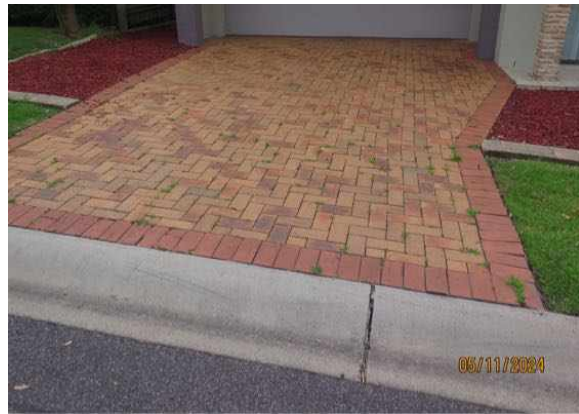
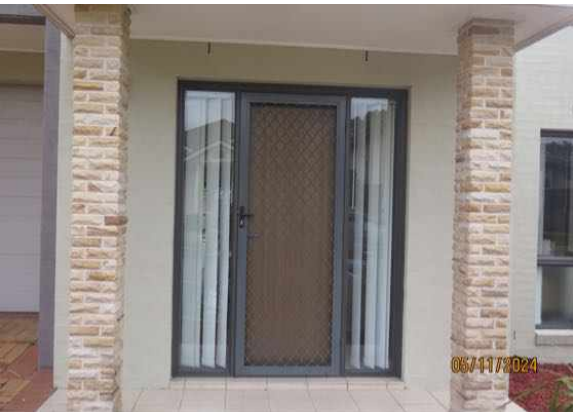
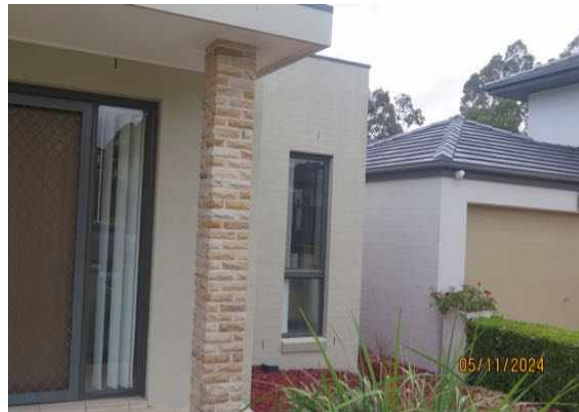
Building: Main Building  
Location: All External Areas  
Finding: Additional Photos  
Information: Additional photos are provided for your general reference

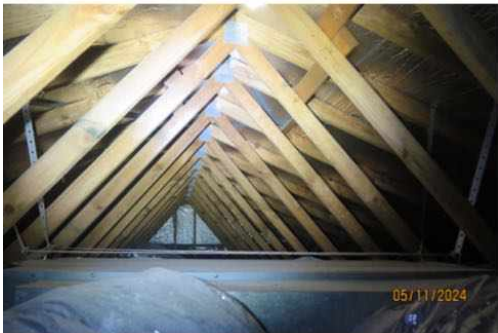
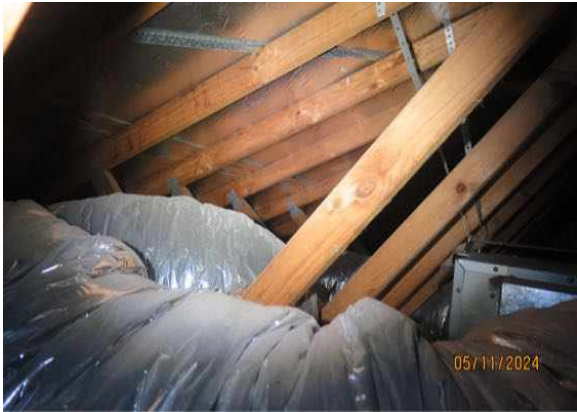
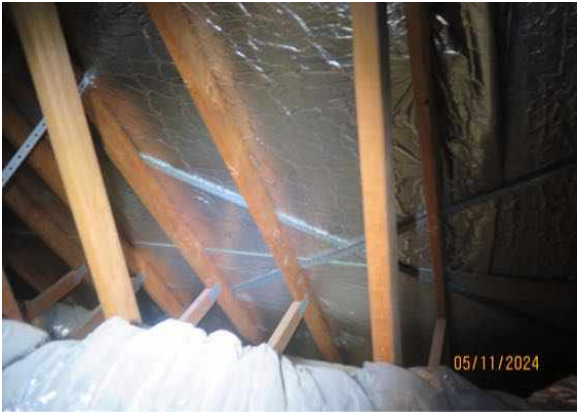
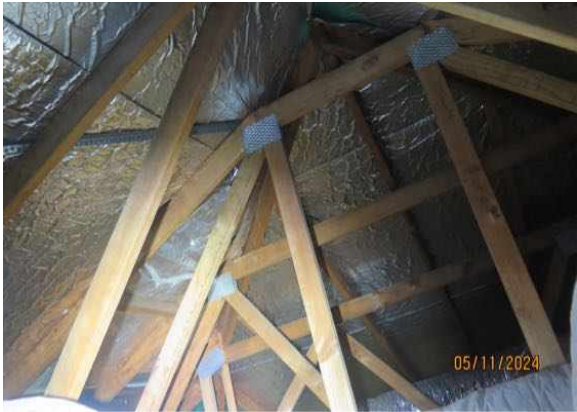
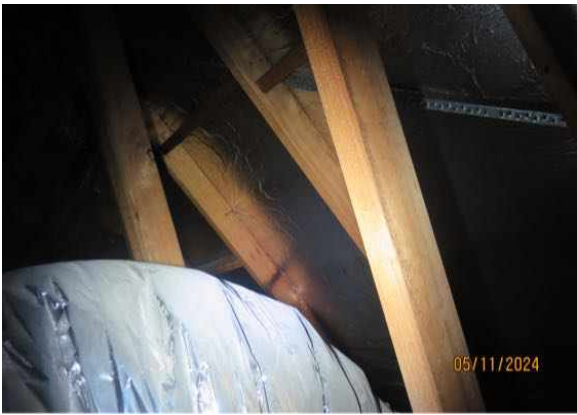
Building: Main Building  
Location: All Areas  
Finding: Additional Photos  
Information: Additional photos are provided for your general reference
