# Building and Timber Pest Inspection Report

Inspection Date: Sun, 19 May 2024

Property Address: 2 Glasshouse Rd, Beaumont Hills NSW  
2155, Australia

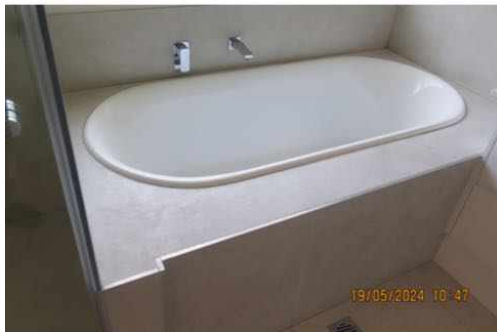
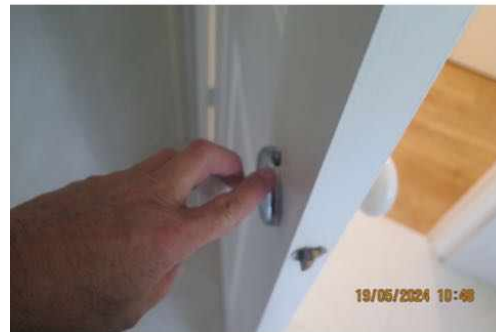
Building: Main Building  
 Location: Bathroom  
 Finding: Lock - Not working  
 Information: The lock in this area was not operational at the time of inspection. Where locks have deteriorated to a point where they are no longer usable, the security of the property is immediately compromised.

Repair or replacement of the lock is highly recommended. Consultation with a locksmith or general handyman is required to gain further advice on any added security that may be available for the area.

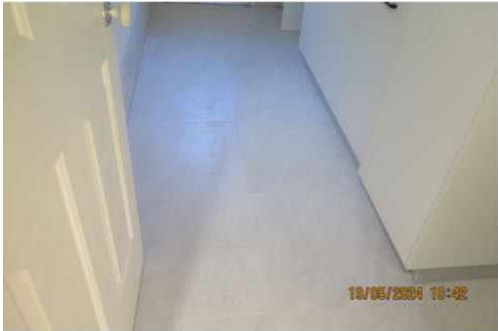
#### Finding 3.02

Building: Main Building  
 Location: All Areas  
 Finding: Door - Binding/jamming  
 Information: Binding and/or jamming of this door is evident during standard operation. This defect inhibits the functionality of the affected door as well as creating potential for secondary defects to associated building elements, such as damage to the floor covering.

A door that binds to flooring or to the associated door frame may have several causes, ranging from minor defects, such as poor installation of the door or deteriorated hinges, through to major structural issues, such as damage to subfloor structures.

Where door binding/jamming appears to indicate major structural issues, a registered builder specialising in re-stumping should be appointed to provide an estimate on the cost of rectification.

For minor causes, a qualified carpenter or general handyperson should be appointed to perform minor rectification works at client discretion.

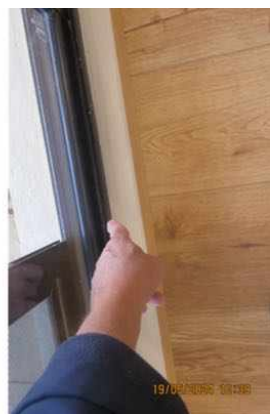
### Finding 3.03

Building:	Main Building
Location:	Dining Room
Finding:	Door - Stiff to slide
Information:	The door in this area was jammed and difficult to slide along the associated tracks at the time of the inspection. Restricted function of the affected door may pose as a potential safety hazard if required for emergency egress from the building.

Generally, factors such as general age of the building element and a lack of maintenance are the usual causes for this type of defect.

Replacement of door hardware or tracks may be required, as well as minor repairs and cleaning. A registered builder or general handy person will be required to repair the affected doors.

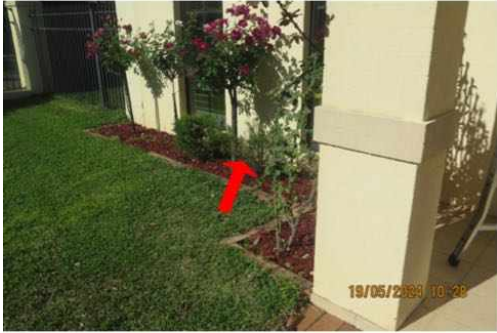
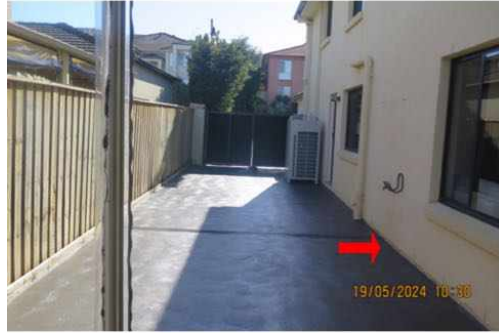
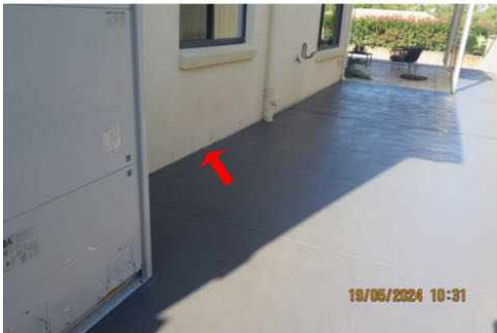
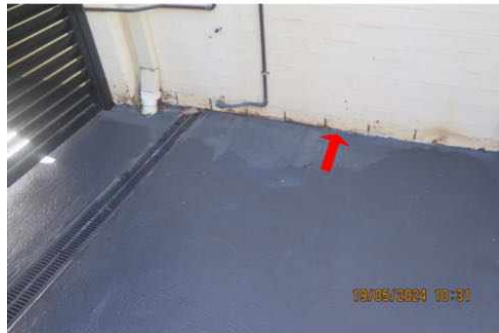
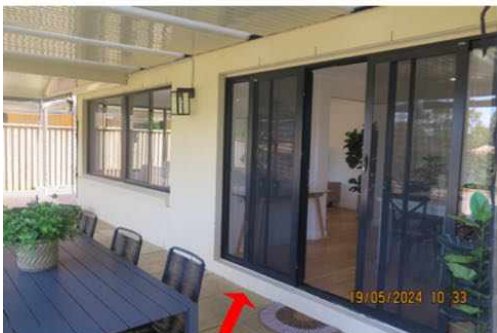
If the slab edge is not properly exposed there is a high risk of termite attack. Sometimes, in order to determine the type of slab, a suitably qualified person such as an architect or builder may be required to consult the construction plans.

Where the slab edge cannot be properly inspected, it is highly recommended that termite or timber pest inspections be carried out every 6-12 months to aid protection of the property against infestation.

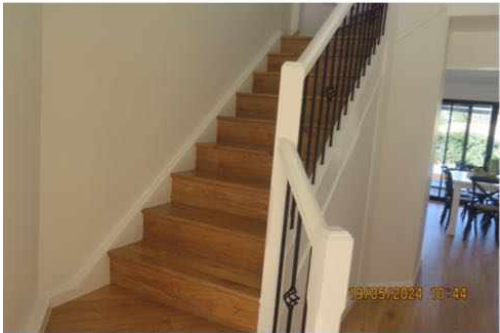
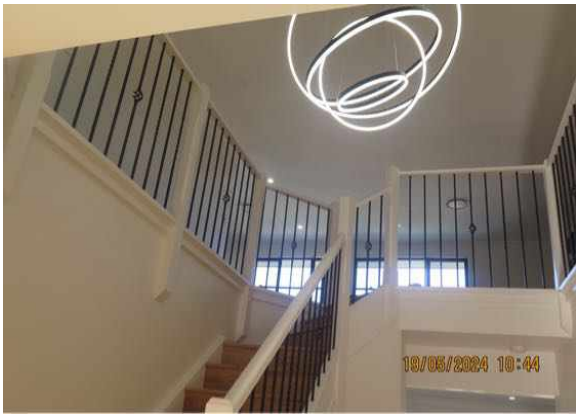
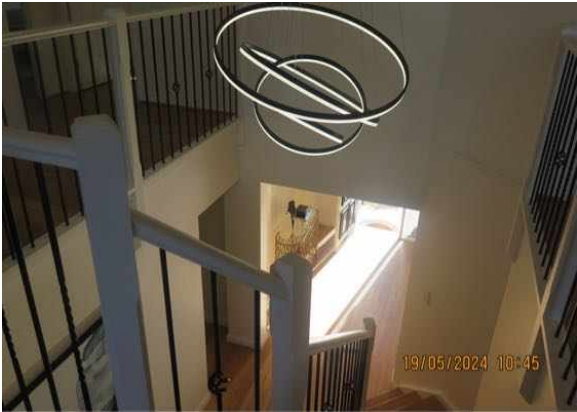
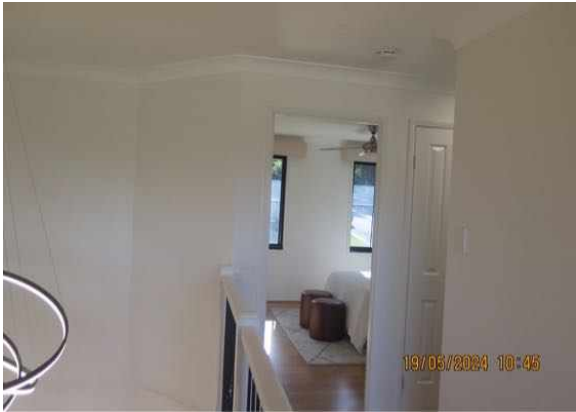
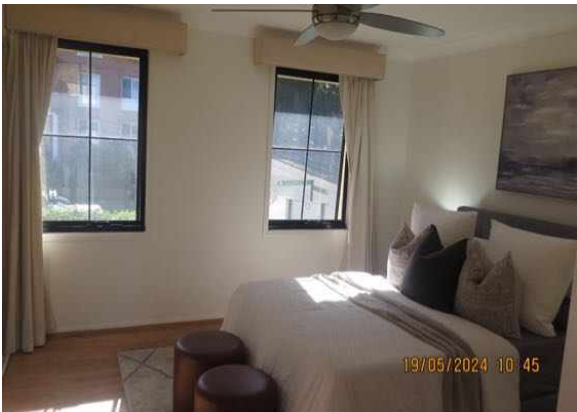
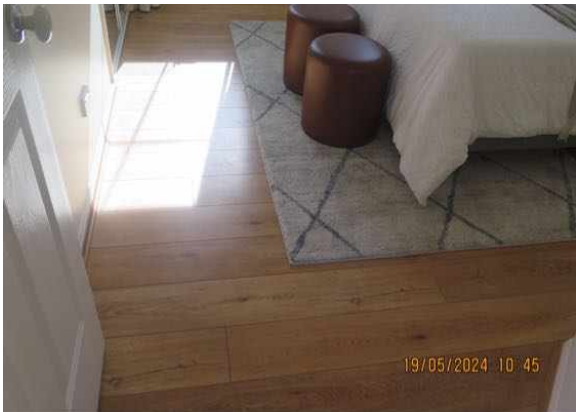
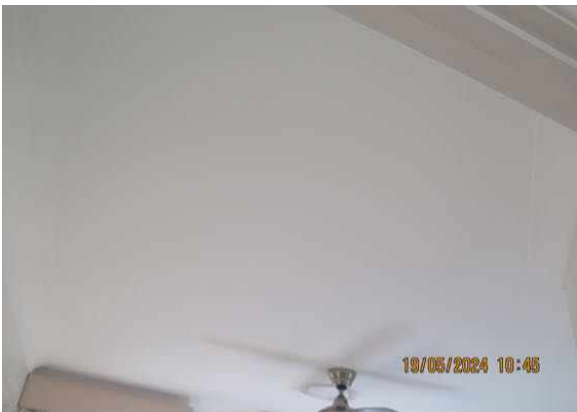
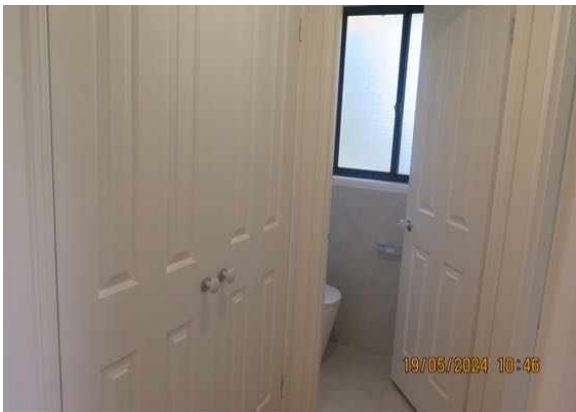
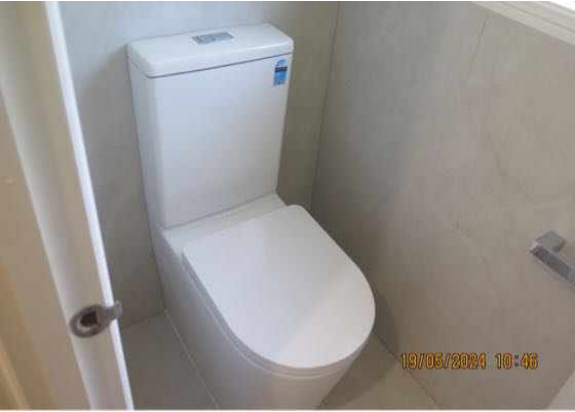
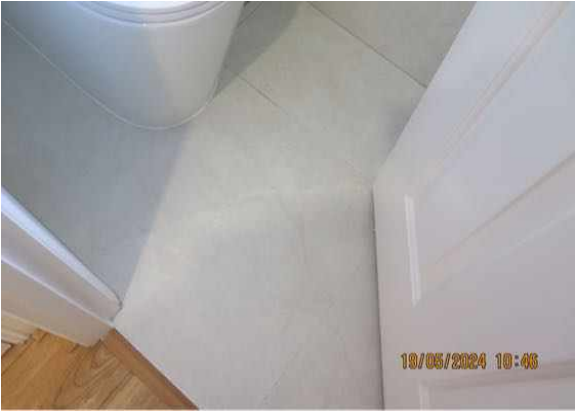
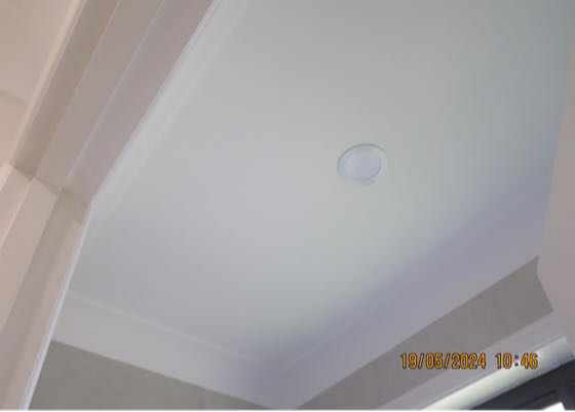
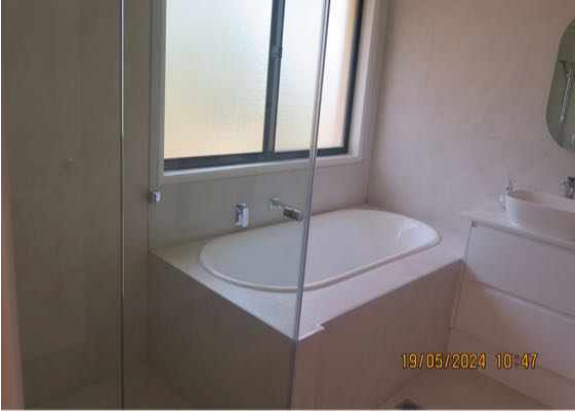
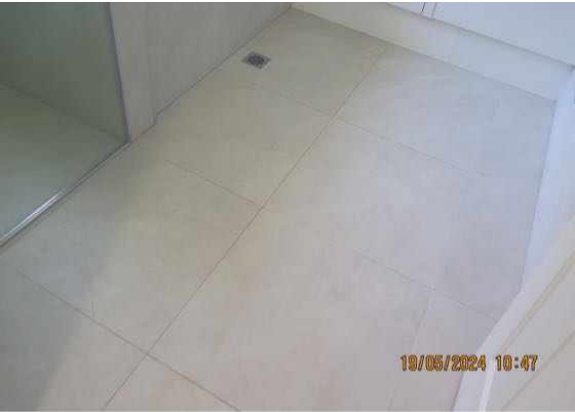
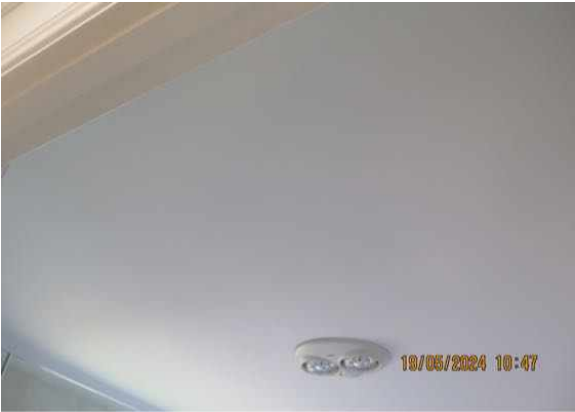
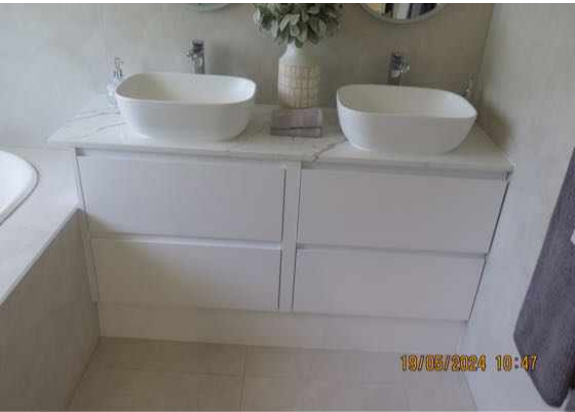
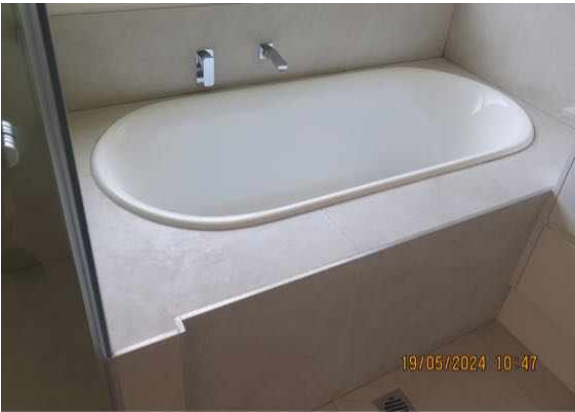
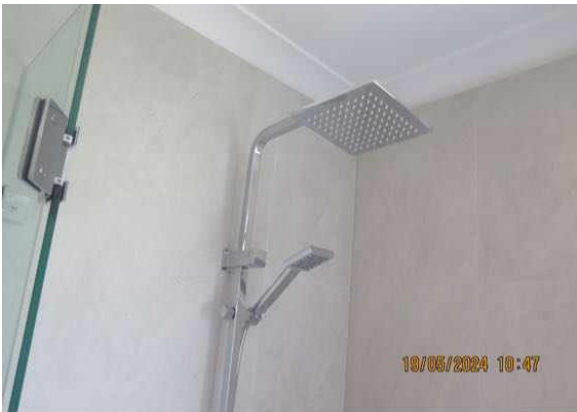
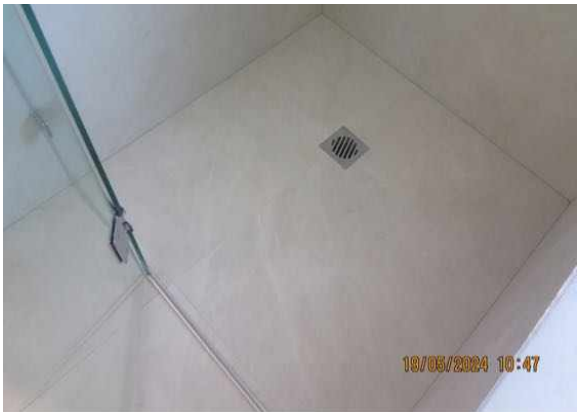
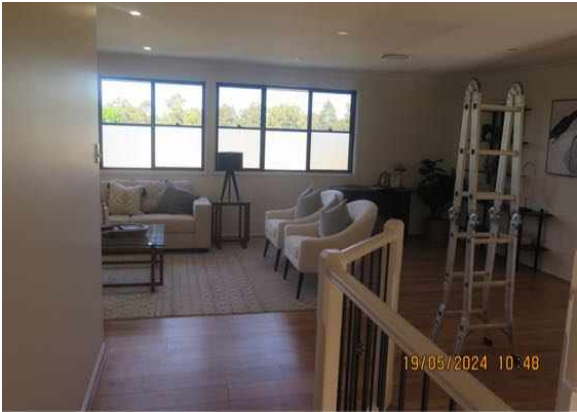
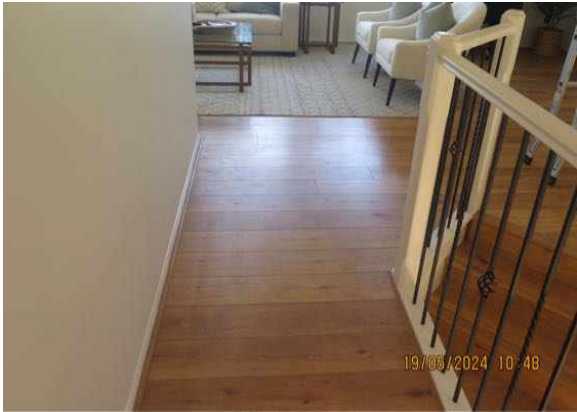
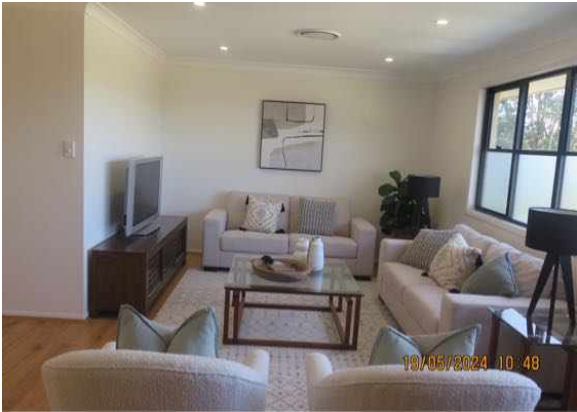
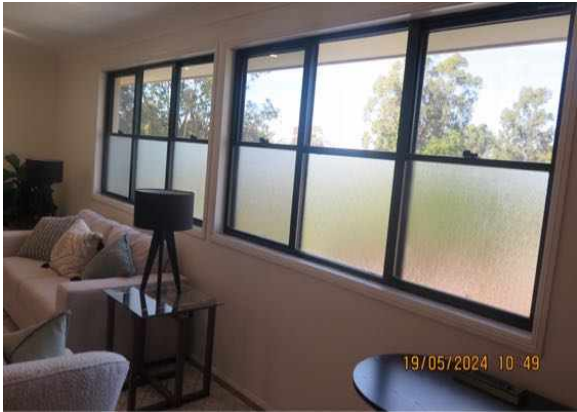
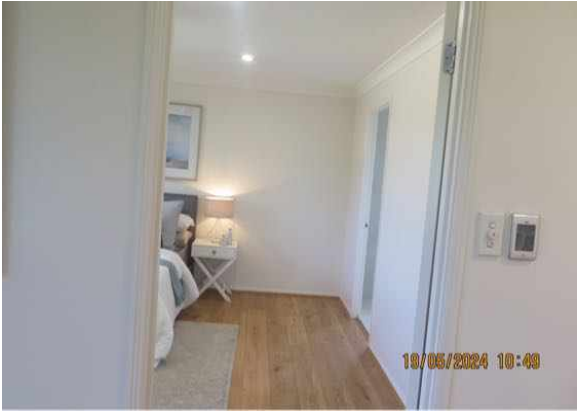
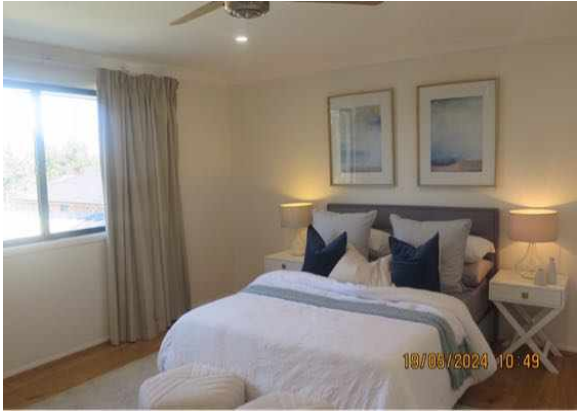
**Noted Item**

Building: Main Building  
Location: All Internal Areas  
Finding: Additional Photos  
Information: Additional photos are provided for your general reference

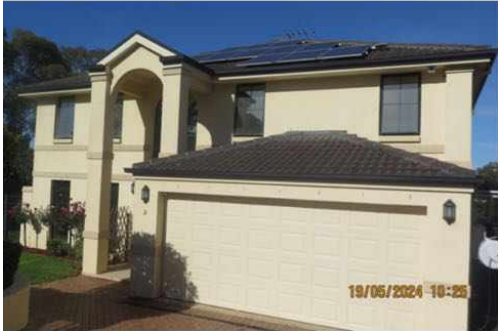
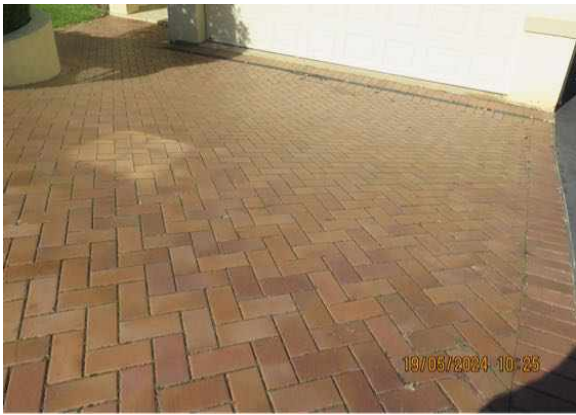
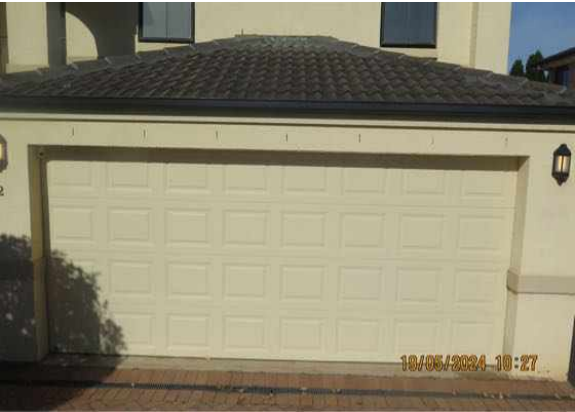
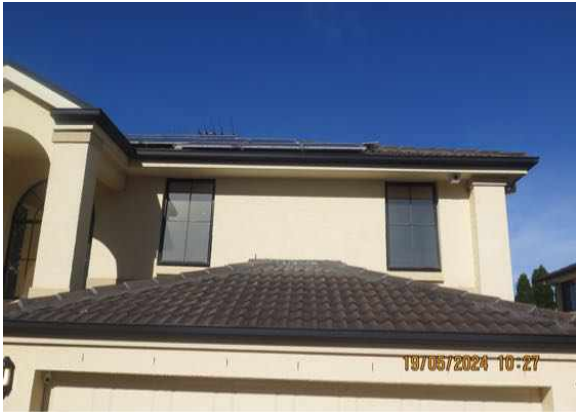
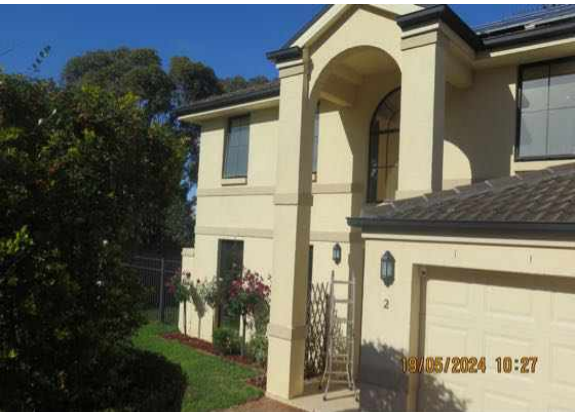
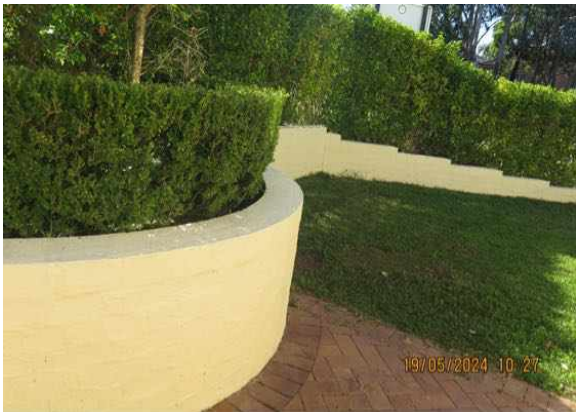
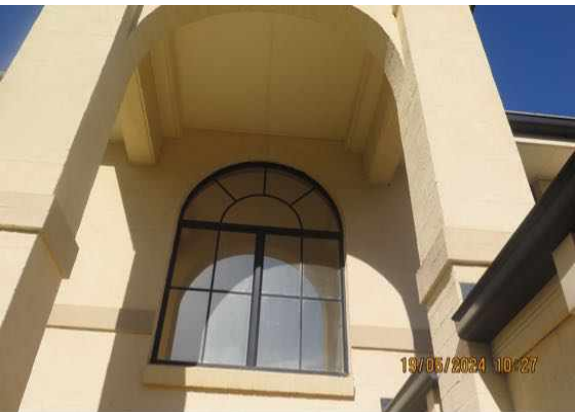
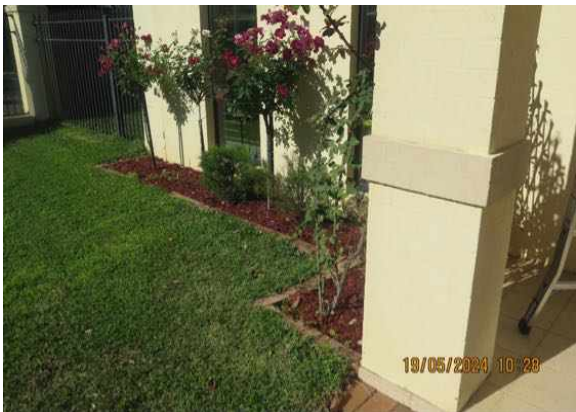
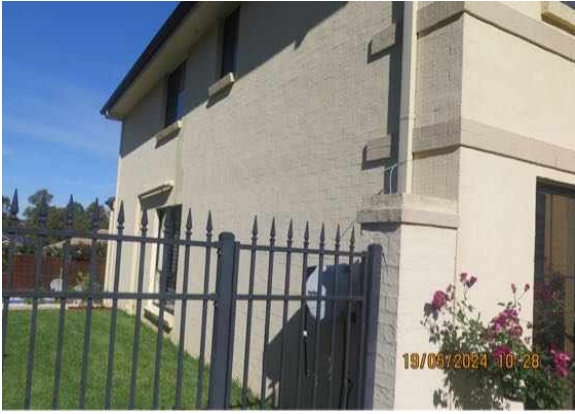
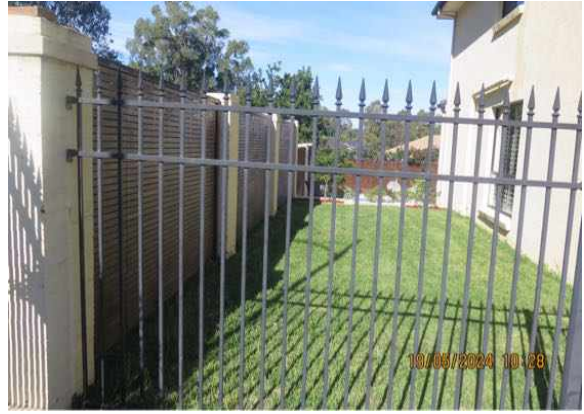
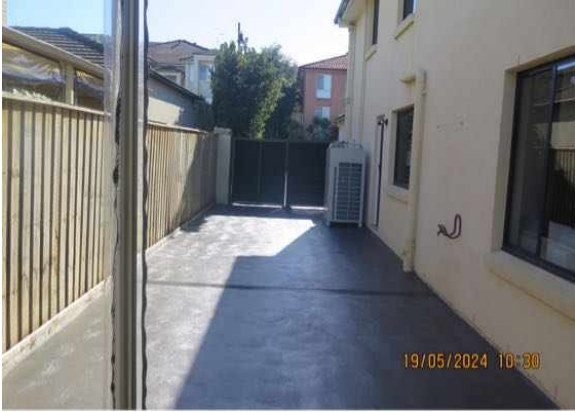
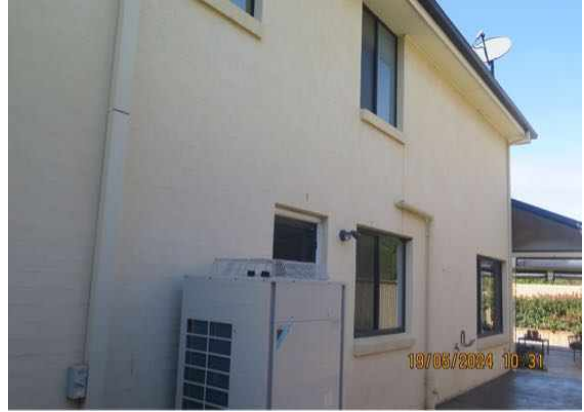
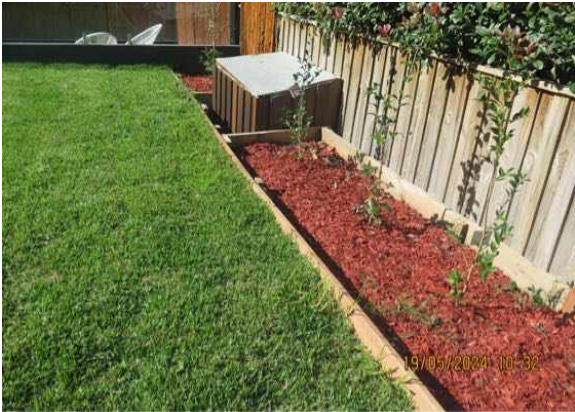
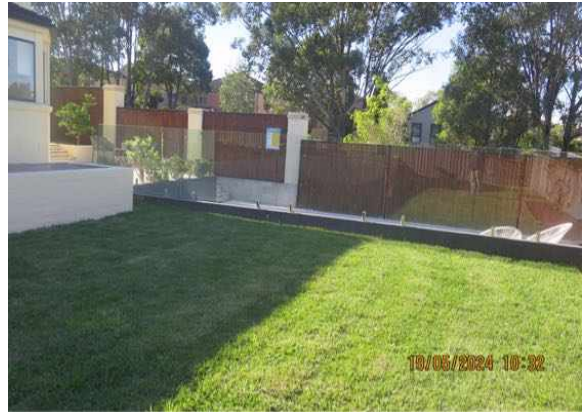
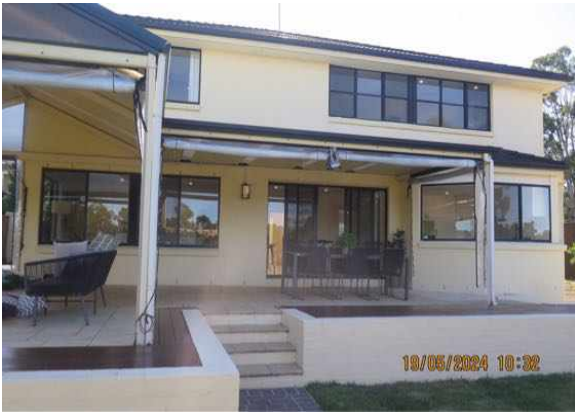
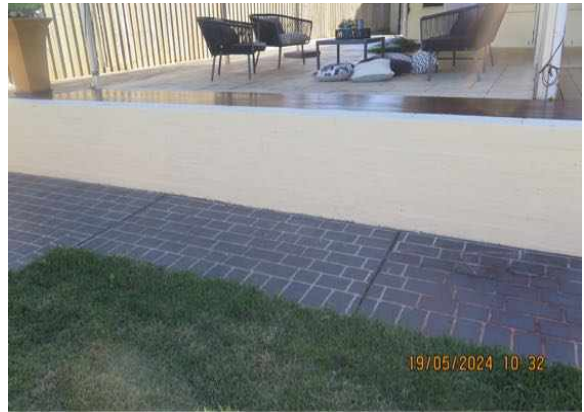
Building: Main Building  
 Location: All External Areas  
 Finding: Additional Photos  
 Information: Additional photos are provided for your general reference

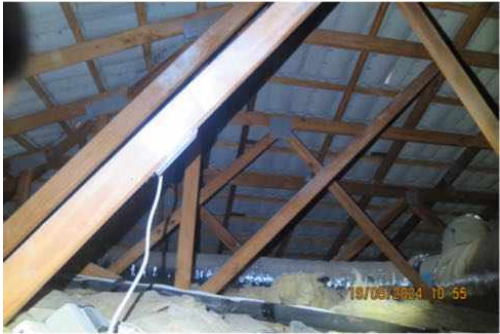
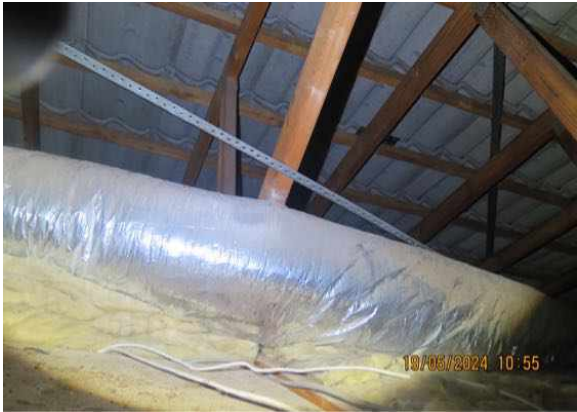
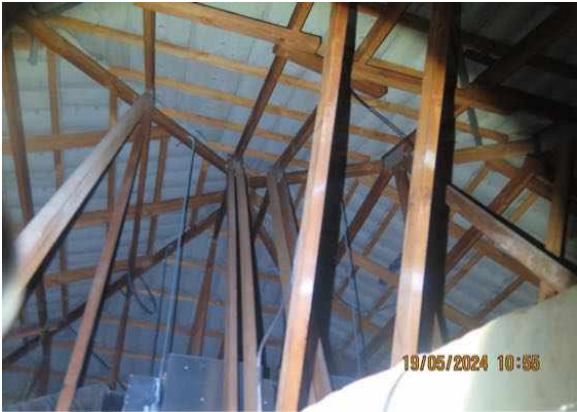
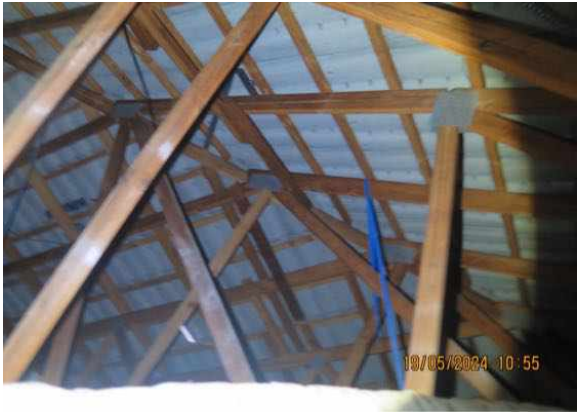
Building: Main Building  
 Location: All Areas  
 Finding: Additional Photos  
 Information: Additional photos are provided for your general reference
