Building and Timber Pest Inspection Report VR

Inspection Date: Wed, 19 Jun 2024

Property Address: 19 Galaxy St, Schofields NSW 2762,
Australia

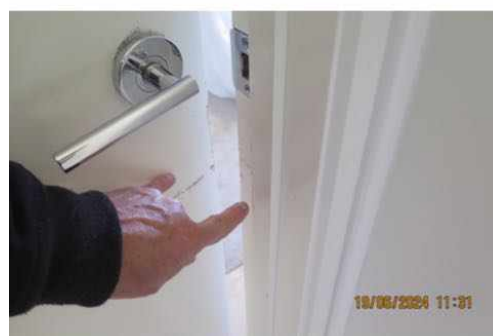
Finding 3.04

Building:	Main Building
Location:	Bedroom

Finding: Fitting or fixture - Loose
 Information: The fitting in this area is loose and requires adjustment to tighten.

If left unmanaged, the fitting may further deteriorate, causing potential for the development of other minor secondary defects.

A relevant tradesperson should be appointed to perform these rectification works at discretion of the client.

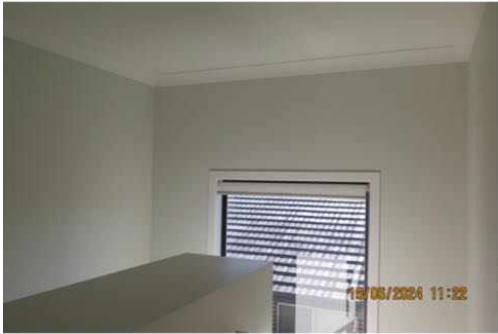
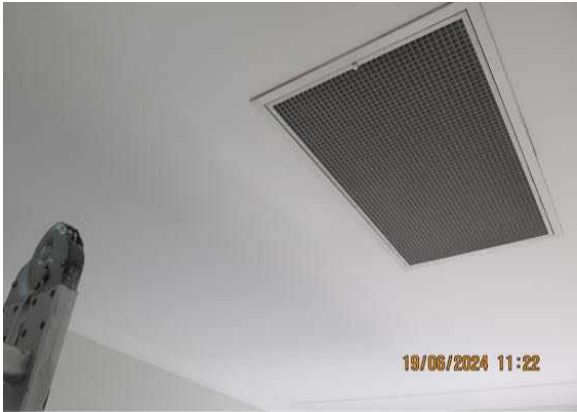
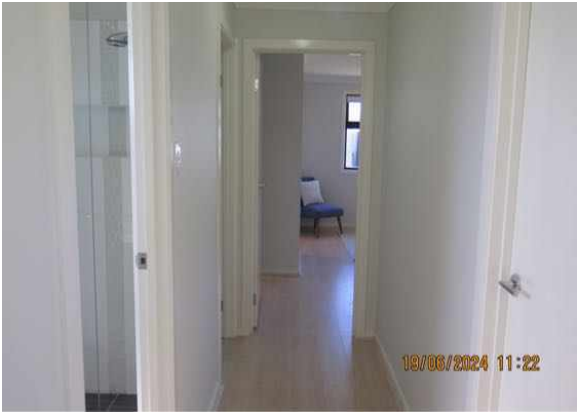
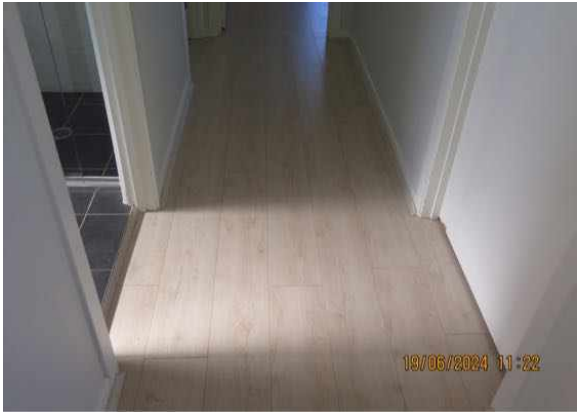
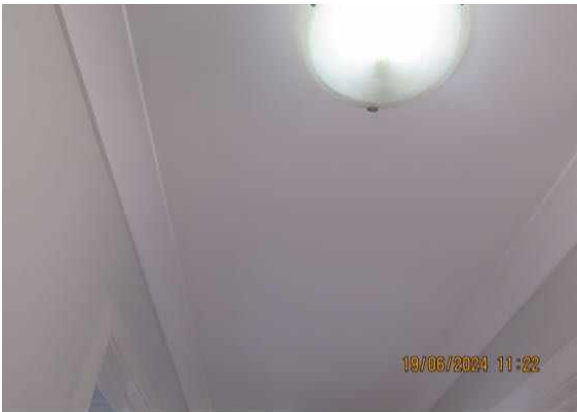
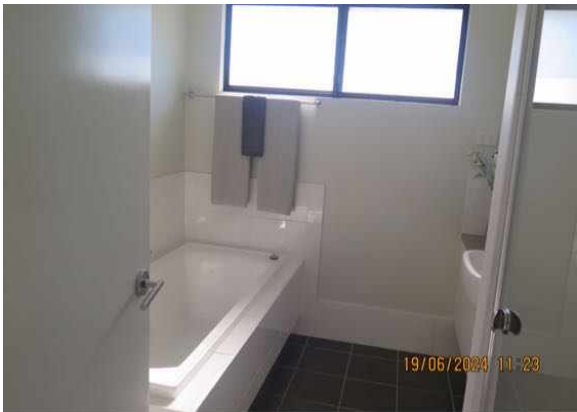
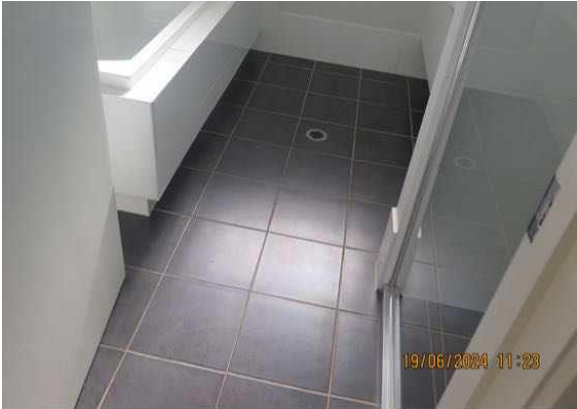
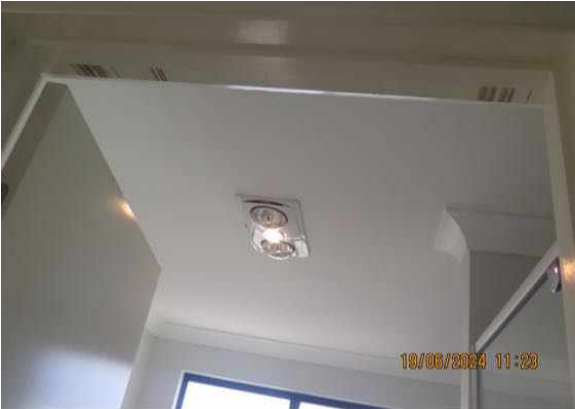
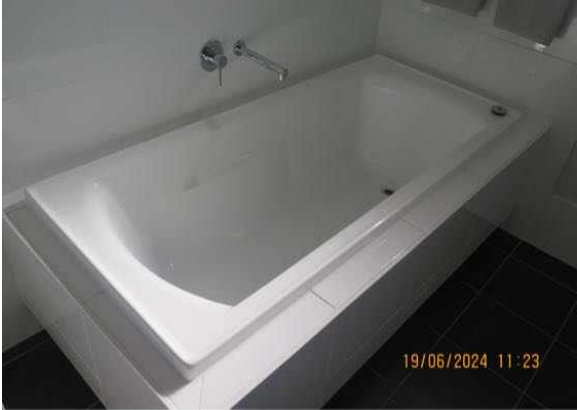
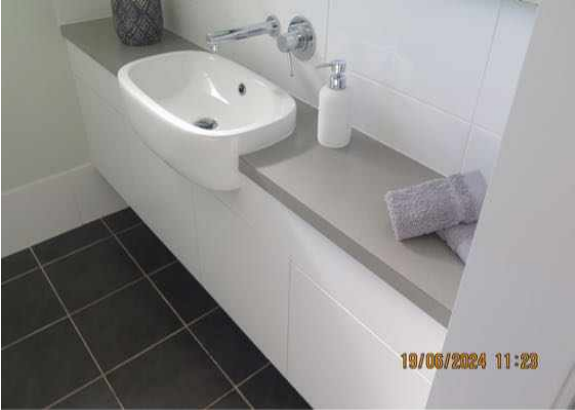
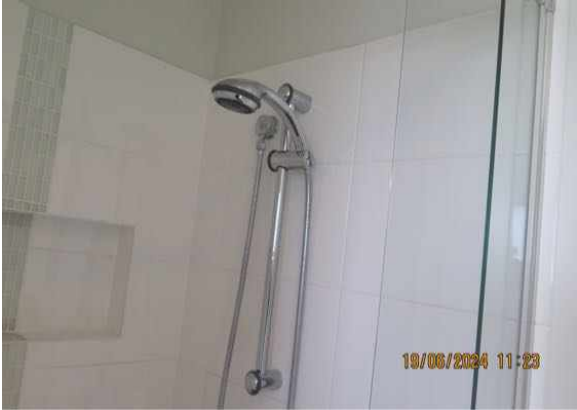
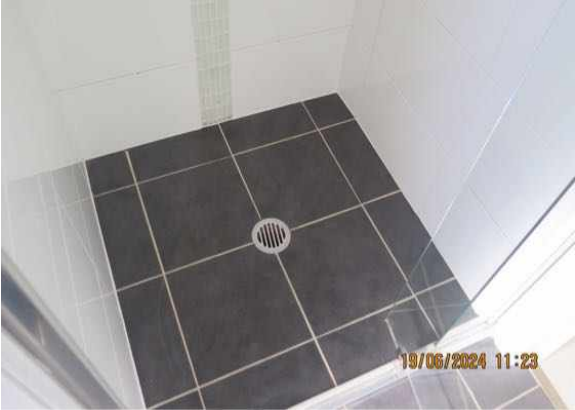
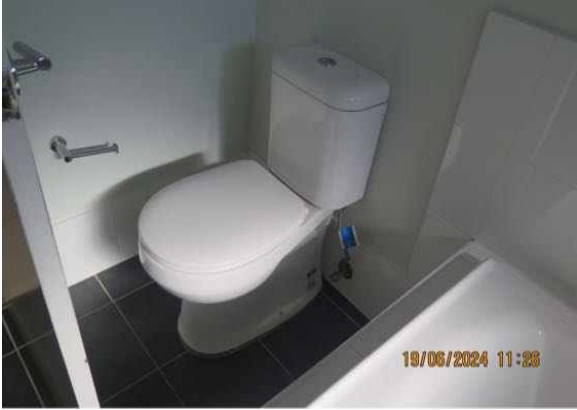
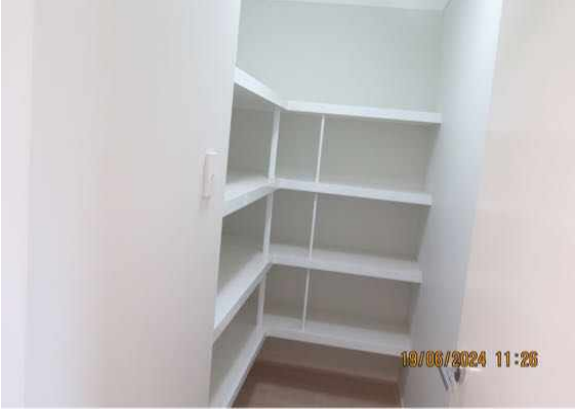
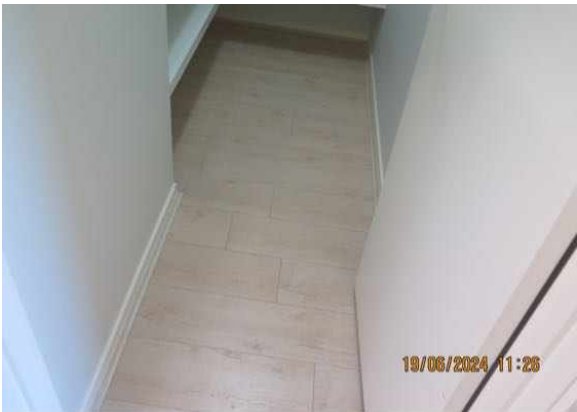
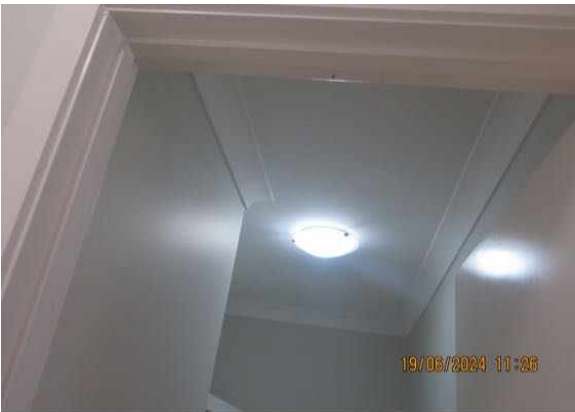
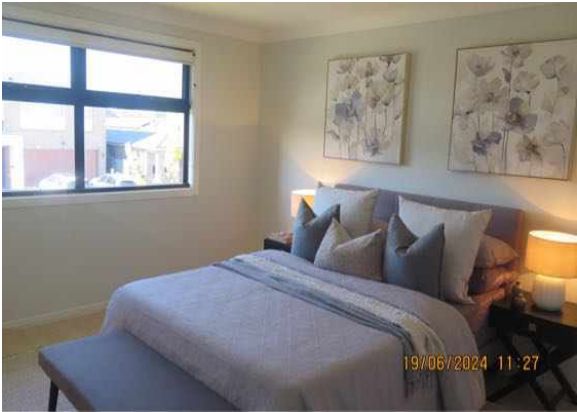
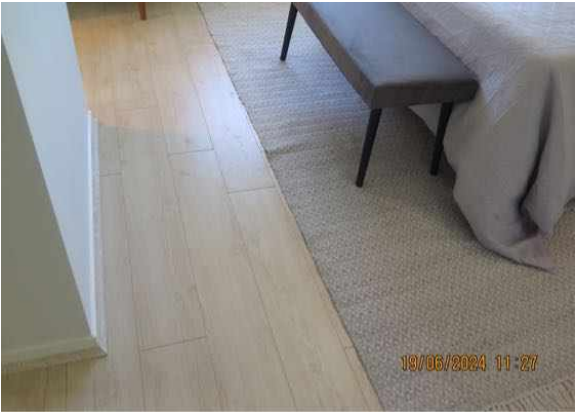
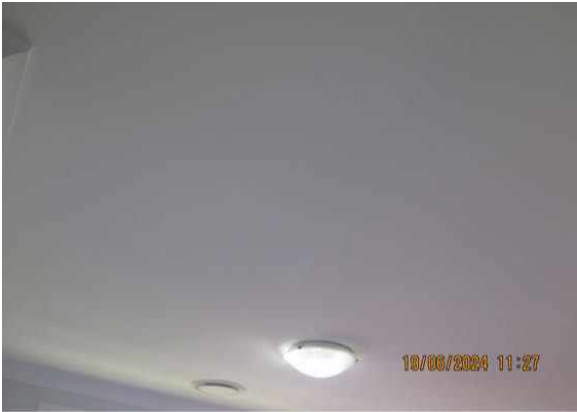
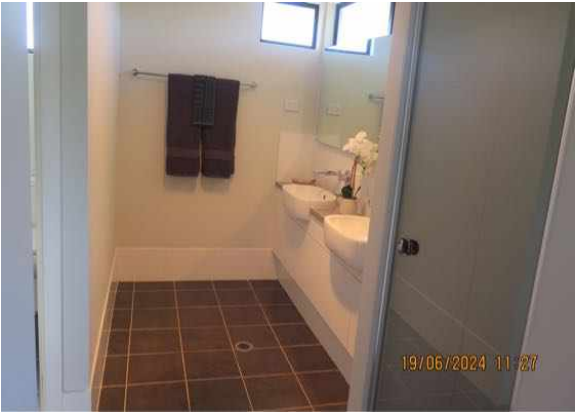
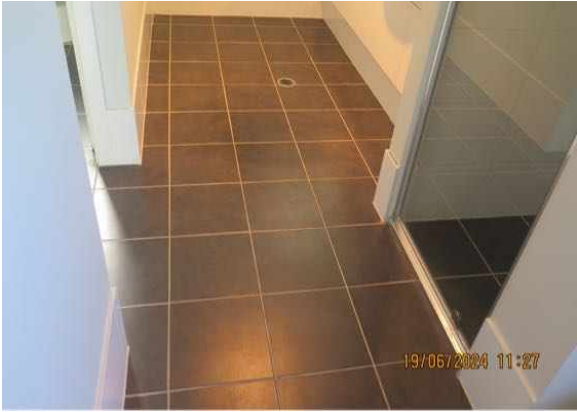
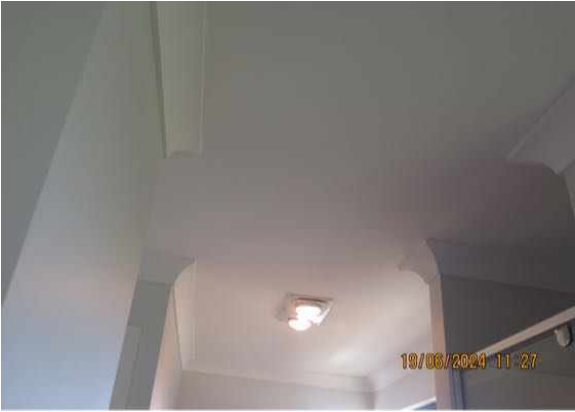
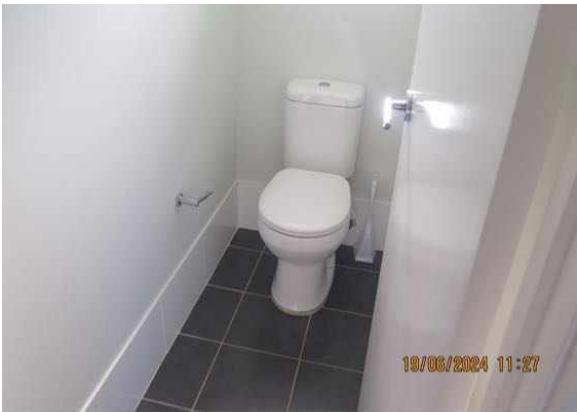
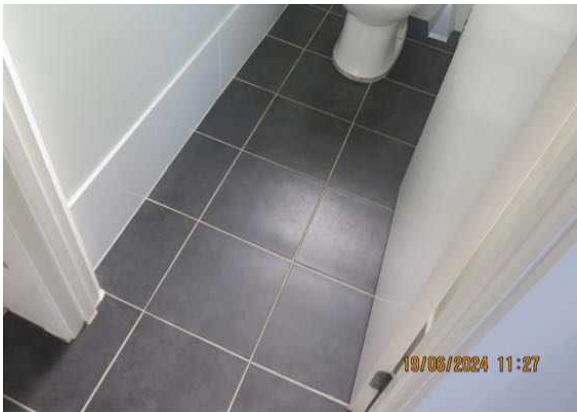
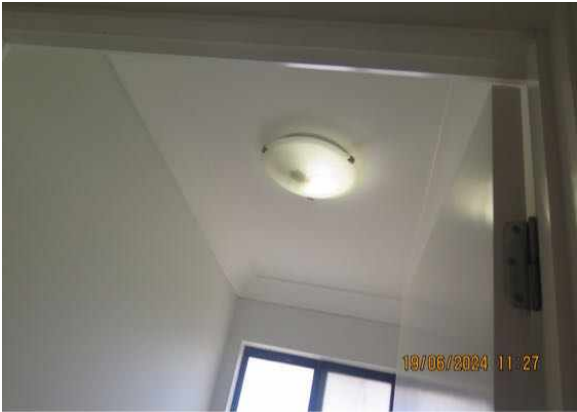
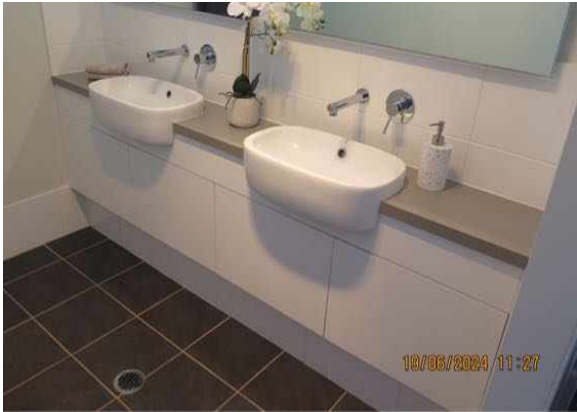
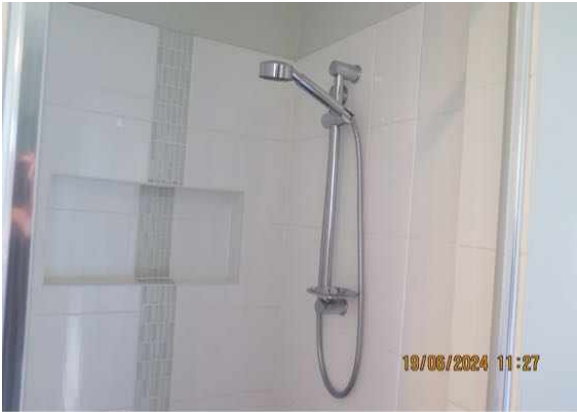
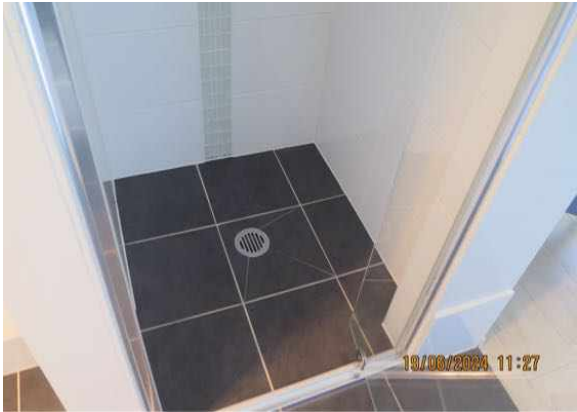
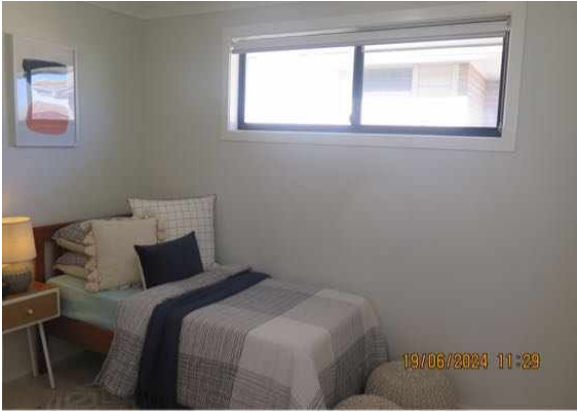
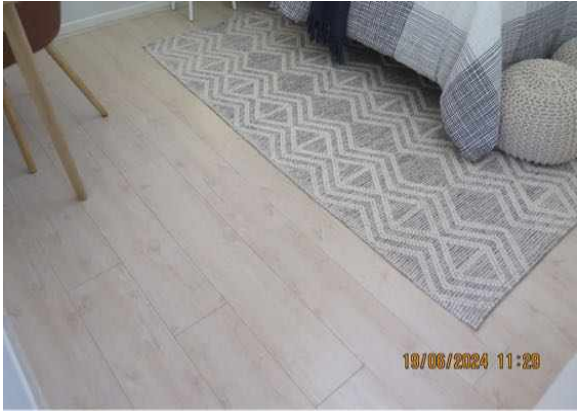
Noted Item

Building: Main Building
Location: All Internal Areas
Finding: Additional Photos
Information: Additional photos are provided for your general reference

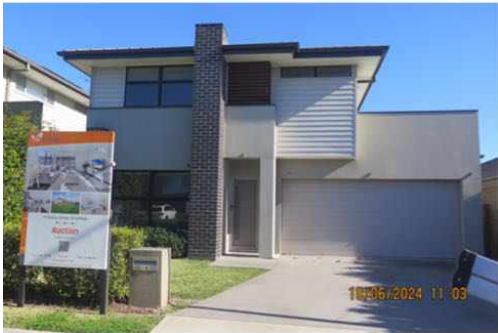
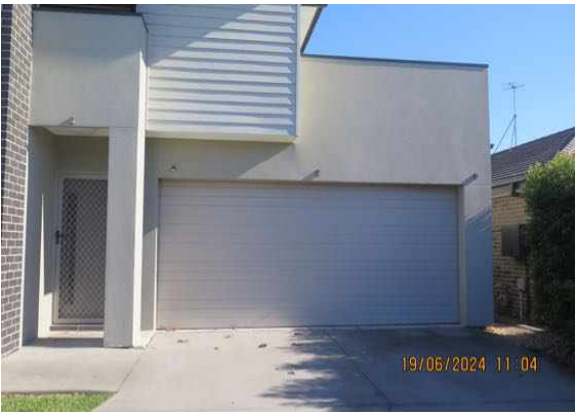
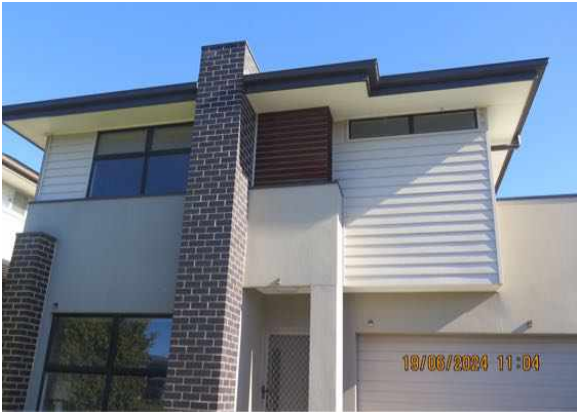
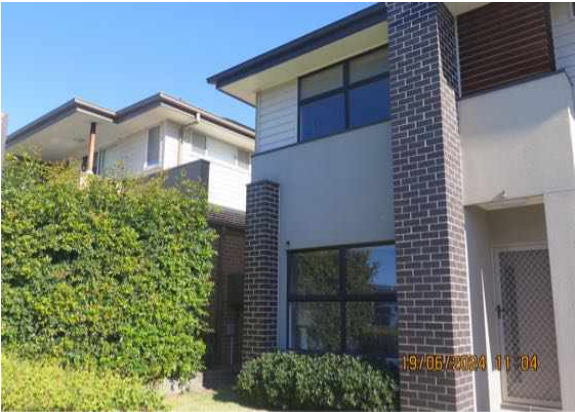
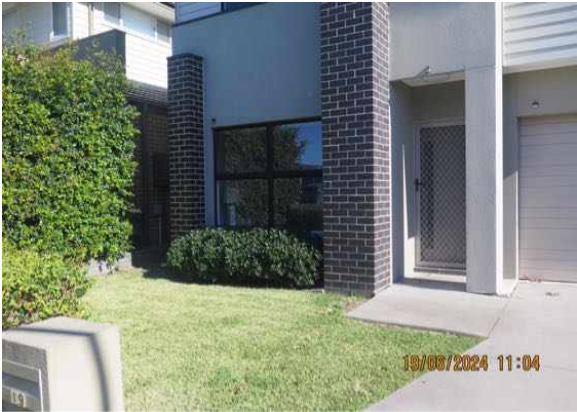
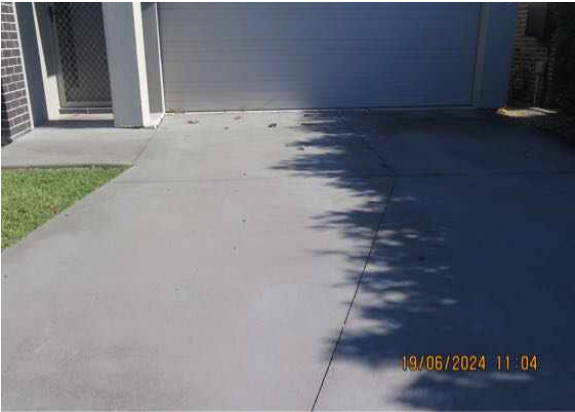
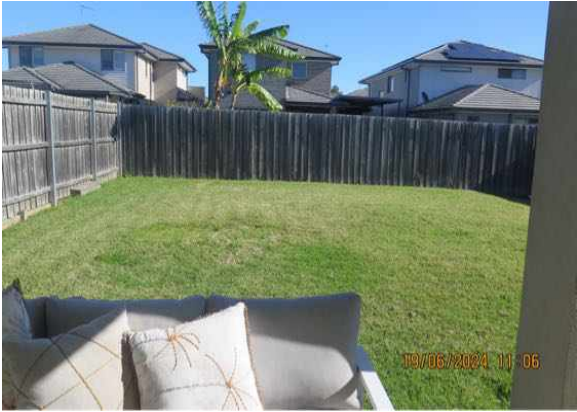
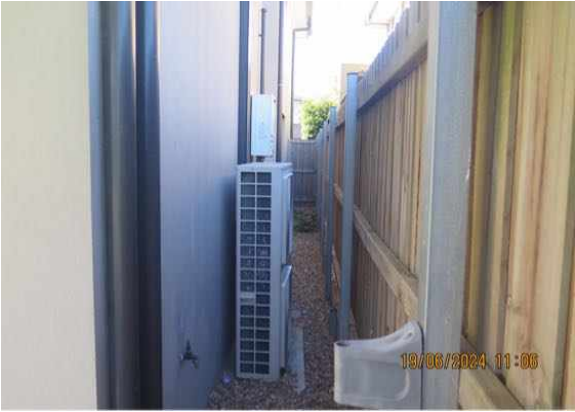
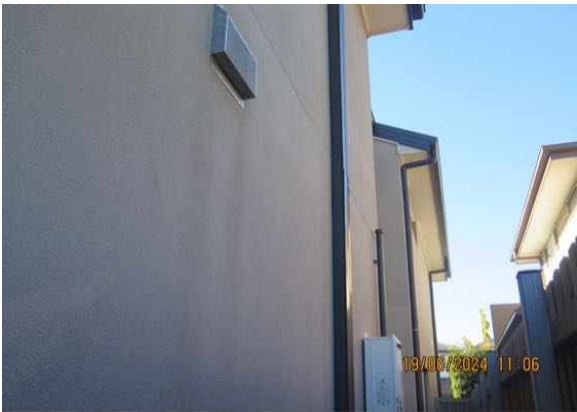
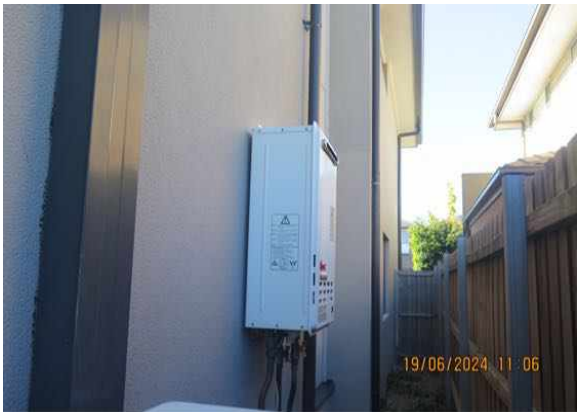
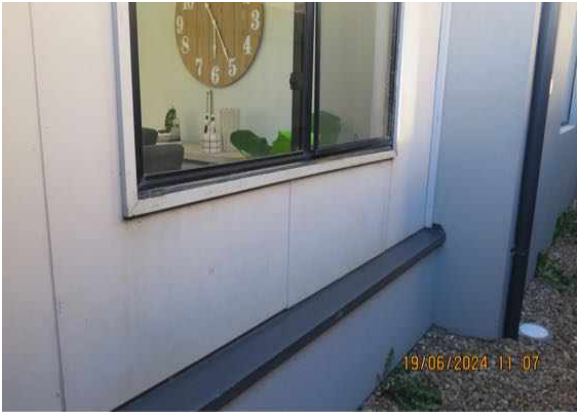
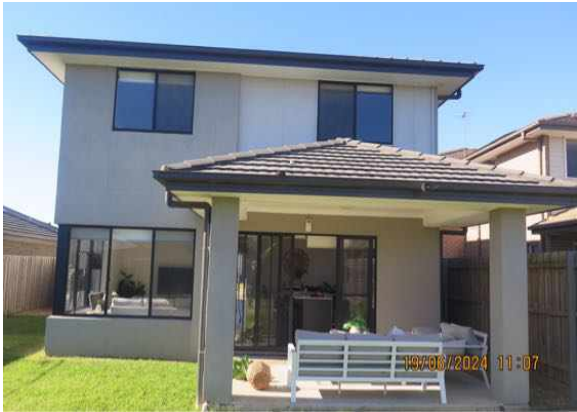
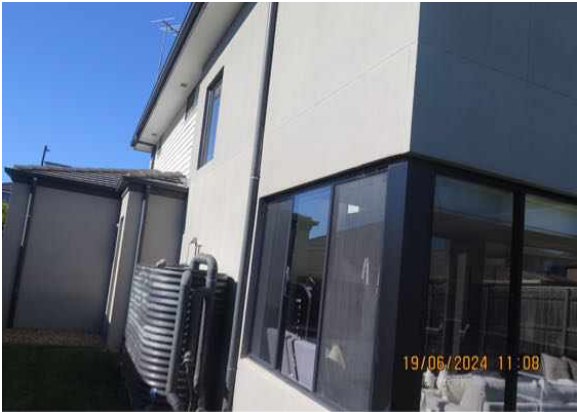
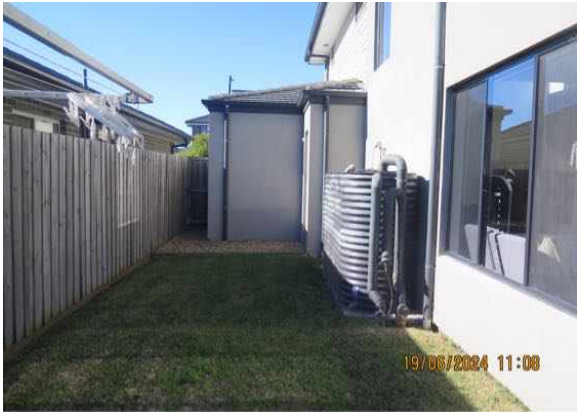
Noted Item

Building: Main Building
Location: All External Areas
Finding: Additional Photos
Information: Additional photos are provided for your general reference

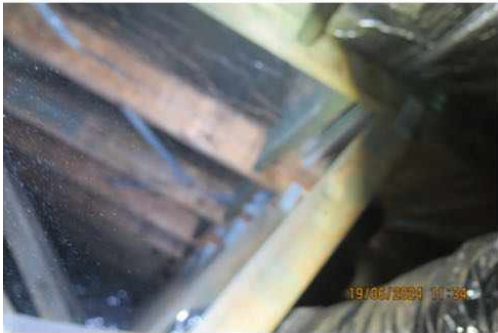
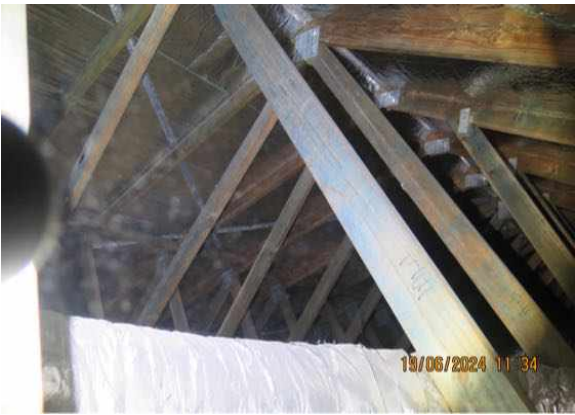
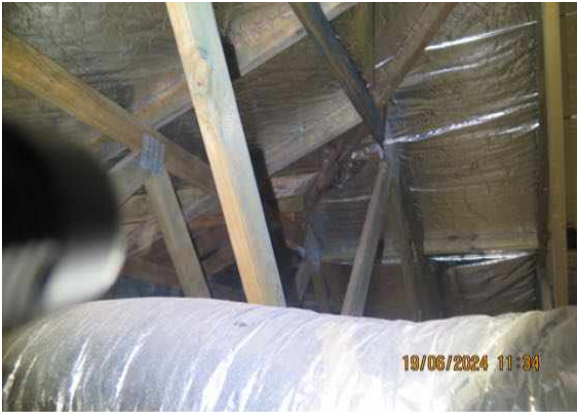
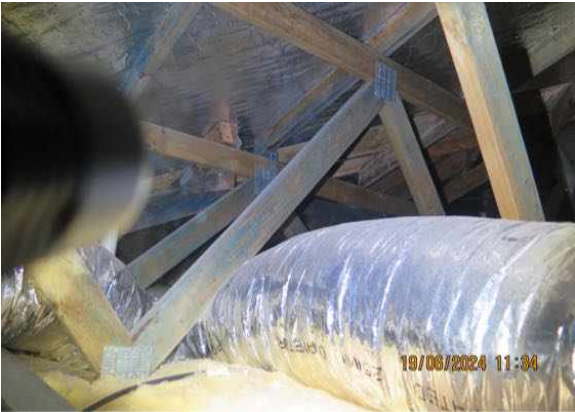
Noted Item

Building: Main Building
Location: All Areas
Finding: Additional Photos
Information: Additional photos are provided for your general reference
