Building Inspection Report

Inspection Date: Sat, 1 Oct 2022

Property Address: 16 Prahran Ave, Frenchs Forest NSW 2086,
Australia

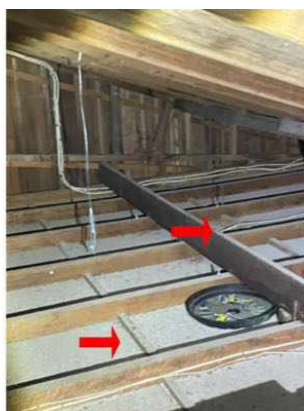
Defects 1.01

Building: Building 1
Location: All Areas
Finding: Asbestos - Suspected ACM Identified on Site
Information: Reporting on Asbestos is outside the Scope of this Report. This suspected defect is highlighted as a caution only. We suspect, based on our experience in the building industry, that there is a higher risk of the identified building element containing asbestos.

As Asbestos Reporting is outside the scope of this report, we advise that you consider a separate Asbestos Inspection and Condition Audit, which can include the taking of samples for definitive confirmation of the presence of Asbestos.

In the interim, the client is advised to act with caution, especially when considering any damage to building materials general wear and tear renovations extensions demolition and general maintenance activities due to the suspected presence of Asbestos.

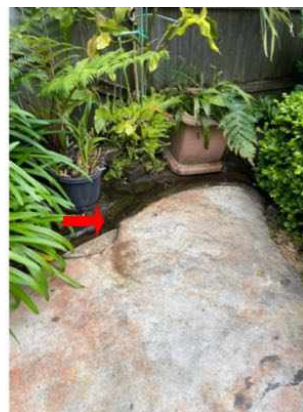
Defects 3.02

Building:	Building 1
Location:	All External Areas
Finding:	Site drainage - suspected Inadequate
Information:	The site drainage in this area was found to be suspected inadequate at the time of inspection, creating potential for subsequent water damage to associated building elements.

Where site drainage is inadequate, installation of an Agricultural (Aggie) Drain may be required. A qualified plumber should be appointed to further inspect the property and perform any remedial works as necessary. Water damage and secondary defects are likely to occur if left unmanaged.

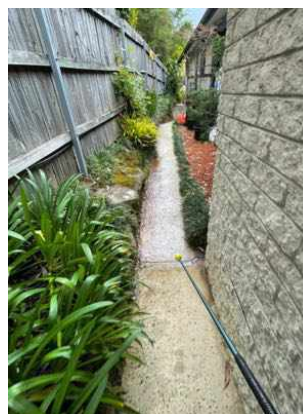
Defects 3.03

Building:	Building 1
Location:	All External Areas
Finding:	Cracking - External Concrete Paving Damage Category 1 - Fine (less than 2mm)
Information:	Fine cracks were identified in external concrete paving. Although fine cracks are quite noticeable, they are often only considered to be an appearance defect, and usually do not indicate any structural damage. To be considered a Category 1 or fine crack, the crack is found to be less than 2mm in width.

Generally the cause of a hairline crack in existing concrete paving such as driveways and pathways is indicative of the expansion and contraction of the concrete. Such causes are generally due to environmental factors, such as moisture levels, weather conditions, root systems of nearby trees or the soil types on which they are laid.

Fine cracks may also be due to poor original installation of the concrete. Factors such

as poor compaction of the sub surface and/or inadequate reinforcing of the slab may create cracking and other secondary defects.

Monitoring of all cracking should be conducted frequently. Always contact a building inspector should cracks widen, lengthen, or become more numerous.

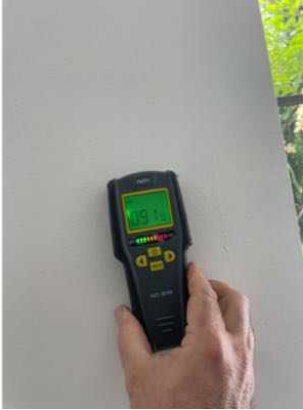
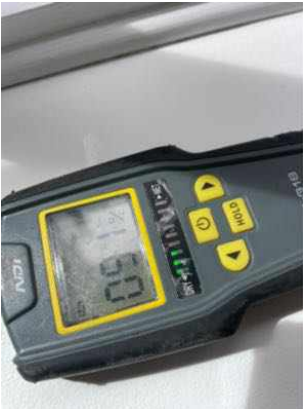
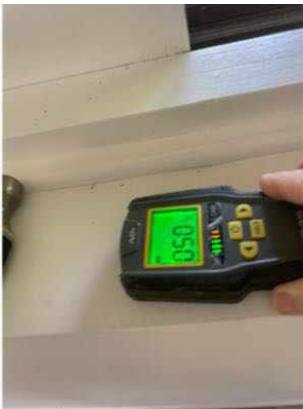
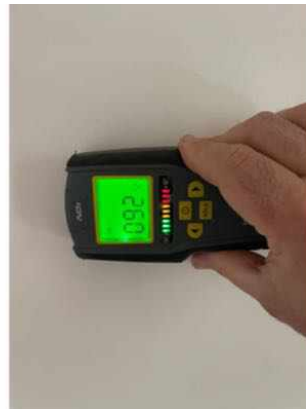
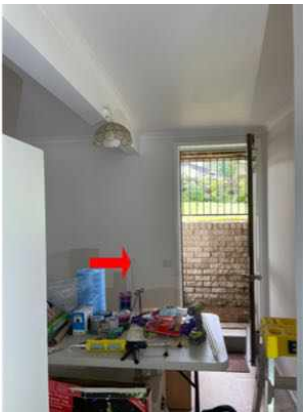
condenser units and poor site drainage.

It is highly recommended that all plumbing and drainage fixtures and fittings be maintained regularly in order to prevent excessive moisture being present in the external / internal property.

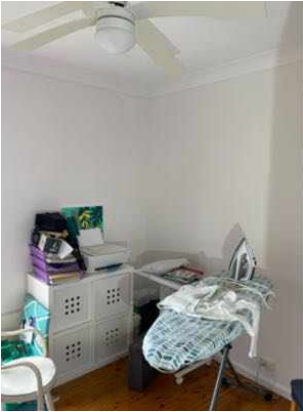
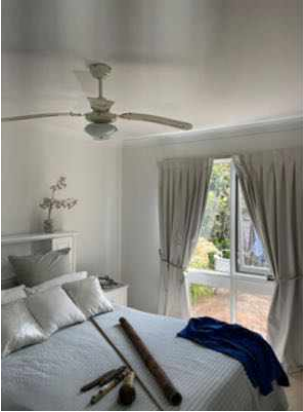
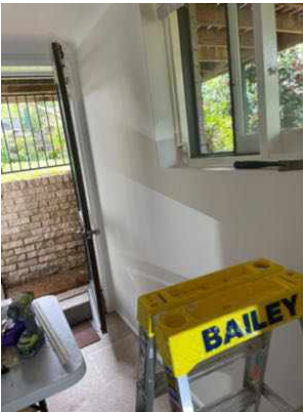
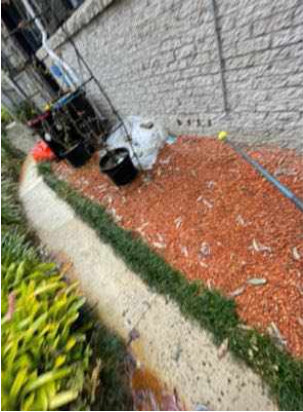
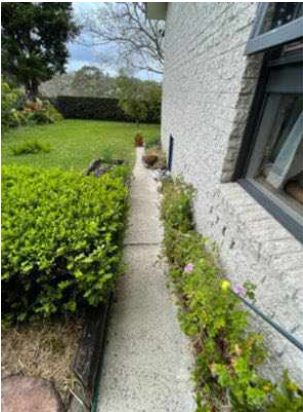
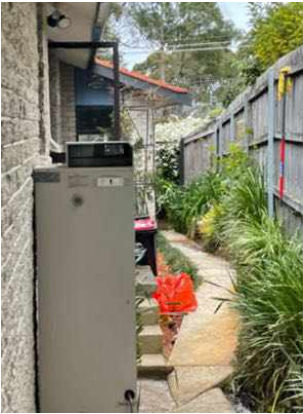
Building: Building 1
Location: All Areas
Finding: Additional Photos - Obstructions and Limitations
Information: These photographs are an indication of the obstructions and limitations which impeded full inspection of the property at the time of inspection. These obstructions can hide an array of defects and should be removed to allow full inspection to be carried out. A re-inspection is recommended once the areas are made accessible.
