## Building Inspection Report

Inspection Date: Thu, 10 Nov 2022

Property Address: 28 Myra St, Frenchs Forest NSW 2086,  
Australia

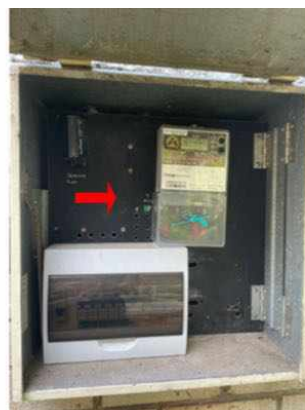
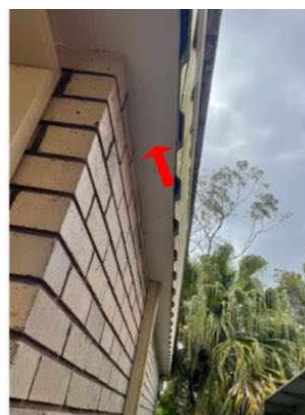
#### Defects 1.02

Reporting on Asbestos is outside the Scope of this Report. This suspected defect is highlighted as a caution only. We suspect, based on our experience in the building industry, that there is a higher risk of the identified building element containing asbestos.

As Asbestos Reporting is outside the scope of this report, we advise that you consider a separate Asbestos Inspection and Condition Audit, which can include the taking of samples for definitive confirmation of the presence of Asbestos.

In the interim, the client is advised to act with caution, especially when considering any damage to building materials general wear and tear renovations extensions demolition and general maintenance activities due to the suspected presence of Asbestos.

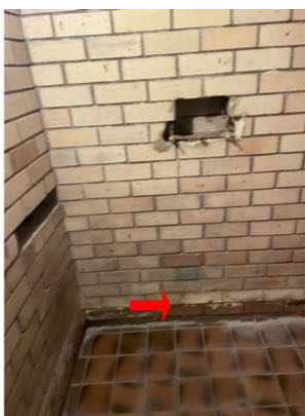
## Defects 1.03

Building:	Building 1
Location:	All Areas > Ground Level
Finding:	Visual mould inspection
Information:	A visual mould inspection of the property was conducted and identified areas of suspected mould and deterioration. Mould is a visible fungal growth, but may also be evidenced by a musty smell in the immediate area.

Mould, which poses a significant respiratory hazard, generally forms and develops as a result of dark and damp conditions over a prolonged period of time. These conditions,

While mould and dampness are present, the area is considered a health and safety hazard. Tenants with respiratory health conditions are advised to exercise great caution and care whilst in the area.

The first action should be to identify the cause of the mould in this area. Replacement of the affected carpet is required as a matter of urgency to ensure the safety of the area. Where required, remedial works should be undertaken to any associated walls and flooring showing evidence of mould.

Where mould is excessive, further inspection by an Environmental Health inspector is advisable.

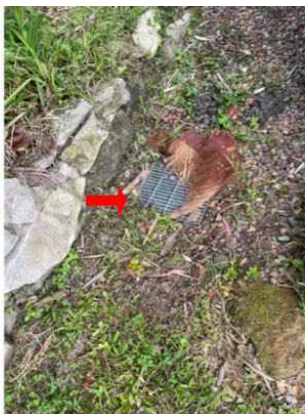
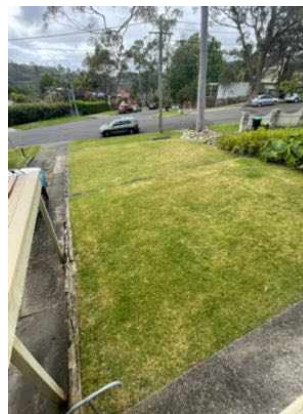
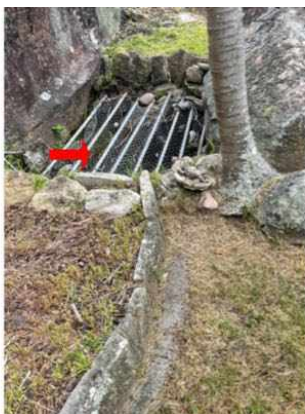
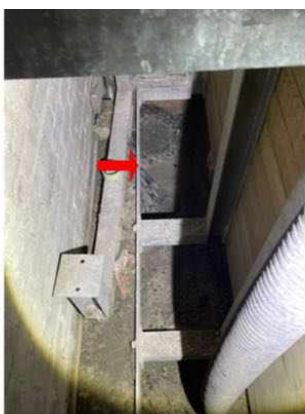
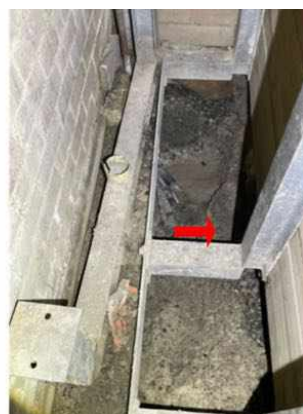
### Defects 3.02

Building:	Building 1
Location:	All External Areas
Finding:	Site drainage - suspected Inadequate
Information:	The site drainage in this area was found to be suspected inadequate at the time of inspection, creating potential for subsequent water damage to associated building elements.

It is important that water does not lie against the base of walls; surrounding paths and ground levels should be sloped to drain water away from walls. Downpipes should not discharge stormwater onto lower walls or plinths. Stormwater should be carried away by large, regularly cleaned drains. Ground levels may need to be lowered to expose a buried DPC.

Where site drainage is inadequate, installation of an Agricultural (Aggie) Drain may be required. A qualified plumber should be appointed to further inspect the property and perform any remedial works as necessary. Water damage and secondary defects are likely to occur if left unmanaged.

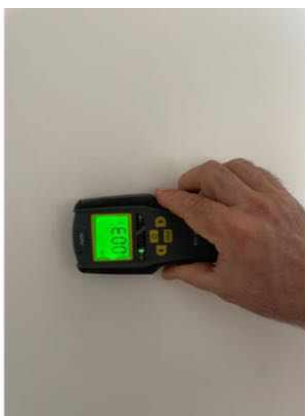
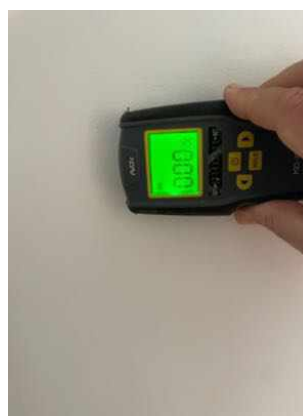
### Defects 3.03

Building:	Building 1
Location:	All Areas
Finding:	Moisture meter readings - low
Information:	The moisture meter result for the areas inspected.

The moisture reading of 0-15% is quite normal and gives no cause for concern. However, moisture readings in excess of 15% indicate the need for further inspection.

Levels between 25-30% indicate that there may be water ingress, meaning that remedial work could be required.

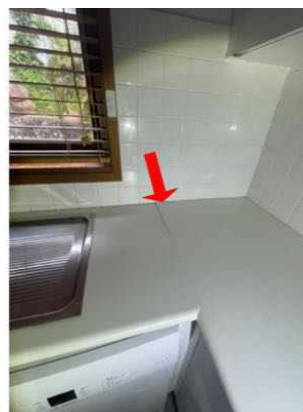
### Defects 3.04

Building:	Building 1
Location:	All Areas
Finding:	Sealant - missing/ deteriorated
Information:	Flexible and mould resistant materials should be applied to affected areas to prevent any subsequent water damage that is likely to occur. Regular maintenance and replacement of damage or missing or damaged sealant is highly recommended to the wet areas, as this is a regular wear and tear defect.

Sealant in areas that come into regular contact with water should be maintained for the long term care of your property. A sealant specialist or tiling contractor should be

appointed to complete these works as soon as possible

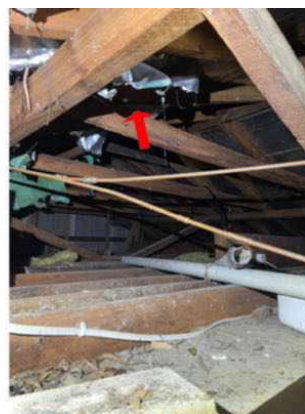
### Defects 3.05

Building:	Building 1
Location:	Roof Void
Finding:	Sarking - Damaged
Information:	Sarking, a laminated aluminium foil applied to the interior of the roof covering, assists in insulating the property and acting as a vapour-barrier to the roof void and, subsequently, to the household.

Where sarking is damaged, both insulation and moisture protection of the property are inhibited. This creates a loss of energy and thus negatively impacts the energy efficiency of the property, allowing potential for moisture ingress from condensation or leaking roof tiles.

It is important to repair any holes or damaged sections of sarking to ensure that the building material is fully functional. A registered builder or qualified carpenter should be consulted to provide further advice on this defect and to perform rectification works at client discretion.

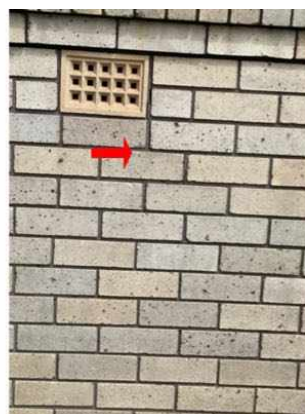
### Defects 3.09

Building:	Building 1
Location:	All External Areas
Finding:	Brickwork - Deteriorated mortar
Information:	Mortar, or 'bedding', is the material which fills joins and intersections between bricks in masonry walls and structures. Sections of mortar in this brickwork were identified as having deteriorated, which is generally expected for a property of this age and condition.

Mortar may deteriorate as a result of age of building materials, minor movement of bricks, or frequent exposure to weathering. Mortar should be replaced to ensure that bricks remain in their intended location and to prevent gaps, which would allow water or moisture ingress and secondary damage as a result.

Mortar deterioration can be addressed by a bricklayer where areas of deterioration are localised and easily accessible. Alternatively, appointment of a registered builder is advised, to repoint large areas of decaying mortar. Where secondary structural defects have become evident, consultation with a structural engineer may be required.

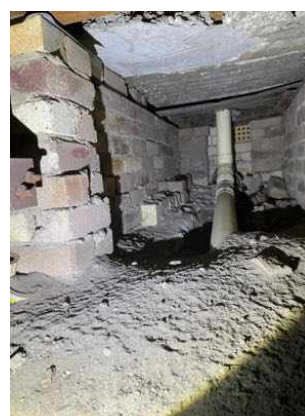
### Defects 3.10

Location: Subfloor  
 Finding: Formwork timber and corrugated iron - removal  
 Information: Sometime formwork material is not removed during construction which increases the risk of termite activity, wood rot and corrosion being present.

It is recommended that formwork to be removed from these areas.

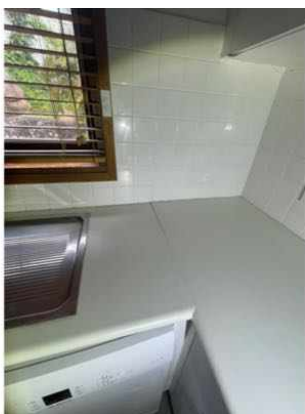
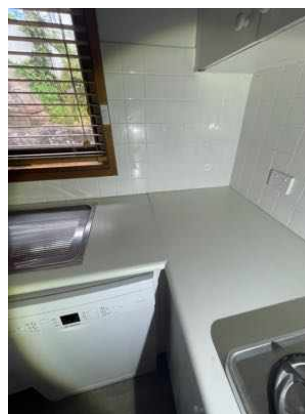
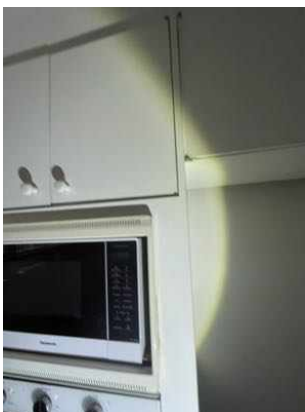
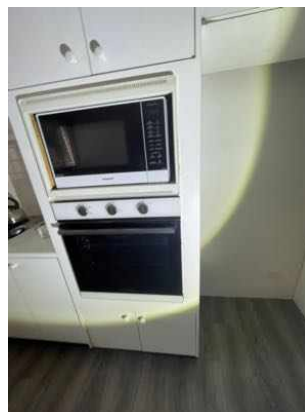
### Defects 3.11

Building: Building 1  
 Location: Kitchen  
 Finding: Cabinetry- Evidence of deterioration  
 Information: Rectification works may include replacement of cabinetry depending on the extent of the damage.

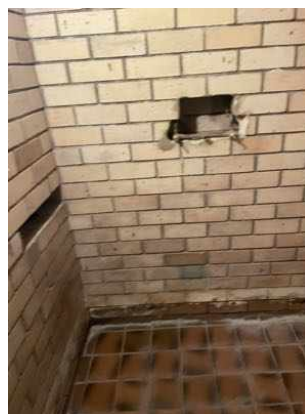
### Defects 3.12

Building:	Building 1
Location:	All Areas > Ground Level
Finding:	Evidence of excessive moisture was present at the time of inspection
Information:	Excessive moisture can attract termites and produce conditions that promote termite attack fungal growth and wood decay.

Excessive moisture is generally caused by deteriorated inadequate or missing roof drainage leaking plumbing pipes or fixtures poorly plumbed HWS overflows or condenser units and poor site drainage.

It is highly recommended that all plumbing and drainage fixtures and fittings be maintained regularly in order to prevent excessive moisture being present in the external / internal property.

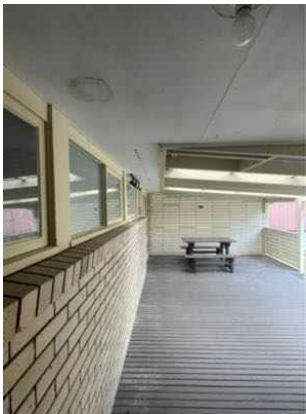
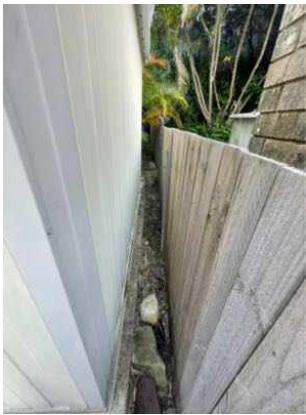
Building: Building 1  
Location: All Areas  
Finding: Additional Photos - Obstructions and Limitations  
Information: These photographs are an indication of the obstructions and limitations which impeded full inspection of the property at the time of inspection. These obstructions can hide an array of defects and should be removed to allow full inspection to be carried out.

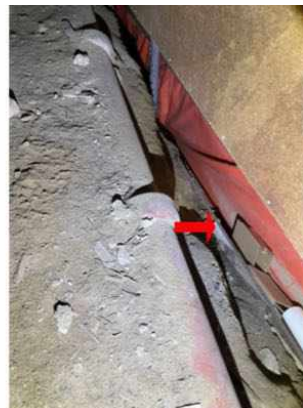
Information: An array of debris was found in the subfloor area at the time of inspection. Debris in this area restricts subfloor ventilation and creates potential for concealed pest entry. Stored timbers and other materials may also make the area susceptible to termite activity and wood rot.

A clear and empty subfloor will be better ventilated and easier to maintain in a dry condition. The removal of any timber debris is vital in minimising the risk of termite or wood borer activity.

Debris in the subfloor should be removed as soon as possible. Depending on the location and amount of debris and stored items, the homeowner may elect to undertake this task. Alternatively there are a large number of rubbish removal subcontractors that could undertake these works.

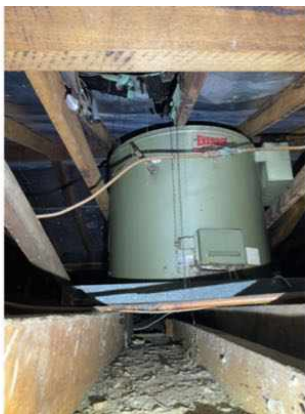
Building:	Building 1
Location:	Roof Void
Finding:	Gravity-Fed HWS - Disconnected
Information:	It was noted at the time of inspection that a disconnected gravity-fed hot water system (HWS) remains in this area.

Despite this plumbing structure being unused, it is likely to be storing residual water, and is therefore susceptible to rust and corrosion. If allowed to continue, rust and corrosion is likely to lead to damage to adjoining building elements, and may also make the area susceptible to termite or timber pest activity.

While it is a costly exercise to remove the disused gravity-fed HWS, it is advisable in the short-term future to prevent any further damage to the area. Further consultation with a licensed plumber is required to gain further advice on removal of the structure.

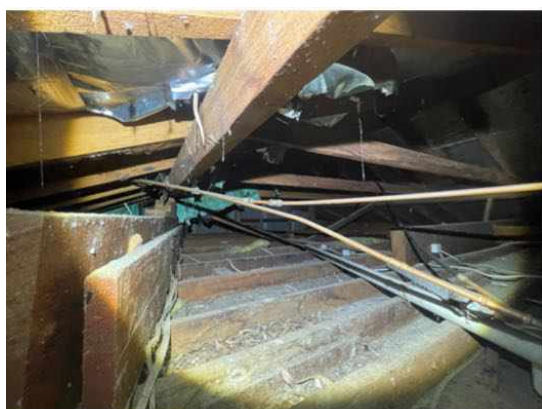
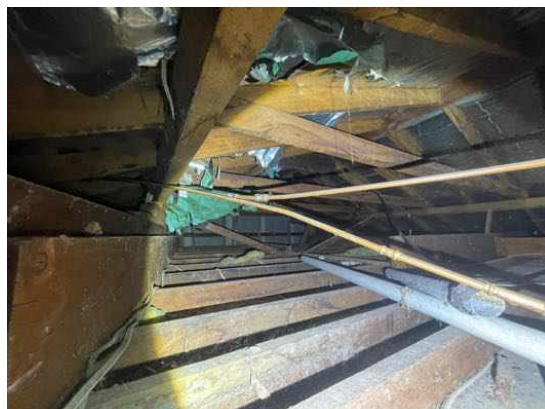
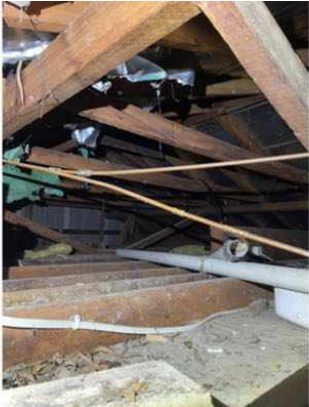
Building: Building 1  
 Location: Roof Void  
 Finding: Insulation - not present  
 Information: Upon inspection of the roof void it was noted that there is was no insulation.

Example - Where there is a gap in coverage totaling 5% there is a potential for up to 50% of the energy efficiency to escape.
