Timber Pest Inspection Report

Inspection Date: Wed, 28 Sep 2022

Property Address: 6 Ocean View Way, Belrose NSW 2085,
Australia

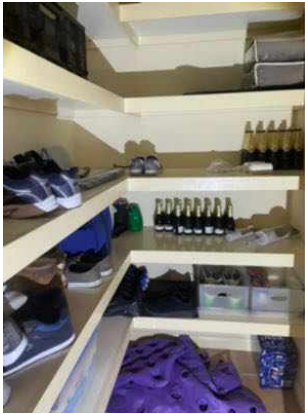
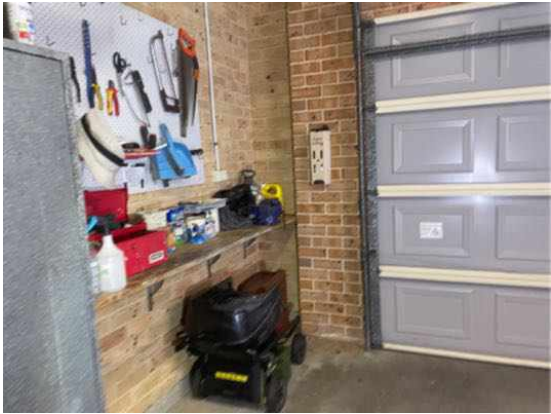
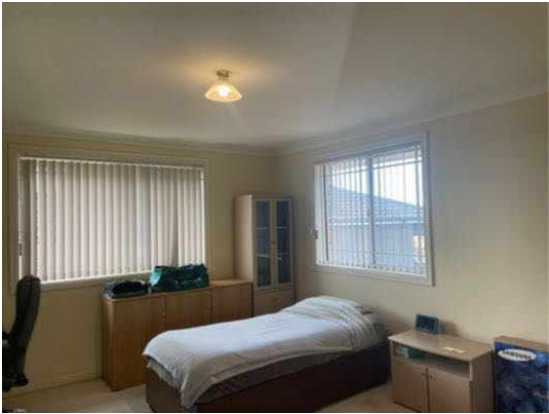
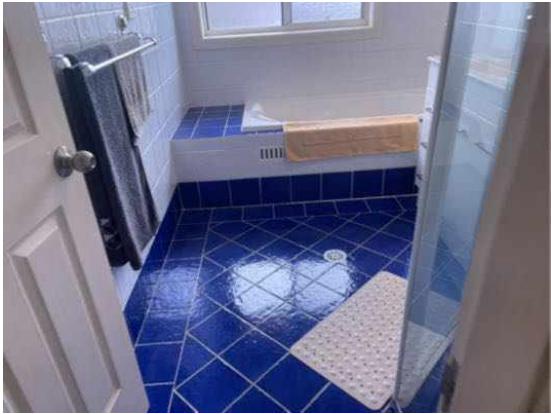
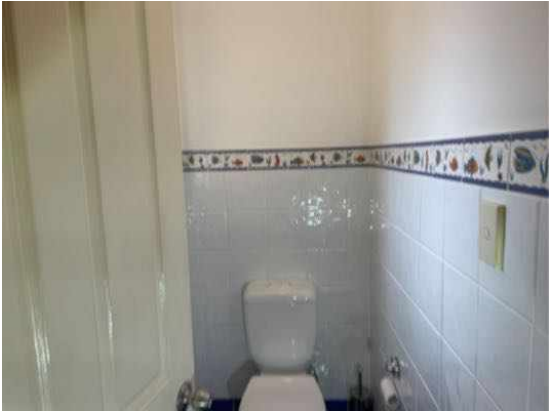
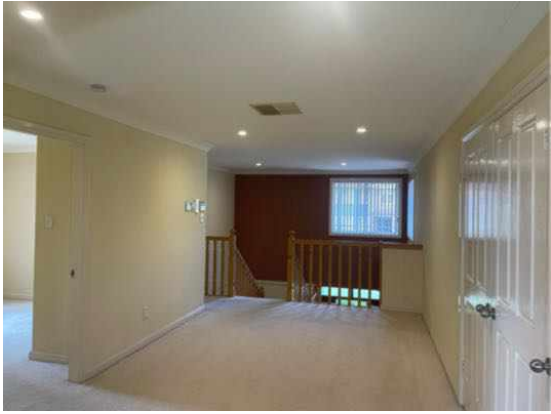
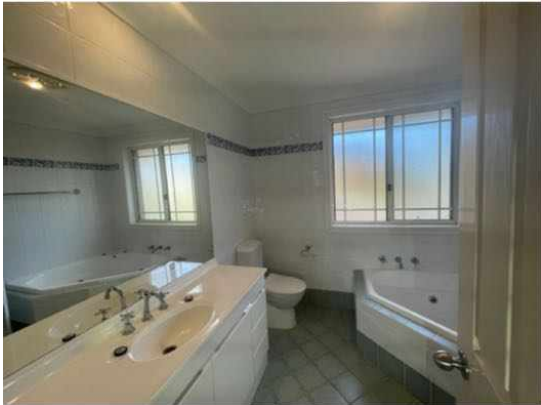
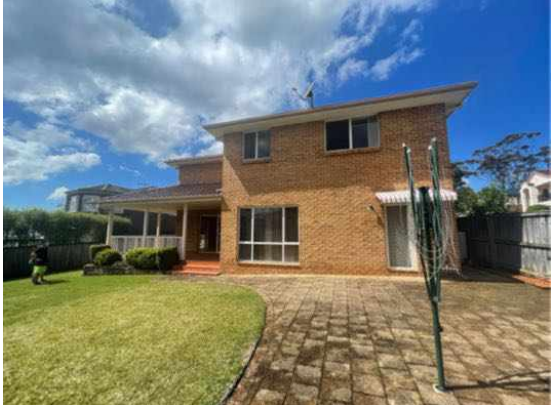
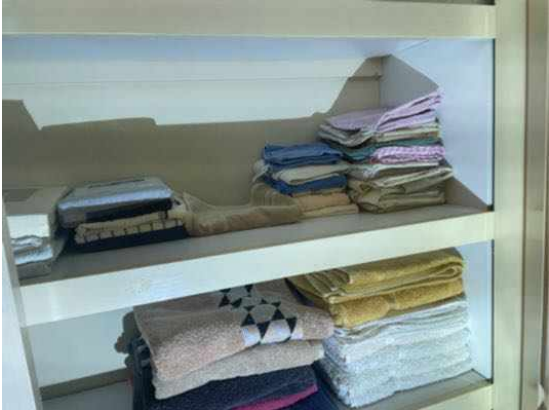
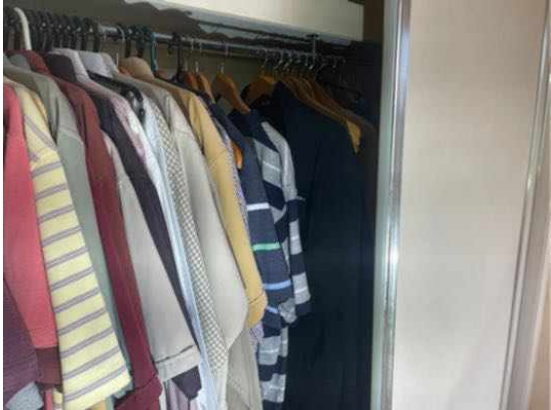
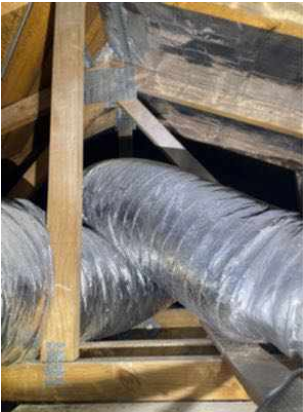
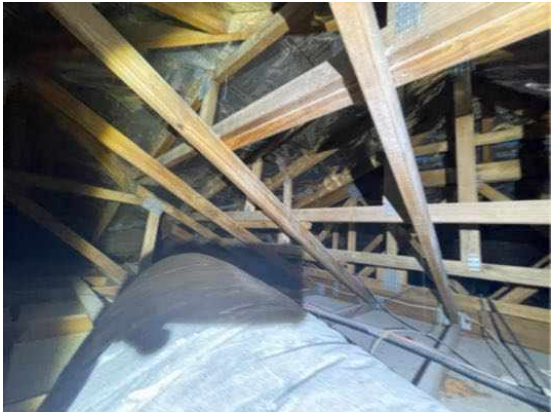
Building: Building 1
Location: All Areas
Finding: Additional Photos - Obstructions and Limitations
Information: These photographs are an indication of the obstructions and limitations which impeded full inspection of the property at the time of inspection. These obstructions can hide an array of defects and should be removed to allow full inspection to be carried out.
