Timber Pest Inspection Report

Inspection Date: Tue, 15 Nov 2022

Property Address: 7 Romford Rd, Frenchs Forest NSW 2086,
Australia

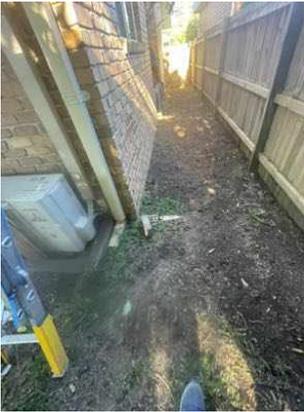
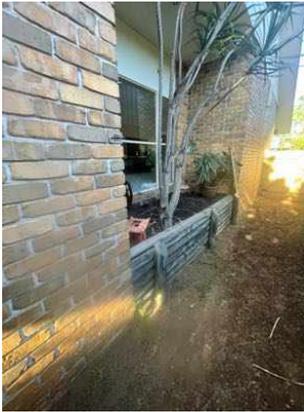
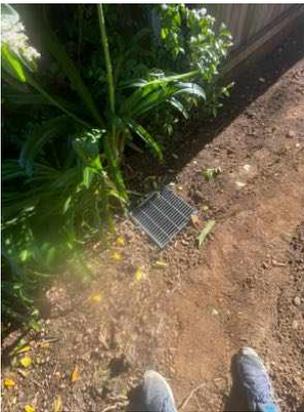
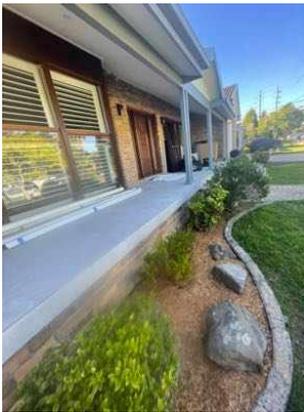
Building: Building 1
Location: All Areas
Finding: Additional Photos - Obstructions and Limitations
Information: These photographs are an indication of the obstructions and limitations which impeded full inspection of the property at the time of inspection.

When the risk of undetected defects medium or high we strongly recommend further inspection once access is provided or if the obstruction can be removed. Contact us for further advice.
