# Building Inspection Report

Inspection Date: Sat, 25 Jul 2020

Property Address: 25 Daren St, Beacon Hill NSW 2100, Australia

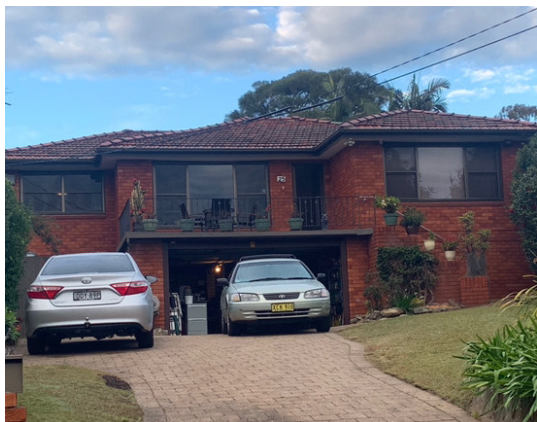
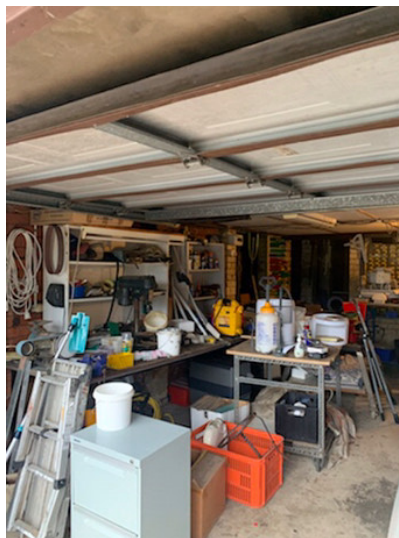
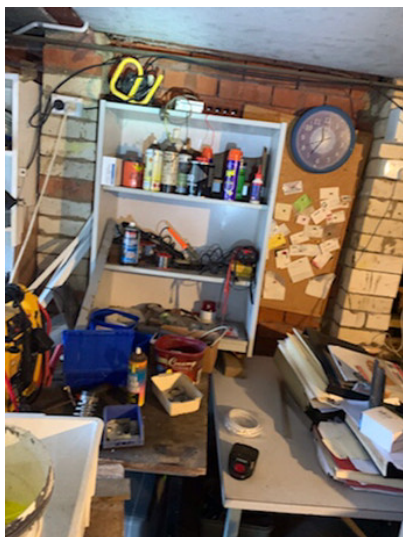
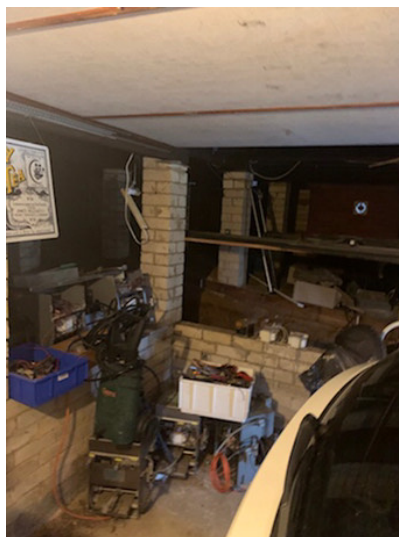
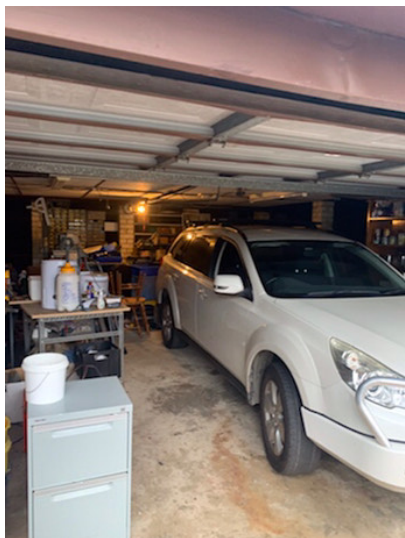
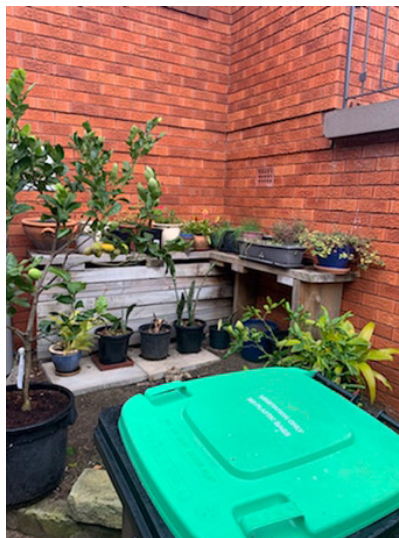
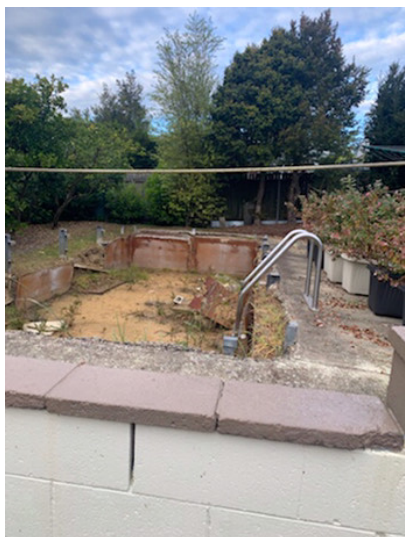
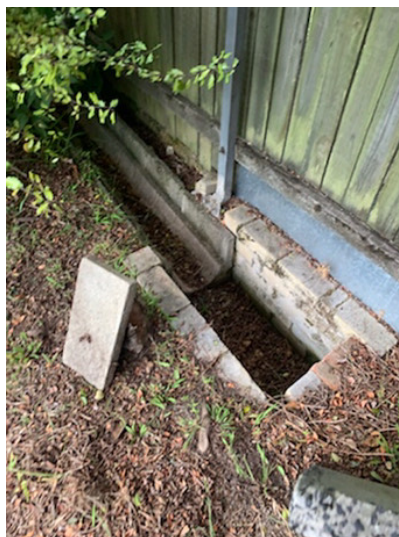
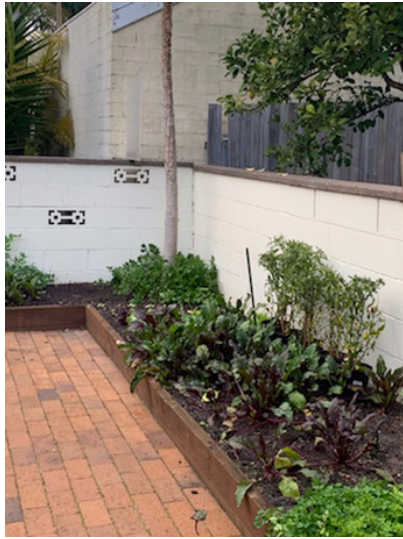
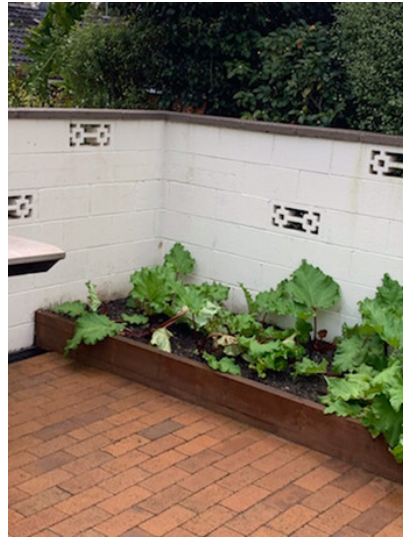
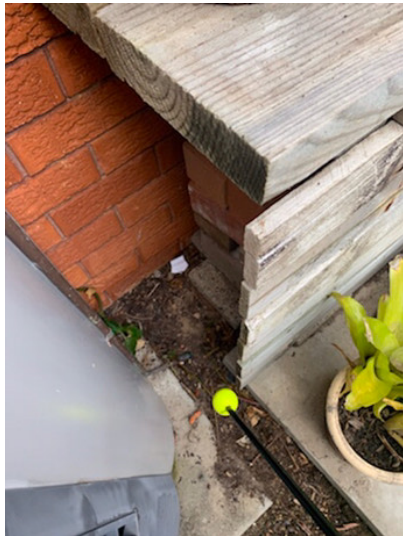
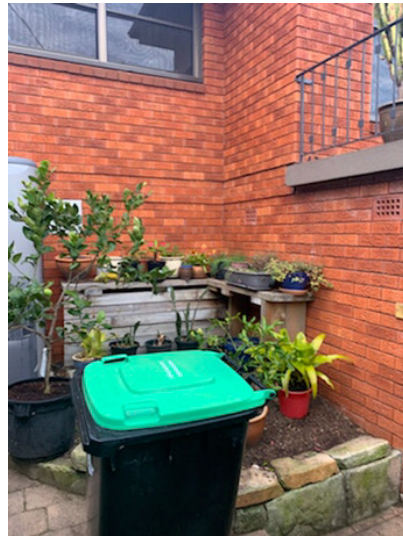
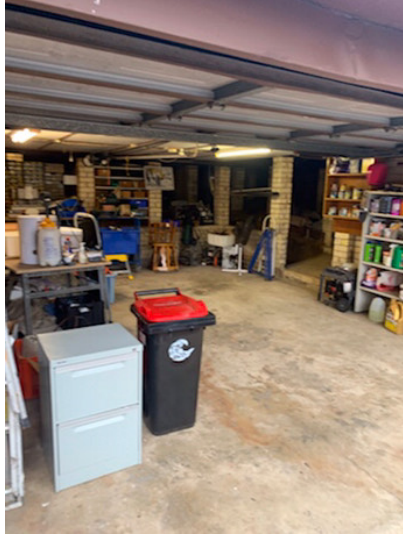
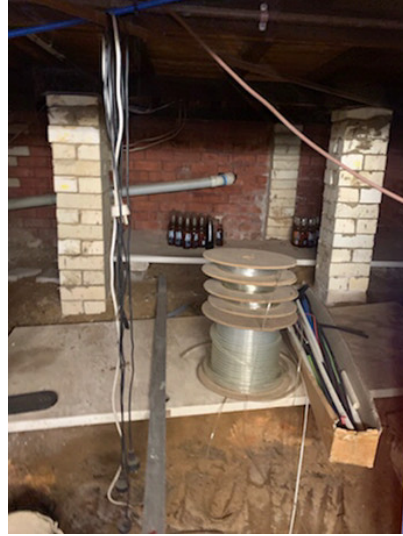
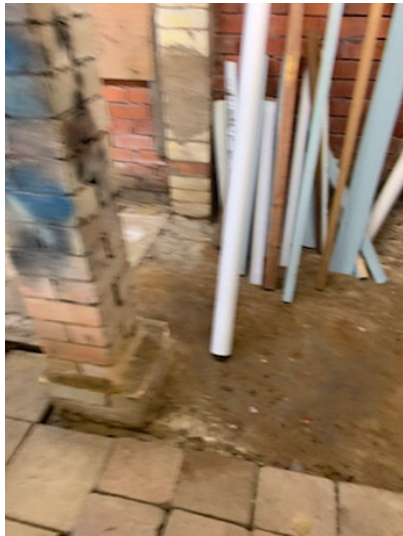
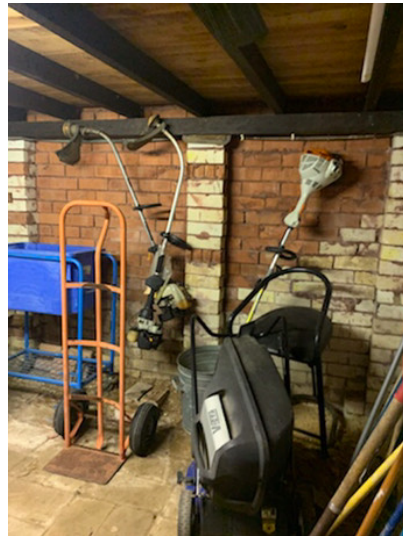
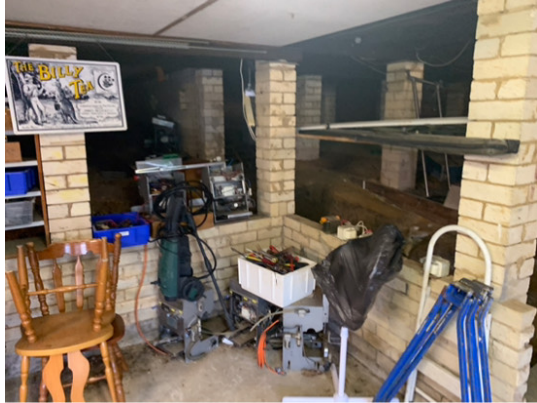
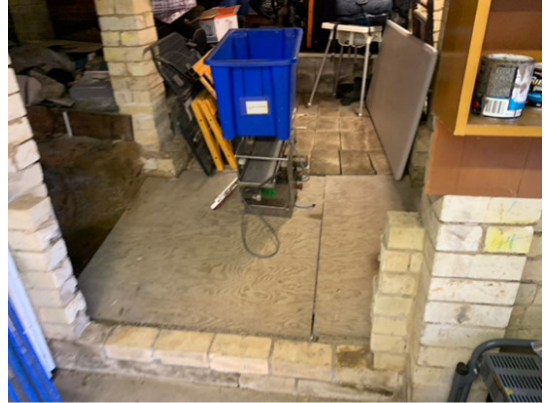
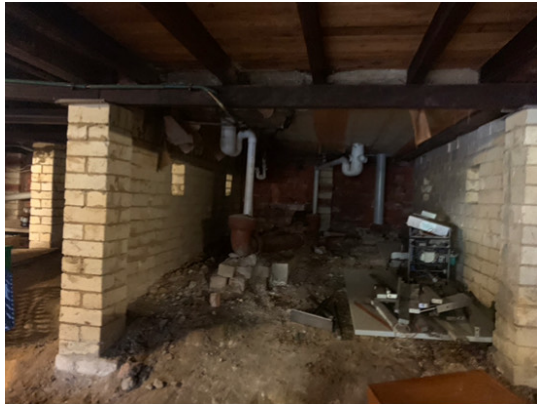
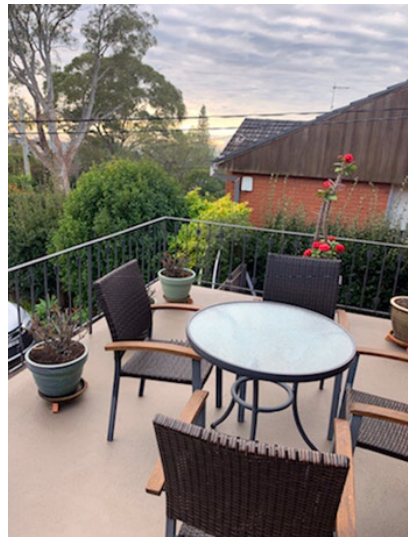
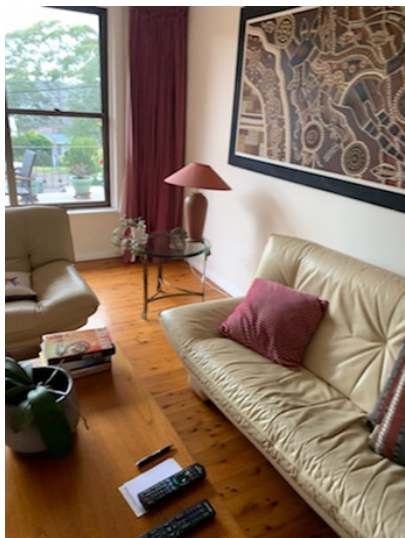
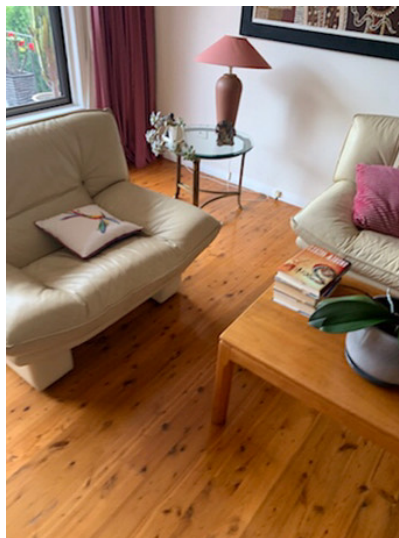
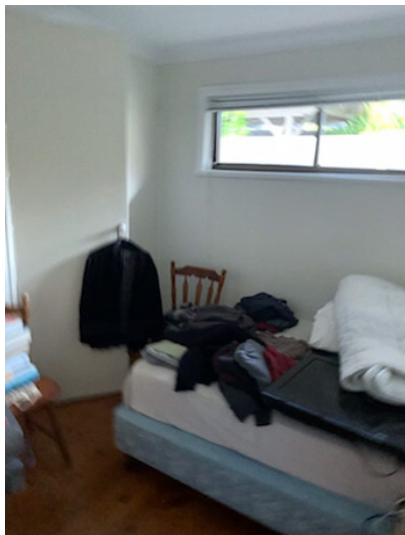
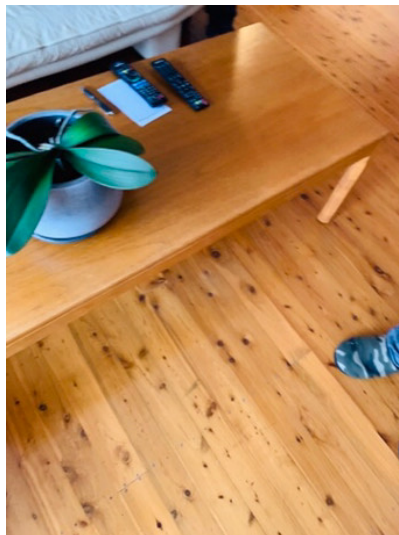
Building:	Building 1
Location:	All Areas
Finding:	Additional Photos - Obstructions and Limitations
Information:	These photographs are an indication of the obstructions and limitations which impeded full inspection of the property at the time of inspection.
