Building and Timber Pest Inspection Report VR

Inspection Date: Mon, 5 Jun 2023

Property Address: 118 Westminster St, Schofields NSW 2762, Australia

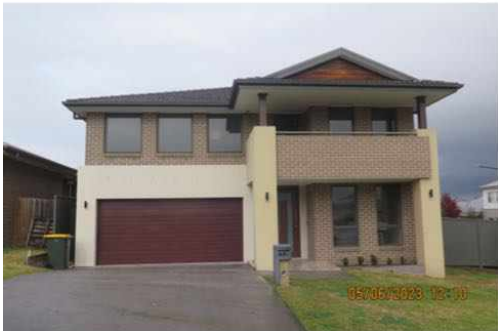
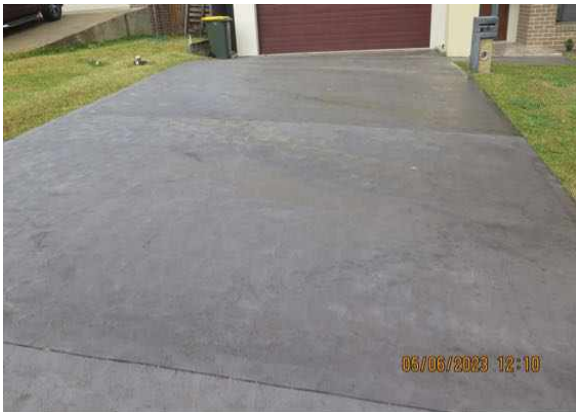
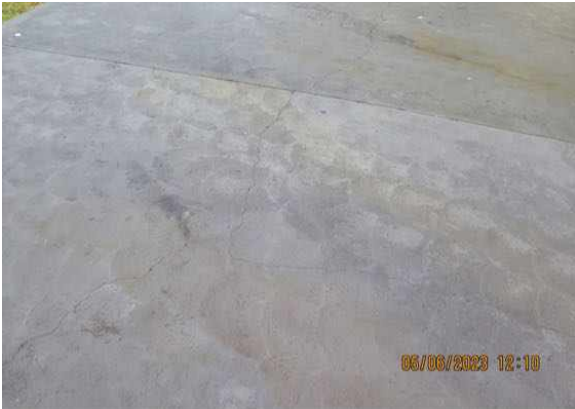
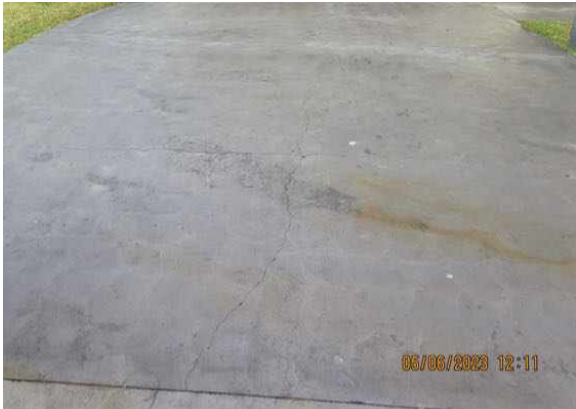
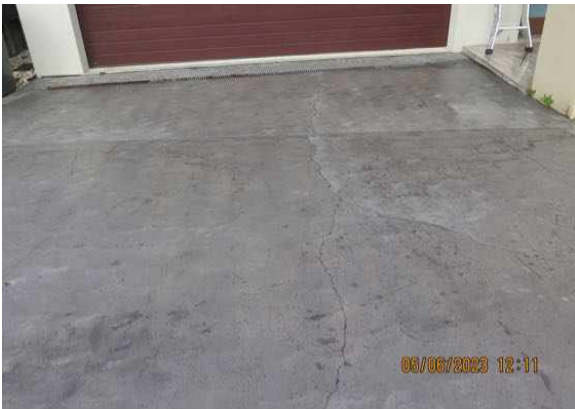
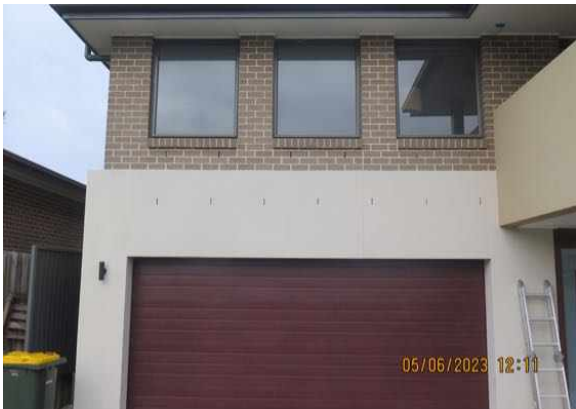
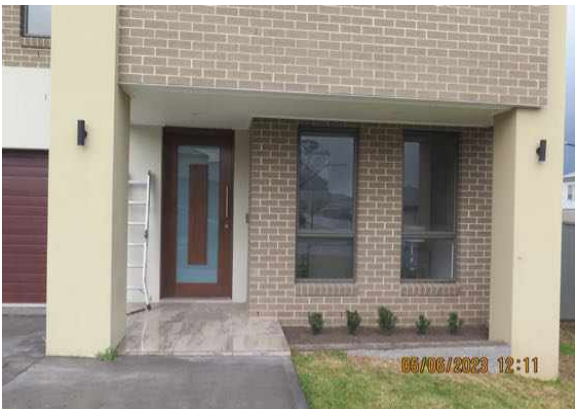
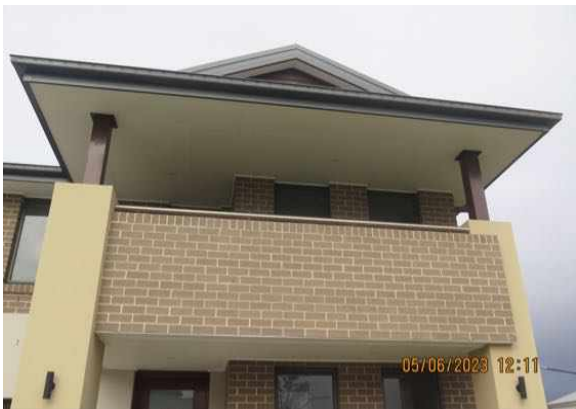
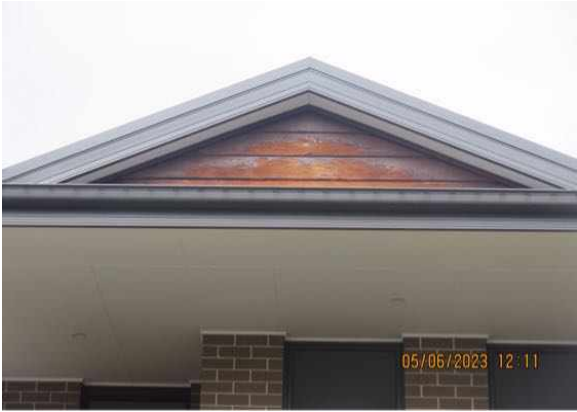
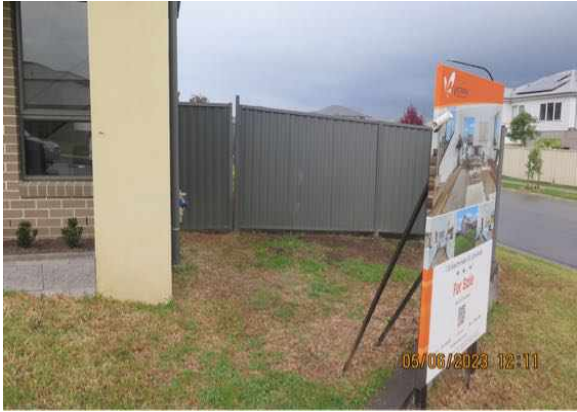
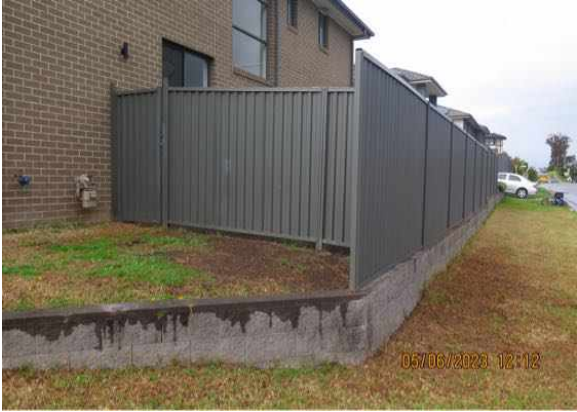
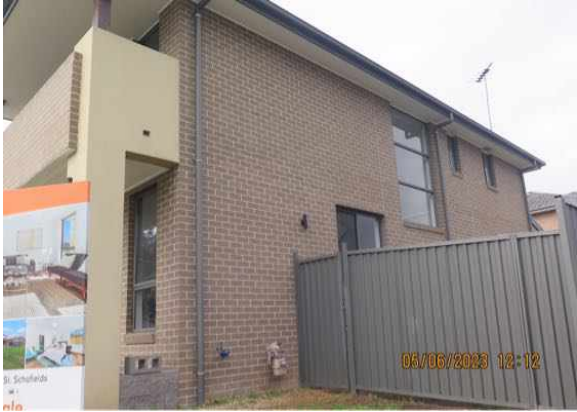
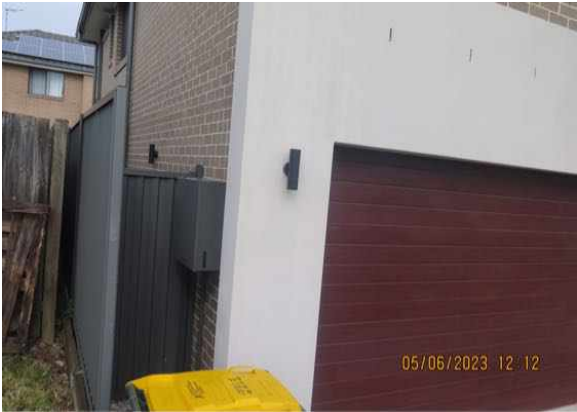
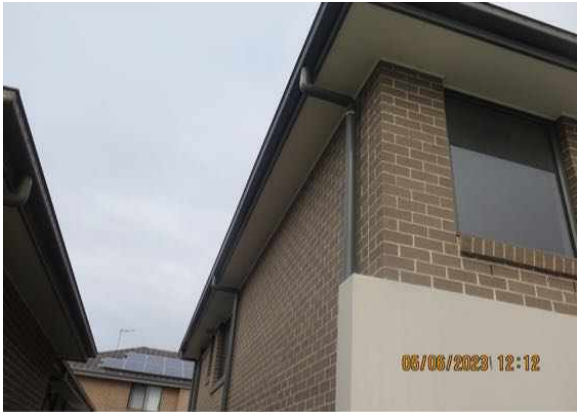
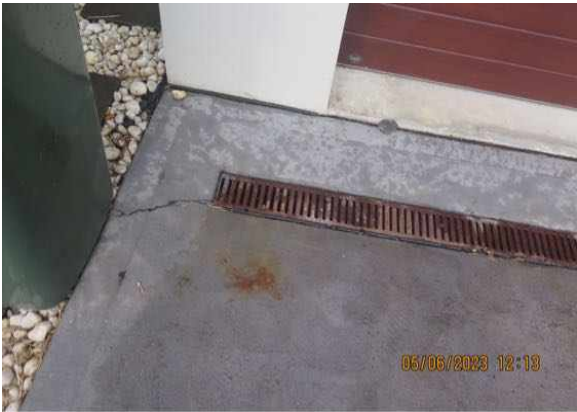
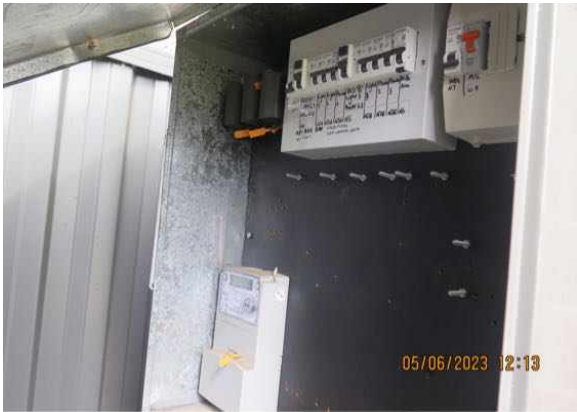
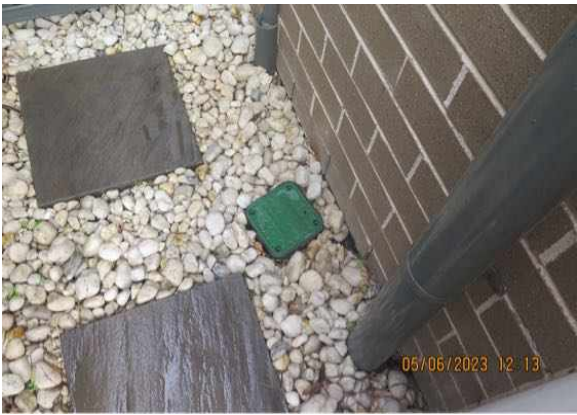
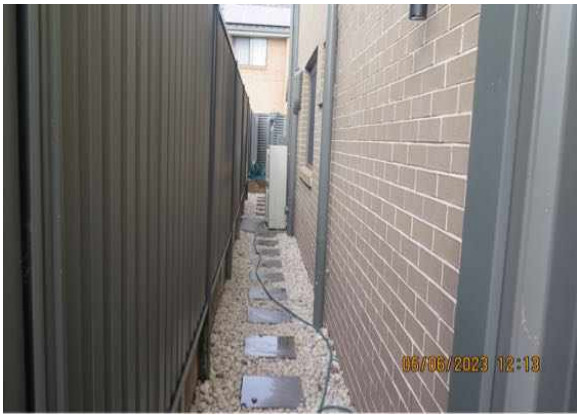
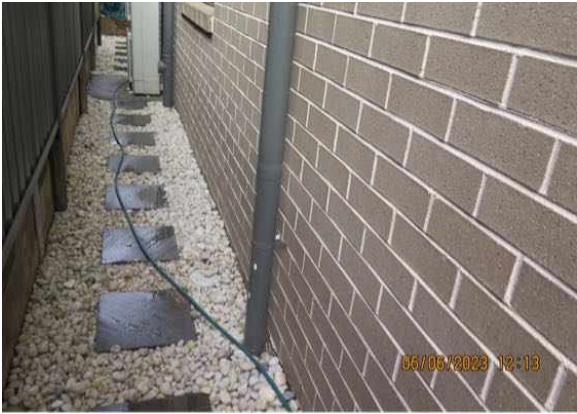
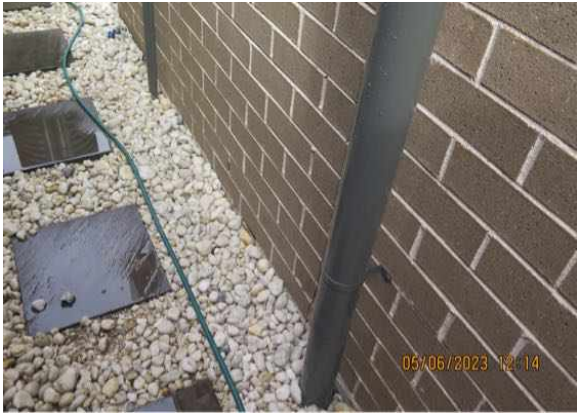
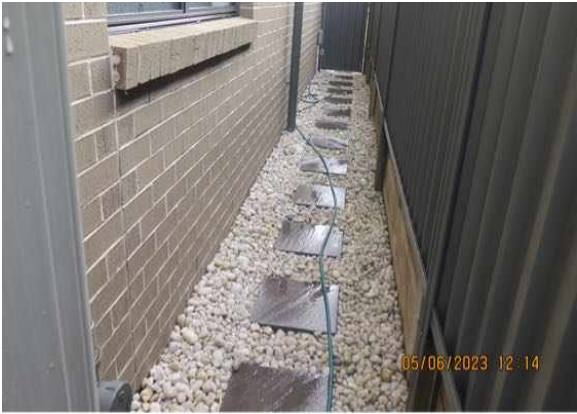
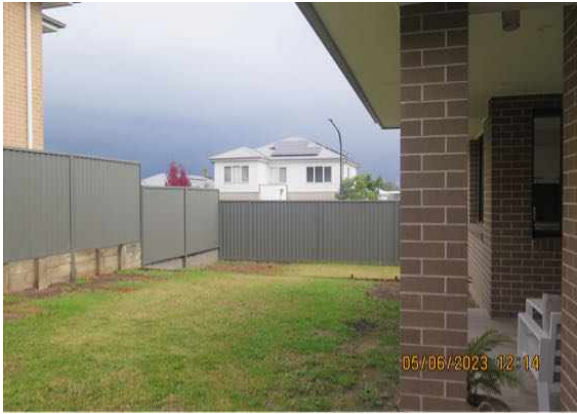
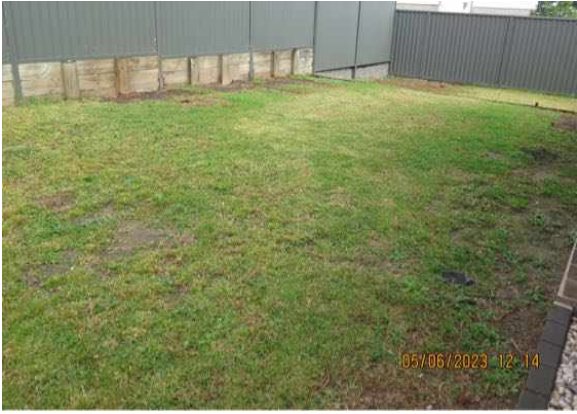
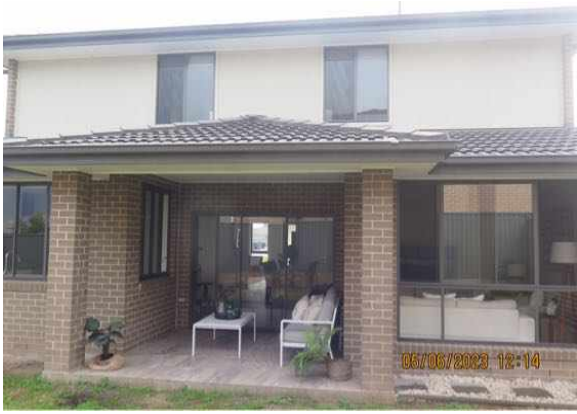
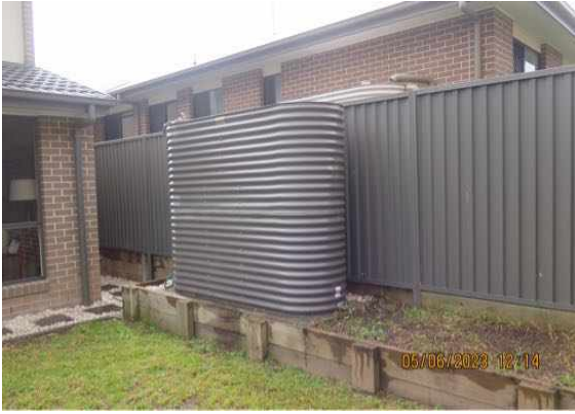
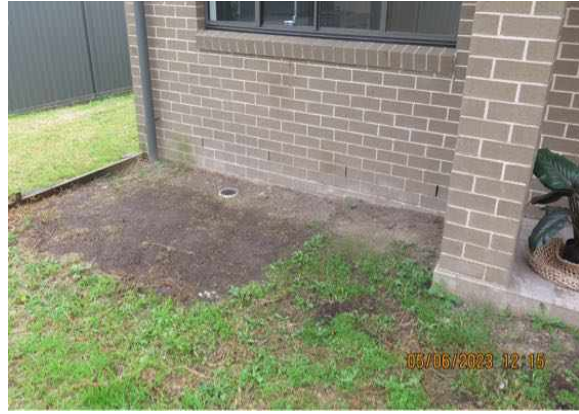
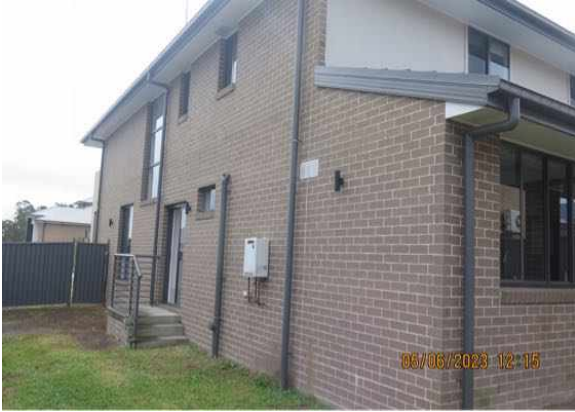
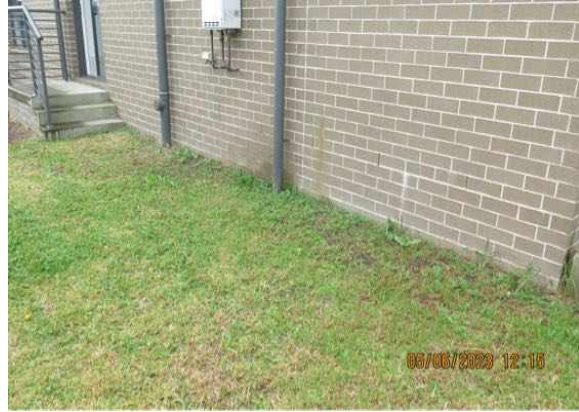
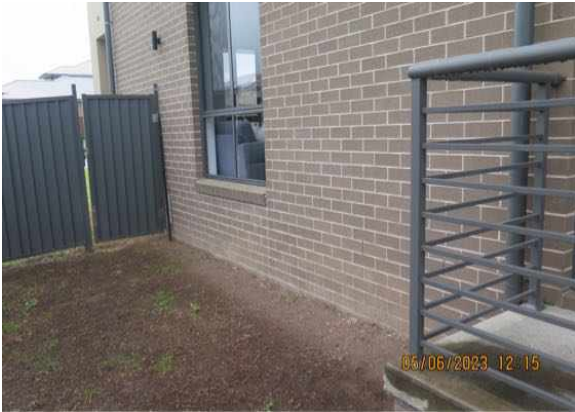
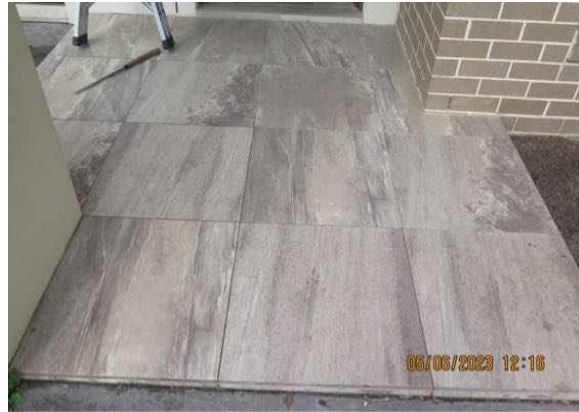
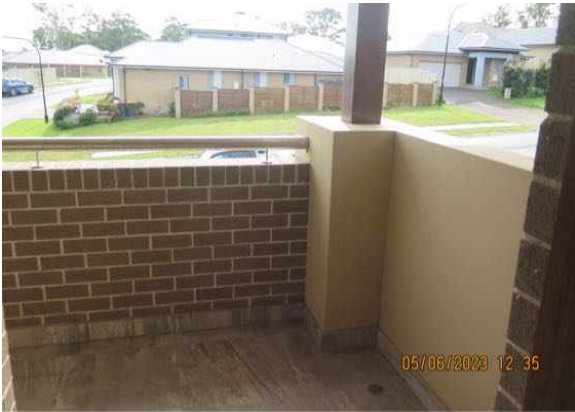
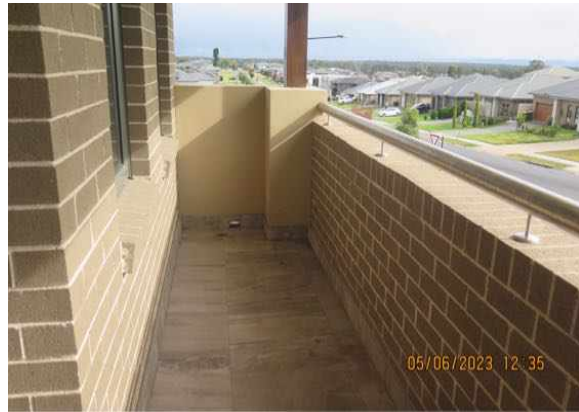
Noted Item

Building: Main Building
Location: All External Areas
Finding: Additional Photos
Information: Additional photos are provided for your general reference
