## Building and Timber Pest Inspection Report

Inspection Date: Wed, 2 Jun 2021

Property Address: 69 Iris St, Frenchs Forest NSW 2086,  
Australia

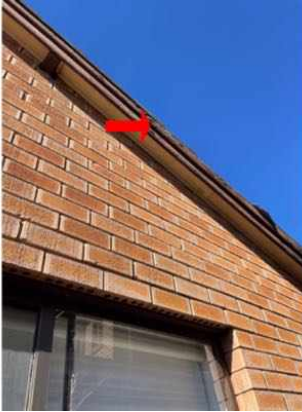
### Defects 3.04

| Finding: | Wood rot |
| Information: | This building element shows evidence of wood rot. Wood rot, also known as Fungal Decay, occurs when timbers and other cellulose building materials are exposed to damp conditions on an ongoing basis. This could be the result of exposure to weathering over a prolonged period of time, or the attraction of excessive moisture from other abutting building materials. Contributing factors also include poor air ventilation in the area. |

Early intervention and regular maintenance, particularly of exterior timbers, will prolong the useful life of these building elements. Prior to any works being performed, the cause of the moisture that has created the visible wood rot should be identified and addressed in a suitable manner. Replacement of affected timbers may then be a necessary step in protecting surrounding building elements from such deterioration.

A qualified carpenter or registered builder may also be required to replace affected building materials.

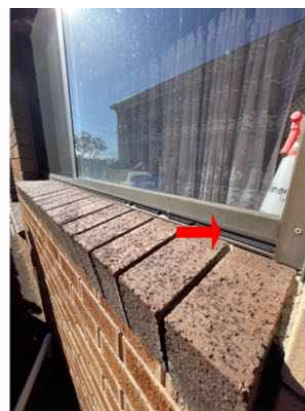
### Defects 3.06

Finding: Window seals - deteriorated

Where window seals have deteriorated, the window is no longer weather-tight; rain penetration and subsequent water damage is therefore likely to ensue. Insulation of the area against external weather conditions will also be compromised.

It is recommended that all deteriorated window seals be replaced by a general handyman or sealant expert to prevent any further damage and to restore the window to a fully functional level.

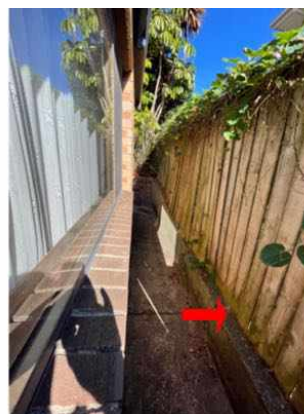
### Defects 3.07

If left unattended, it is likely that further damage will occur. It is suspected that repair of several elements of the fencing may be required however replacement may be a consideration of the client also.

A licensed fencing contractor should be appointed to provide further advice and perform rectification works as necessary.

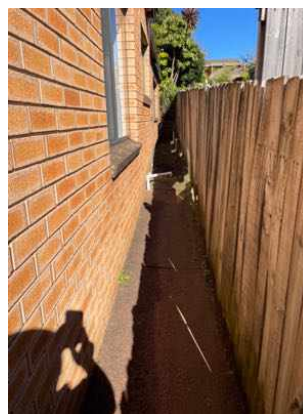
Where site drainage is inadequate, installation of an Agricultural (Aggie) Drain may be required. A qualified plumber should be appointed to further inspect the property and perform any remedial works as necessary. Water damage and secondary defects are likely to occur if left unmanaged.

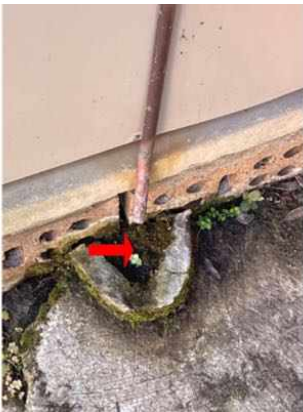
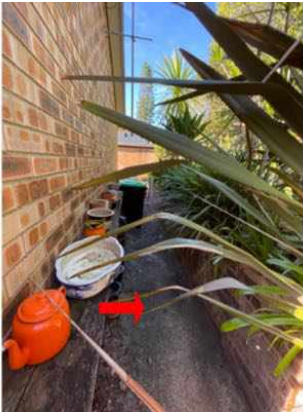
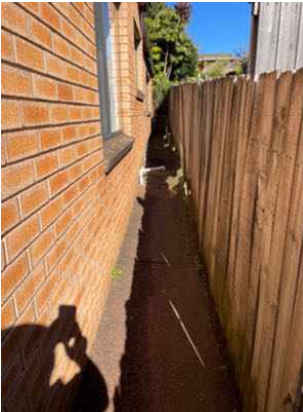
### Defects 3.12

Excessive moisture is generally caused by deteriorated inadequate or missing roof drainage leaking plumbing pipes or fixtures poorly plumbed HWS overflows or condenser units and poor site drainage.

It is highly recommended that all plumbing and drainage fixtures and fittings be maintained regularly in order to prevent excessive moisture being present in the external / internal property.

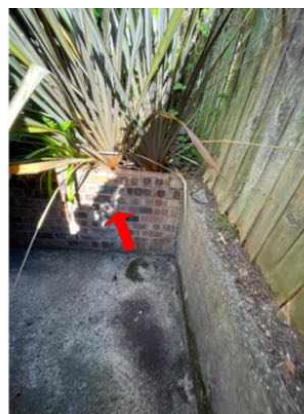
Building: Building 1  
 Location: All External Areas  
 Finding: Garden Beds - Conditions Conducive to Termites  
 Information:

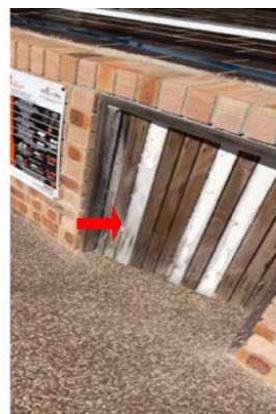
Building: Building 1  
 Location: All External Areas  
 Finding: Building materials in direct ground contact - conducive to termites  
 Information: Where timber elements are in direct contact with the ground and consequently moisture or dampness they become conducive to termite activity. Whether timber is used as a building element part of a fencing structure or stored as an unused item they can provide an environment that is attractive to termite infestation. When met with excessive moisture timber begins to decay and develop wood rot. Any timbers that are in direct contact with external grounds especially if left untreated or non-durable also provide ingress for subterranean termites into that particular element. The removal of any such materials that may be conducive to termite activity should be removed as soon as possible to minimise the risk of termite attack.

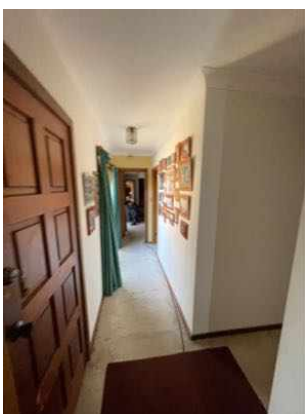
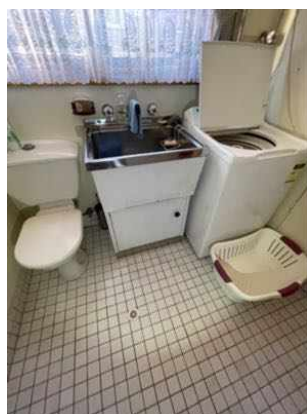
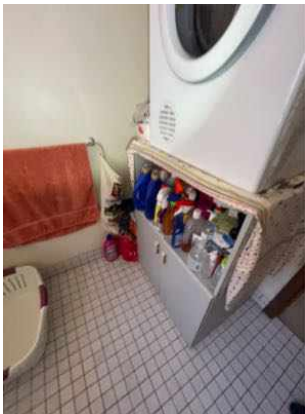
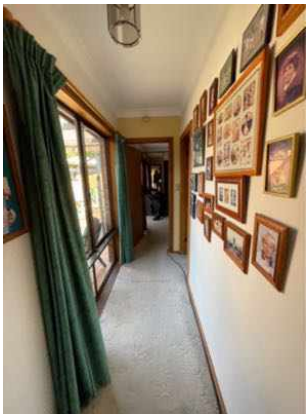
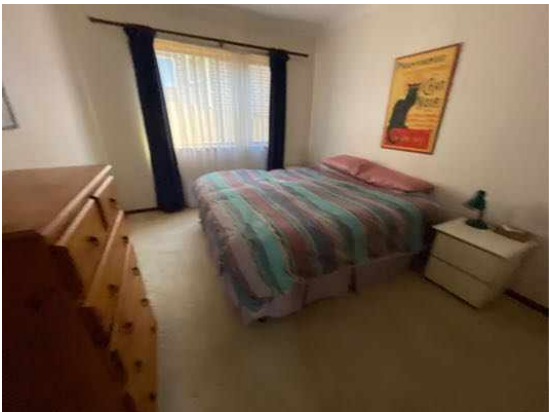
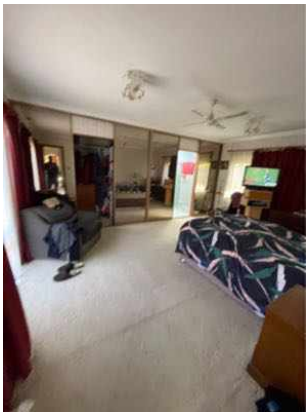
Information: These photographs are an indication of the obstructions and limitations which impeded full inspection of the property at the time of inspection. These obstructions can hide an array of defects and should be removed to allow full inspection to be

carried out. A re-inspection is recommended once the areas are made accessible.
