Building Inspection Report

Inspection Date: Thu, 6 Oct 2022

Property Address: 7 Trigalana Pl, Frenchs Forest NSW 2086,
Australia

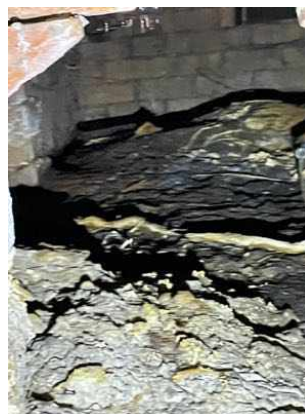
Defects 1.01

Building:	Building 1
Location:	Subfloor
Finding:	Visual mould inspection
Information:	A visual mould inspection of the property was conducted and identified areas of suspected mould and deterioration. Mould is a visible fungal growth, but may also be evidenced by a musty smell in the immediate area.

Mould, which poses a significant respiratory hazard, generally forms and develops as a result of dark and damp conditions over a prolonged period of time. These conditions,

While mould and dampness are present, the area is considered a health and safety hazard. Tenants with respiratory health conditions are advised to exercise great caution and care whilst in the area.

The first action should be to identify the cause of the mould in this area. Replacement of the affected carpet is required as a matter of urgency to ensure the safety of the area. Where required, remedial works should be undertaken to any associated walls and flooring showing evidence of mould.

Where mould is excessive, further inspection by an Environmental Health inspector is advisable.

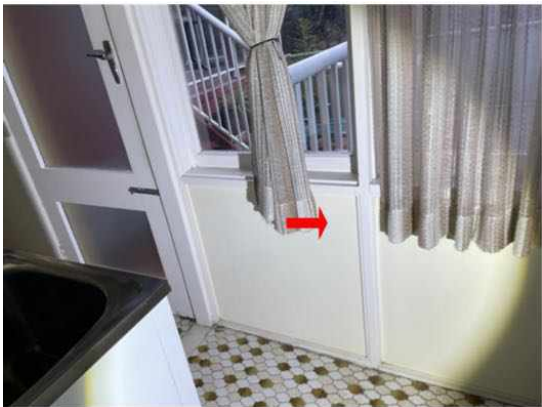
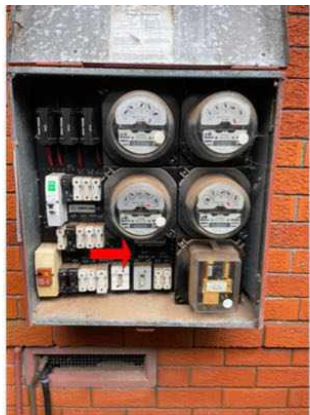
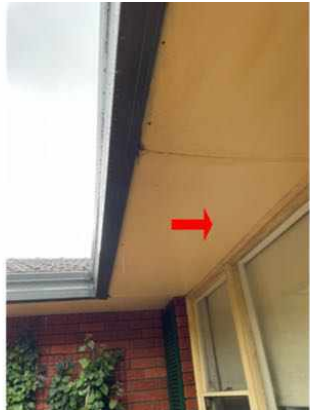
Defects 1.02

Building:	Building 1
Location:	All Areas
Finding:	Asbestos - Suspected ACM Identified on Site
Information:	Reporting on Asbestos is outside the Scope of this Report. This suspected defect is highlighted as a caution only. We suspect, based on our experience in the building industry, that there is a higher risk of the identified building element containing asbestos.

As Asbestos Reporting is outside the scope of this report, we advise that you consider a separate Asbestos Inspection and Condition Audit, which can include the taking of samples for definitive confirmation of the presence of Asbestos.

In the interim, the client is advised to act with caution, especially when considering any damage to building materials general wear and tear renovations extensions demolition and general maintenance activities due to the suspected presence of Asbestos.

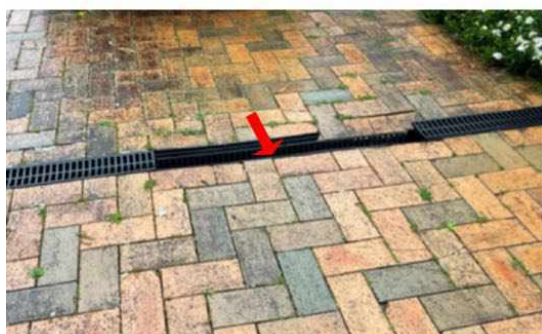
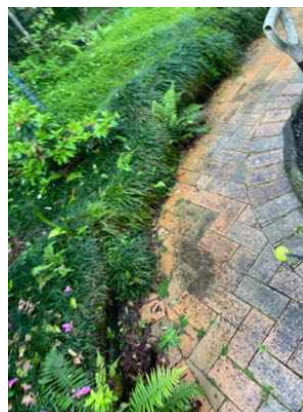
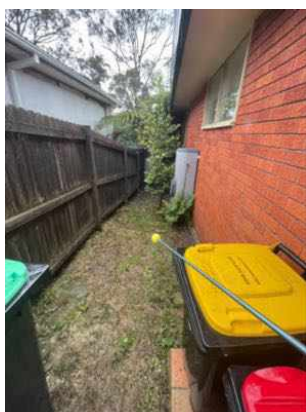
Defects 3.01

Building:	Building 1
Location:	All External Areas
Finding:	Site drainage - suspected Inadequate
Information:	The site drainage in this area was found to be suspected inadequate at the time of inspection, creating potential for subsequent water damage to associated building elements.

It is important that water does not lie against the base of walls; surrounding paths and ground levels should be sloped to drain water away from walls. Downpipes should not disgorge stormwater onto lower walls or plinths. Stormwater should be carried away by large, regularly cleaned drains. Ground levels may need to be lowered to expose a buried DPC.

Where site drainage is inadequate, installation of an Agricultural (Aggie) Drain may be required. A qualified plumber should be appointed to further inspect the property and perform any remedial works as necessary. Water damage and secondary defects are likely to occur if left unmanaged.

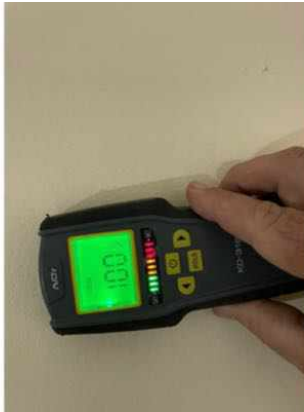
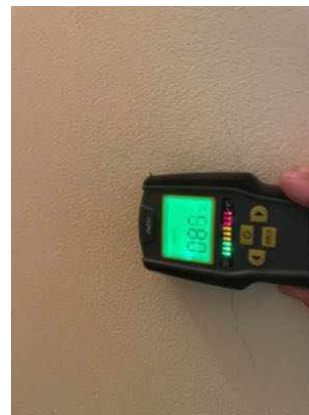
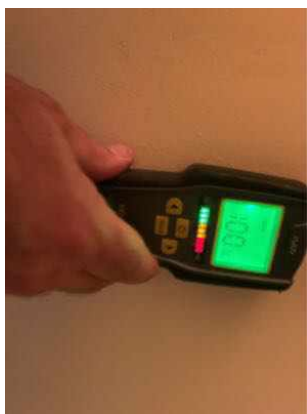
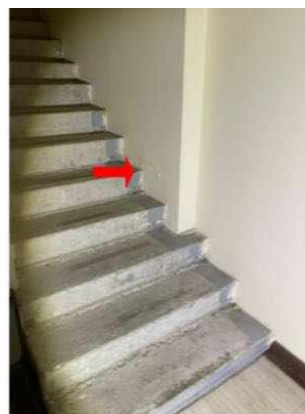
Defects 3.02

Building:	Building 1
Location:	Basement
Finding:	Evidence of excessive moisture was present at the time of inspection
Information:	Excessive moisture can attract termites and produce conditions that promote termite attack fungal growth and wood decay.

Excessive moisture is generally caused by deteriorated inadequate or missing roof drainage leaking plumbing pipes or fixtures poorly plumbed HWS overflows or condenser units and poor site drainage.

It is highly recommended that all plumbing and drainage fixtures and fittings be

maintained regularly in order to prevent excessive moisture being present in the external / internal property.

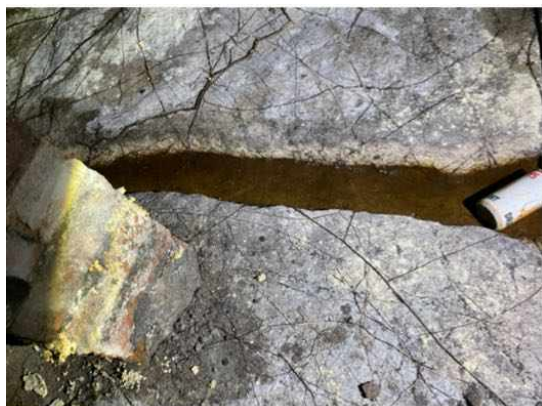
Defects 3.04

Building: Building 1
 Location: Subfloor
 Finding: Water pooling - subfloor
 Information: Water appears to be pooling in the subfloor. It is suspected that this is a result of poor site drainage but may also be due to excessive moisture from an unidentified source.

Where water is pooling in the subfloor water damage to the external wall cladding is imminent.

Such water pooling also increases the risk of termite activity and the development of fungal decay in the area.

Consult a Plumber regarding the cost of potential site drainage rectification works.

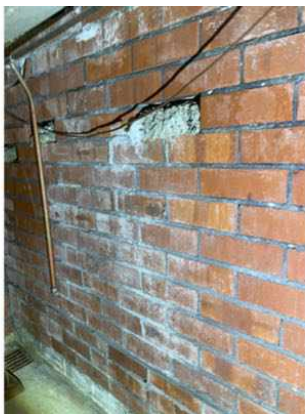
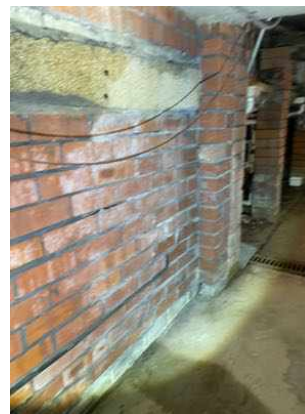
Defects 3.07

It is typically seen as white salt deposits on the surfaces of concrete pavement or mortar between bricks or tiles. While detracting from the overall appearance of the affected area, efflorescence is not likely to develop into secondary damage if left unmanaged.

Generally, soluble salt deposits can be removed by dry brushing with a stiff-bristled brush. Repeated dry brushing is an ideal treatment for eliminating this forming of efflorescence. A cleaning contractor or general handyperson may be appointed to perform these works at the discretion of the client.

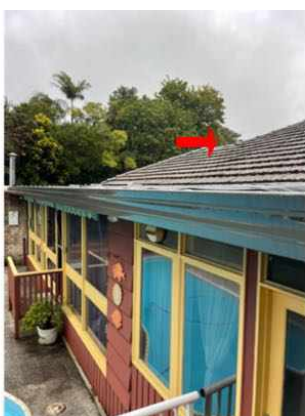
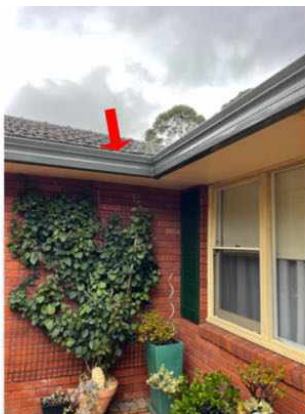
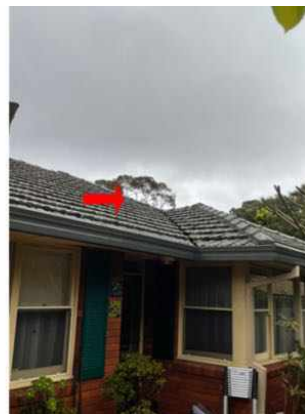
Defects 3.08

Building:	Building 1
Location:	Roof Exterior
Finding:	Roof tiles - Weathered
Information:	Upon inspection of the exterior roofing, the majority of roof tiles were considered to be in a fair condition. While weathering of the tiles is consistent with the age of the property, maintenance works are required.

Where left unmanaged, deteriorating roof tiles are likely to lead to a number of secondary defects, including minor water leaks and weather exposure to internal roofing structures.

Consultation with a roofing contractor is advised to gain advice on cost of remedial works that may be required in the short to medium term. Remedial works are likely to increase the longevity of the exterior roofing structure.

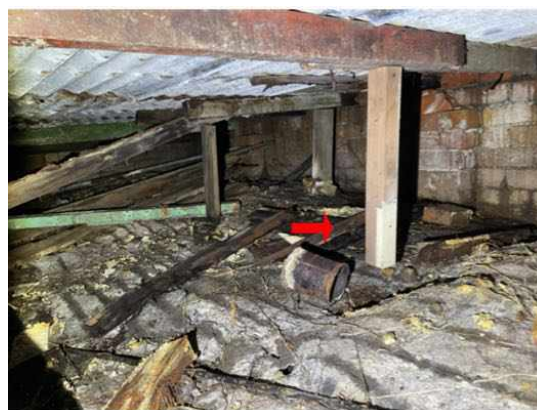
Defects 3.11

Building:	Building 1
Location:	Subfloor
Finding:	Formwork timber and corrugated iron - removal
Information:	Sometime formwork material is not removed during construction which increases the risk of termite activity, wood rot and corrosion being present.

It is recommended that formwork to be removed from these areas.

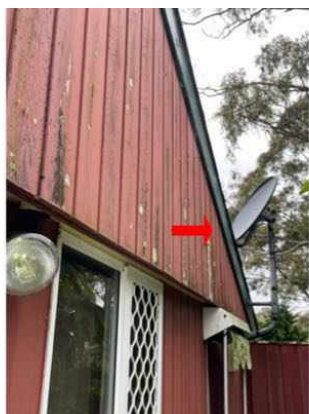
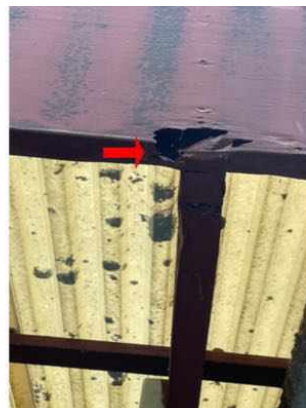
Defects 3.12

Building:	Building 1
Location:	All External Areas
Finding:	External painting deteriorated
Information:	Much of the external paintwork including but not limited to windows, fascias, guttering, veranda and other external fitments have been neglected and require attention to prepare and re-paint.

Whilst incomplete or missing paint finish is generally an appearance defect, it can also lead to the development of secondary building defects over time. Incomplete areas of paint finish expose the area to moisture, potentially accelerating the deterioration of underlying building materials.

Degraded paint finishes should be sanded back, filled, leveled and painted, as applicable. Where inadequate or missing paint protection has led to the deterioration of the associated building element, repair and/or replacement of this building element may be required.

A painting contractor should be appointed as soon as possible to perform necessary works to aid the appearance of the affected area and to ensure the area is protected against further deterioration. Alternatively, the homeowner following manufacturer instructions may perform these works.

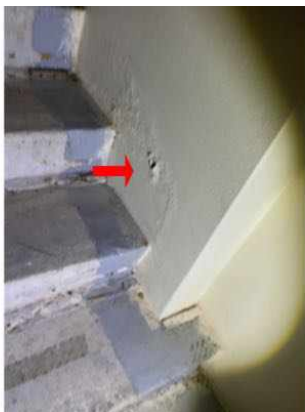
Defects 3.13

Building:	Building 1
Location:	All Internal Areas > Basement
Finding:	Painted surface - Bubbling
Information:	Sections of paint in this area was found to have bubbled and deteriorated. Paint bubbling is generally an indication of excessive moisture in the area, that is currently hidden by the painted surface.

The presence of excessive moisture can have major implications on associated building elements if left unattended. While only seemingly minor at this stage, the damage cannot be determined due to the paint obstructing any further inspection of

the damage.

It is highly advised that the affected paint be cleaned to allow a further, more invasive inspection by a licensed plumber. Failure to act on this defect may necessitate major works in the future.

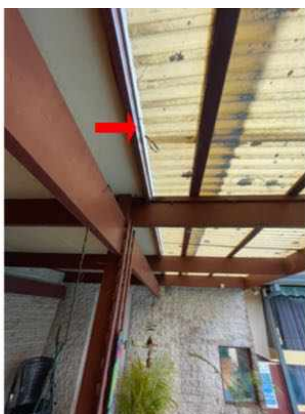
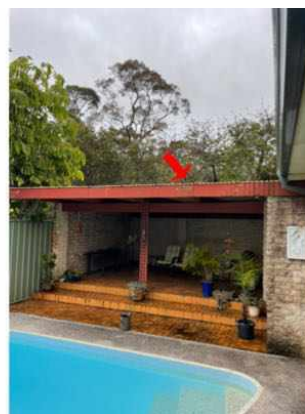
Defects 3.14

Building:	Building 1
Location:	Yard - Back
Finding:	Roof plumbing - Flashing inadequate
Information:	Some sections of the roof are missing or have inadequate roof flashings. Flashings are metal and other materials which are applied to seals and intersections between roof coverings and building elements. They are designed to aid in weatherproofing of roof joins.

Flashings that are not installed adequately or are missing are likely to result in water penetration to the interior of the property, as well as creating excessively damp conditions against the exterior surfaces and around the base perimeter of the building.

Premature ageing and secondary building defects are imminent where roof plumbing is missing or inadequately installed. Additionally, water pooling also creates an environment that is susceptible to termite and pest infestation.

A roofing plumber should be appointed as soon as possible to install relevant roof plumbing materials, ensuring that no further damage is sustained.

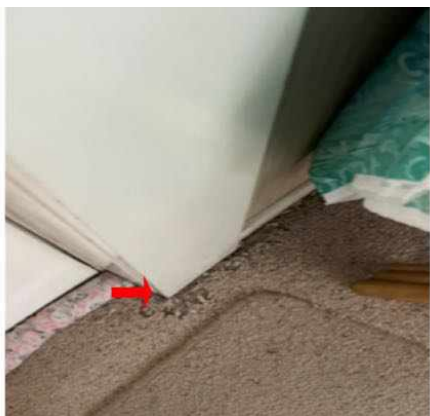
Defects 3.16

Building: Building 1
 Location: All Areas
 Finding: Carpet - Deteriorated
 Information: Sections of the carpet floor covering in this area appeared to be deteriorated .

Replacement of the affected carpet is required.

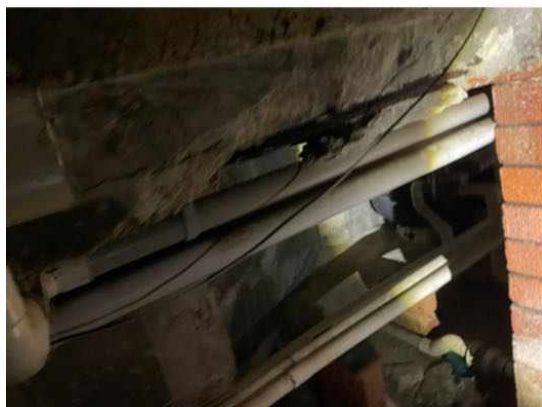
Defects 3.17

Building: Building 1
 Location: Subfloor
 Finding: Concrete - Cancer
 Information: Concrete cancer is the common term used to describe a number of factors which cause concrete construction to deteriorate. Generally, water penetration causes the concrete reinforcement to rust and expand, creating stresses on the surrounding concrete and in turn causing it to spall (or break away). Alternatively, if the cement component is too alkaline, reactions with the general atmosphere occurs and star-shaped cracks appear which allow rainwater to penetrate. Concrete cancer may also originate from poor original water proofing.

In some instances, repairs are possible; however, repair works will generally involve extensive works, including removal of affected concrete and the treatment or replacement of any exposed steel. Some injection of resins or special mortars may also be possible, however this depends on the size and extent of consequent damage.

Ultimately, the cause of the concrete cancer (e.g. poor water proofing) must also be addressed, otherwise the problem is likely to recur. Treatment of concrete cancer can be expensive and, left unmanaged, the problem is likely to worsen over time, potentially leading to the development of major structural defects or safety hazards.

The client is advised to exercise caution and to prepare for the potential cost of remedial and / or replacement works. A structural engineer should be appointed to provide estimates on the required works.

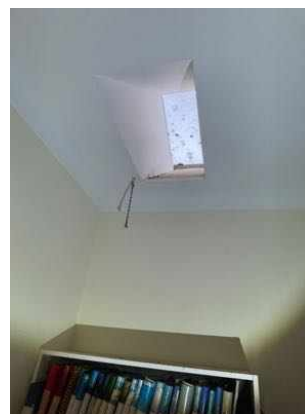
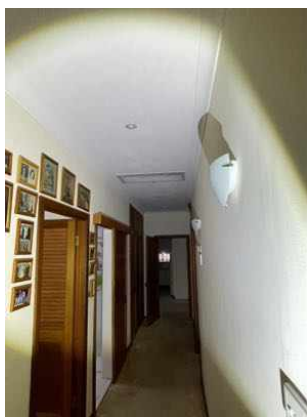
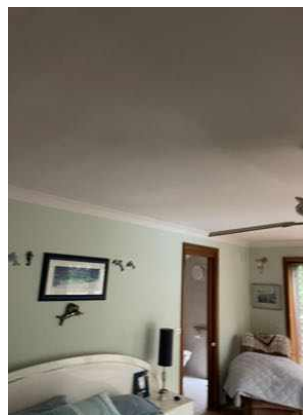
Defects 3.18

Finding: painting deteriorated

Information: Whilst incomplete or missing paint finish is generally an appearance defect, it can also lead to the development of secondary building defects over time. Incomplete areas of paint finish exposes the area to moisture, potentially accelerating the deterioration of underlying building materials.

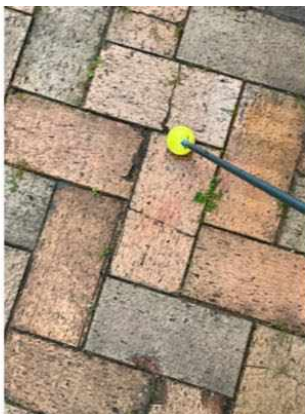
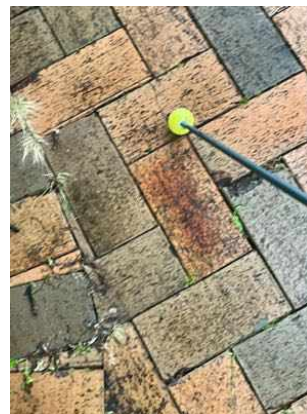
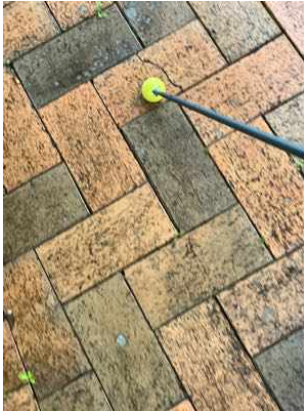
Defects 3.20

Building:	Building 1
Location:	All External Areas
Finding:	Cracked pavers
Information:	Cracking in the pavers was evident in this area at the time of inspection. It is suspected that this cracking has occurred as a result of minor settlement .

Cracked pavers detract from the overall appearance of the affected areas however it is unlikely to create or lead to any secondary defects.

While not considered a matter of urgency, replacement of pavers is recommended at the clients discretion.

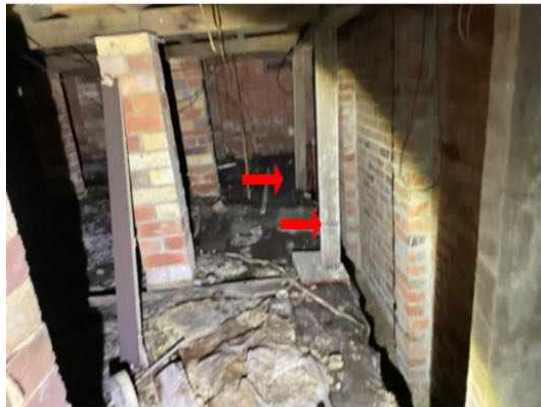
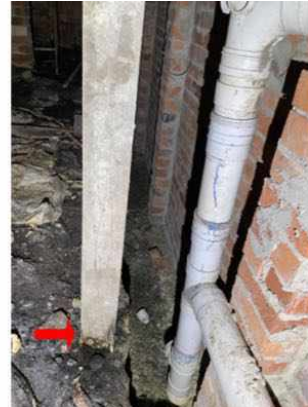
Defects 3.21

Building:	Building 1
Location:	Subfloor
Finding:	Timber supports need to be made permanent
Information:	These Timbers are suspected to be failing in their structural purpose, which is likely to lead to a range of major and minor defects. Further (potentially major) damage to the stumps and structure may be imminent if left unattended.

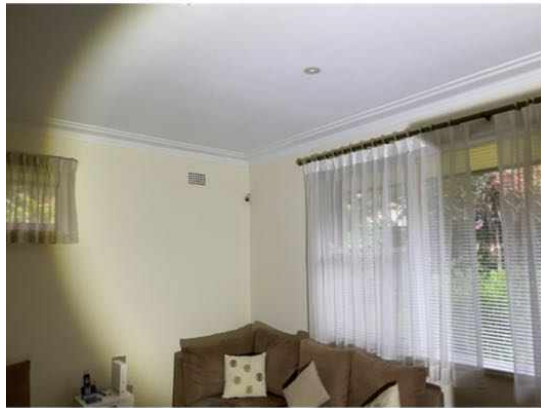
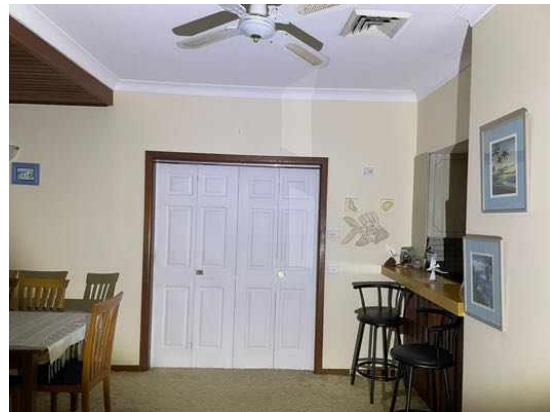
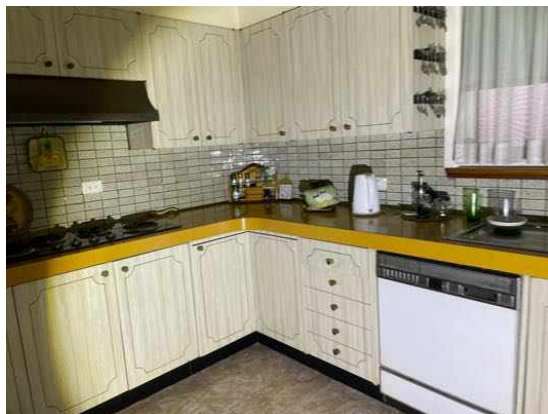
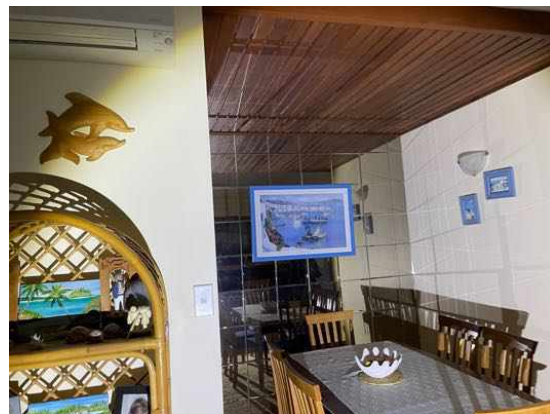
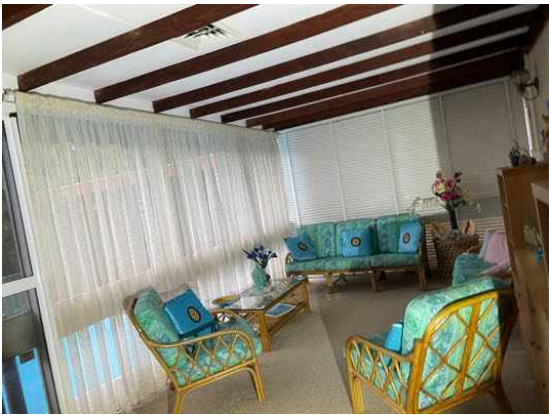
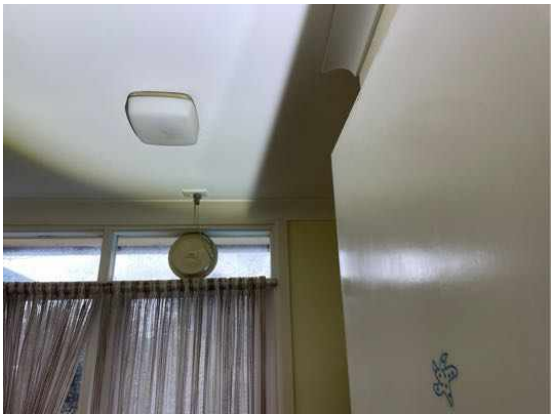
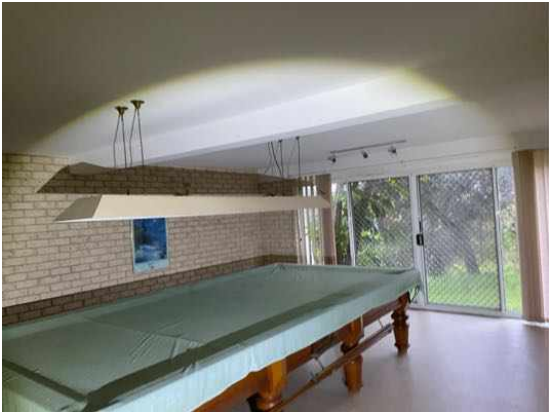
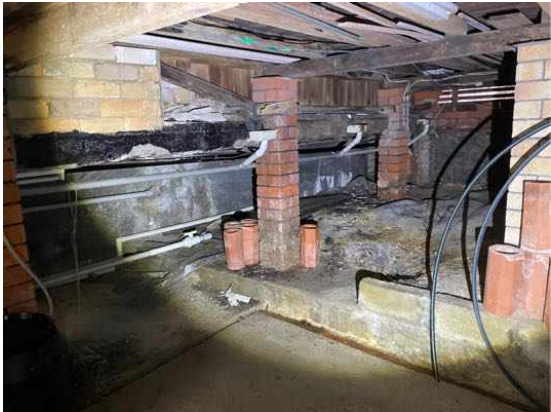
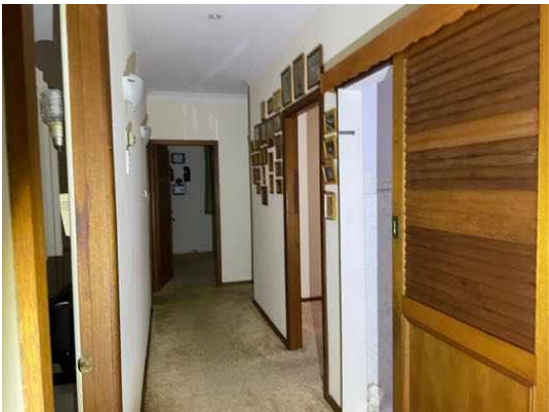
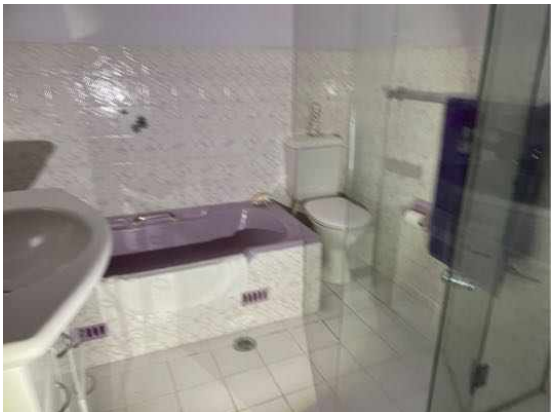
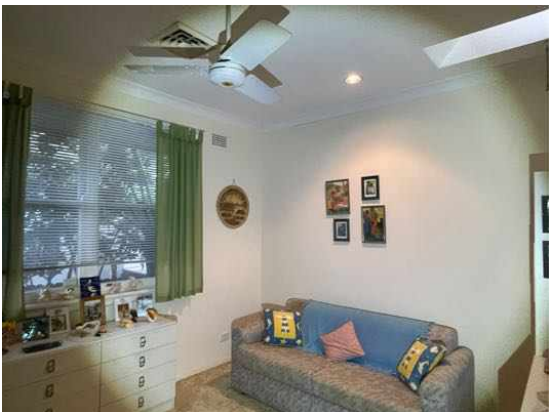
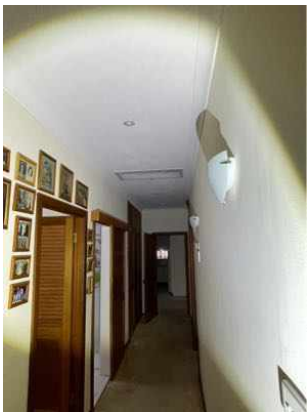
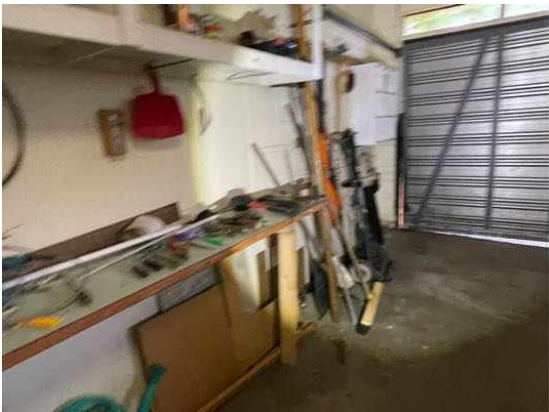
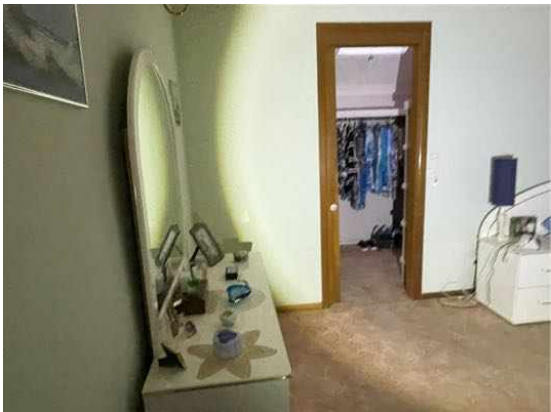
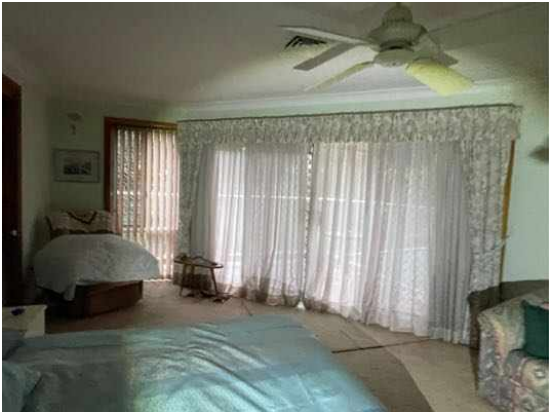
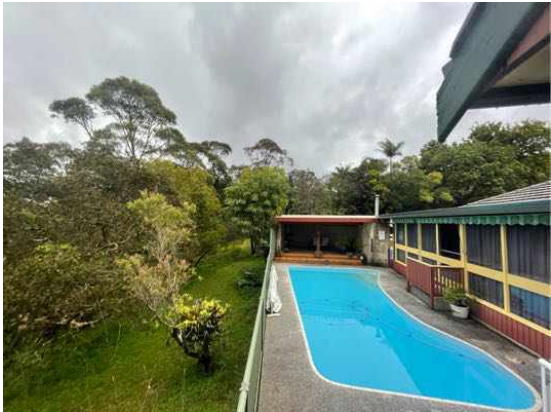
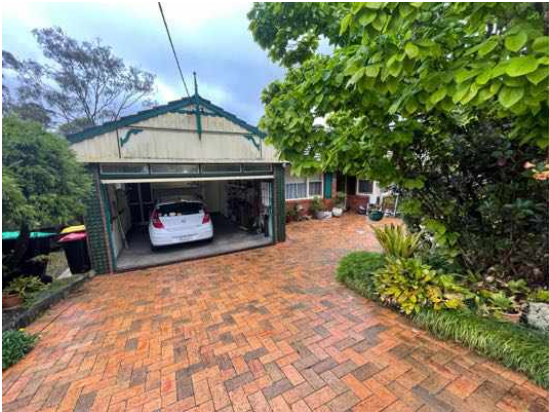
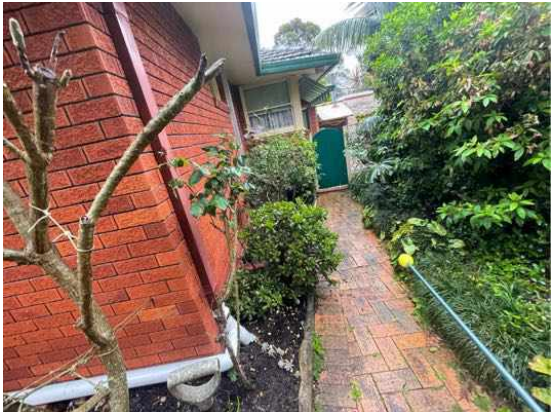
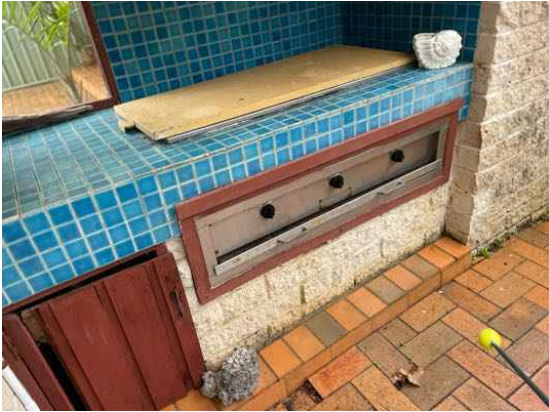
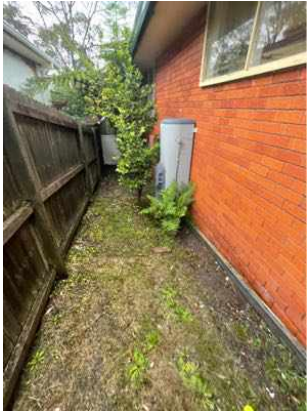
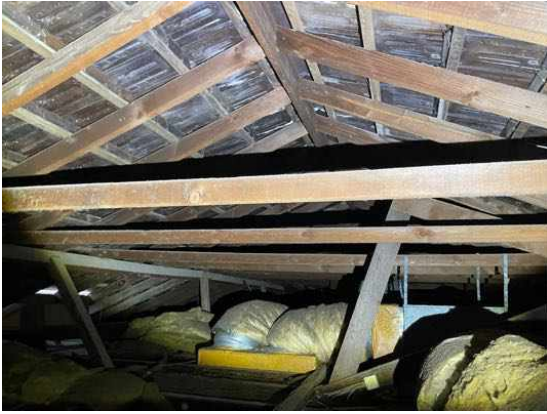
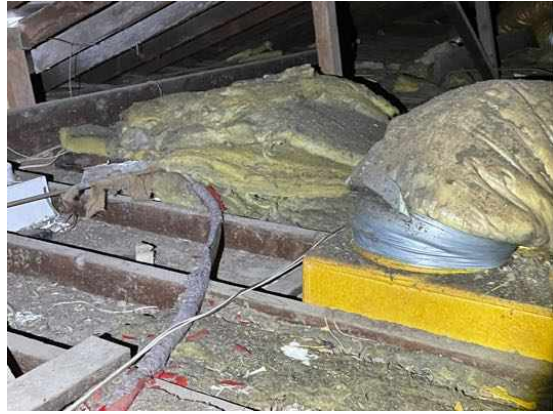
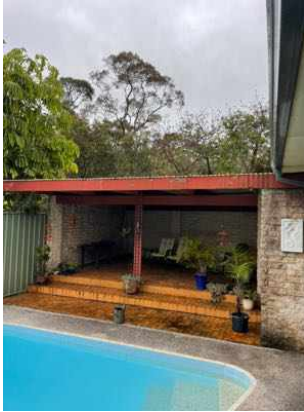
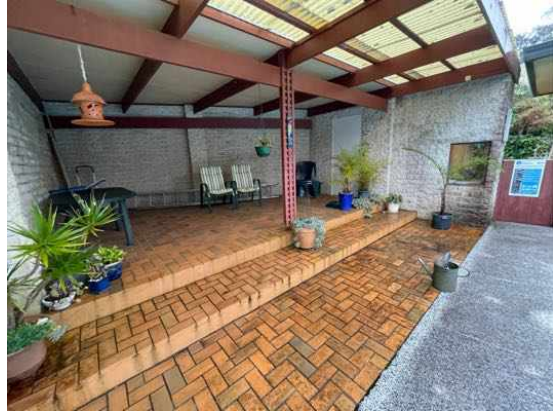
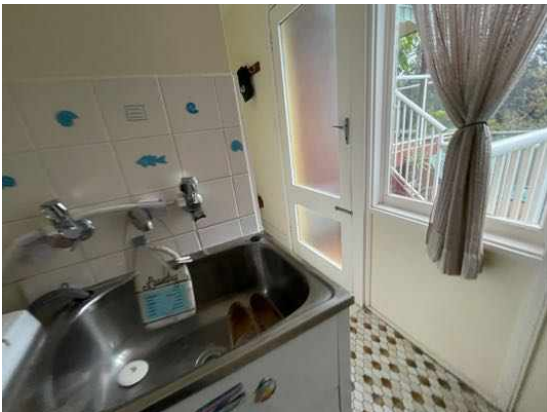
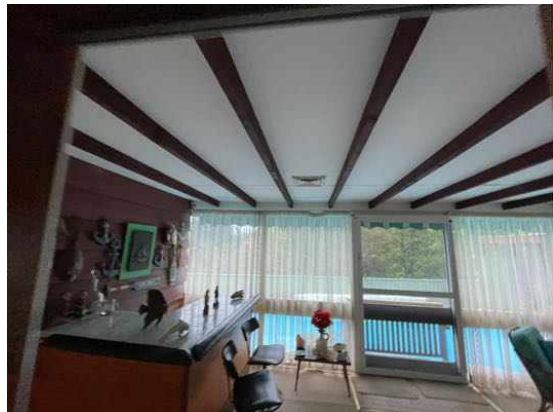
Building: Building 1
 Location: All Areas
 Finding: Additional Photos - Obstructions and Limitations
 Information: These photographs are an indication of the obstructions and limitations which impeded full inspection of the property at the time of inspection. These obstructions can hide an array of defects and should be removed to allow full inspection to be carried out.

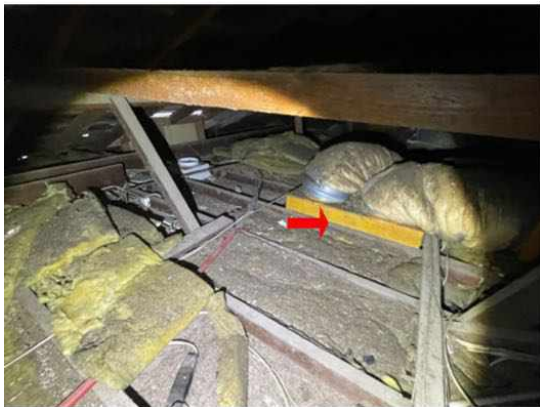
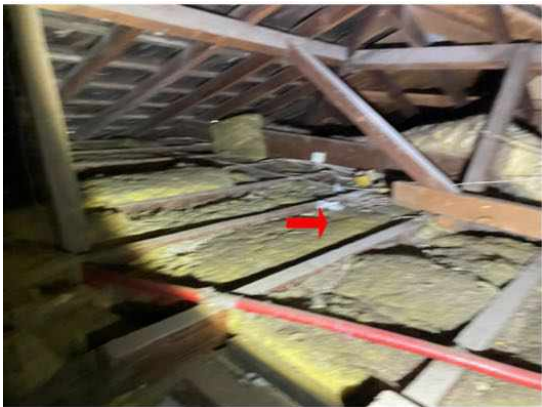
Building:	Building 1
Location:	Roof Void
Finding:	Insulation- installed
Information:	Insulation is under the roof sheeting. Insulation acts as an insulator that helps with heat reduction.

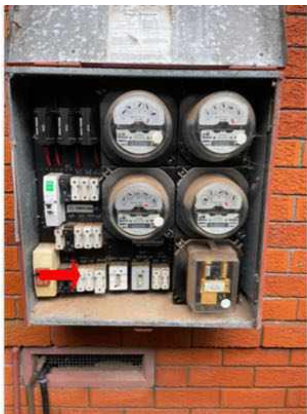
Building: Building 1
Location: Yard - Side
Finding: Electrical switchboard - Old ceramic fuses
Information: The electrical switchboard while appearing to have adequate safety switches installed has old ceramic fuses in place.

While this on its own on is not considered a defect it is noted for the clients consideration that a switchboard upgrade may be required in the short to mid term to improve the functionality of the electrical system. A licensed electrician could be appointed to provide quotation for the works at the client's discretion which may in turn expose other required works to bring the system up to a compliant state.

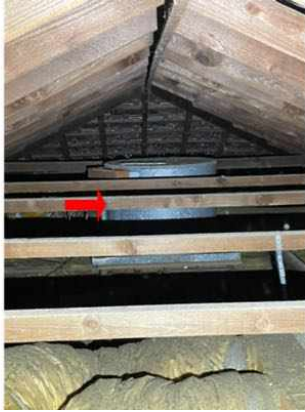
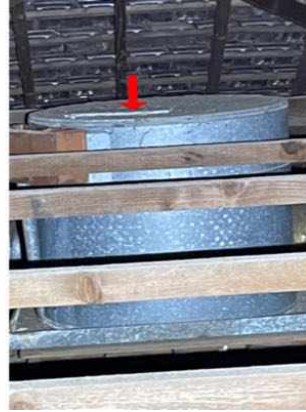
Building: Building 1
Location: Roof Void
Finding: Gravity-Fed HWS - Disconnected
Information: It was noted at the time of inspection that a disconnected gravity-fed hot water system (HWS) remains in this area.

and is therefore susceptible to rust and corrosion. If allowed to continue, rust and corrosion is likely to lead to damage to adjoining building elements, and may also make the area susceptible to termite or timber pest activity.

While it is a costly exercise to remove the disused gravity-fed HWS, it is advisable in the short-term future to prevent any further damage to the area. Further consultation with a licensed plumber is required to gain further advice on removal of the structure.
