# Timber Pest Inspection Report

Inspection Date: Tue, 01 Oct 2019

Property Address: 94 Bantry Bay Road, Frenchs Forest NSW, Australia

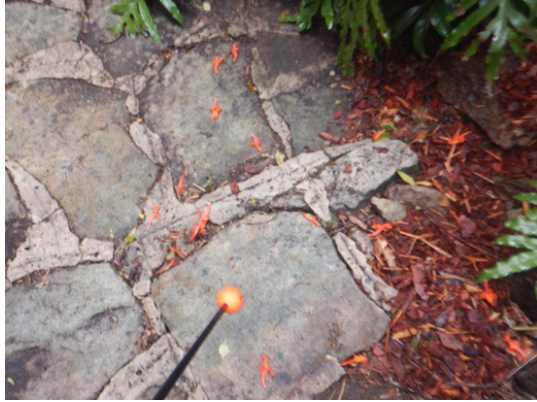
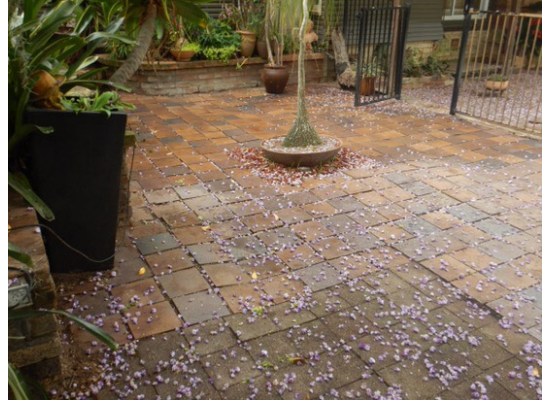
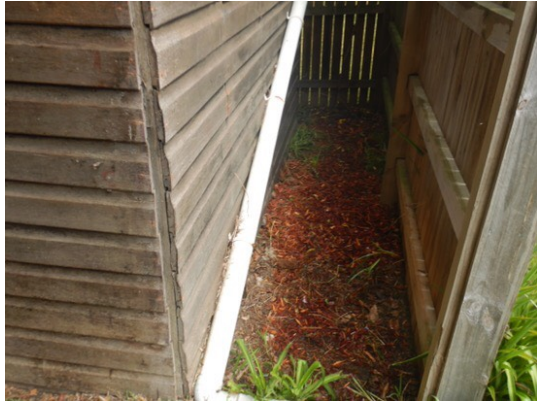
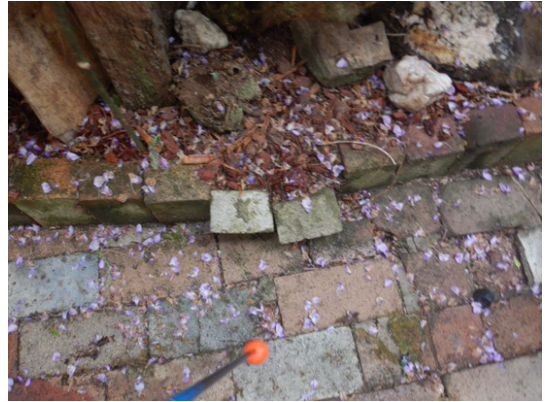
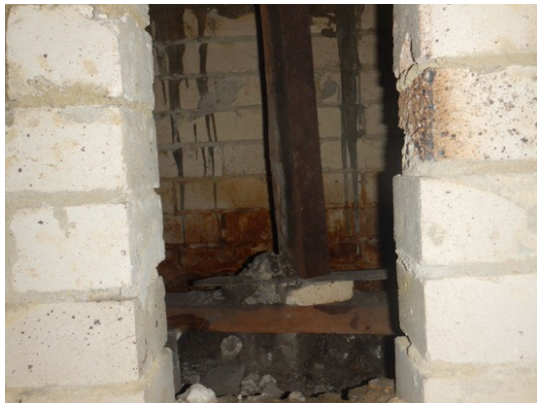
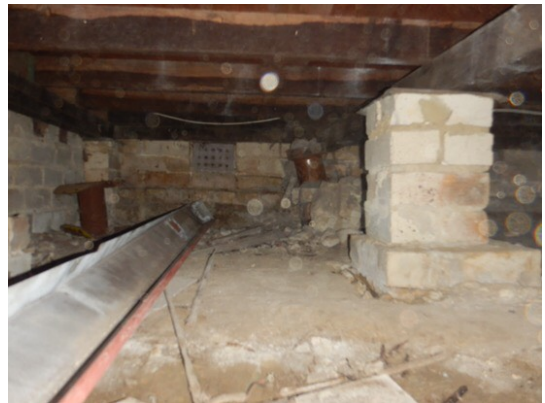
Building: Main Building  
Location: All Areas  
Finding: Evidence of excessive moisture was present at the time of inspection  
Information: Excessive moisture can attract termites and produce conditions that promote termite attack fungal growth and wood decay.

Excessive moisture is generally caused by deteriorated inadequate or missing roof drainage leaking plumbing pipes or fixtures poorly plumbed HWS overflows or condenser units and poor site drainage.

It is highly recommended that all plumbing and drainage fixtures and fittings be maintained regularly in order to prevent excessive moisture being present in the external / internal property.

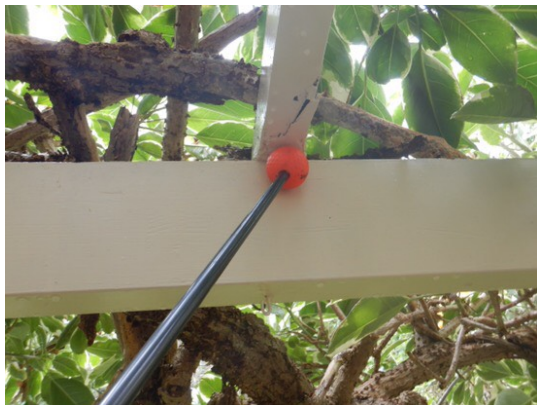
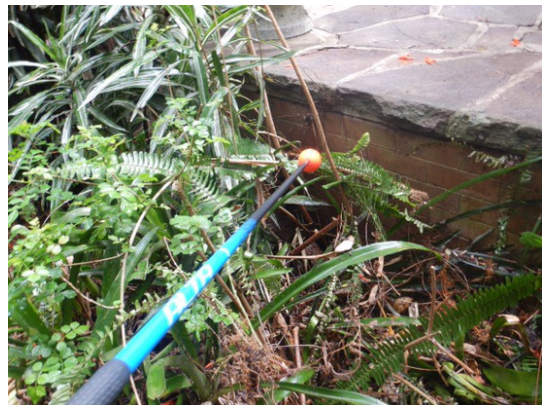
Finding: Additional Photos - Obstructions and Limitations

Information: These photographs are an indication of the obstructions and limitations which impeded full inspection of the property at the time of inspection.

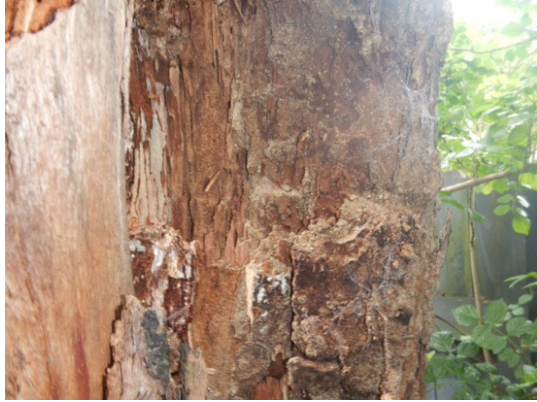
Information: Past activity was found in tree stump located front left hand side of house. It is highly recommended regular inspections to be done by a pest controller or for the stump to be removed.
