Building and Timber Pest Inspection Report

Inspection Date: Tue, 15 Apr 2025

Property Address: 288 Bungarribee Rd, Blacktown NSW 2148,
Australia

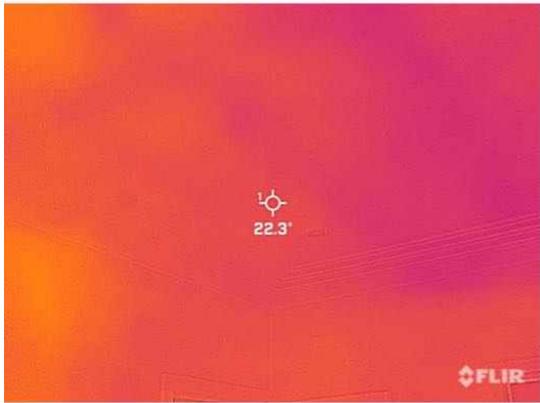
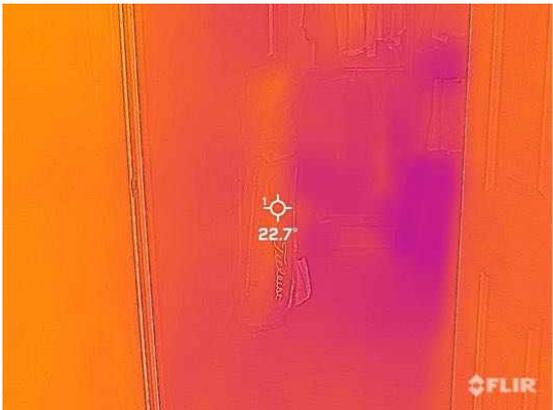
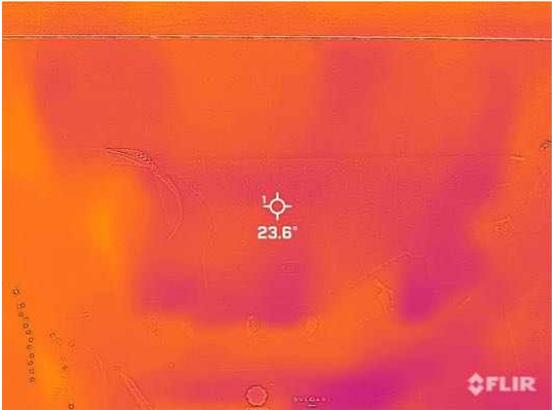
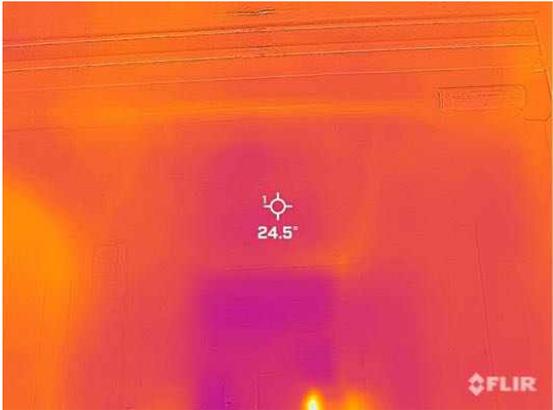
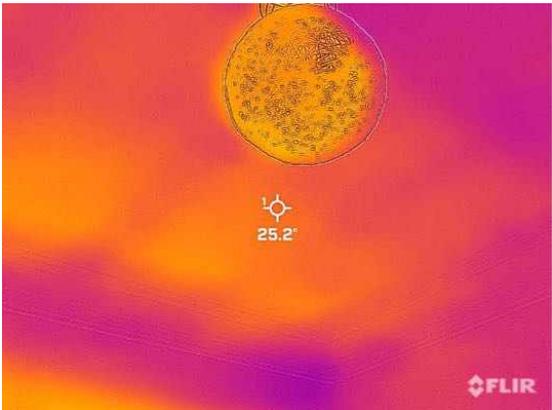
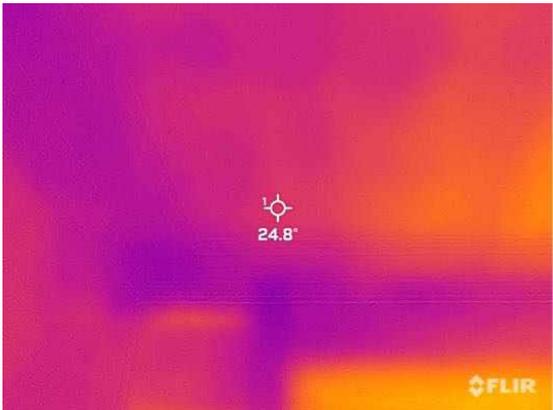
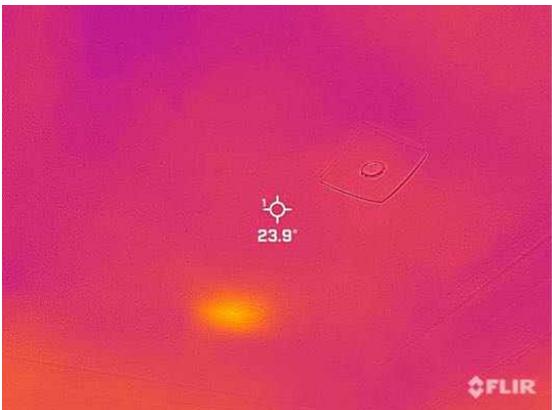
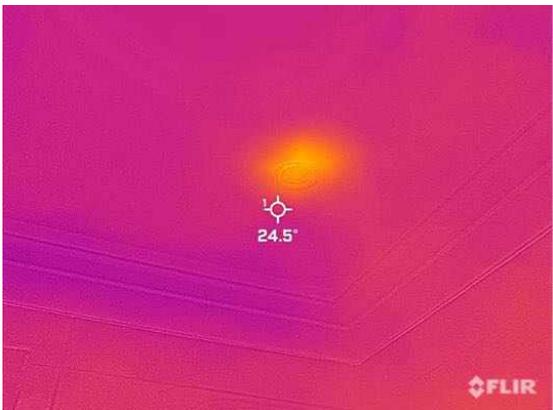
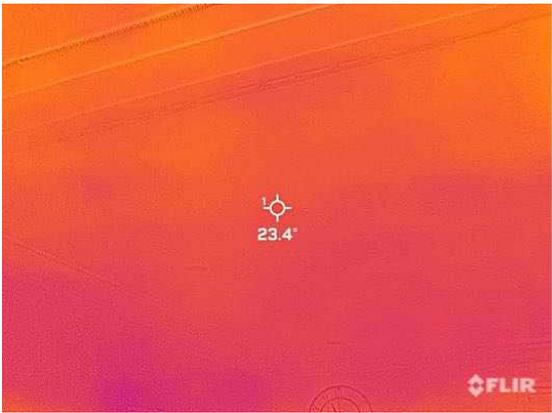
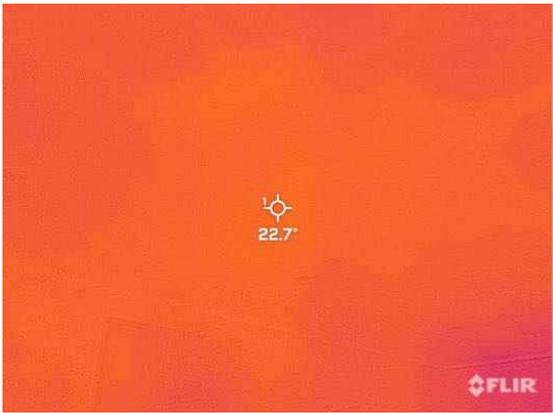
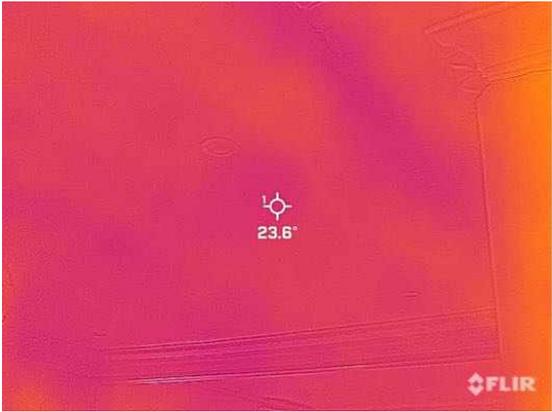
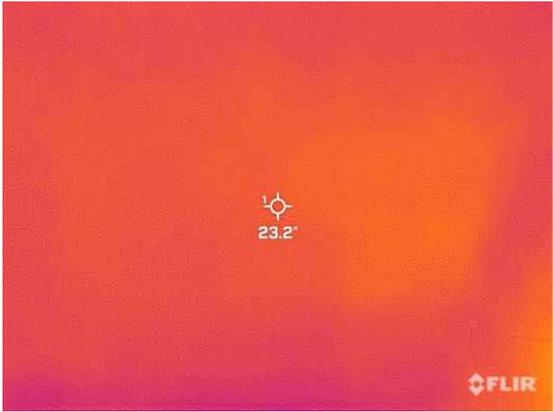
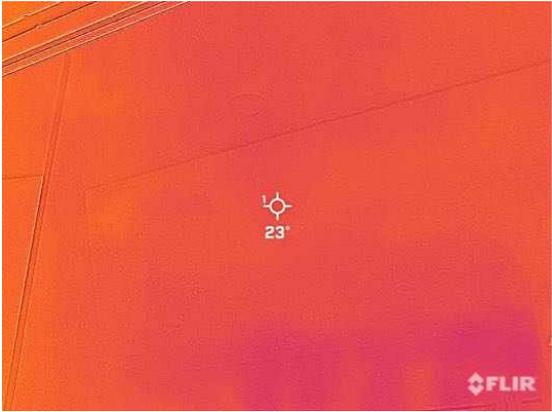
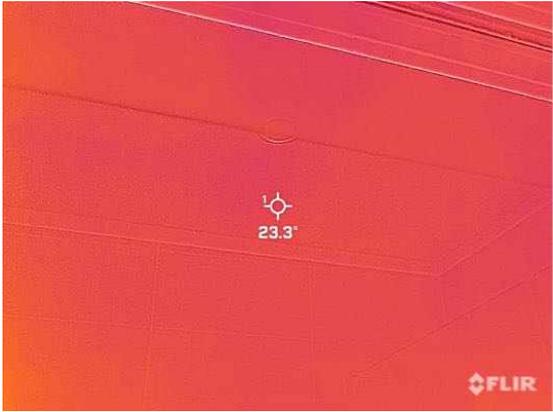
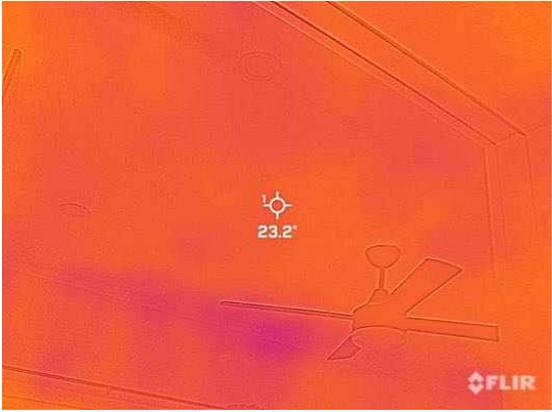
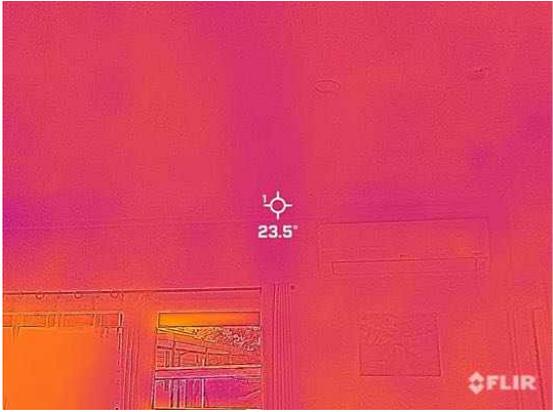
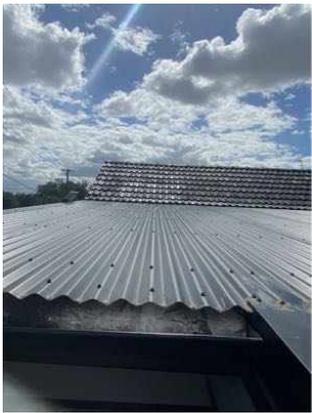
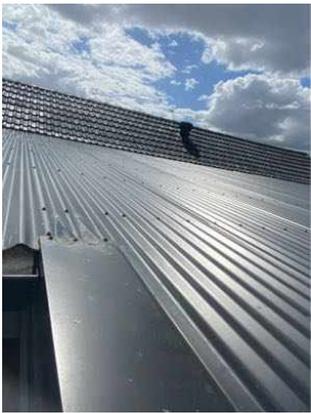
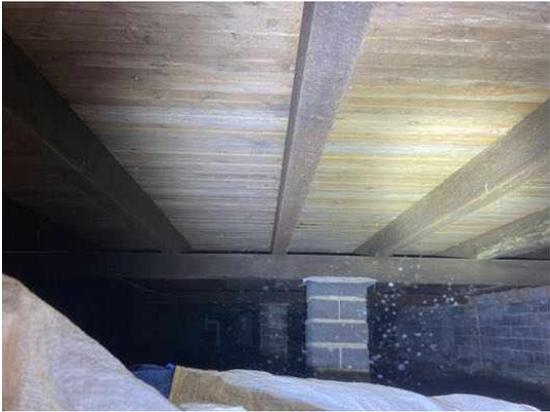
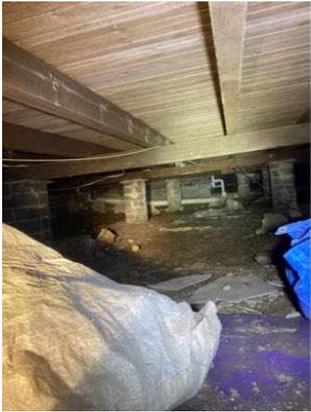
Building: Main Building
Location: All Areas
Finding: Additional Photos
Information: Thermal imaging camera was used to detect any active water leaks or/ and termite activities in the property. No water leaks or termite activities were found from inspection by thermal imaging camera. Additional photos are attached for general reference.
