## Building Inspection Report

Inspection Date: Sat, 11 Jul 2020

Property Address: 56 Epping Dr, Frenchs Forest NSW 2086, Australia

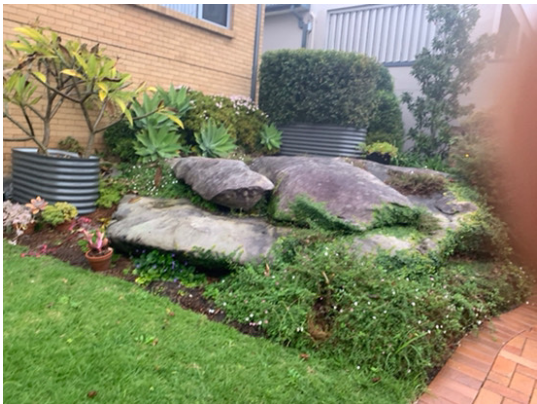
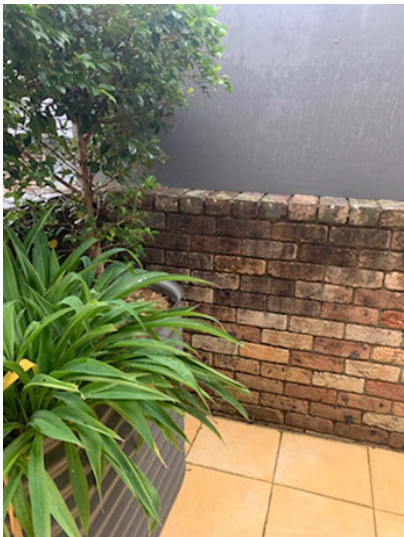
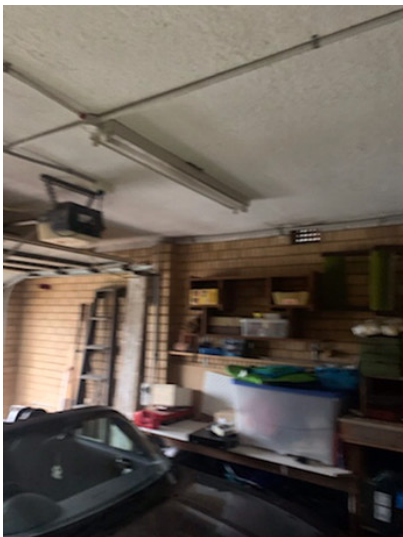
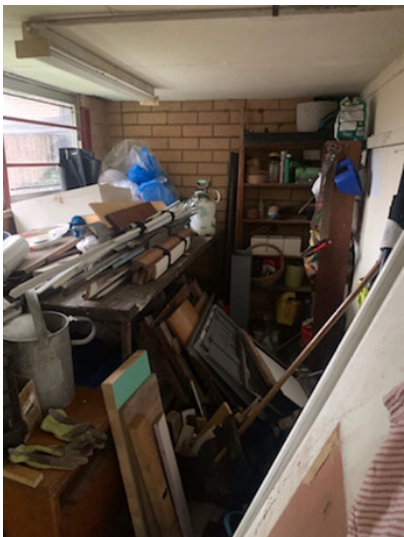
These photographs are an indication of the obstructions and limitations which impeded full inspection of the property at the time of inspection.
