**ACCURATE PROPERTY INSPECTIONS
BUILDING INSPECTION REPORT**

Domestic, two storey, brick veneer and weatherboard, brick piers, timber floors with concrete areas and a tiled roof.

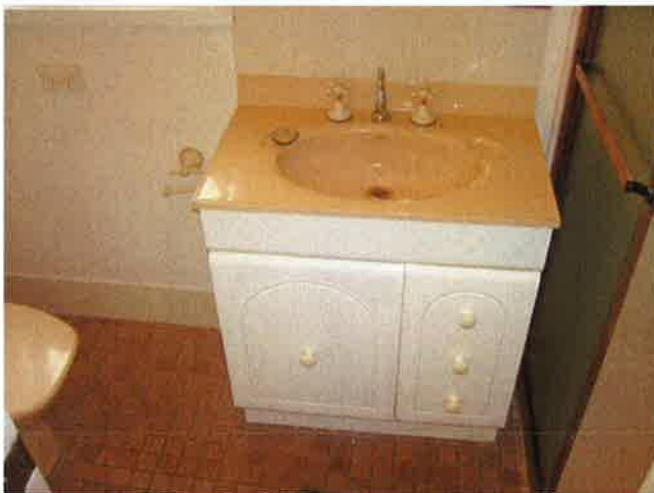
Ensuite

Condition: The ensuite is in average condition for its age and type.

Maintain the waterproof flexible sealant to the perimeter of the shower to help prevent possible water leakage.

Shower leaks can occur at anytime and may not be able to be detected during a visual inspection, especially if the shower has not been used for sometime. Monitor the shower recess regularly for any signs of leaks. If leaks occur, the shower recess will need to be waterproofed and maintained.

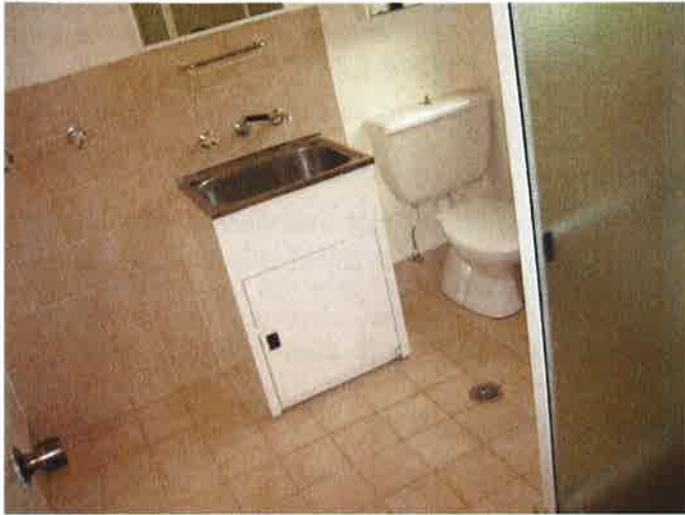
Bathroom/Laundry

Condition: The bathroom/laundry is in average condition for its age and type.

Maintain the waterproof flexible sealant to the perimeter of the shower, wash basin and laundry cabinet to help prevent possible water leakage.

Shower leaks can occur at anytime and may not be able to be detected during a visual inspection, especially if the shower has not been used for sometime. Monitor the shower recess regularly for any signs of leaks. If leaks occur, the shower recess will need to be waterproofed and maintained.
