Property Inspection Report

32 Greygum Avenue, Rouse Hill, NSW 2155
Inspection prepared for: Wen Yuan Rui
Real Estate Agent: Mandeep Singh - Urban Land Housing - Box Hill

Date of Inspection: 15/8/2023 Time: 10:00AM
Weather: Sunny, 13C

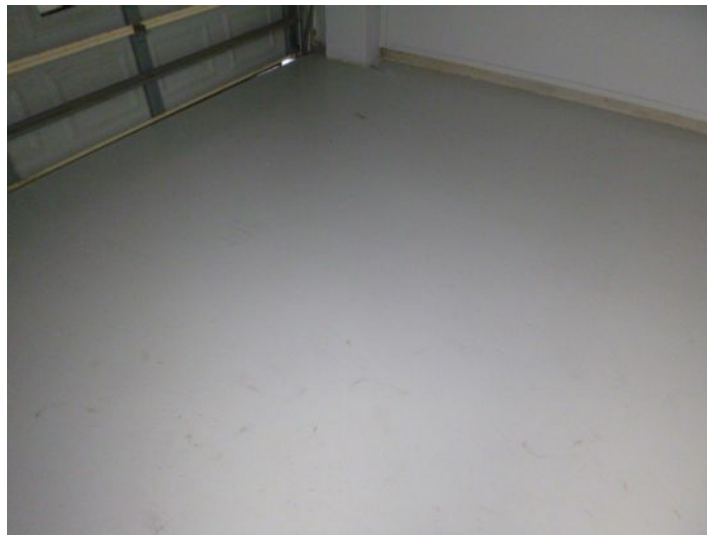
1. Slab Foundation

- Visible sections of the concrete slab appeared satisfactory.
- Most areas of the concrete slab not visible due to floor coverings.
- All concrete floor slabs experience some degree of cracking due to shrinkage in the drying process. In most instances floor coverings prevent recognition of cracks or settlement in all but the most severe cases. Where carpeting and other floor coverings are installed, the materials and condition of the flooring underneath cannot be determined.

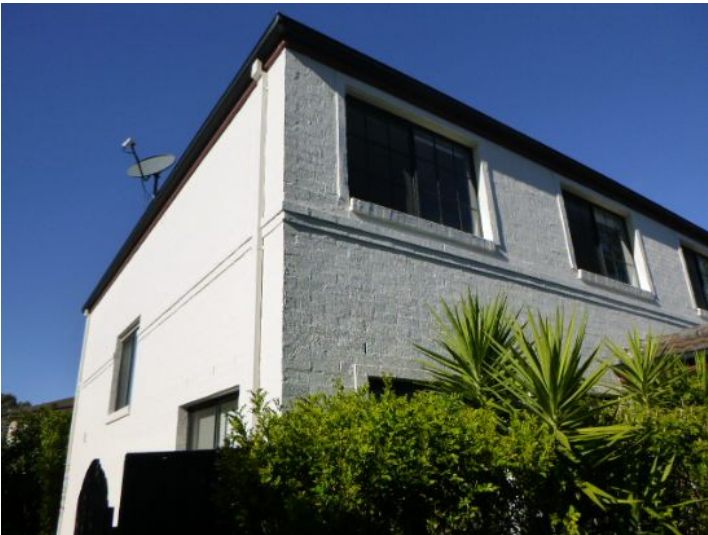
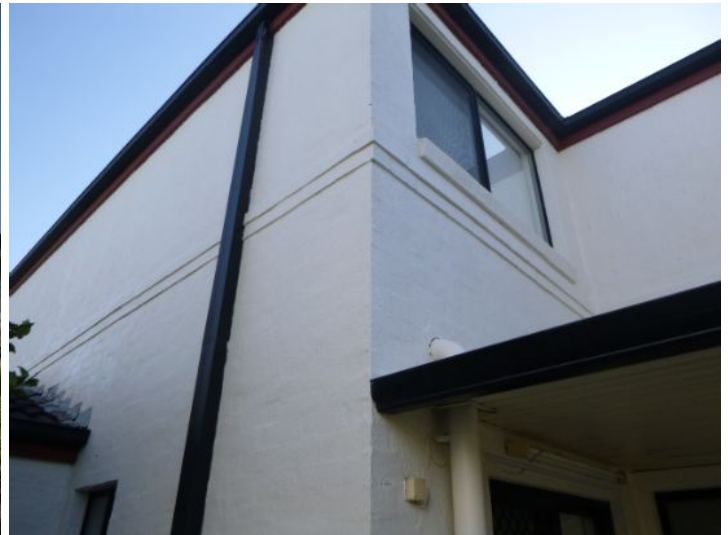
1. Wall Structure

- The wall structure components appeared functional where visible.
- External walls are of a brick veneer construction.

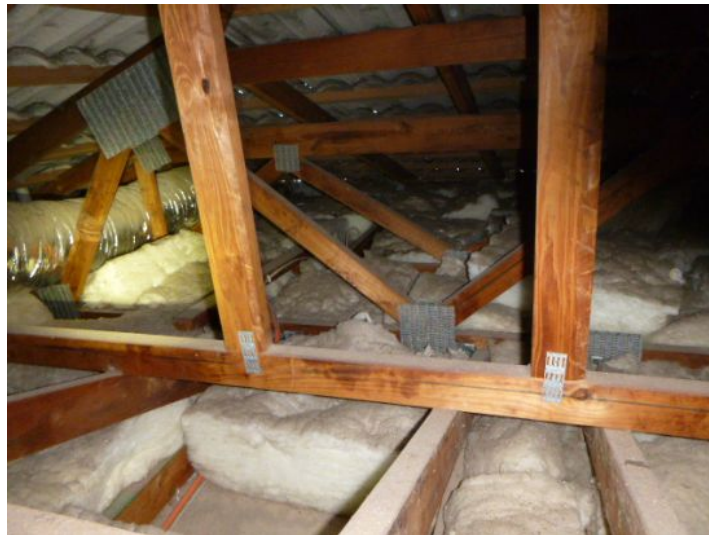
2. Ceiling Structure

- The ceiling structure appeared functional where visible.
- Due to the placement of insulation on the top of the ceilings it is not possible to fully inspect the condition of the ceiling structure and supports. Inspection was limited and based on what was visually accessible at the time of the inspection.

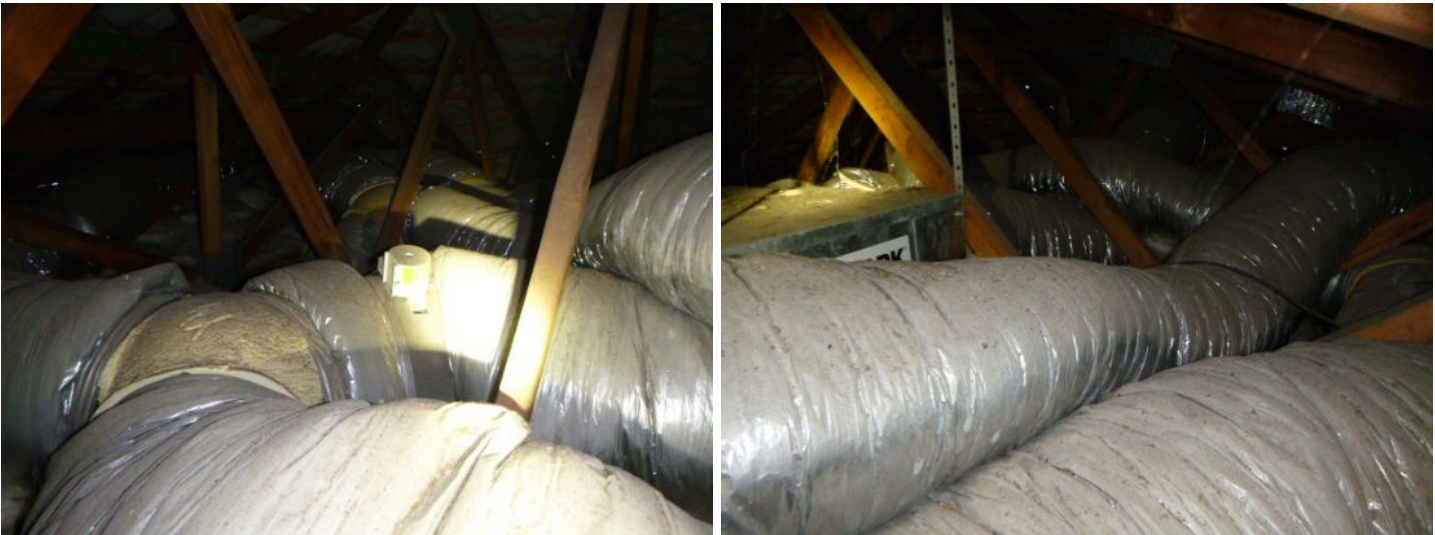
2. Duct Work

- Where visible, the air conditioning duct work appeared to be in a satisfactory condition.

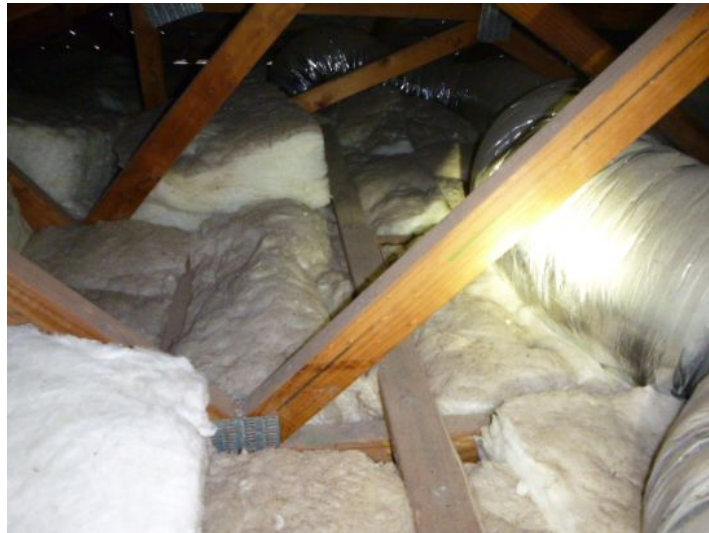
3. Insulation

- Batt insulation noted in the accessible ceiling space.

- Insulation appears adequate where visible.
- Insulation averages about 100 to 125mm in depth.

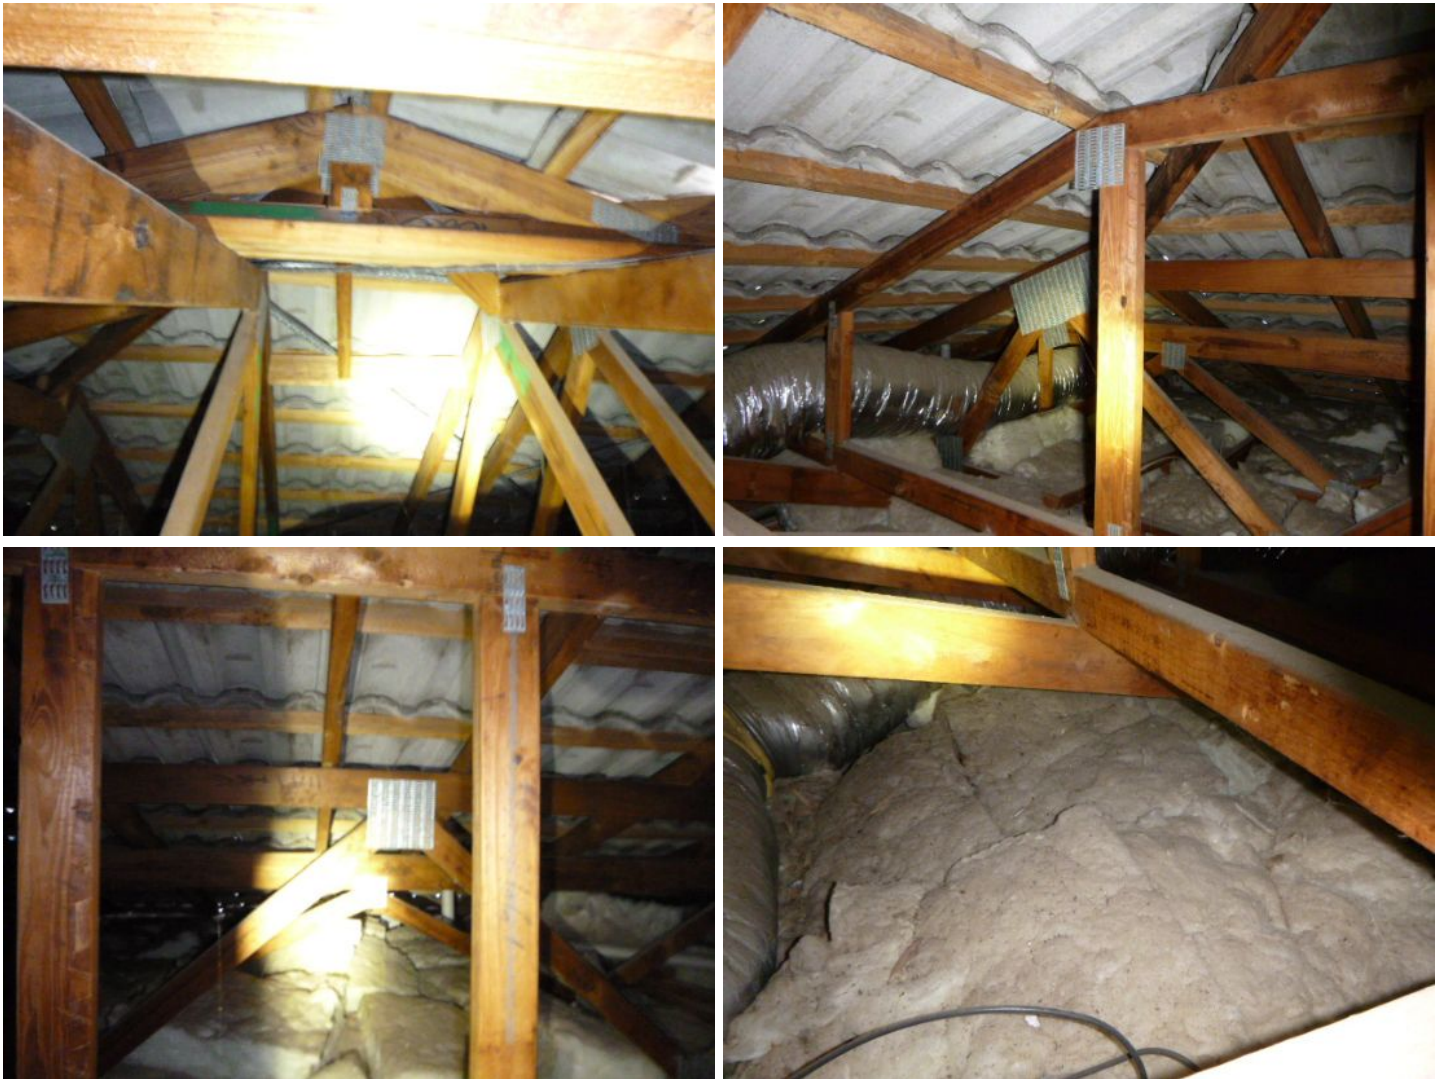
1. Roof Structure

- The timber roof structure appears sound where visible at the time of inspection.
- Due to the roof structure configuration some areas of the roof space were inaccessible and restricted from view.

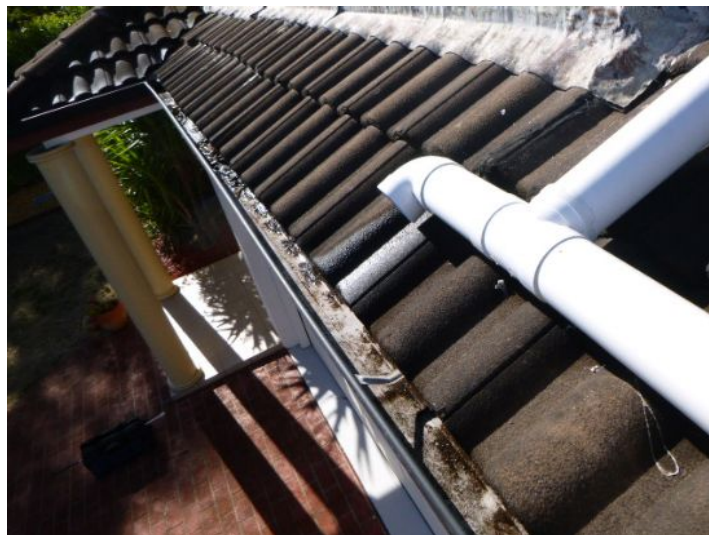
4. Roof Drainage

- No major function concerns noted at the time of inspection.

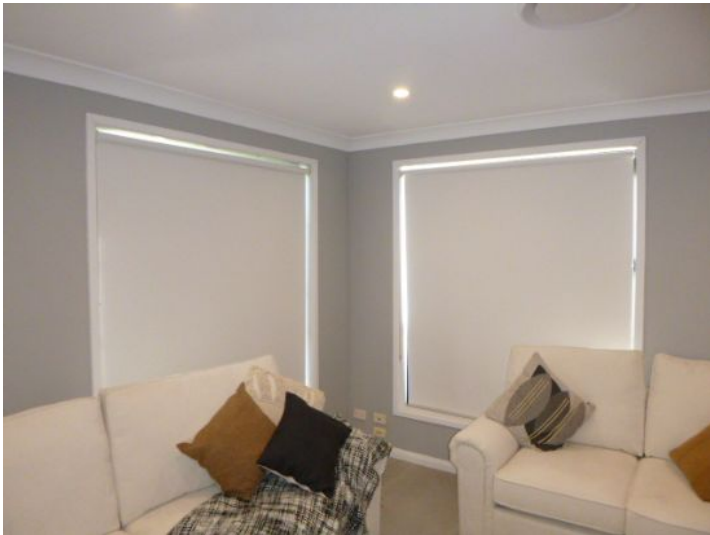
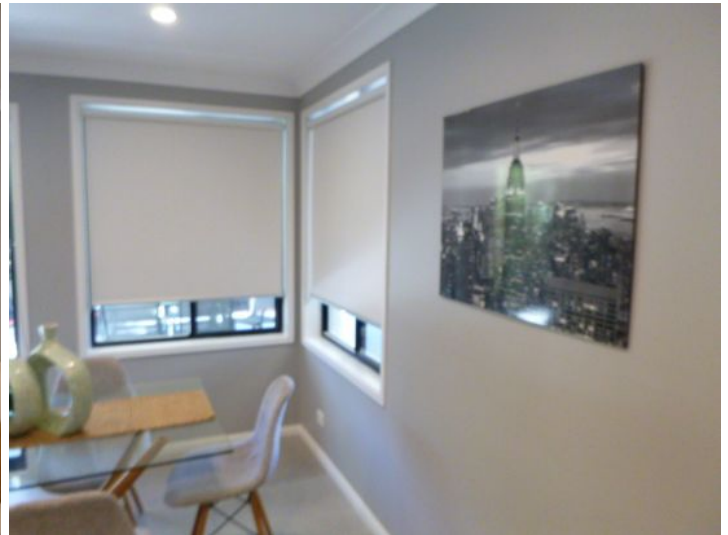
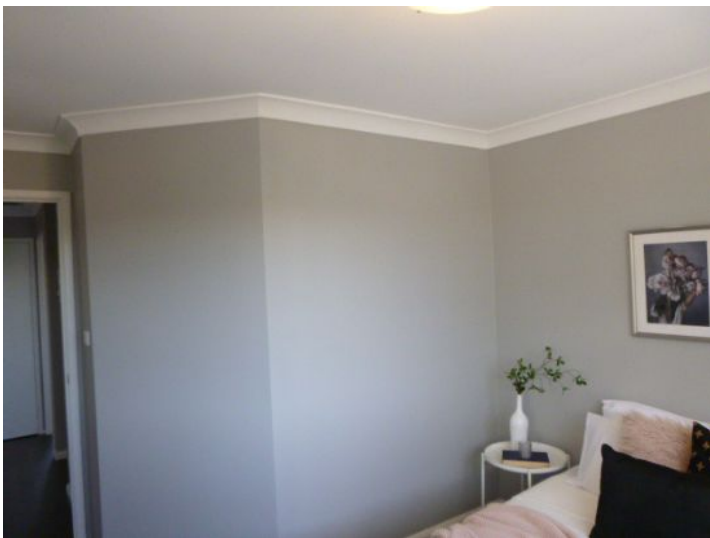
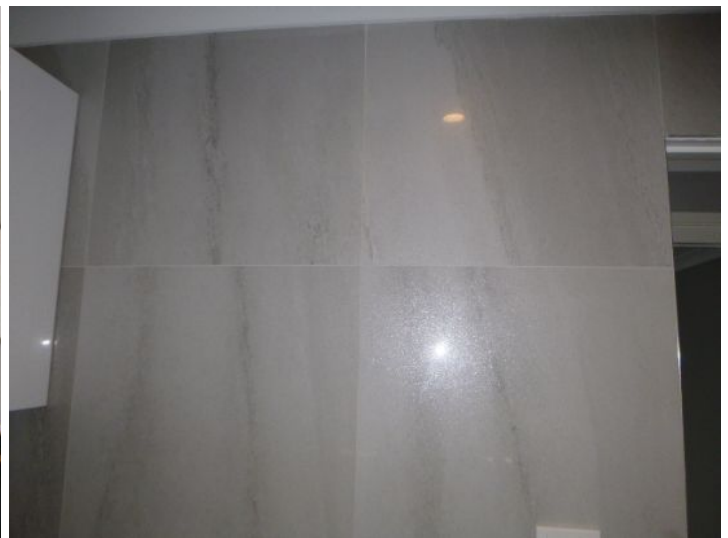
1. Wall Condition

- Plasterboard/gyprock walls noted which appeared functional where visible.
- Tiled walls noted which appeared functional.
- Some areas of the internal walls were not accessible due to stored items and furniture.

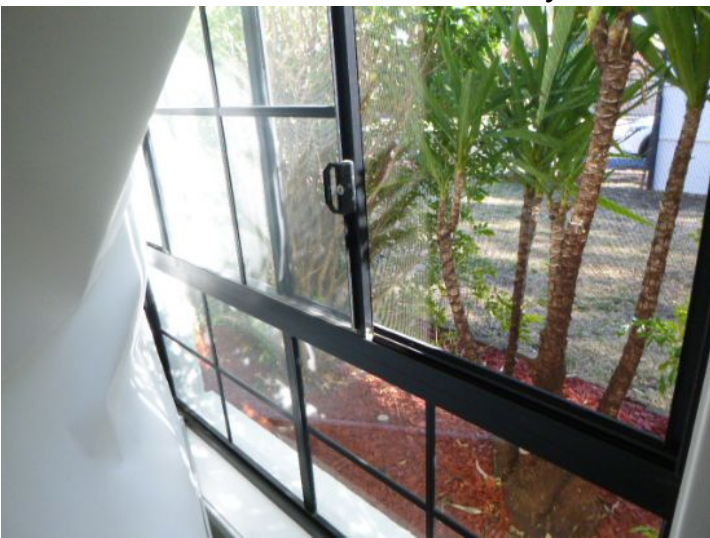
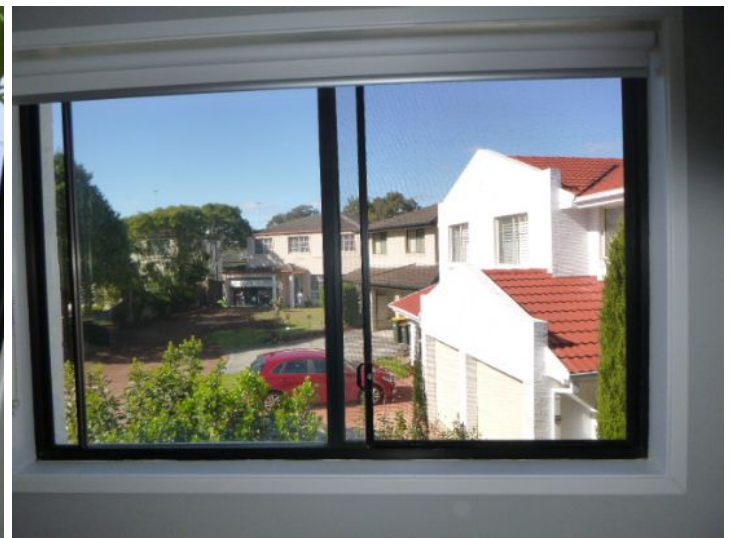
5. Window Condition

- Aluminum framed windows noted.
- Only a representative number of windows were tested/operated during the inspection.

- Windows operated during the inspection appeared functional.
- One or more windows were locked and could not be tested at the time of the inspection. These should be checked at the final inspection.
- Even though the window openings may have met building regulations at the time of construction, current building legislation requires that windows lower than 1700mm above floor level and where a child could fall more than 2m shall have opening limited to 125mm maximum. Windows in the bedrooms do not meet these current safety requirements and should be fixed to limit opening to 125mm maximum or fitted with security screens.

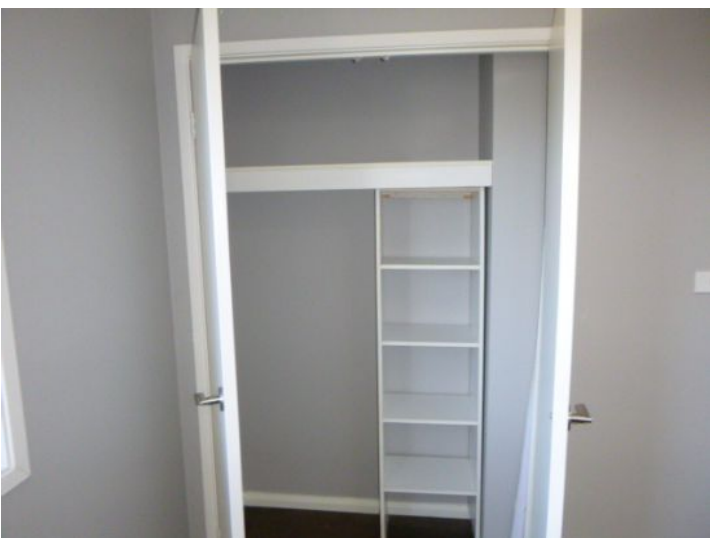
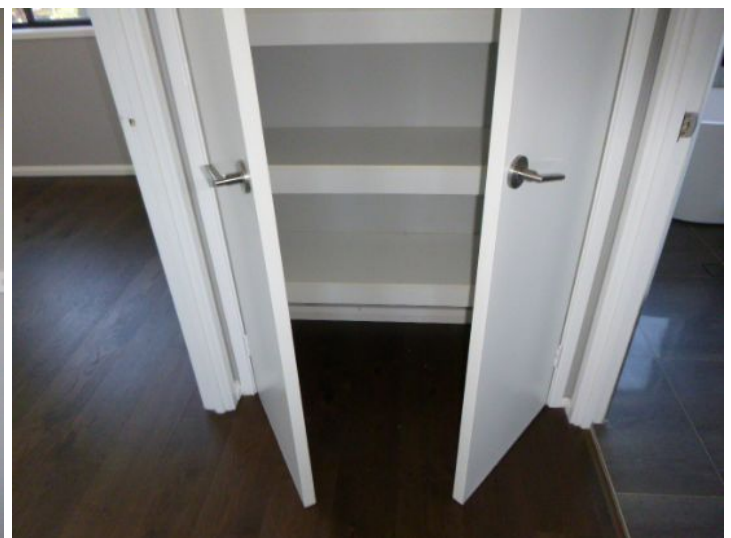
6. Closets

- The closets were in serviceable condition at the time of the inspection.

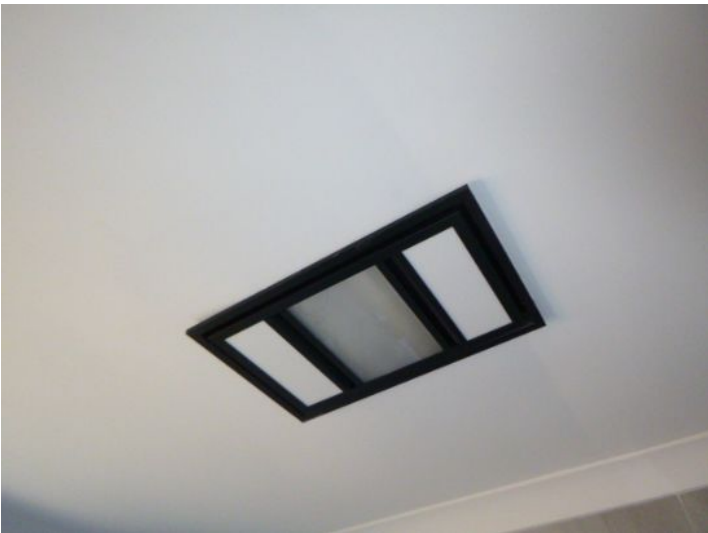
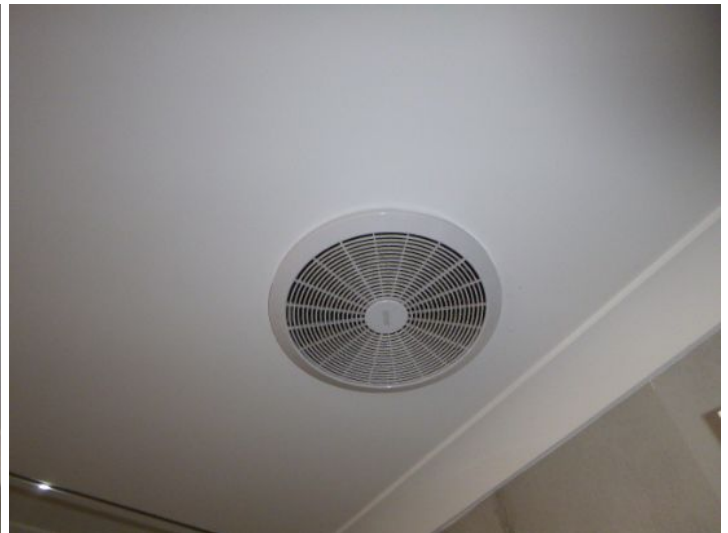
3. Exhaust Fan

- The bathroom exhaust fans responded to normal user controls.

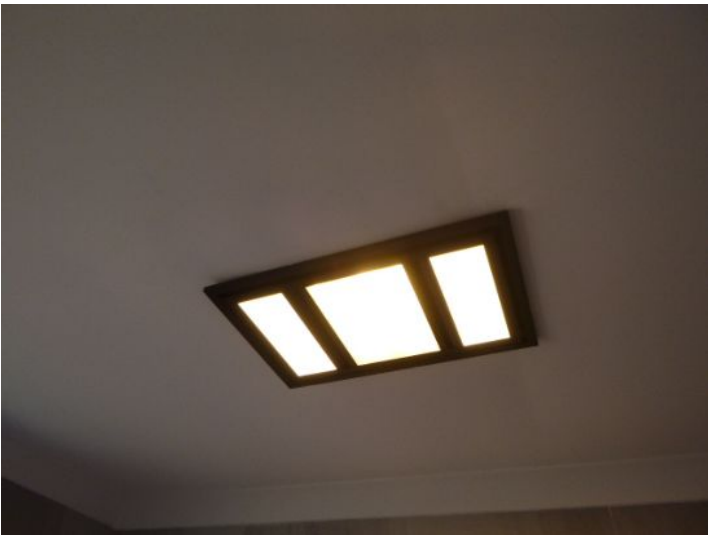
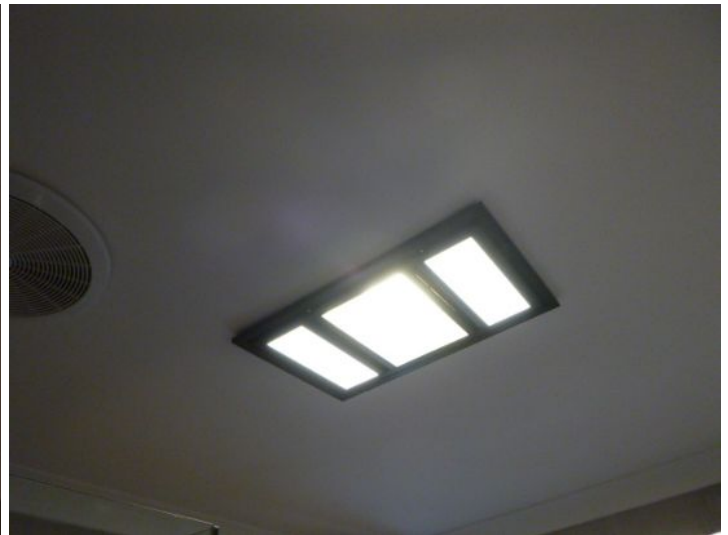
- Heat lamps in the bathrooms functioned normally.

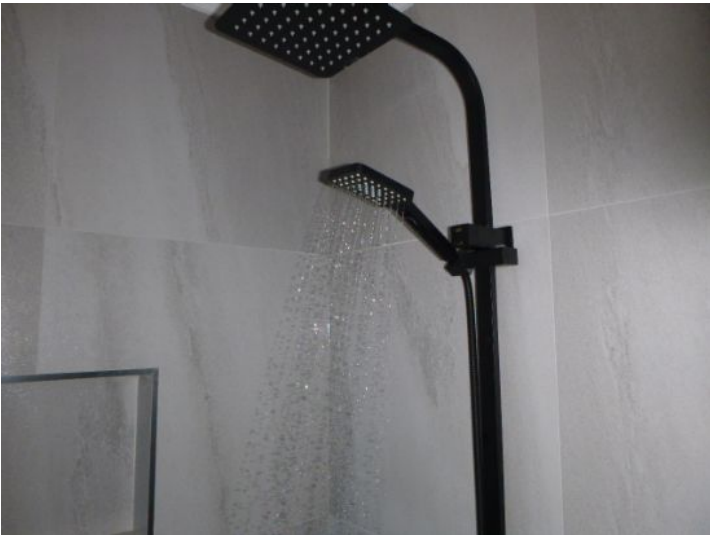
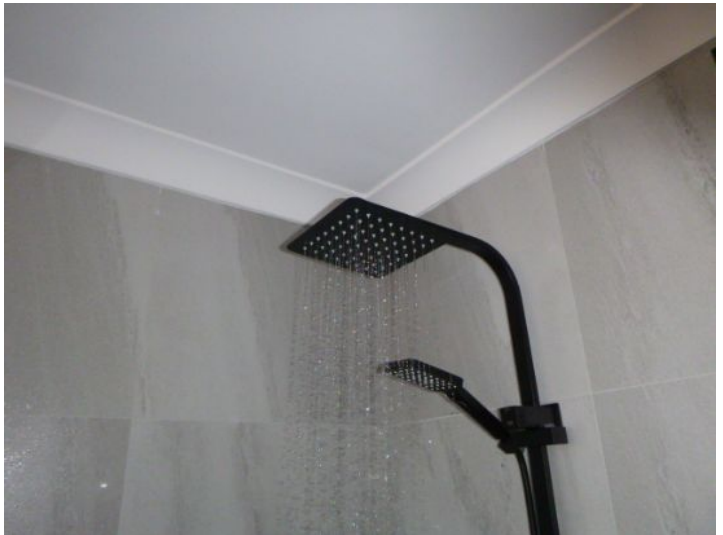
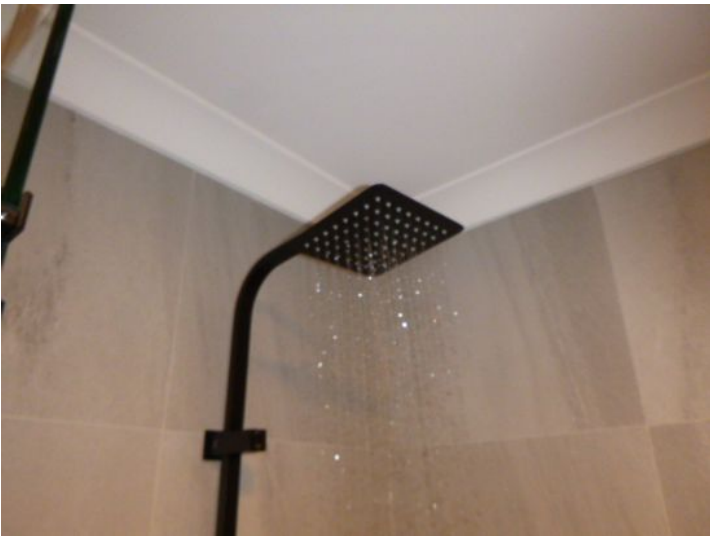
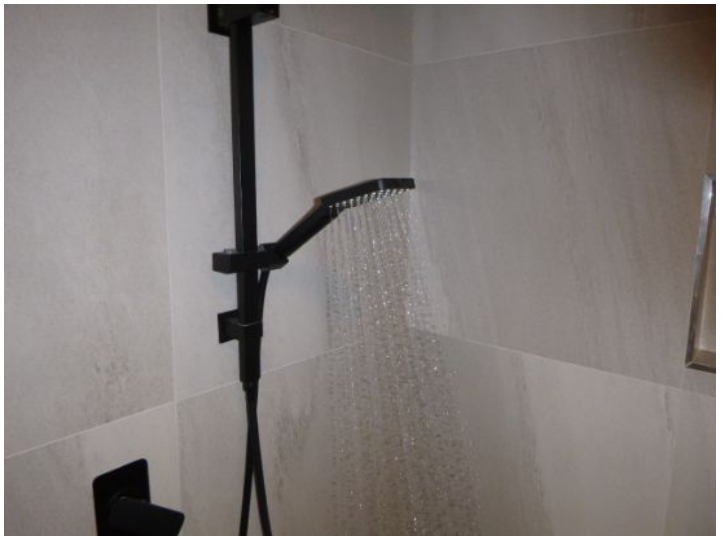
6. Showers

- The showers and related components operated normally when tested.

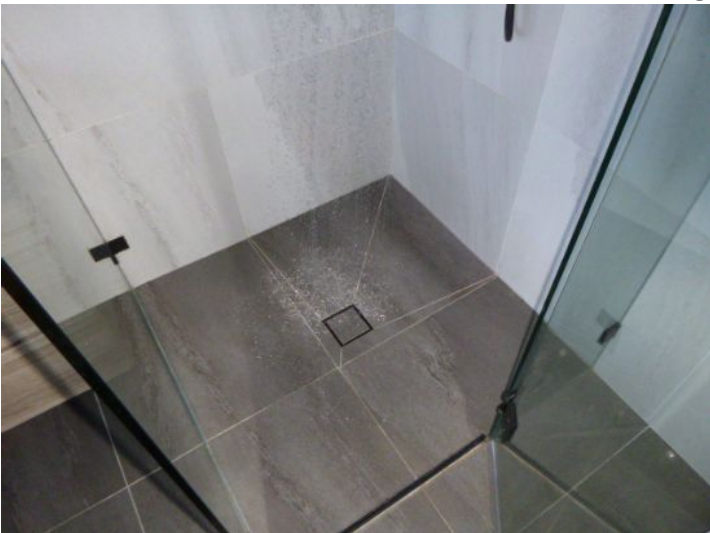
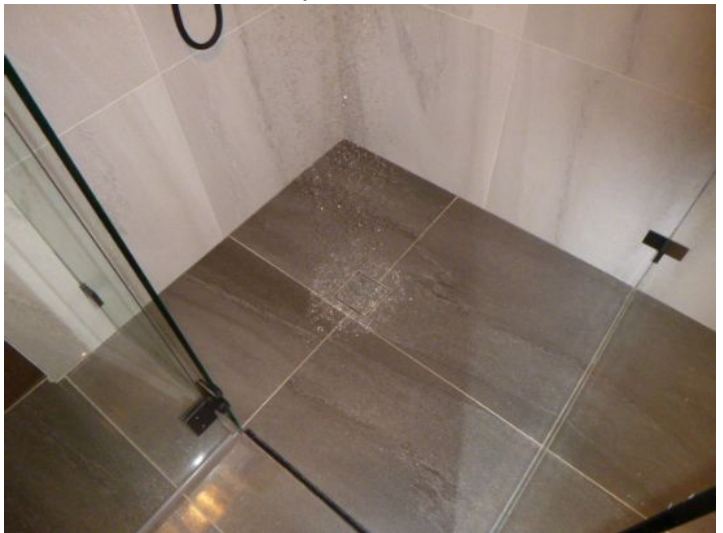
7. Shower Walls

- The shower wall and tiled floor surfaces appear functional.
- This test may not reveal water leaks/penetration until the shower is put into constant use and surrounding areas monitored over a period of time.

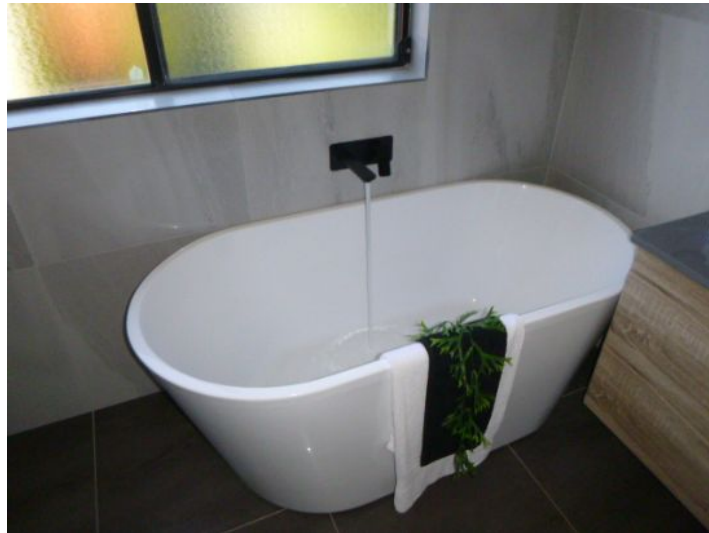
8. Bath Tubs

- The bath tub and related components operated normally when tested.

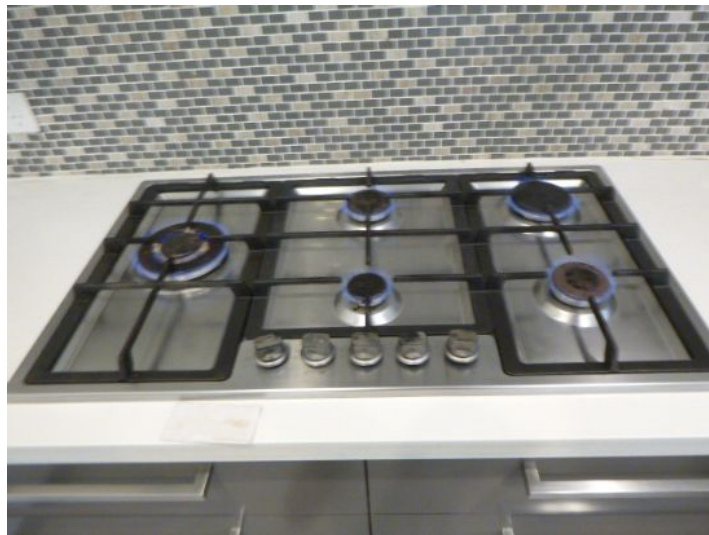
1. Cook top condition

- Gas cook top noted and operated normally when tested.

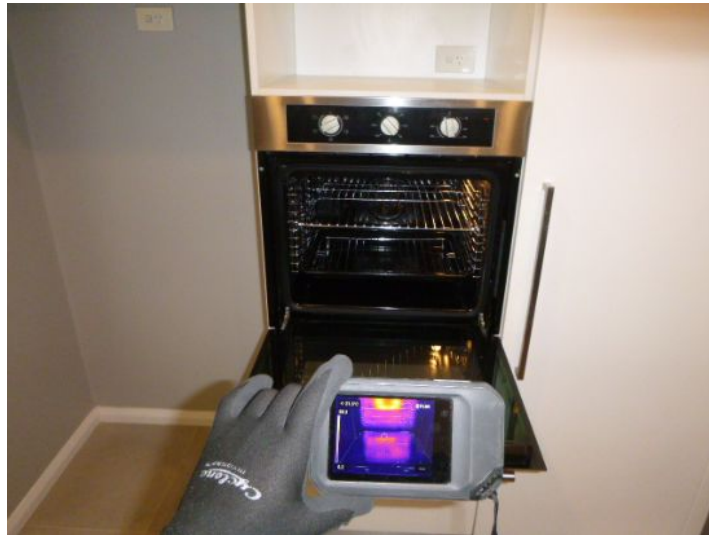
2. Oven & Range

- The electric oven elements were tested at the time of inspection and appeared to function properly.

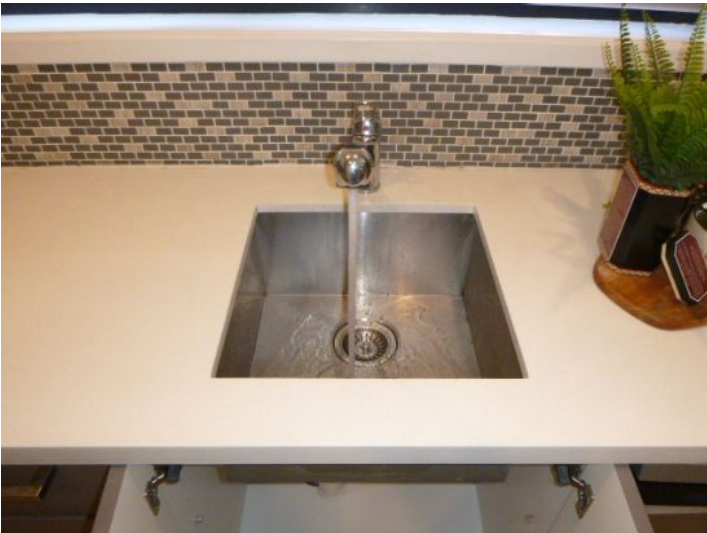
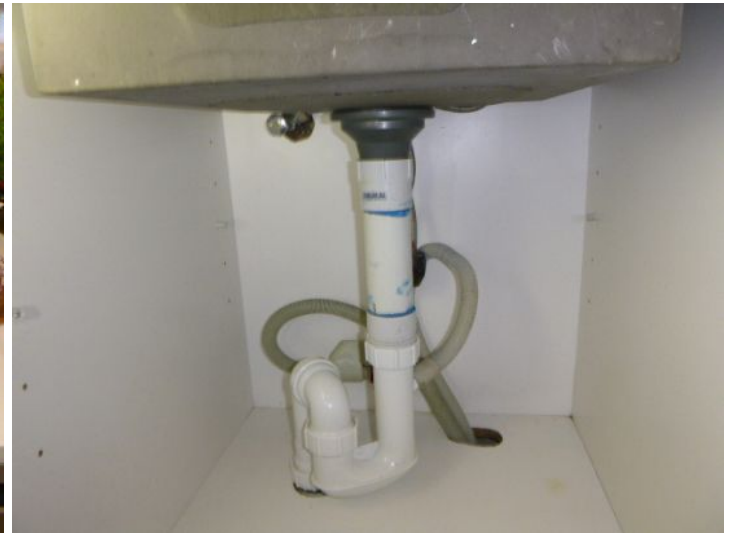
- The sink and related components are functional.
- We recommend all braided flexible water hoses in the property be checked regularly and replaced as required to prevent water damage.

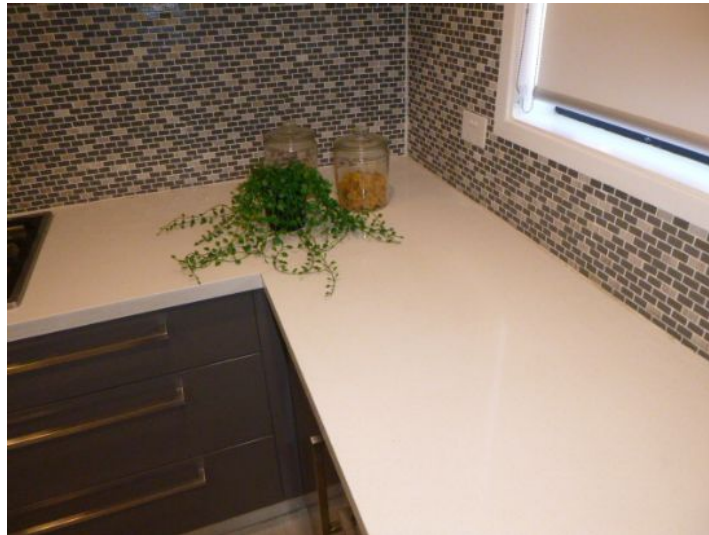
4. Counters

- Appeared functional at the time of inspection.
- Granite tops noted.

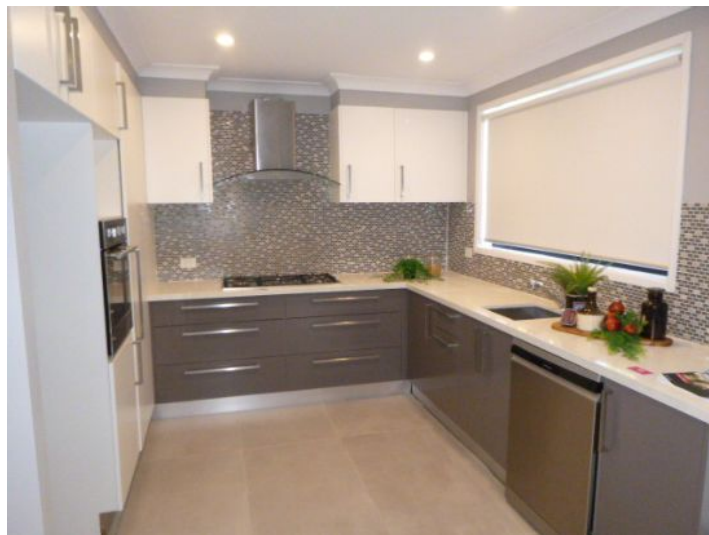
5. Cabinets

- Appeared functional and in satisfactory condition.

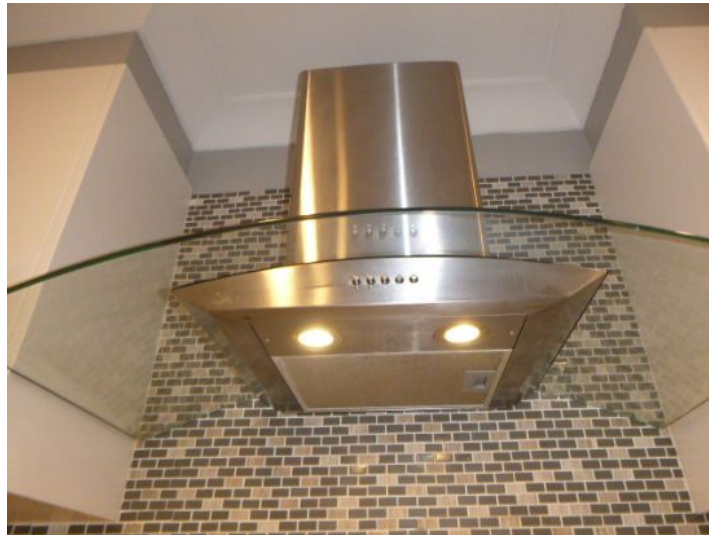
6. Vent Condition

- The exhaust fan is functional.

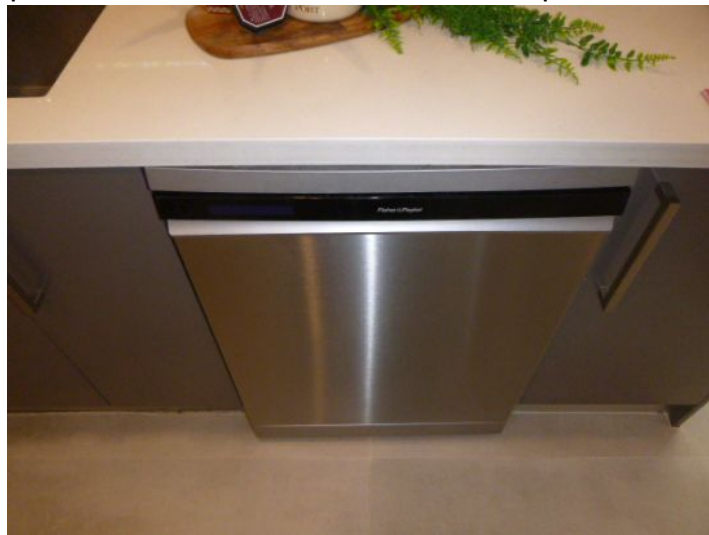
7. Dishwasher

- Dishwasher was noted and not tested as this is not within the scope of our inspection. This should be tested at the final pre-settlement inspection.

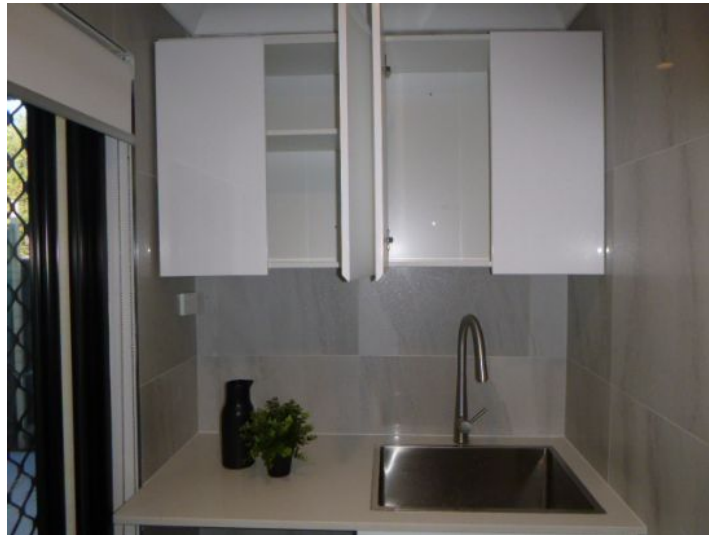
1. Cabinets

- Appeared functional and in satisfactory condition, at time of inspection.

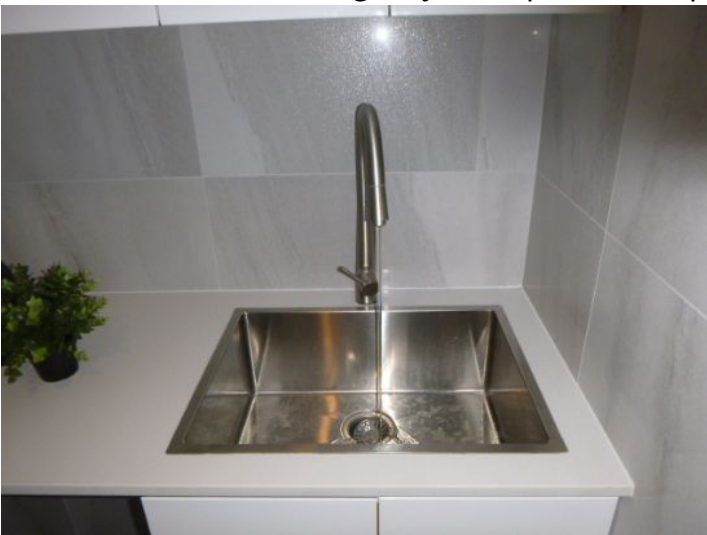
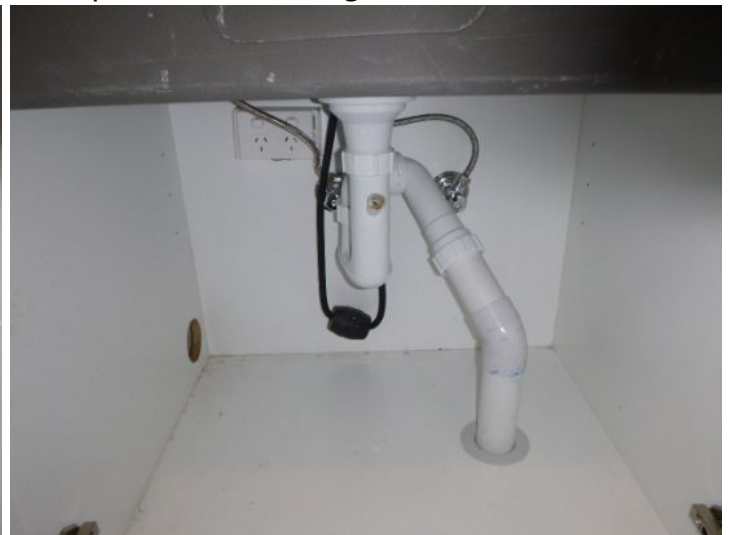
2. Wash Basin

- The trough and related components are functional unless otherwise noted.
- We recommend all braided flexible water hoses in the property be checked regularly and replaced as required to prevent water damage.

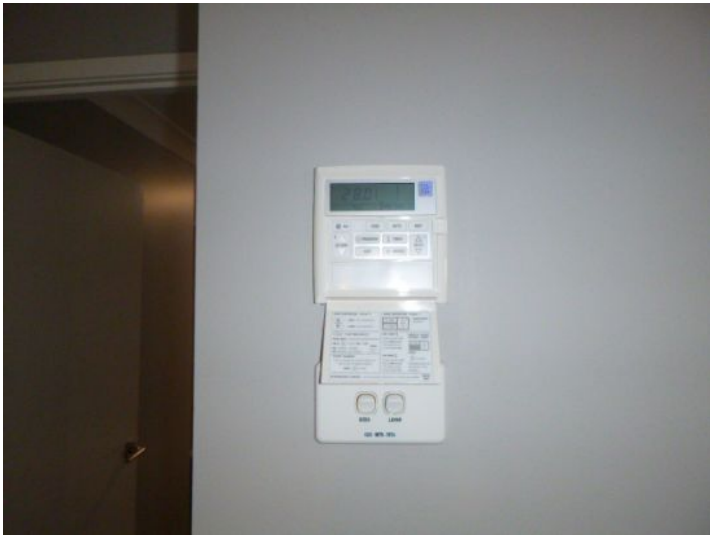
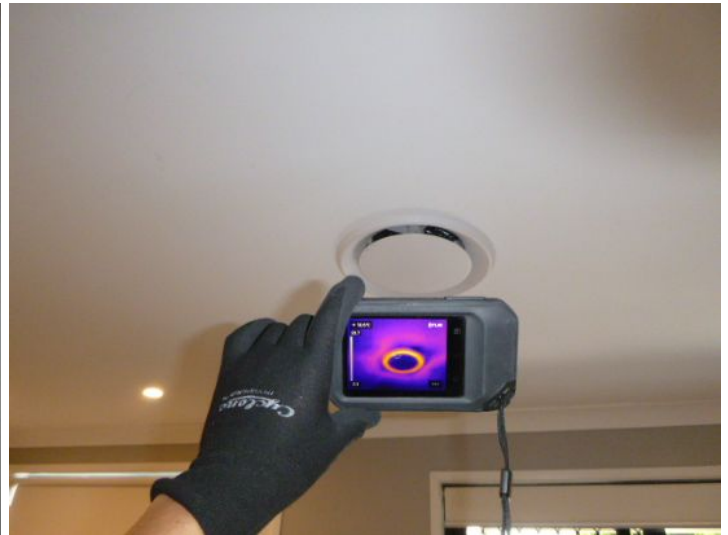
1. Reverse Cycle Air Conditioner

- The central ducted reverse cycle system responded to normal user controls and appeared to be functioning correctly at the time of inspection. However, it was difficult to operate all zones/functions at one given time. We recommend that you check the air conditioning system for full functionality prior to the final pre-settlement inspection.

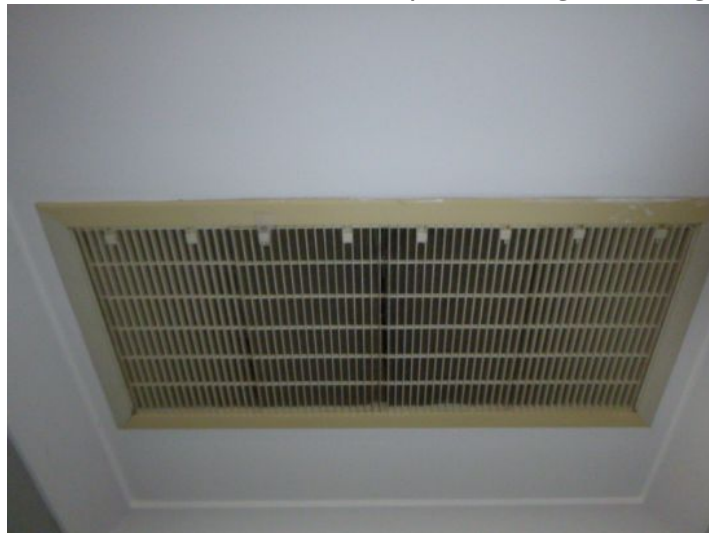
2. Filters

- The air filter(s) should be inspected at least monthly and cleaned or replaced as required. There are two types of filters commonly used: (1) Washable filters, (constructed of aluminum mesh, foam, or reinforced fibers) these may be cleaned by soaking in mild detergent and rinsing with water. Or (2) Fiberglass disposable filters that must be REPLACED before they become clogged. Remember that dirty filters are the most common cause of inadequate heating or cooling performance.

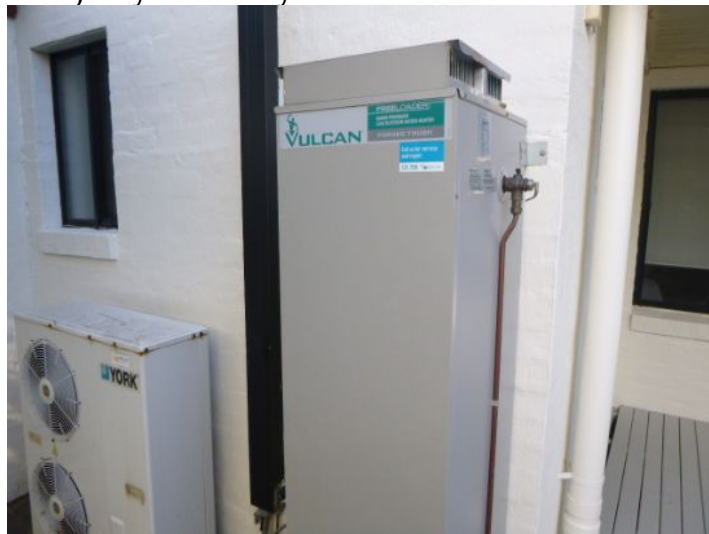
1. Water Heater Condition

- Please note that we only inspect & comment on the operational and safety issues of the hot water system. Issues relating to compliance to relevant codes and standards, and/or installation compliance is excluded from the scope of the inspection.
- No major system safety or function concerns noted at the time of inspection.

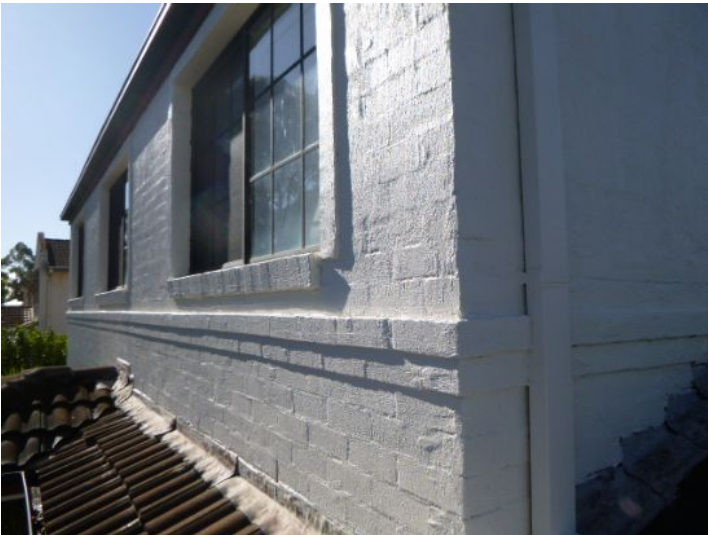
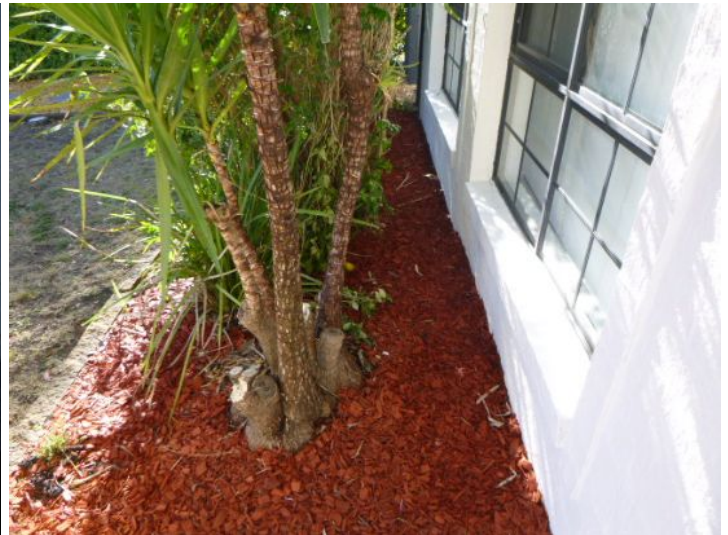
1. Walls

- The brick wall covering is in a satisfactory condition where visible.
- The external rendered walls are in satisfactory condition where visible.

- Due to differential movement within the structure, minor movements have appeared around the property. These movements do not appear to have affected the overall structural integrity of the home. Monitor for changes in condition over the time.
- There are garden beds which are abutting external walls. This can result in water moisture affecting the structure over time. It is recommended that either the beds be removed or a water barrier be placed between the flower bed and the external walls. If these beds are retained it is important that any watering is directed away from the building and kept to an absolute minimum and is controlled.

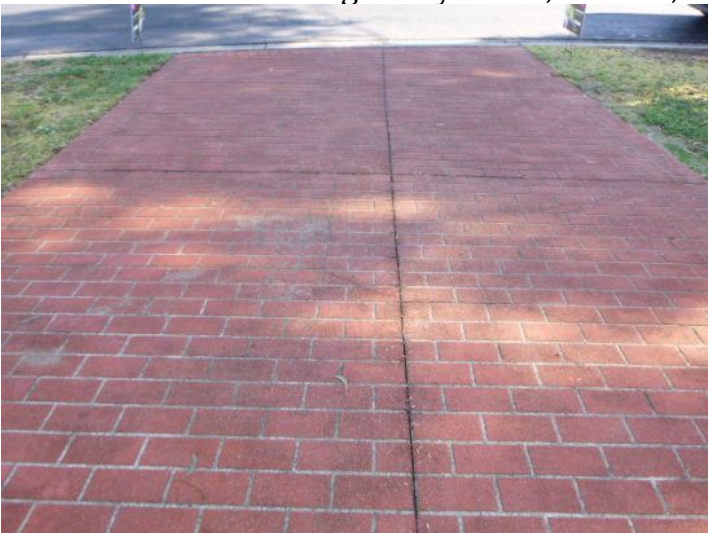
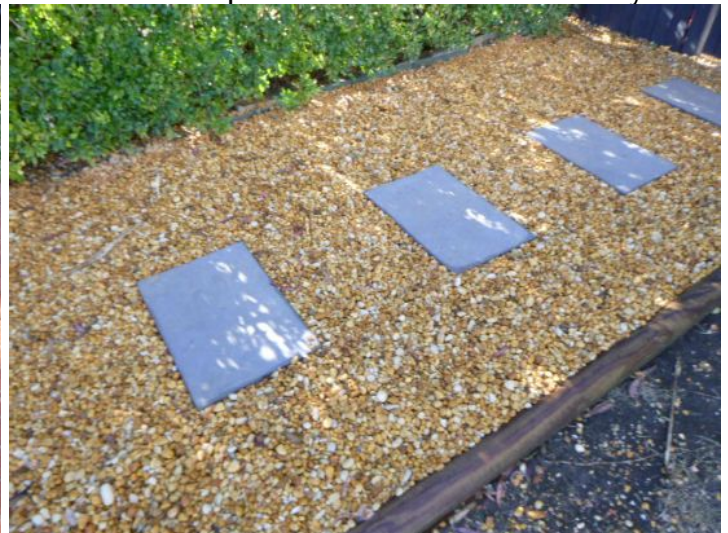
1. Driveway and Walkway Condition

- Concrete driveway noted.
- Concrete sidewalk noted.
- Gravel/Tile sidewalk noted.
- Driveway in reasonable shape for age and wear.
- Sidewalk in reasonable shape for age and wear.

- Minor settlement or "hairline" cracks in driveways are normal to properties of any age. They should, however, be monitored for expansion and sealed as necessary.

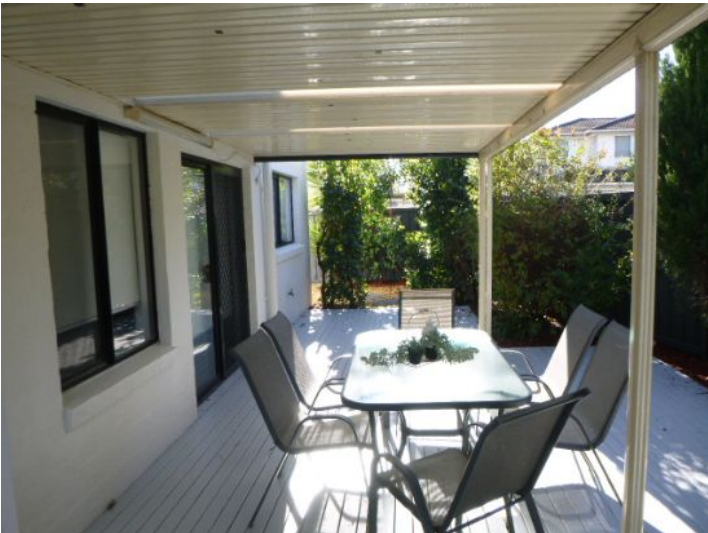
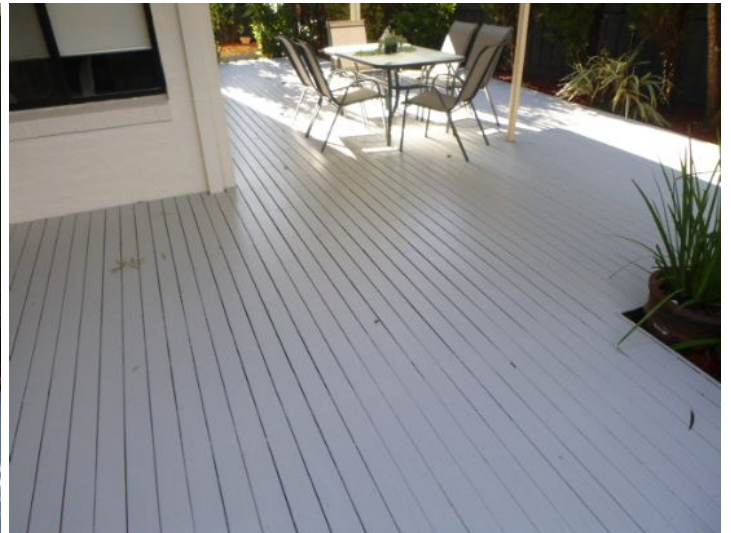
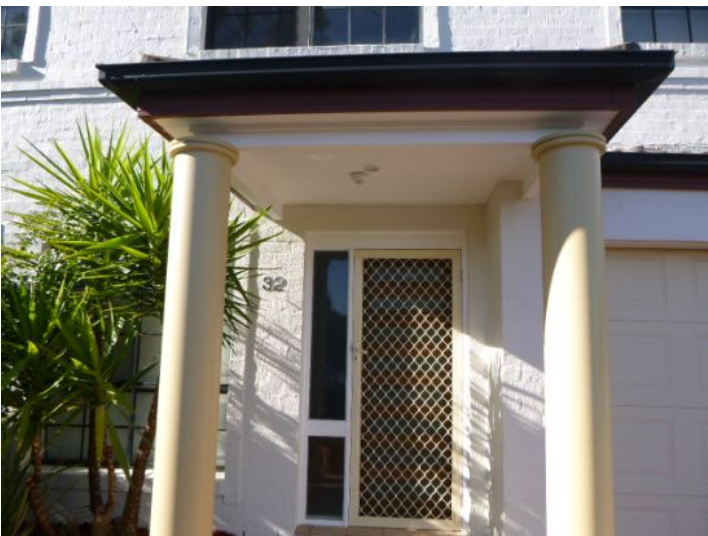
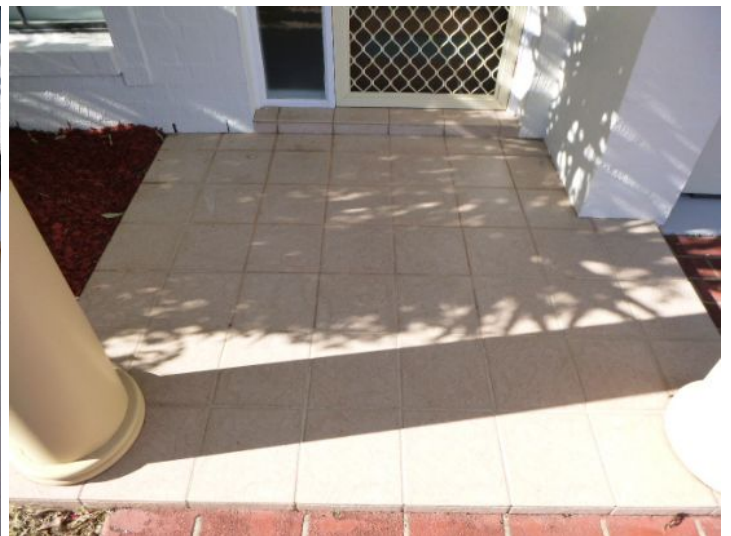
- Pergola/Porch appears in satisfactory and functional condition with normal wear for its age.

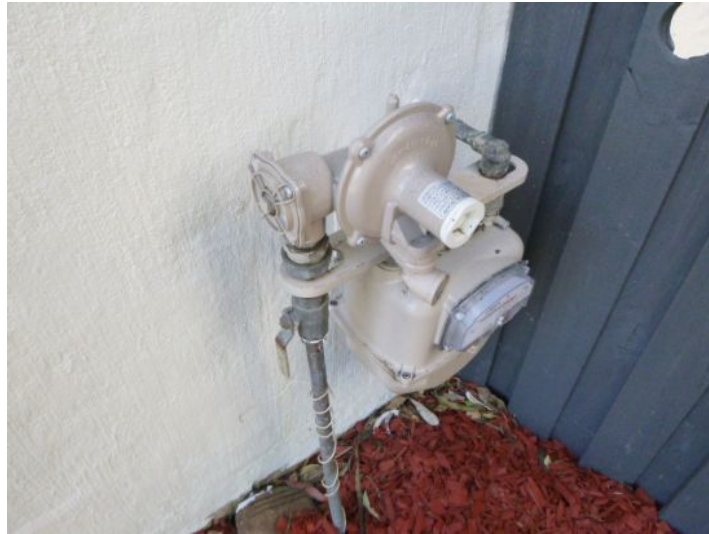
5. Main Gas Valve Condition

- Main gas shut off located at outside meter.
