Property Inspection Report

32 Greygum Avenue, Rouse Hill, NSW 2155
Inspection prepared for: Wen Yuan Rui
Real Estate Agent: Mandeep Singh - Urban Land Housing - Box Hill

Date of Inspection: 15/8/2023 Time: 10:00AM
Weather: Sunny, 13C

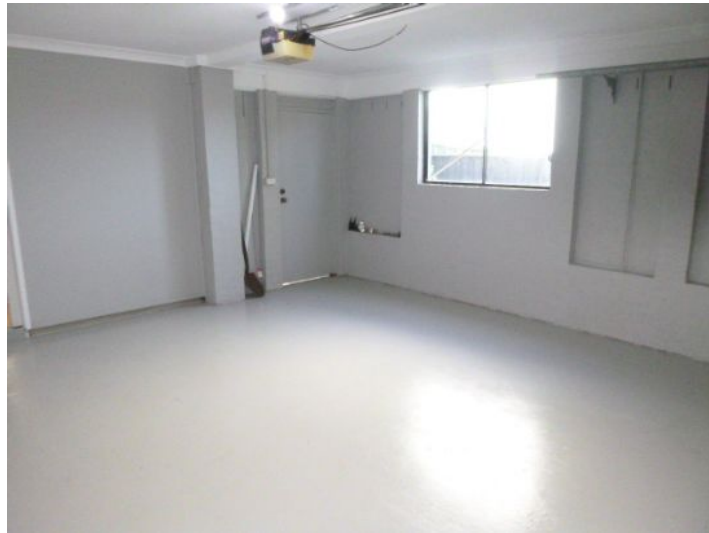
1. Garage and Shed

- The attached brick garage appears functional and structurally sound.

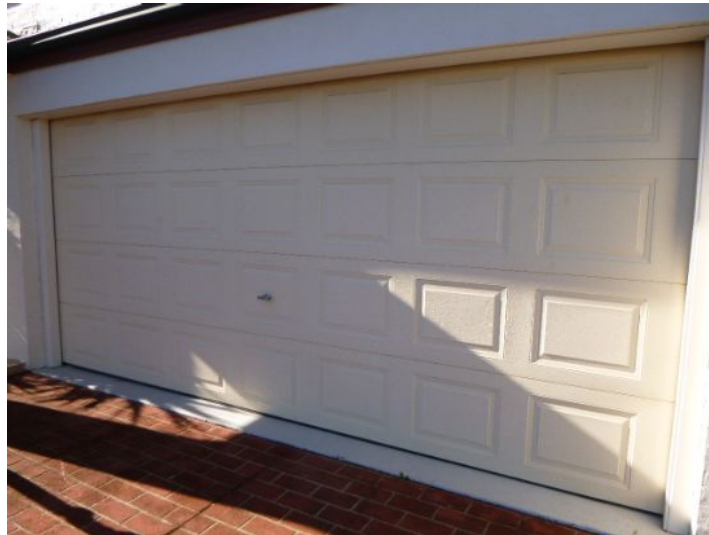
2. Garage Door Condition

- Sectional door noted.

- Appears functional at the time of inspection.

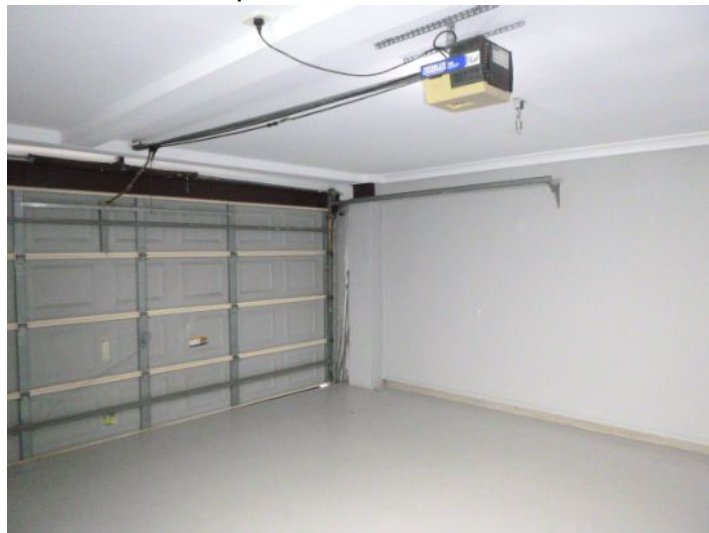
3. Garage Opener Status

- Unable to locate controller for garage door at the time of inspection. This should be tested at the final inspection.
