# Building and Timber Pest Inspection Report VR

Inspection Date: Wed, 19 Jun 2024

Property Address: 22 Agnew Cl, Kellyville NSW 2155, Australia

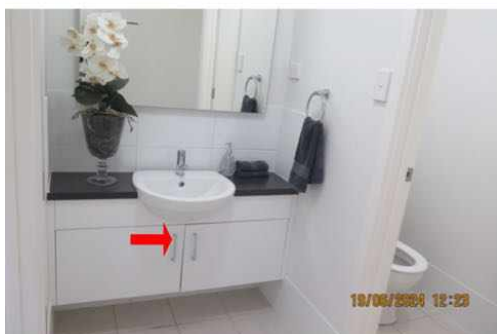
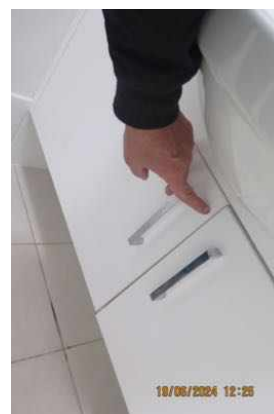
Building: Main Building  
 Location: Bathroom  
 Finding: Doors - Binding/Jamming  
 Information: Binding and/or jamming of several doors throughout the property were evident during standard operation. This defect inhibits the functionality of affected doors as well as creating potential for secondary defects to associated building elements, such as damage to the floor covering.

A door that binds to flooring or to the associated door frame may have several causes, ranging from minor defects, such as poor installation of the door or deteriorated hinges, through to major structural issues, such as damage to subfloor structures.

Where door binding/jamming appears to indicate major structural issues, a registered builder specialising in re-stumping should be appointed to provide an estimate on the cost of rectification.

For minor causes, a qualified carpenter or general handyperson should be appointed to perform minor rectification works at client discretion.

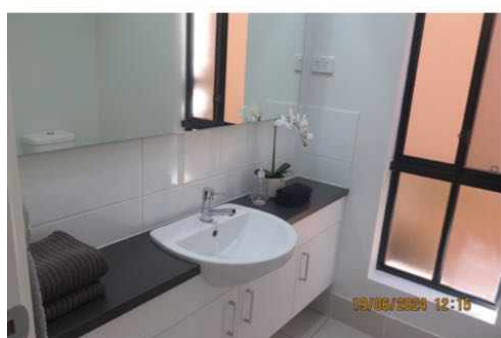
### Finding 3.02

Building: Main Building  
 Location: Bathroom  
 Finding: Lock - Not working  
 Information: The lock in this area was not operational at the time of inspection. Where locks have deteriorated to a point where they are no longer usable, the security of the property is immediately compromised.

Repair or replacement of the lock is highly recommended. Consultation with a locksmith or general handyman is required to gain further advice on any added security that may be available for the area.

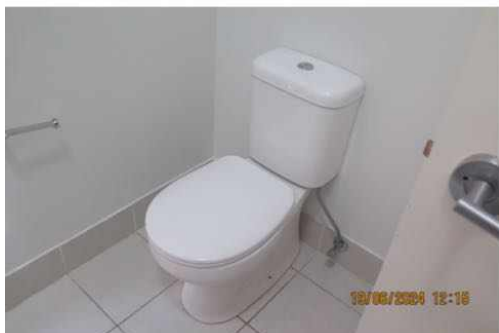
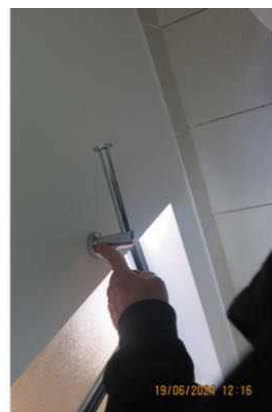
### Finding 3.03

Building: Main Building  
 Location: Toilet (WC)  
 Finding: Fitting or fixture - Loose  
 Information: The fitting in this area is loose and requires adjustment to tighten.

If left unmanaged, the fitting may further deteriorate, causing potential for the development of other minor secondary defects.

A relevant tradesperson should be appointed to perform these rectification works at discretion of the client.

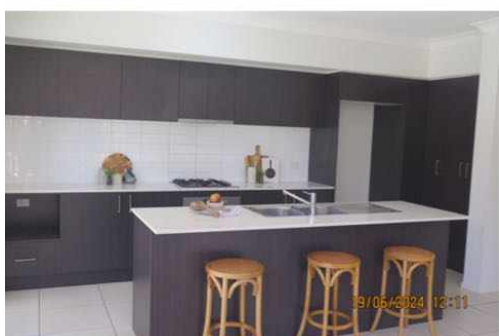
### Finding 3.04

Building:	Main Building
Location:	Kitchen
Finding:	Push to open mechanisms - Not operating - Damaged door - Door binding
Information:	Non-operational items should be addressed to ensure that the full function of the building structure is available. Where some building elements are not operating as intended, it is possible that secondary building defects could arise due to their non-operation.

Repair and/or replacement of the faulty building element is recommended. It is highly recommended that the relevant tradesperson be engaged to perform any necessary works.

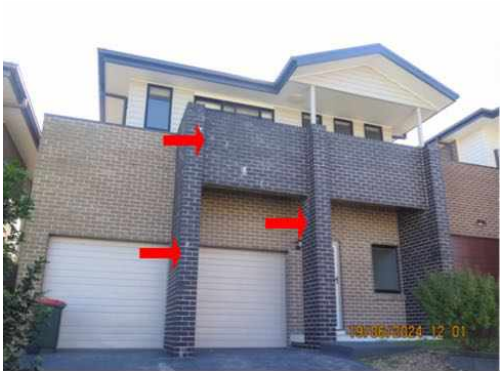
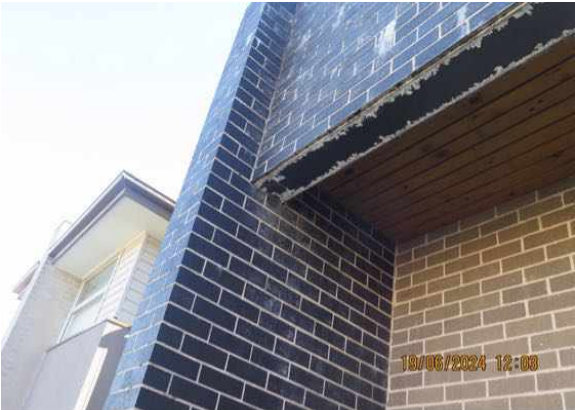
Finding 3.05

It is typically seen as white salt deposits on the surfaces of concrete pavement or mortar between bricks or tiles. While detracting from the overall appearance of the affected area, efflorescence is not likely to develop into secondary damage if left unmanaged.

Generally, soluble salt deposits can be removed by dry brushing with a stiff-bristled brush. Repeated dry brushing is an ideal treatment for eliminating this forming of efflorescence. A cleaning contractor or general handyperson may be appointed to perform these works at the discretion of the client.

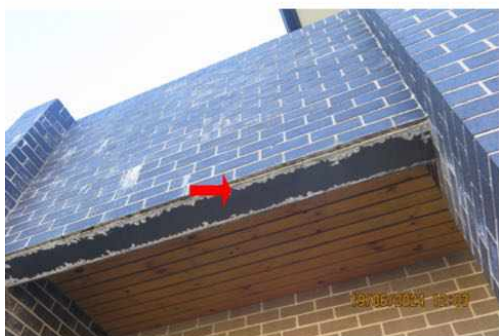
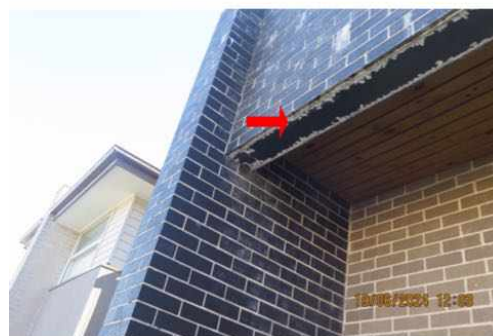
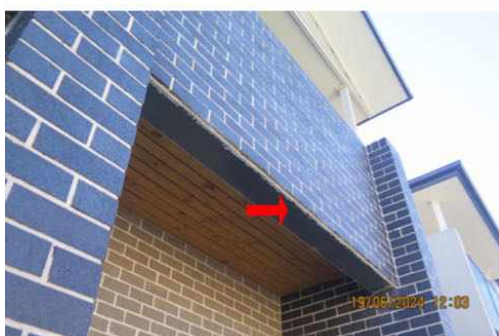
Finding 3.06

Building:	Main Building
Location:	Yard - Front
Finding:	Steel beams - Rusted or corroded
Information:	This building element shows evidence of rusting and corrosion, which is likely to have developed as a result of excessive exposure to moisture and or inadequate coatings.

As surface rust provides no protection to the underlying iron, the deteriorating condition is likely to worsen if not addressed in the short-term future.

Where possible, the use of galvanized (treated) metals or aluminium coated metals aid in rust prevention, as does regular general maintenance. Rust formation can be controlled with coatings, such as paint, that isolate the iron from the environment.

Rusting and corrosion should be managed by ideally removing or limiting the affected surface from exposure to moisture. A registered builder may be appointed to replace any building elements that have been severely affected by rust or water damage.

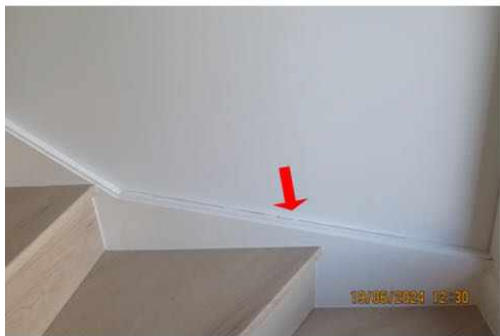
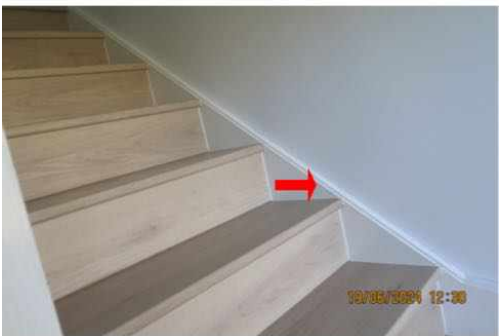
### Finding 3.07

Building:	Main Building
Location:	Stairs - Internal
Finding:	Cracking - Damage Category 2 - Noticeable (up to 5mm)
Information:	Noticeable cracks are a common occurrence as a result of many primary defects.

Such causes may include age, general wear and tear, expected building movement, general expansion/contraction of building materials in different weather conditions, and/or minor failings in the installation or application of building materials.

Noticeable cracks may result in minor sticking or jamming of associated doors and windows, which require easement. However, noticeable cracks are easily filled and repaired. A plasterer can be consulted to install an expansion joint at this point to allow for this movement during different weather conditions.

Monitoring of all cracking should be conducted frequently. Always contact a building inspector should cracks widen, lengthen, or become more numerous. Additionally, your building inspector should also be contacted if associated building elements such as doors and windows become more difficult to operate over time.

Relevant tradespeople, such as carpenters, painters and plasterers, should be appointed to perform remedial works, as deemed necessary.

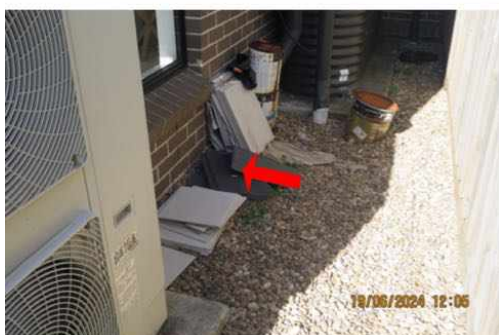
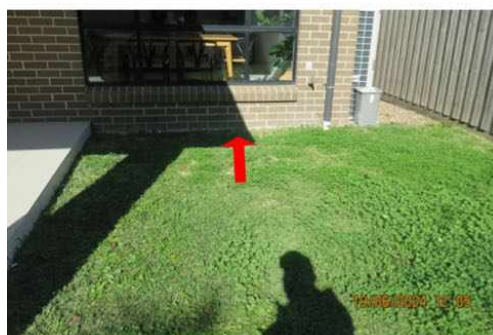
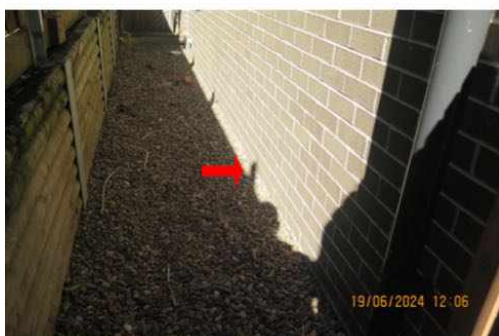
If the slab edge is not properly exposed there is a high risk of termite attack. Sometimes, in order to determine the type of slab, a suitably qualified person such as an architect or builder may be required to consult the construction plans.

Where the slab edge cannot be properly inspected, it is highly recommended that termite or timber pest inspections be carried out every 6-12 months to aid protection of the property against infestation.

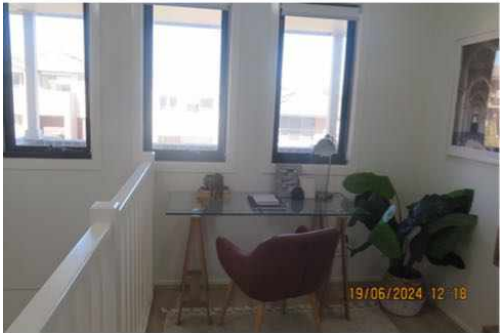
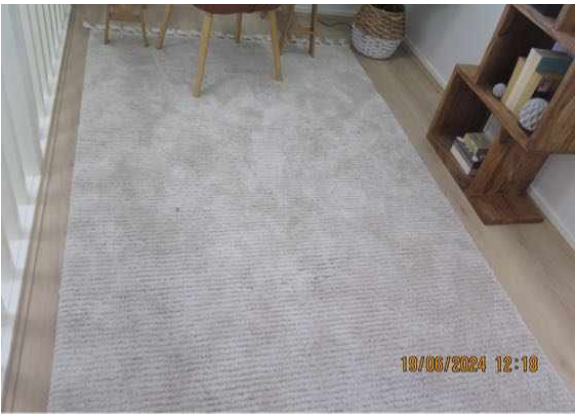
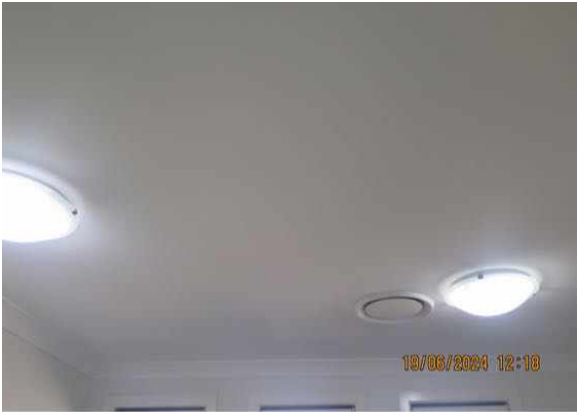
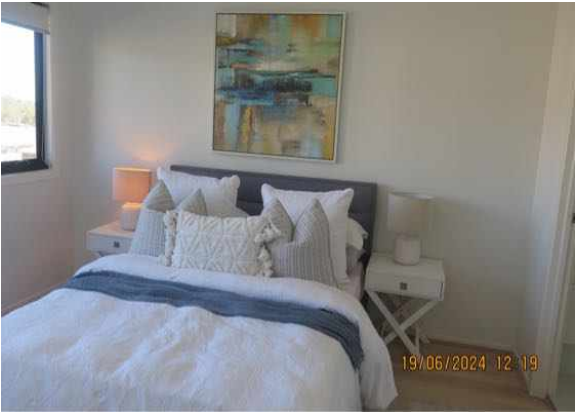
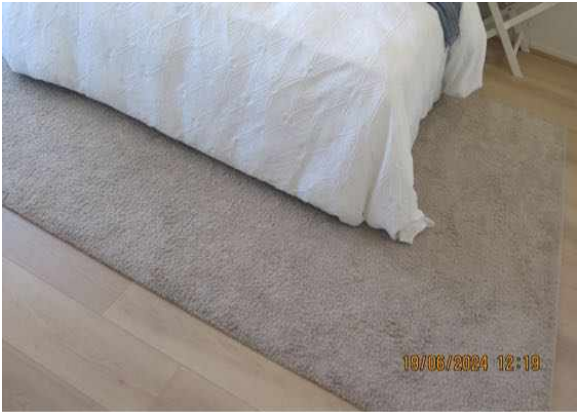
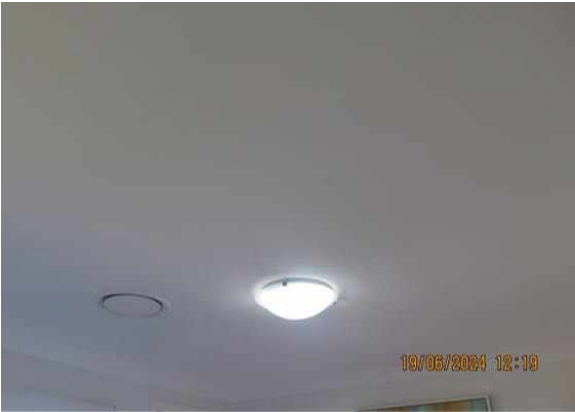
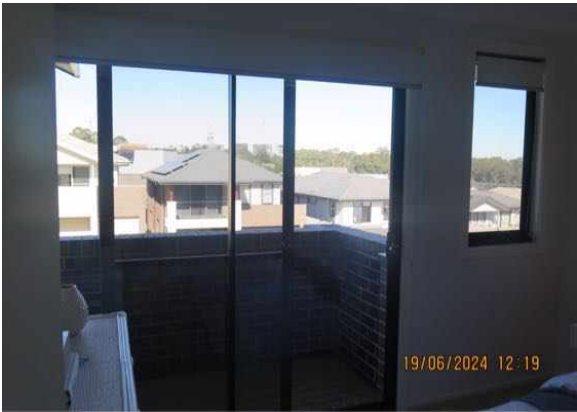
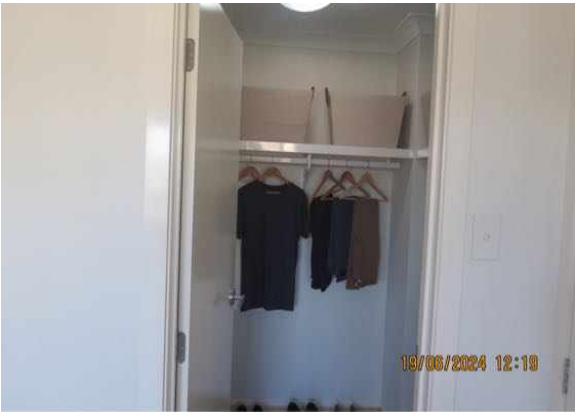
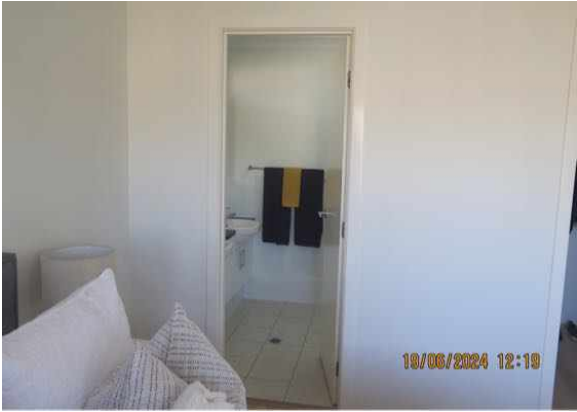
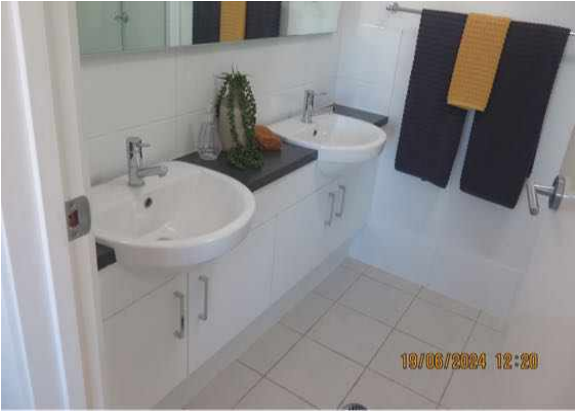
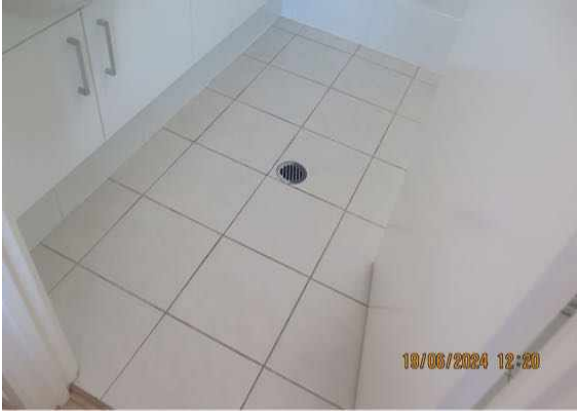
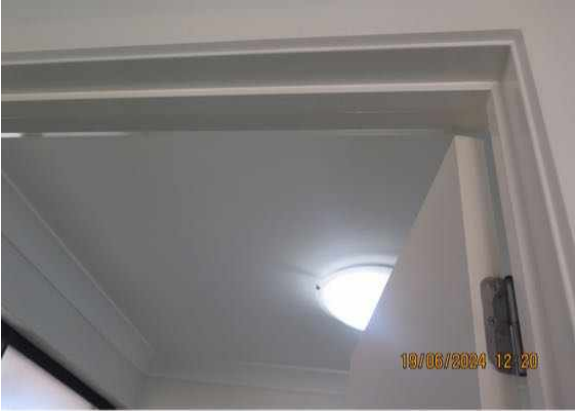
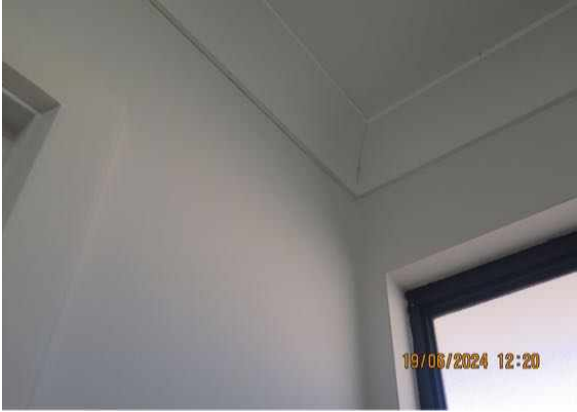
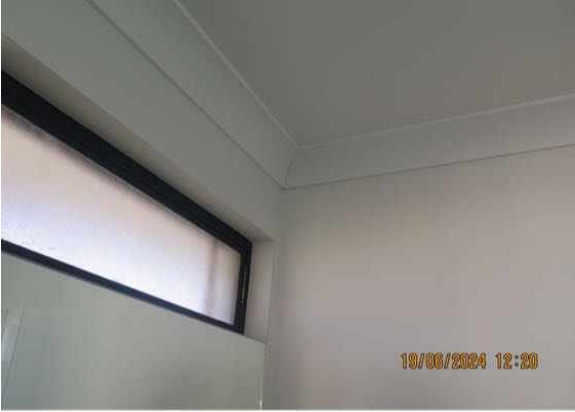
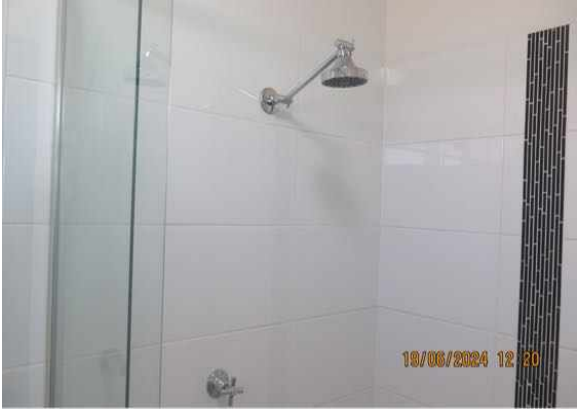
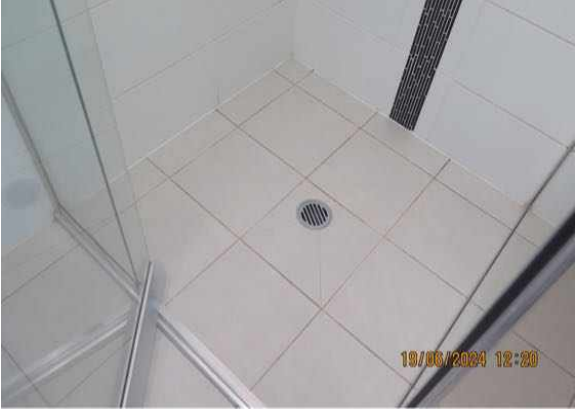
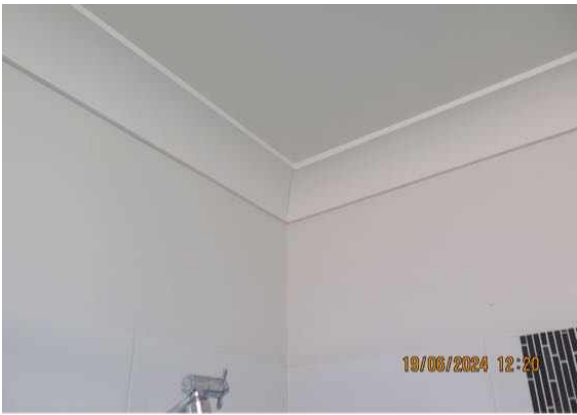
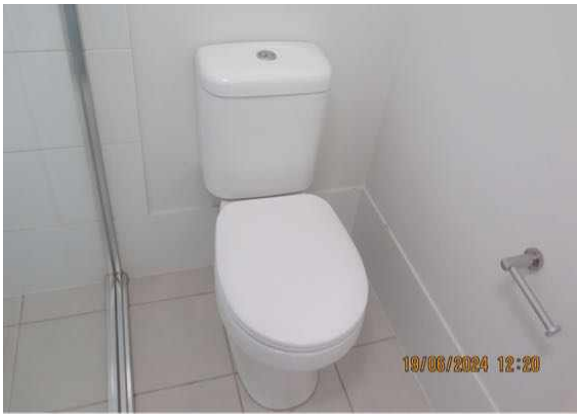
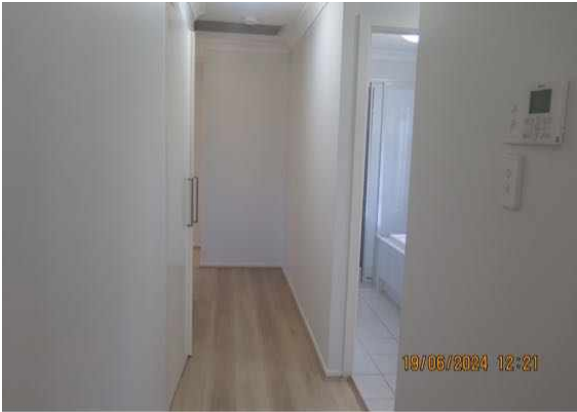
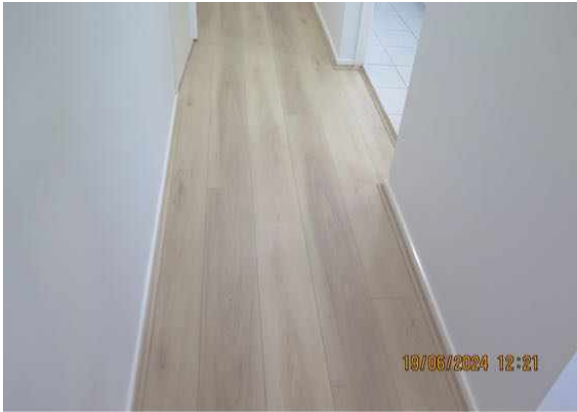
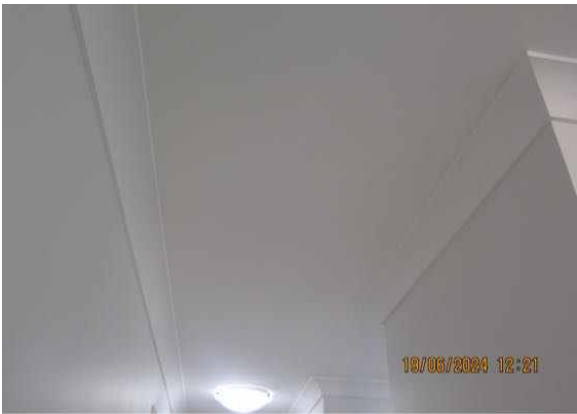
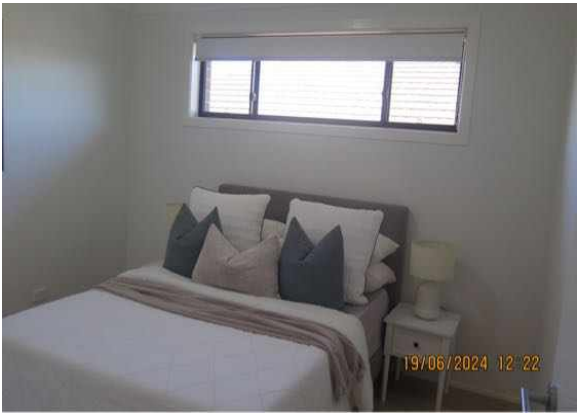
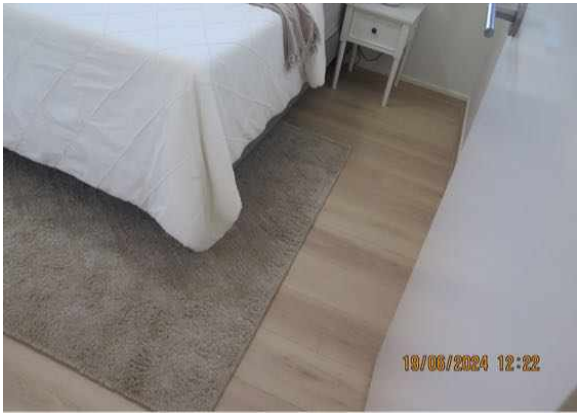
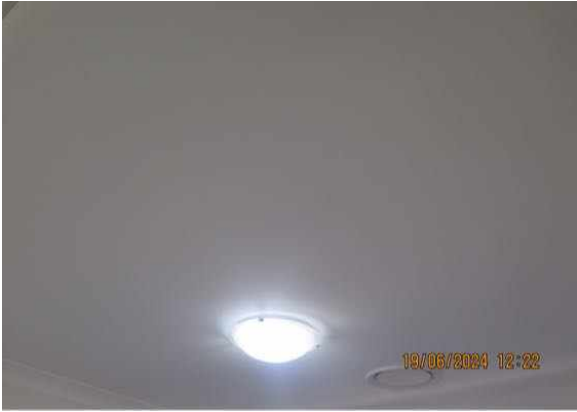
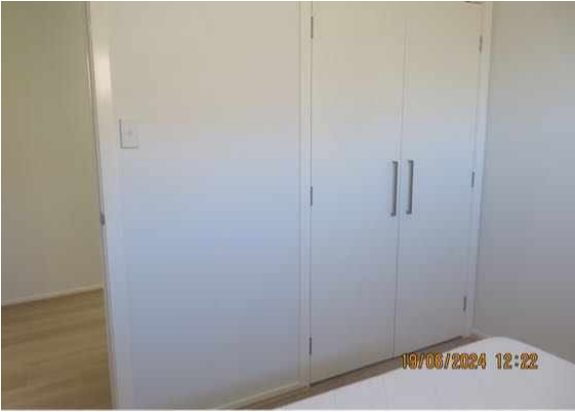
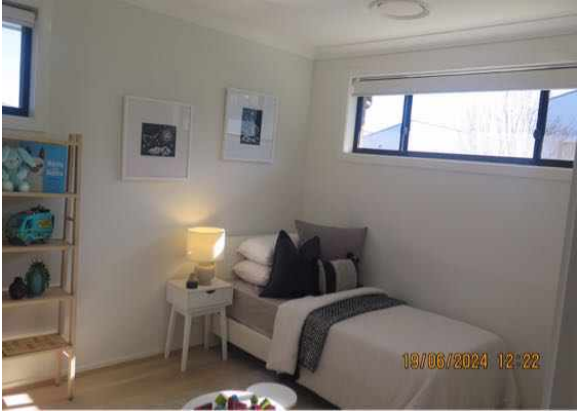
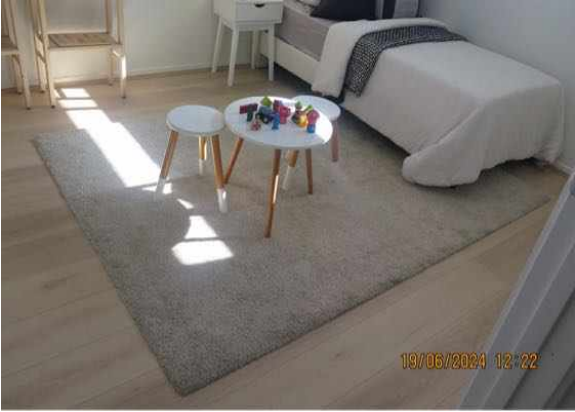
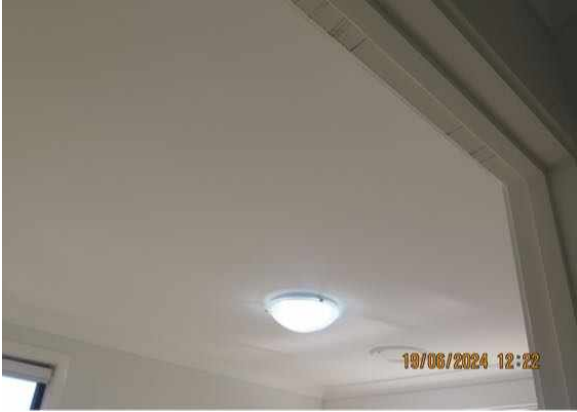
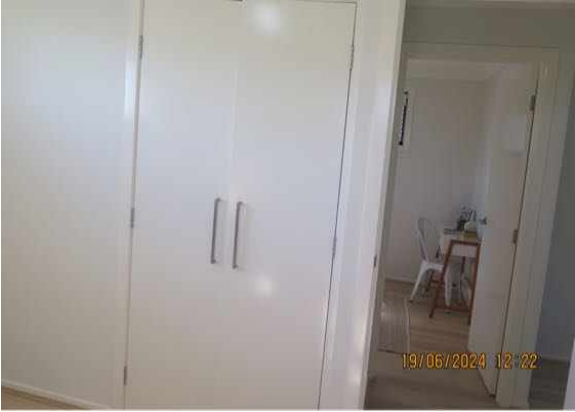
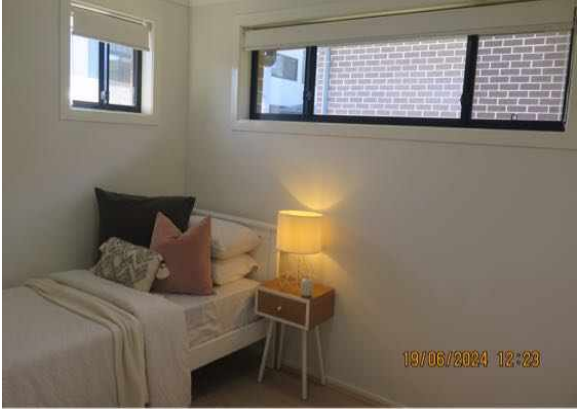
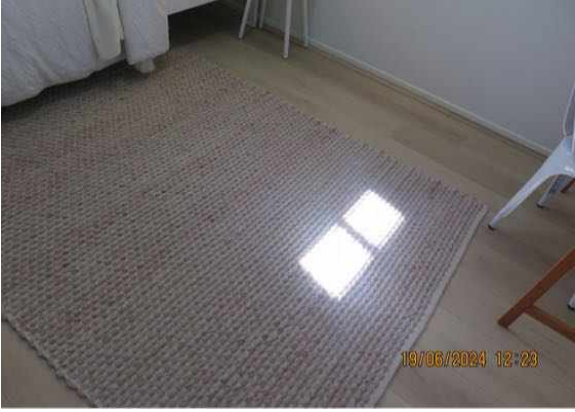
Building: Main Building  
Location: All Internal Areas  
Finding: Additional Photos  
Information: Additional photos are provided for your general reference

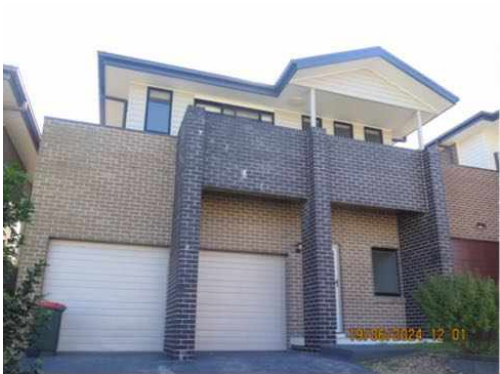
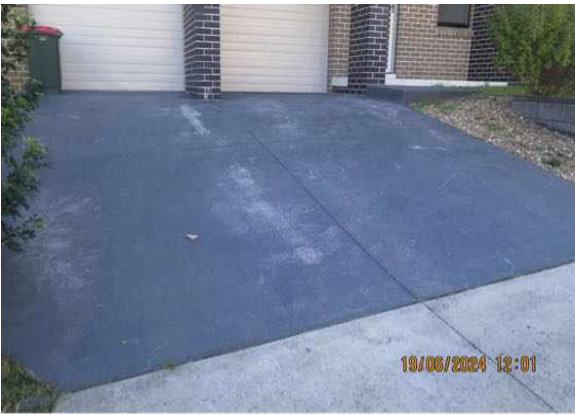
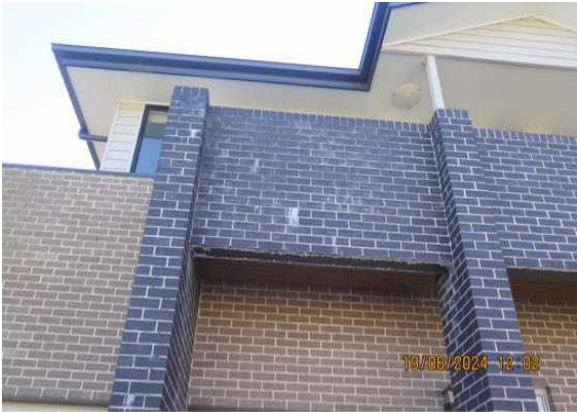
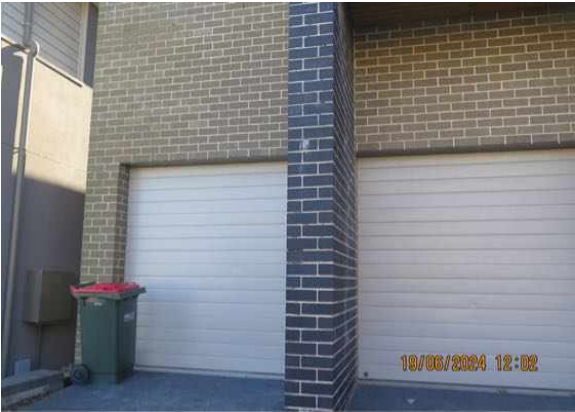
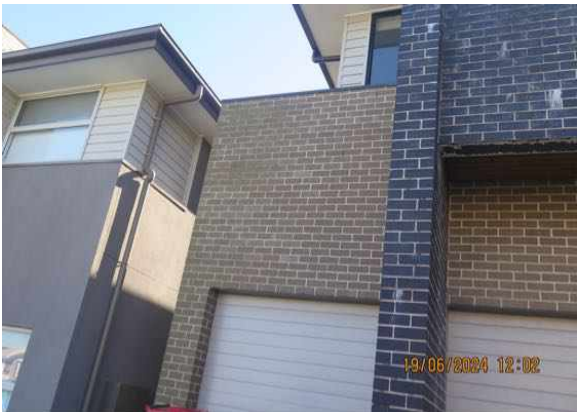
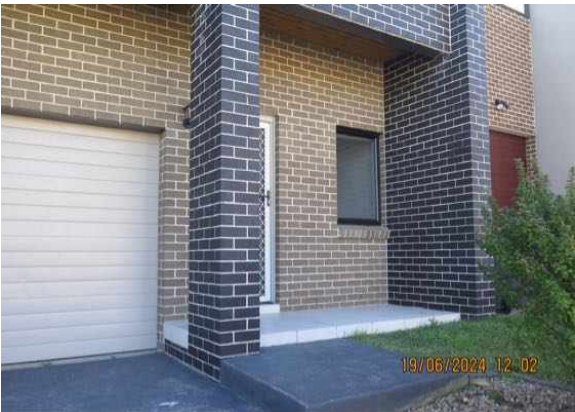
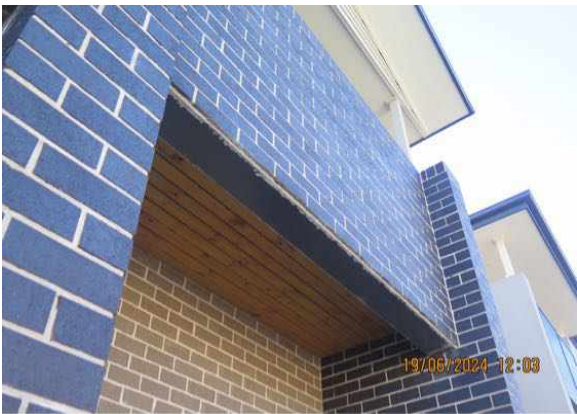
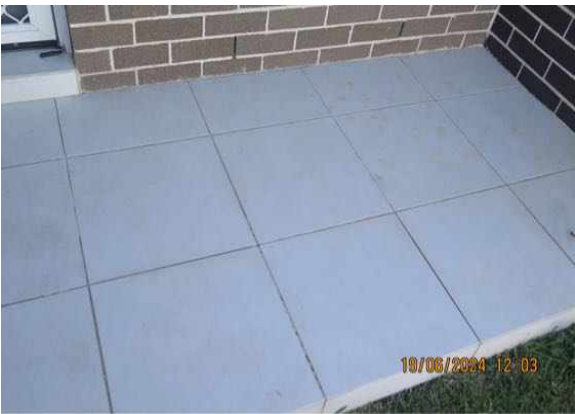
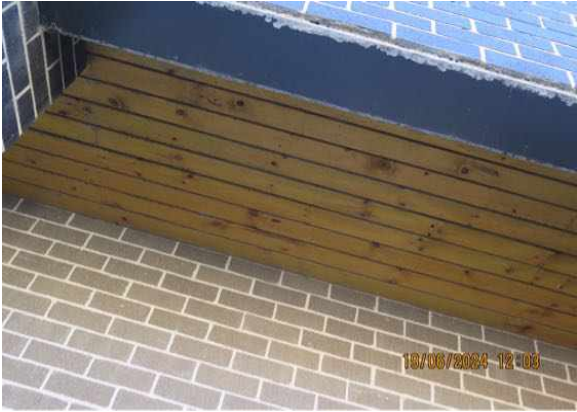
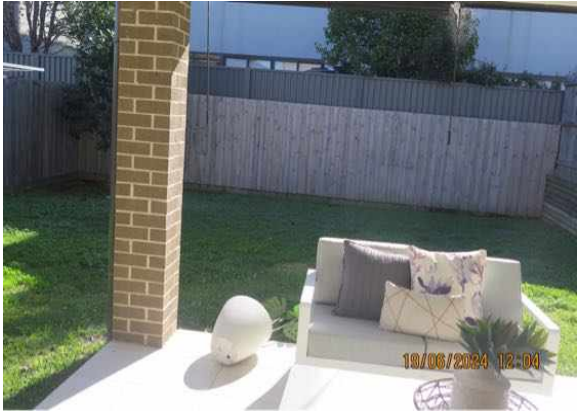
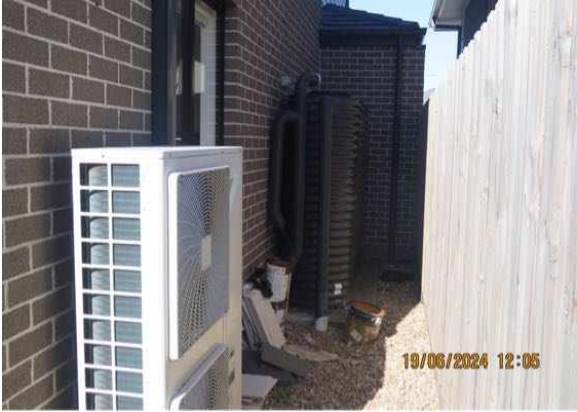
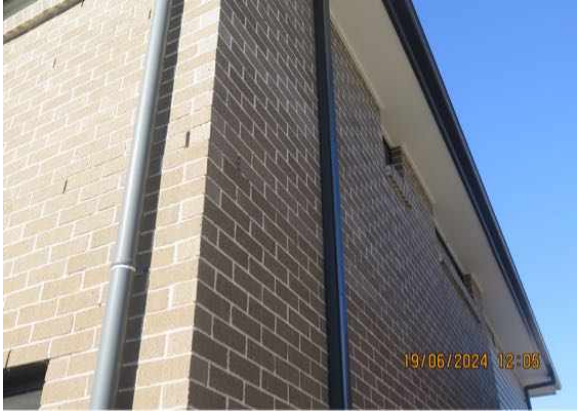
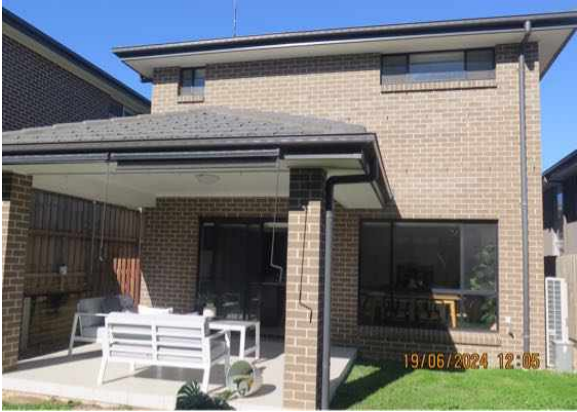
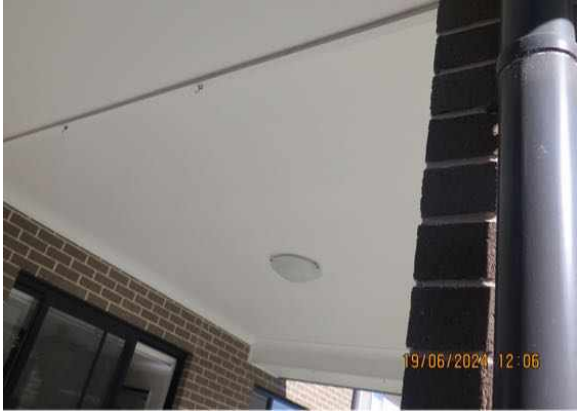
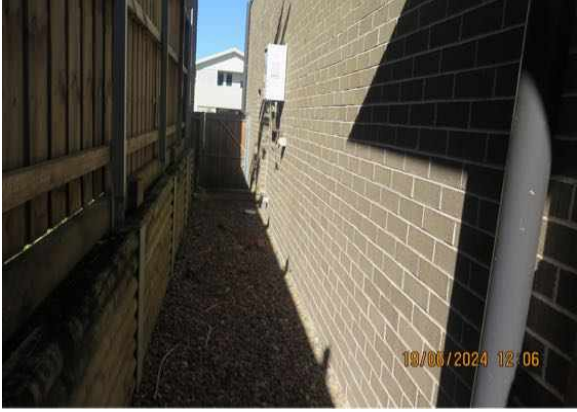
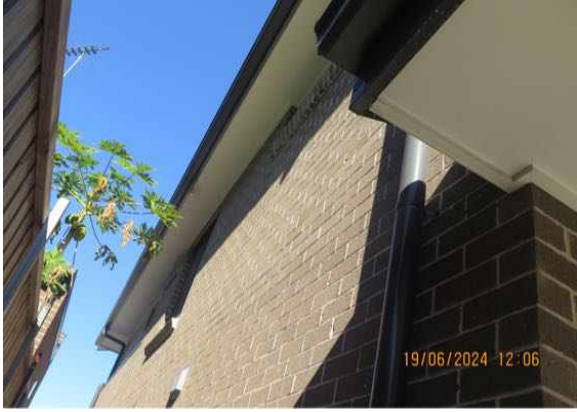
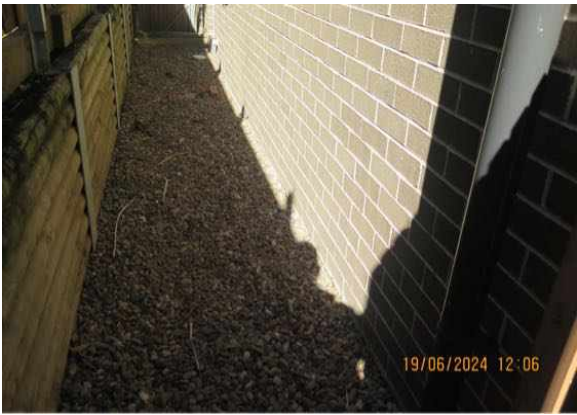
Building: Main Building  
Location: All External Areas  
Finding: Additional Photos  
Information: Additional photos are provided for your general reference

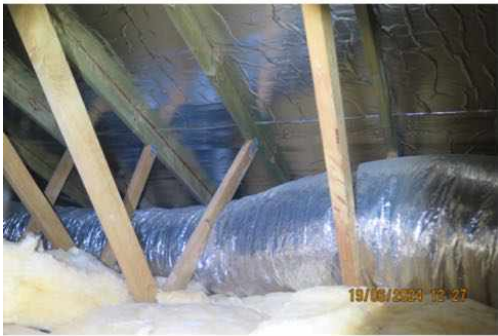
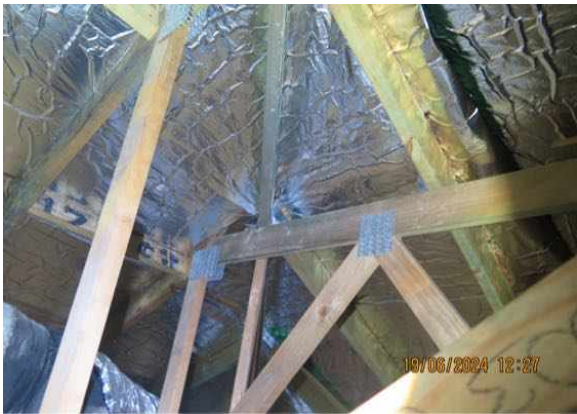
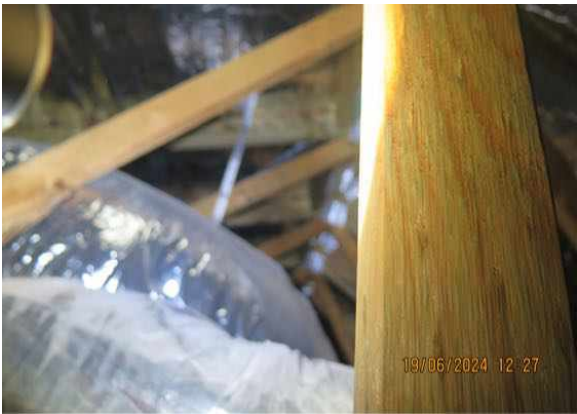
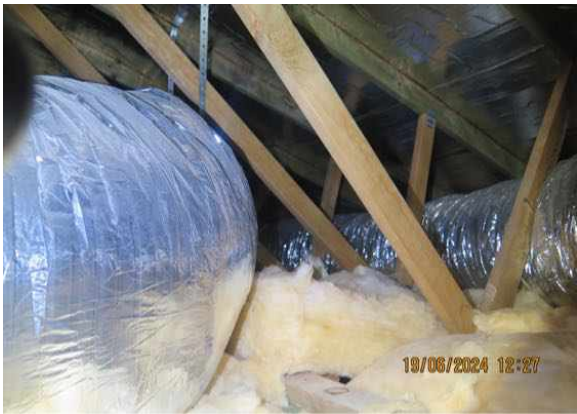
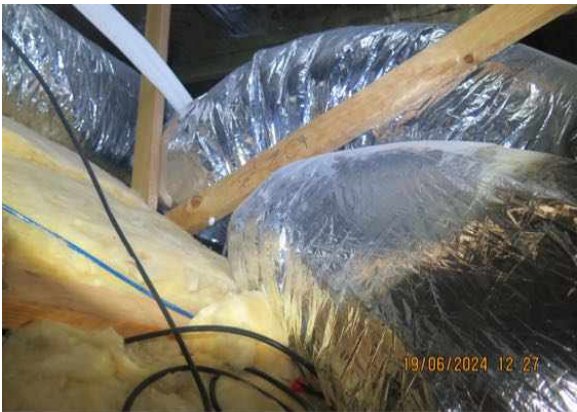
Building: Main Building  
Location: All Areas  
Finding: Additional Photos  
Information: Additional photos are provided for your general reference
