Building and Timber Pest Inspection Report

Inspection Date: Wed, 28 Apr 2021

Property Address: 34 Rangers Retreat Rd, Frenchs Forest
NSW 2086, Australia

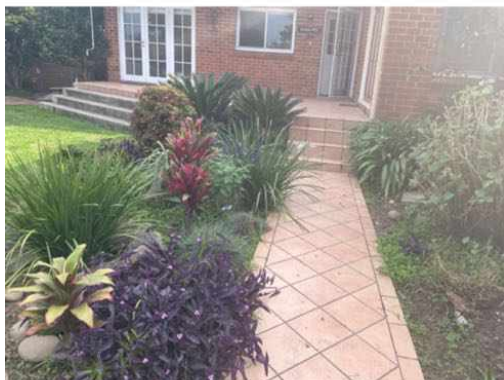
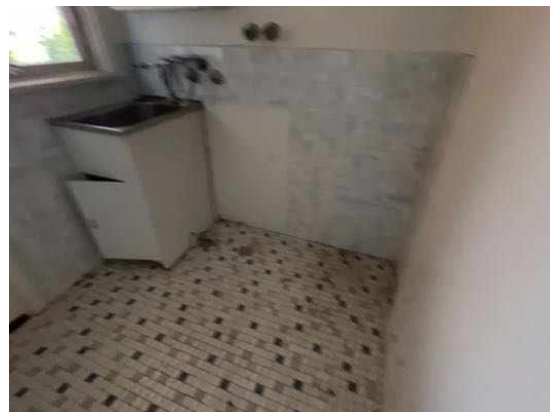
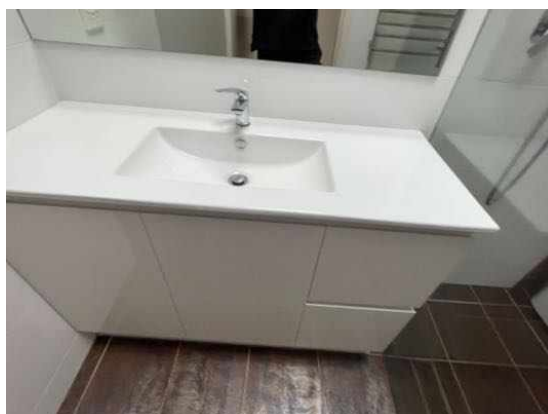
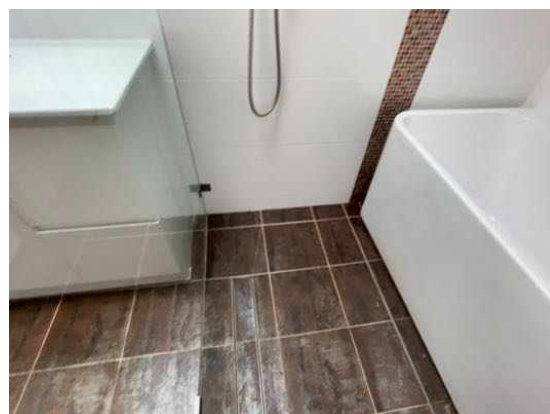
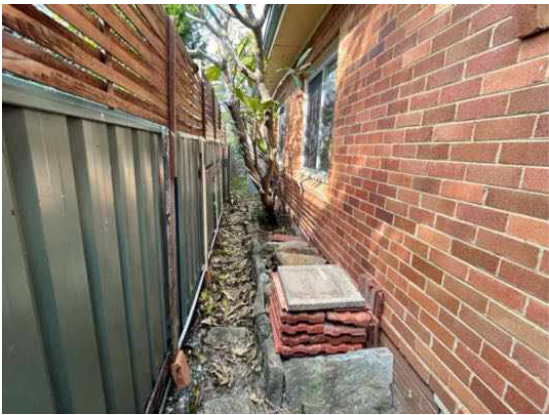
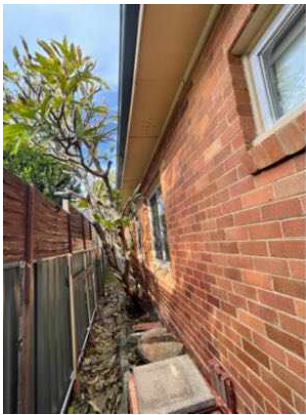
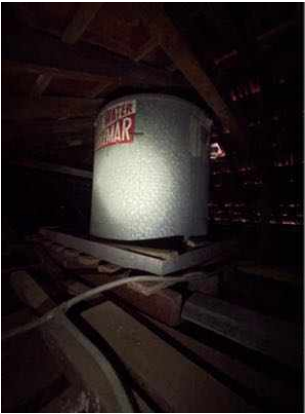
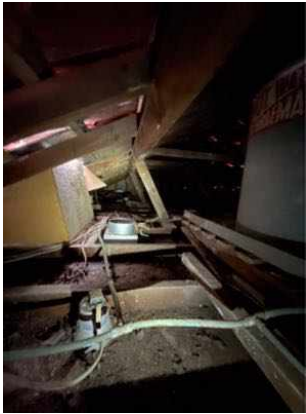
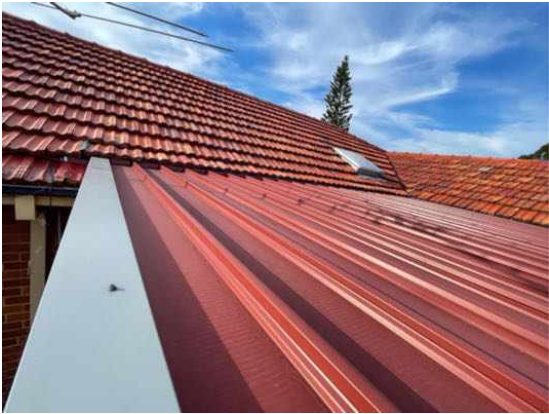
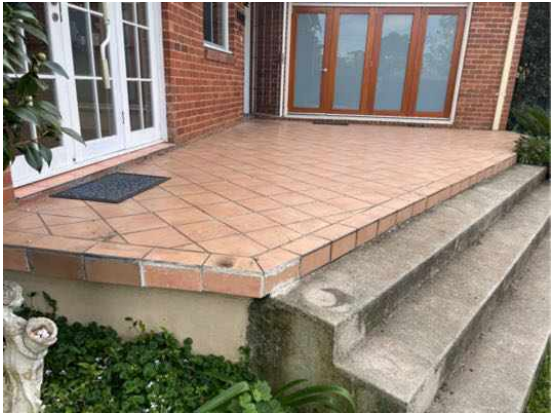
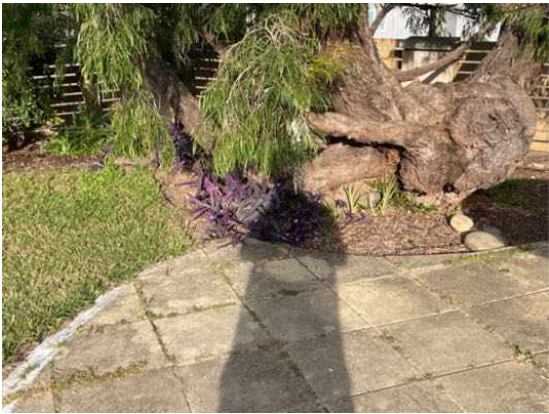
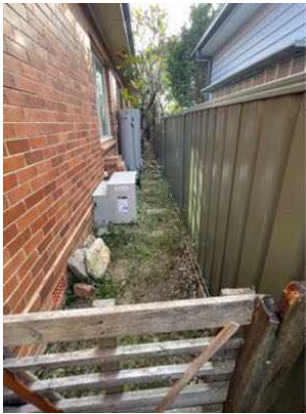
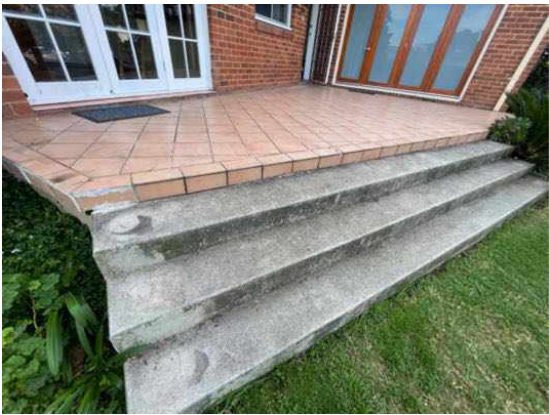
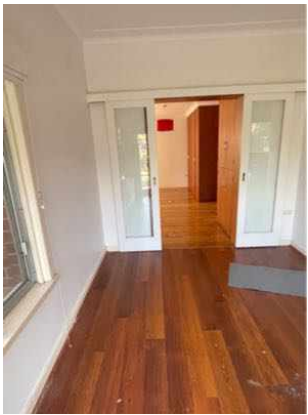
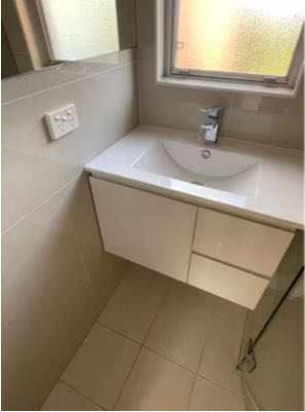
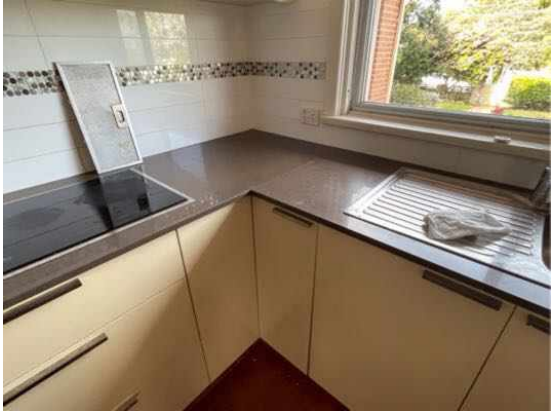
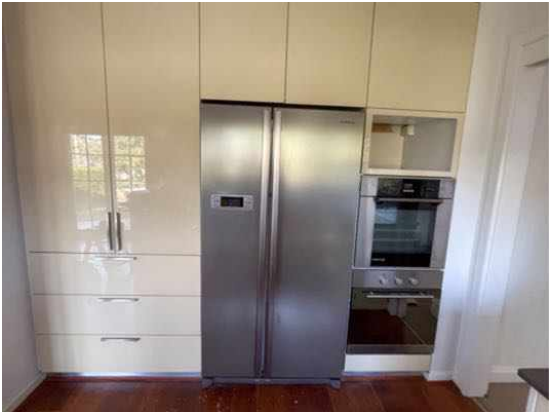
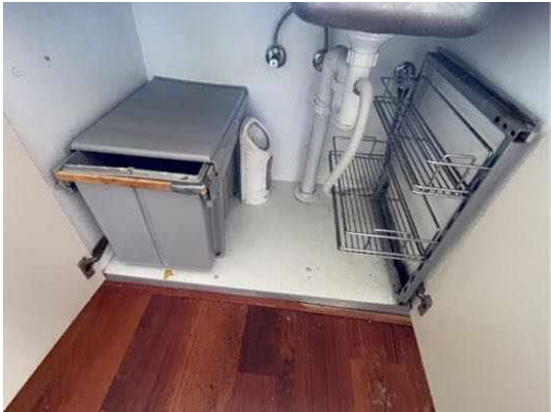
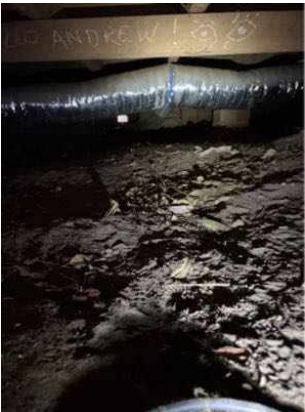
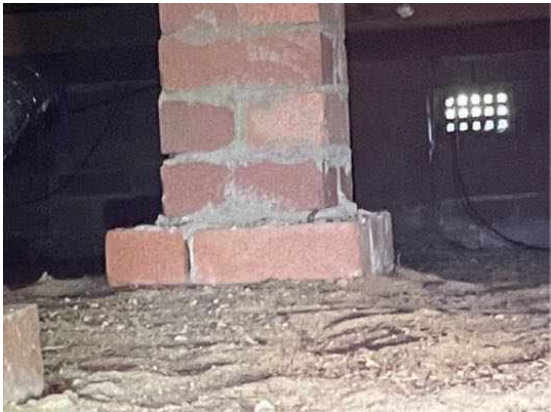
Finding: Additional Photos - Obstructions and Limitations

Information: These photographs are an indication of the obstructions and limitations which impeded full inspection of the property at the time of inspection. These obstructions can hide an array of defects and should be removed to allow full inspection to be carried out.
