## Building and Timber Pest Inspection Report

Inspection Date: Fri, 29 Apr 2022

Property Address: 5 Gilbert Pl, Frenchs Forest NSW 2086,  
Australia

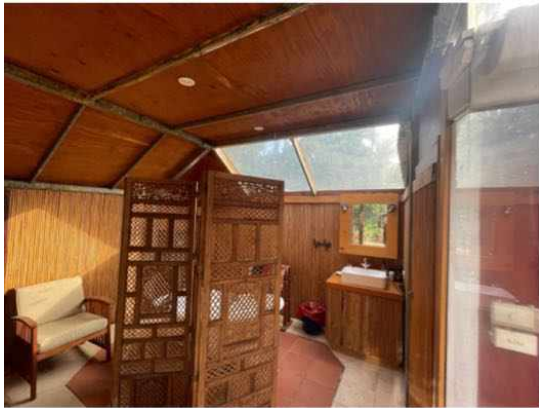
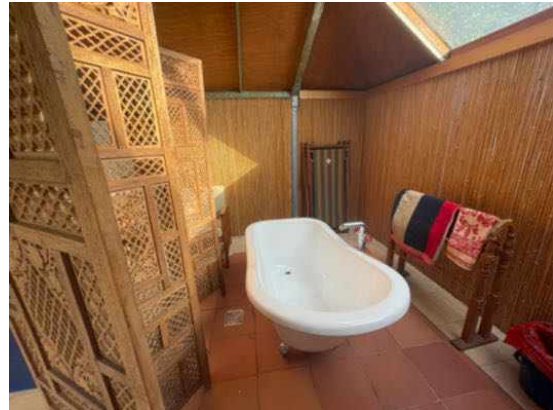
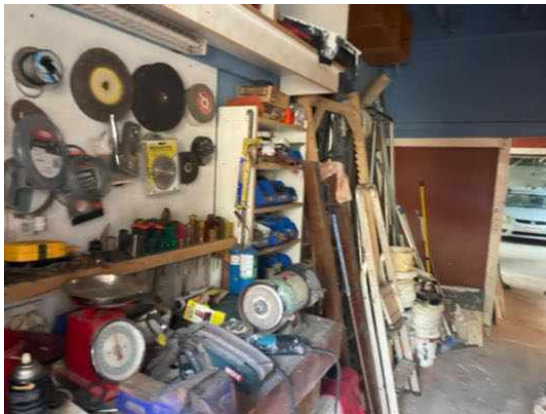
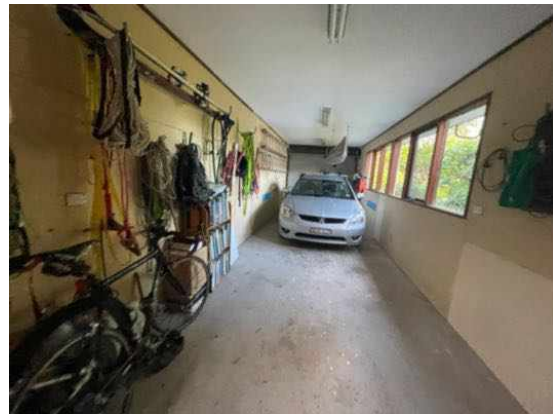
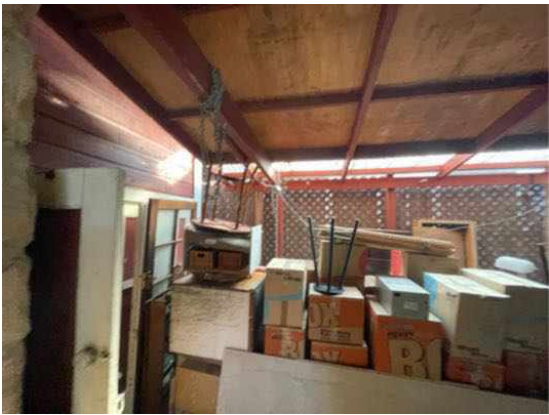
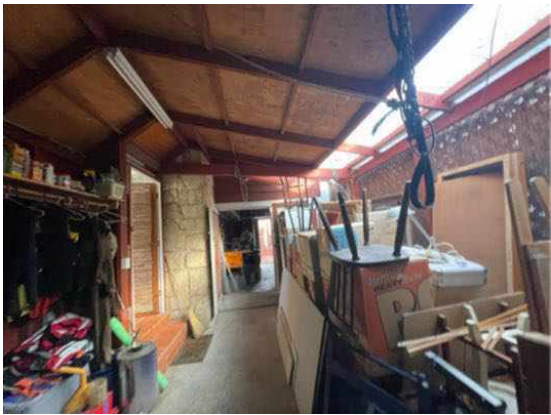
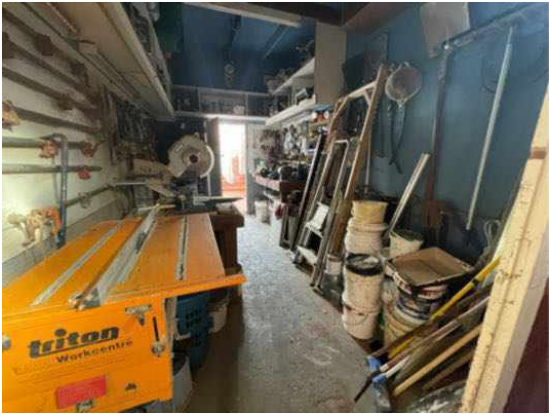
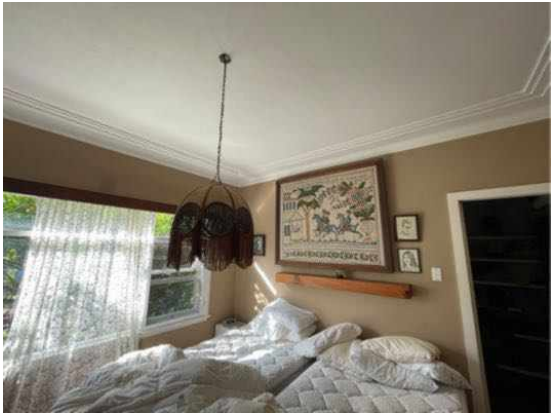
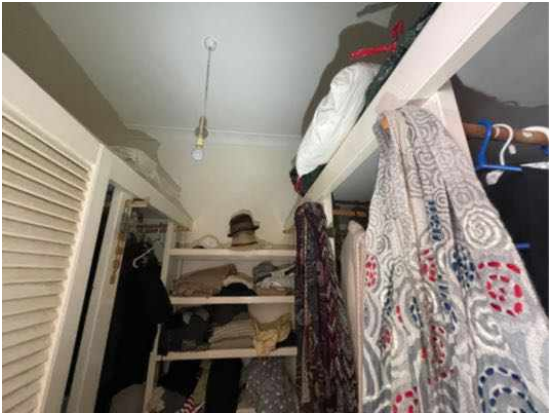
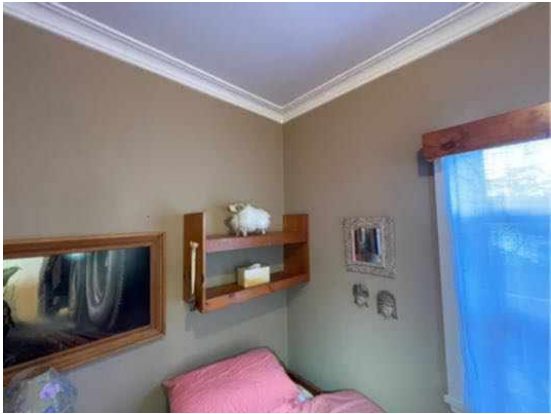
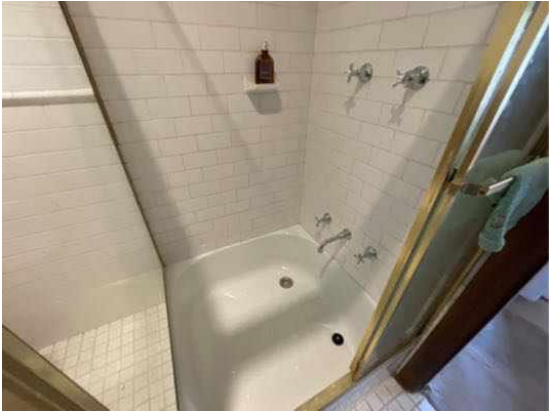
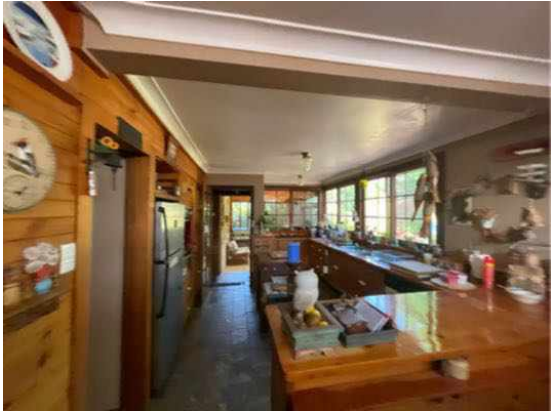
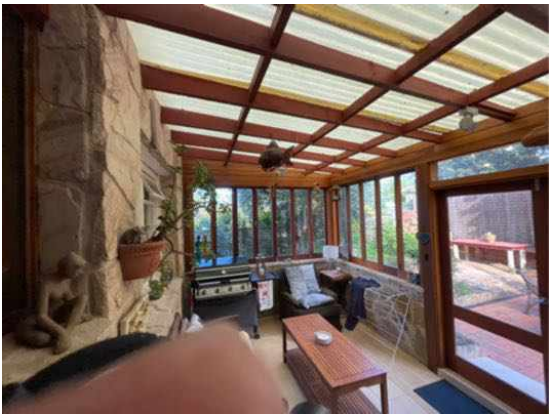
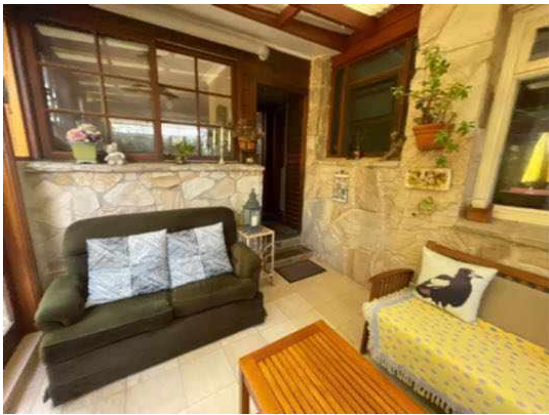
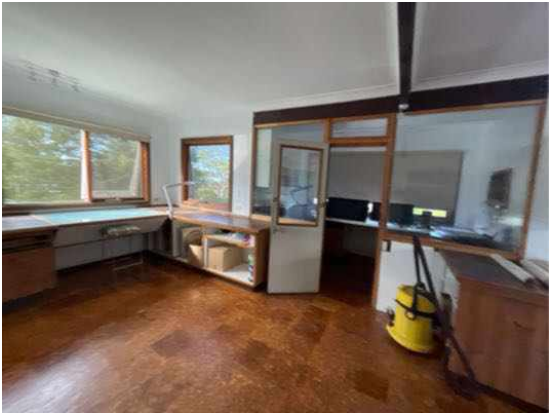
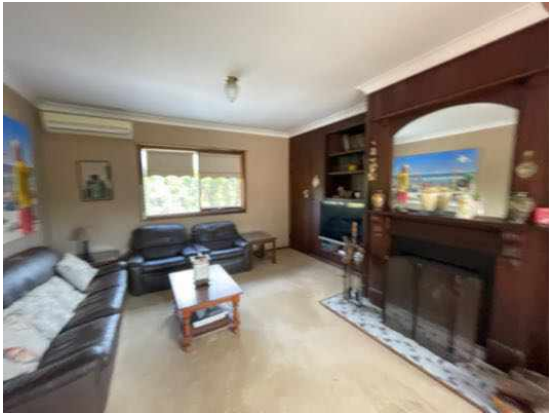
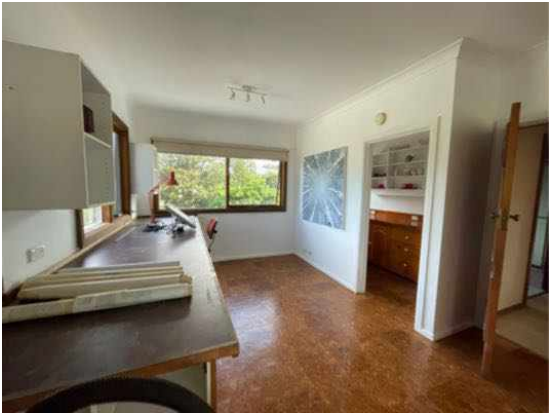
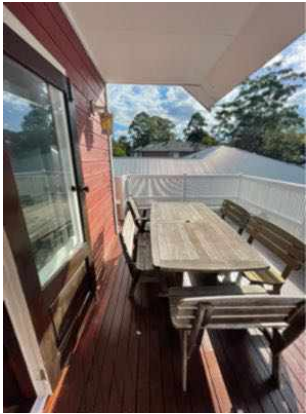
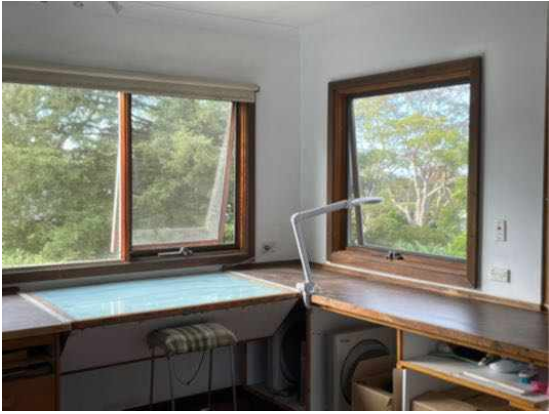
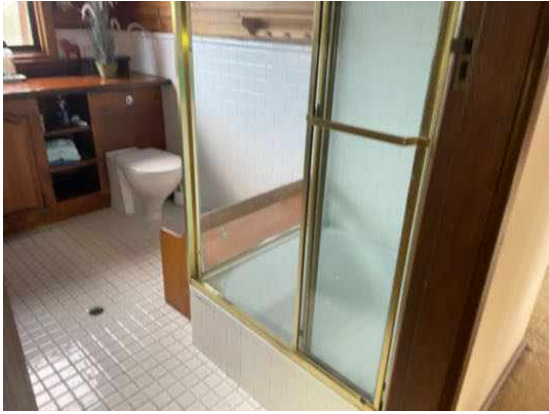
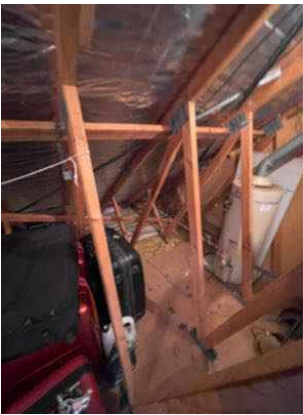
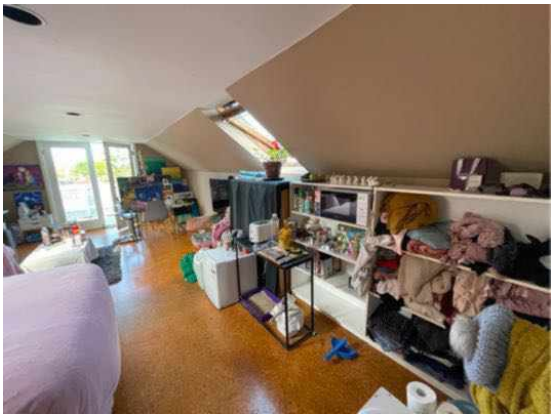
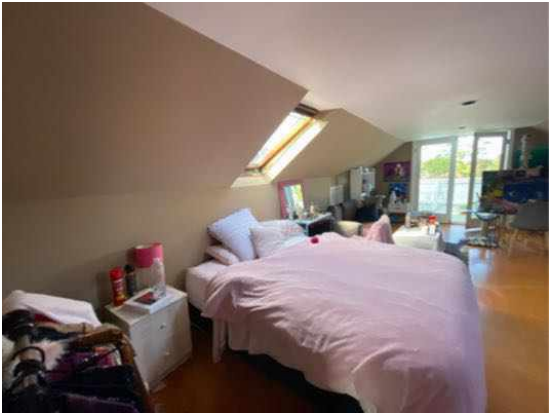
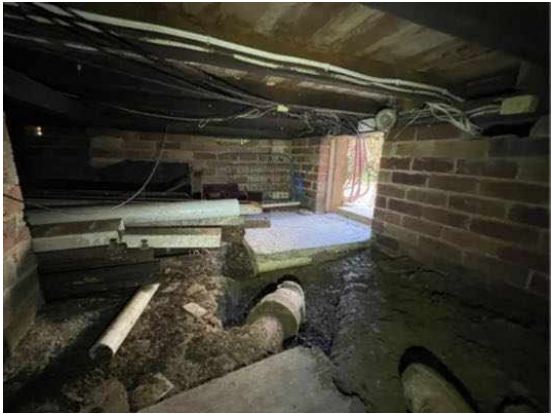
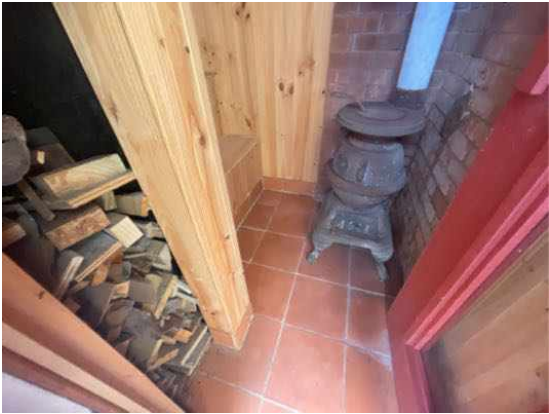
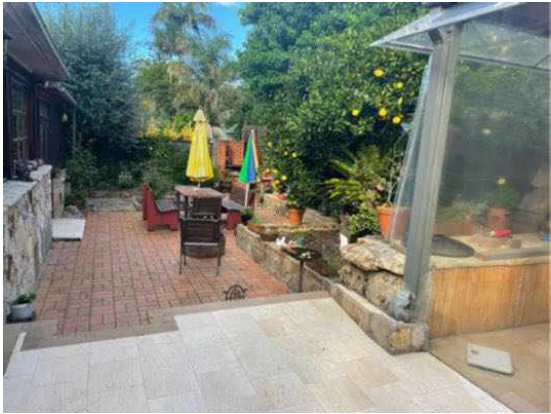
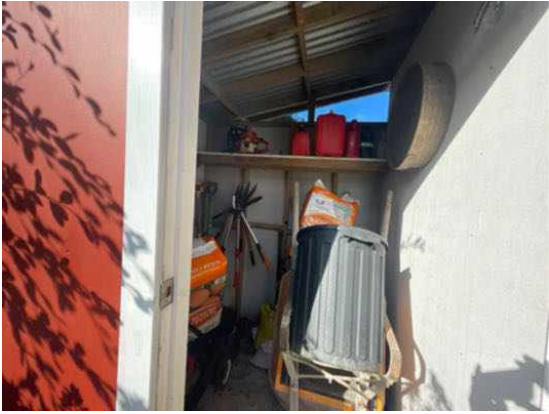
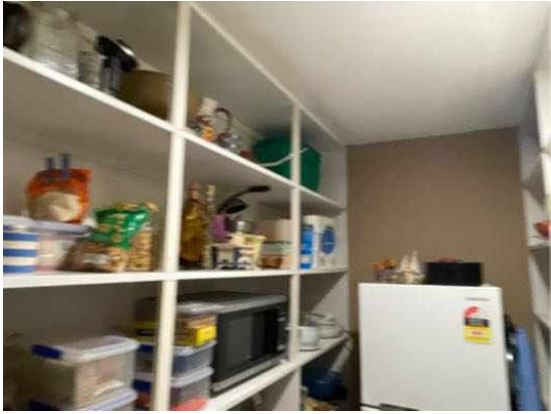
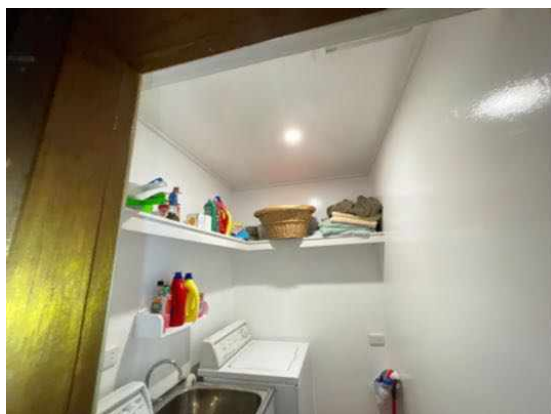
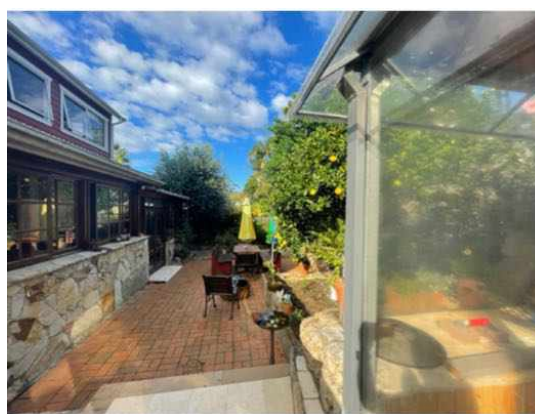
Building: Building 1  
Location: All Areas  
Finding: Additional Photos - Obstructions and Limitations  
Information: These photographs are an indication of the obstructions and limitations which impeded full inspection of the property at the time of inspection. These obstructions can hide an array of defects and should be removed to allow full inspection to be carried out.

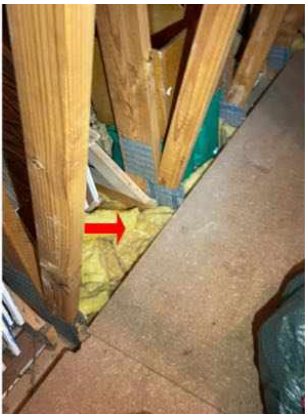
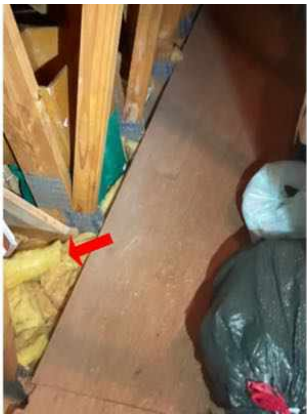
Building: Building 1  
Location: Roof Void  
Finding: Installation - installed  
Information: Installation is under the roof sheeting. Installation acts as an insulator that helps with heat reduction.

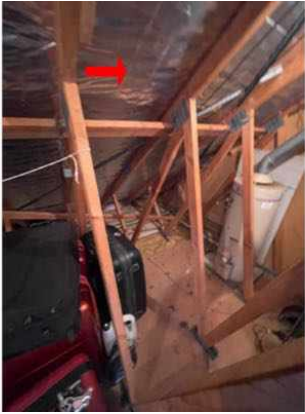
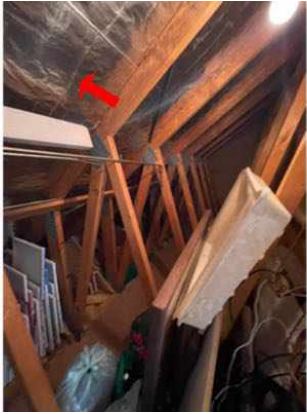
Building: Building 1  
Location: Roof Void  
Finding: Sarking - installed  
Information: Sarking is under the roof sheeting. Sarking acts as an insulator that helps with noise reduction and protects against water penetration. Sarking plays a key role in the operation and function of the overall roofing structure and its performance.
