## **VISUAL BUILDING & PEST INSPECTION REPORT**

Complies with Australian Standard 4349.1 & 4349.6

### **Vendor Report**

**7 Hurdis Avenue Frenchs Forest**

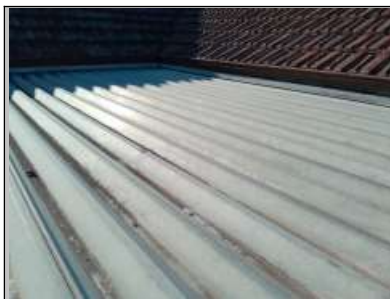
The roof is of skillion style construction.

Corrugated steel.

The overall condition of the roof coverings is fair.

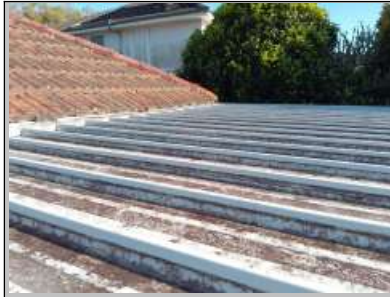
Rear elevation.

The overall condition of the roof coverings is fair.

Flashing material is of sheet metal. Flashings appear to be in serviceable condition.

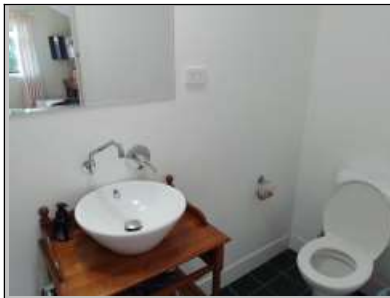
Rear.

The shower recess was tested and there was no visible water penetration to surrounding areas. IMPORTANT NOTE: This test may not reveal water leaks until the shower is put into constant use and surrounding areas monitored over a period of time.

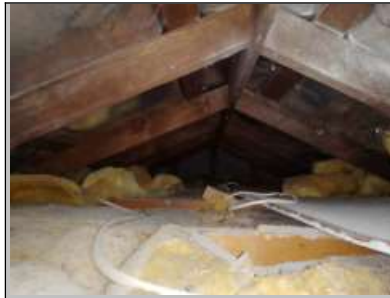
The cut and pitched roof timbers appear to provide adequate support.

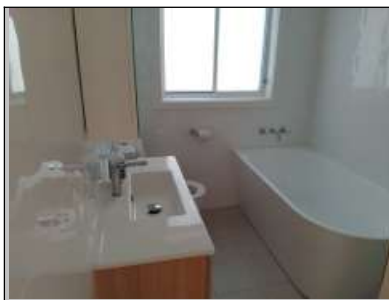
Adjacent to hall.

The shower recess was tested and there was no visible water penetration to surrounding areas. **IMPORTANT NOTE:** This test may not reveal water leaks until the shower is put into constant use and surrounding areas monitored over a period of time.

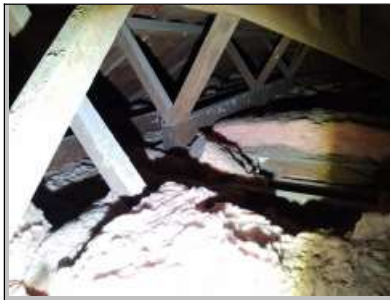
The cut and pitched roof timbers appear to provide adequate support.

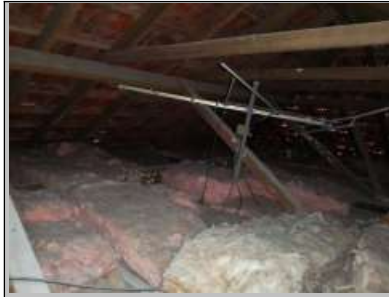
Insulation is present in the roof cavity. This restricted inspection to some roofing timbers. Removal of insulation is not within the scope of a standard visual inspection report, however as in accordance with "industry best standard" the inspector will lift insulation in 3 areas in roof void.
