## Building and Timber Pest Inspection Report

Inspection Date: Fri, 17 Jun 2022

Property Address: 39 Aranda Dr, Davidson NSW 2085,  
Australia

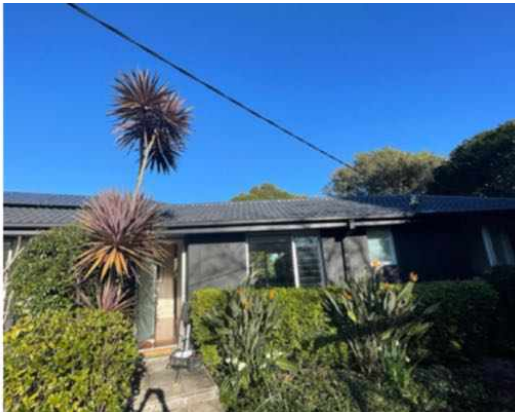
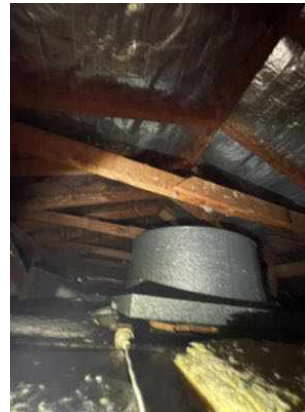
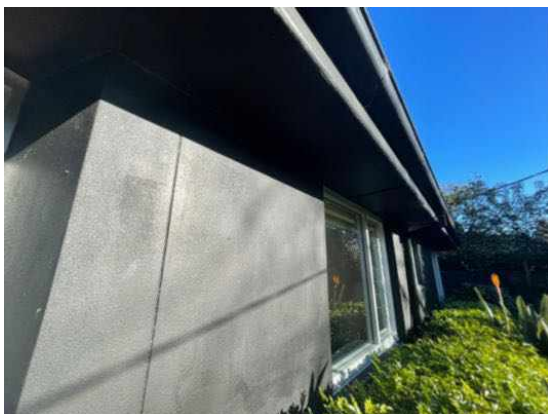
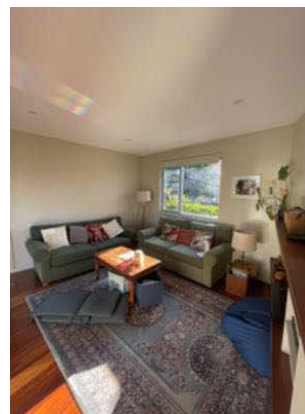
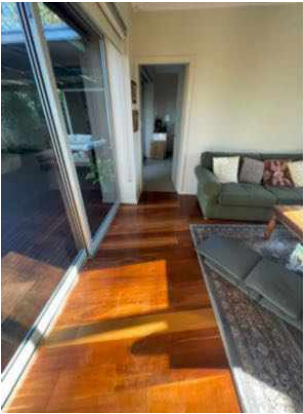
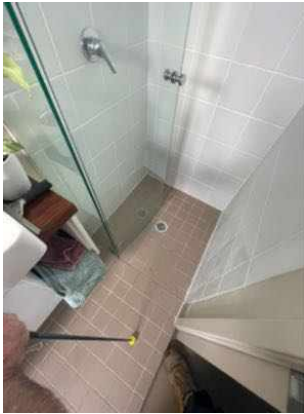
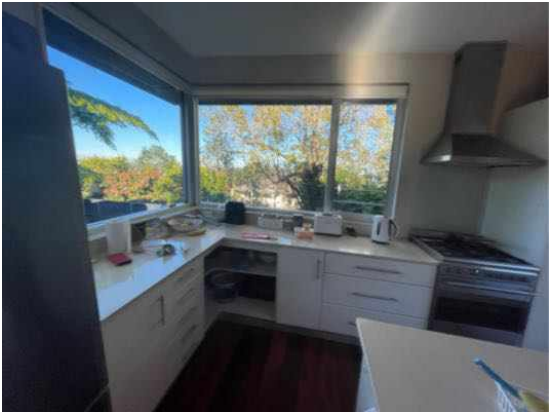
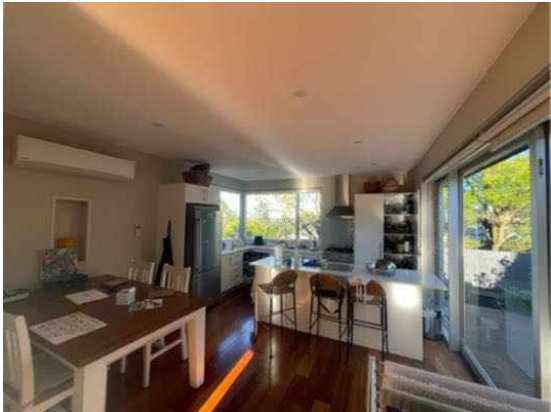
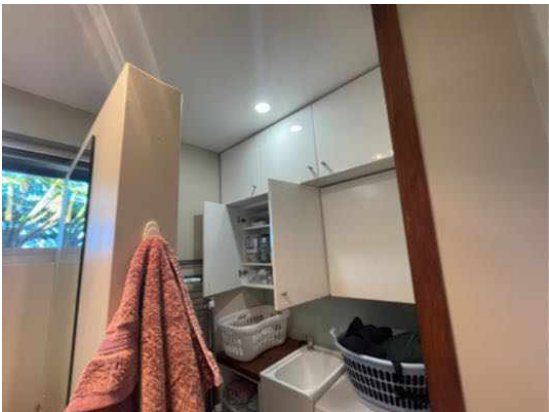
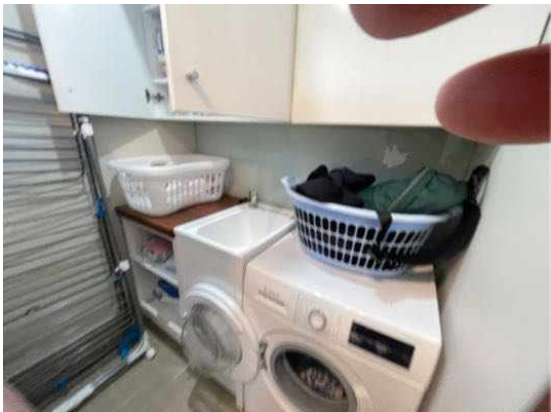
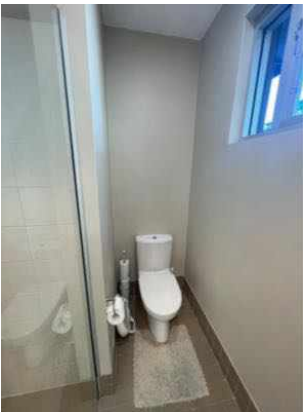
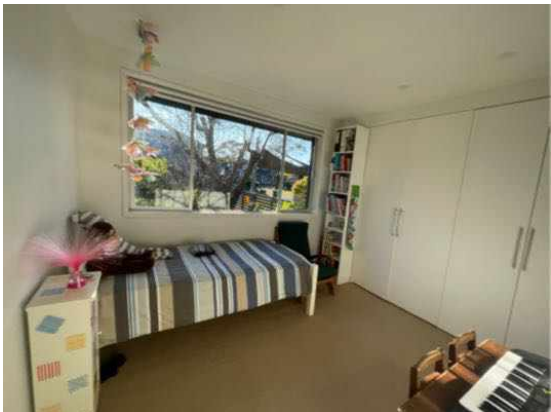
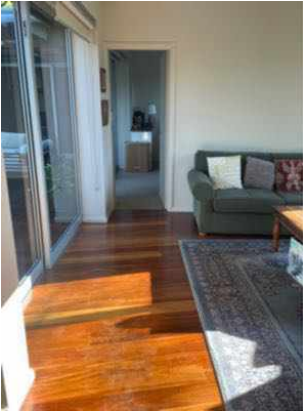
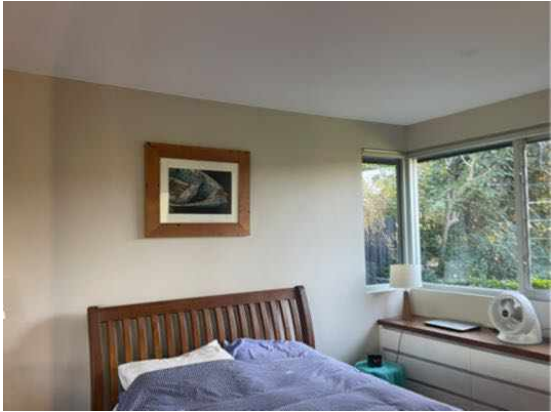
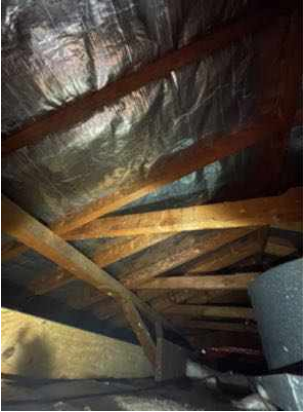
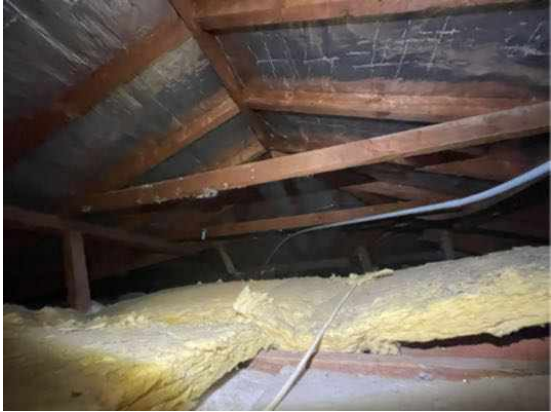
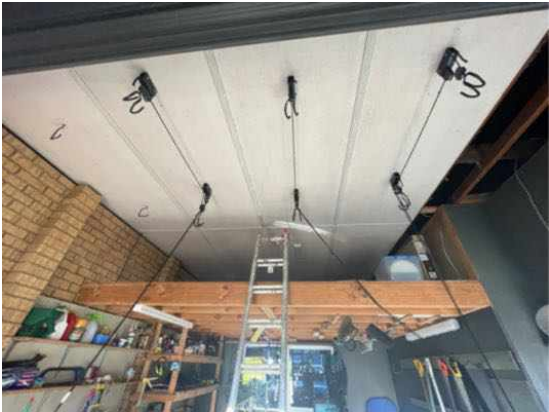
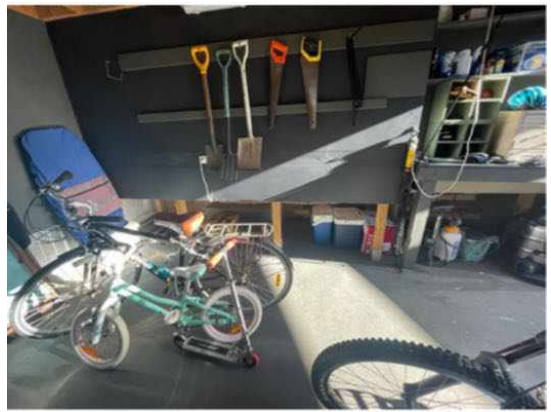
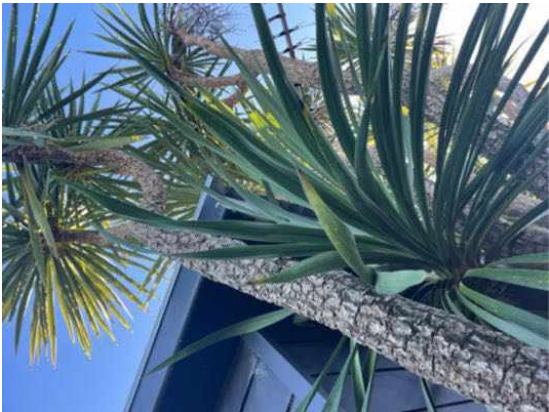
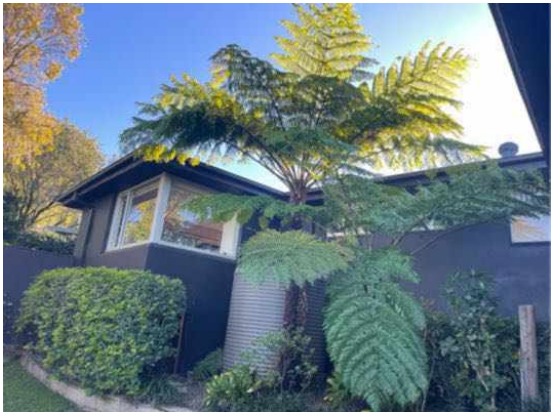
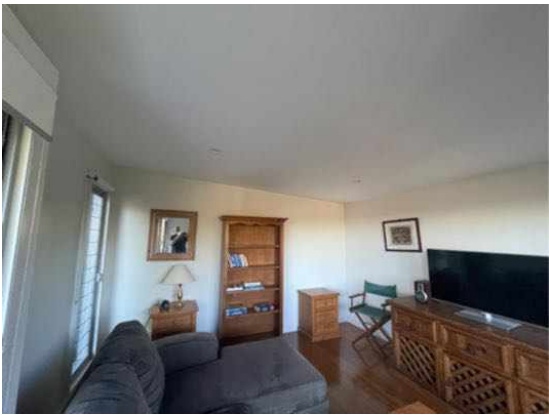
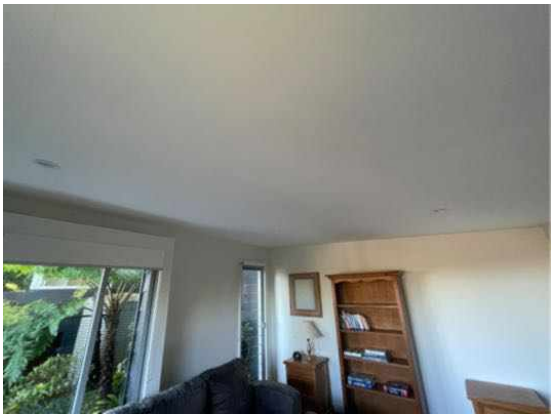
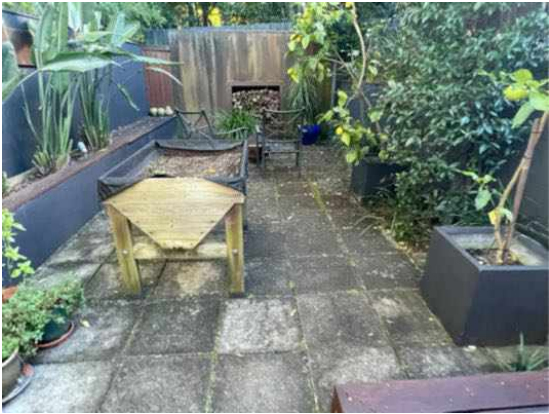
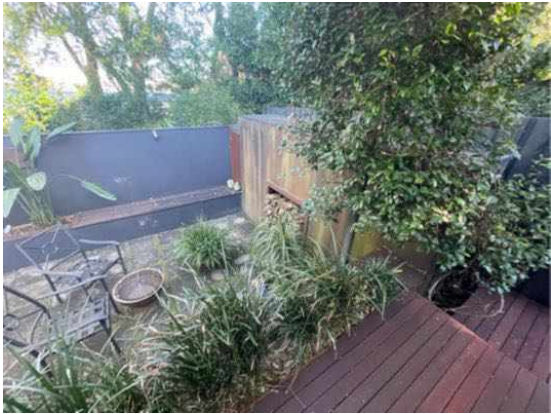
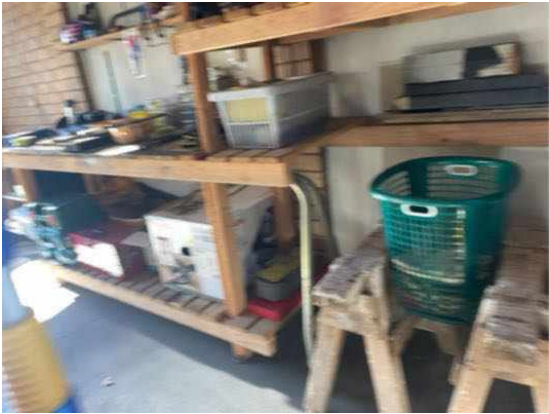
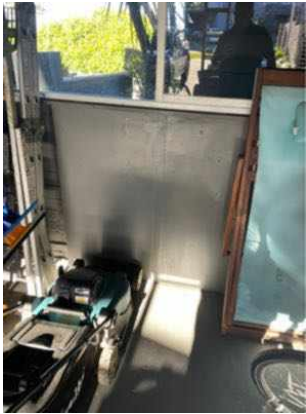
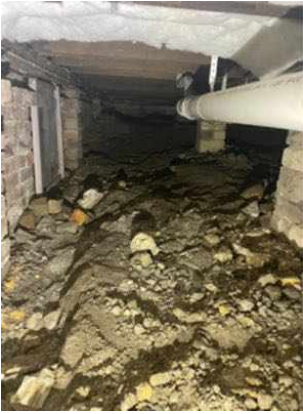
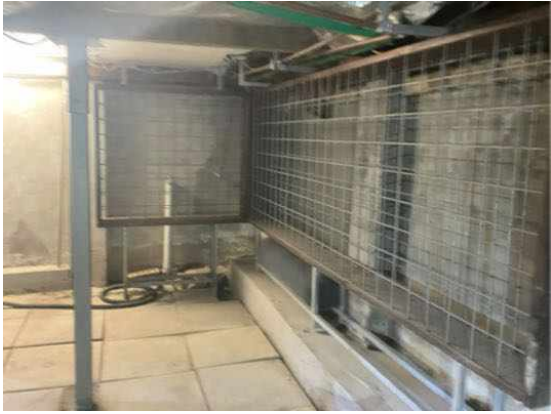
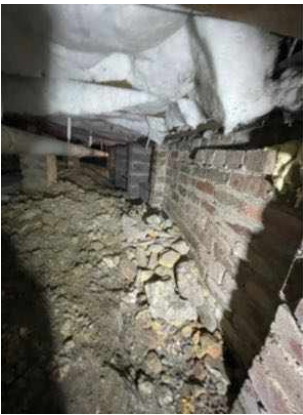
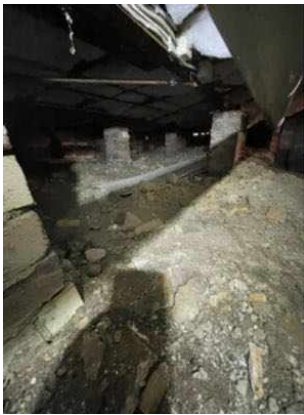
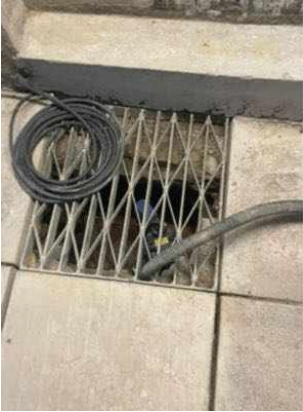
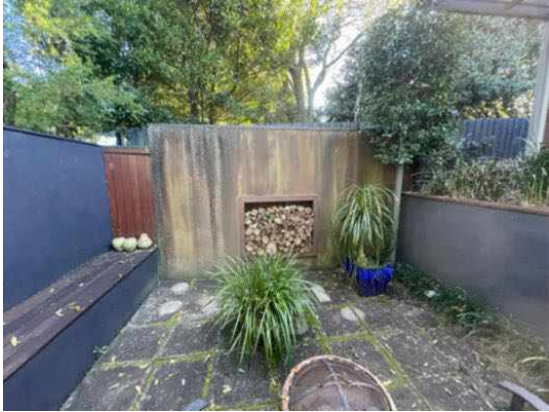
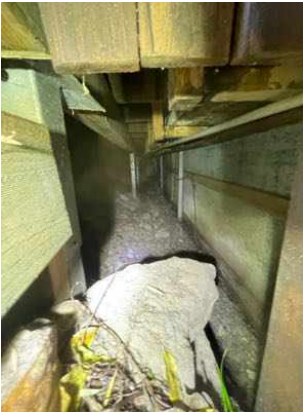
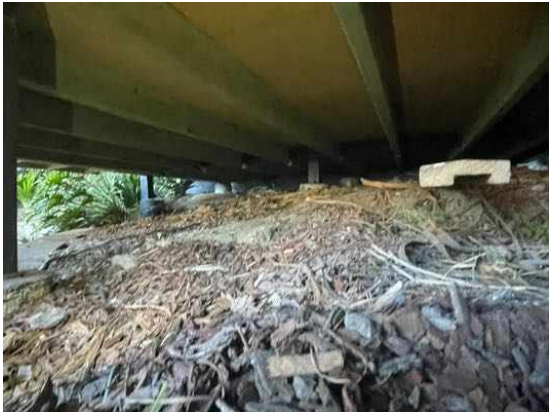
Building:	Building 1
Location:	All Areas
Finding:	Additional Photos - Obstructions and Limitations
Information:	These photographs are an indication of the obstructions and limitations which impeded full inspection of the property at the time of inspection. These obstructions can hide an array of defects and should be removed to allow full inspection to be carried out. A re-inspection is recommended once the areas are made accessible.
