VISUAL BUILDING & PEST INSPECTION REPORT

Vendor Report

2 Naree Road Frenchs Forest

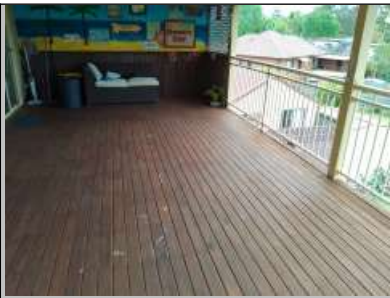
Rear elevation.

The general condition of this structure is fair.

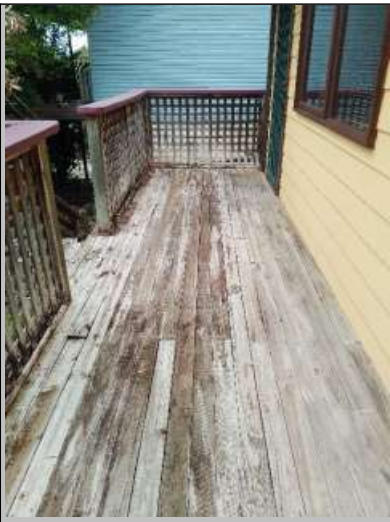
Rear elevation.

Where an external structure is constructed from timber or has significant timber components, and exposed to the elements, a suitably qualified engineer should inspect the structure to determine if it is structurally sound. We cannot determine or advise what weight the structure can hold, The general condition of this structure is fair.

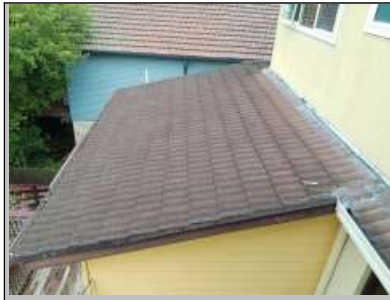
The roof is of pitched construction.

No access was possible to part of the external roof area due to the roof not being accessible from a 3.6 meter ladder.

The overall condition of the roof coverings is fair.

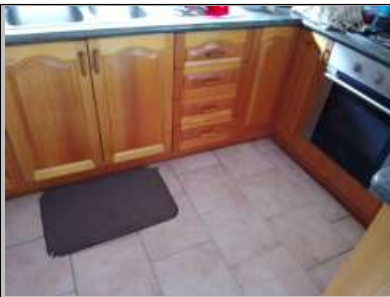
The condition of the fixtures is generally fair.

The condition of the tiles is generally fair.

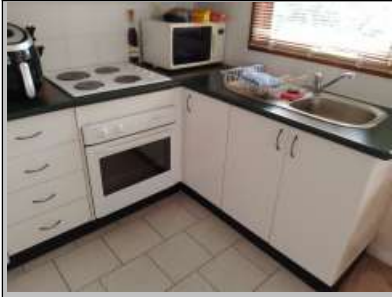
The condition of the fixtures is generally fair.

The condition of the tiles is generally fair.

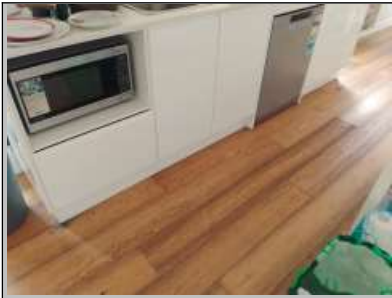
The condition of the fixtures is generally fair. A glass splashback is located over the benchtop area. Glass appears to be in serviceable condition.

Sink and taps appear in serviceable condition. Drain appears serviceable.

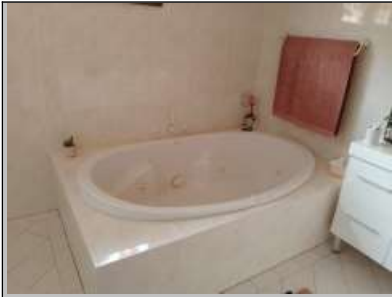
Ground floor. Adjacent to hall.

The shower recess was tested and there was no visible water penetration to surrounding areas. IMPORTANT NOTE: This test may not reveal water leaks until the shower is put into constant use and surrounding areas monitored over a period of time. A spa bath is present however, due to the requirement to fill the unit above jet level for testing the spa was not tested for adequacy or reliability. Defects may be present and not detected.

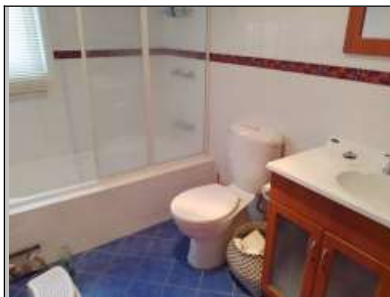
Level one.

The shower is located over the bathtub. The area will need to be kept well sealed to prevent water penetration to surrounding areas.

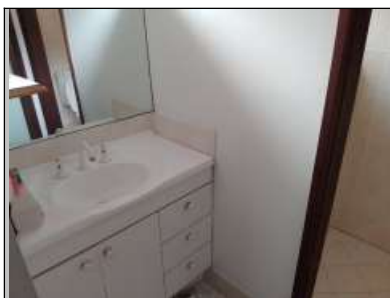
Ground floor.

The shower recess was tested and there was no visible water penetration to surrounding areas. IMPORTANT NOTE: This test may not reveal water leaks until the shower is put into constant use and surrounding areas monitored over a period of time.

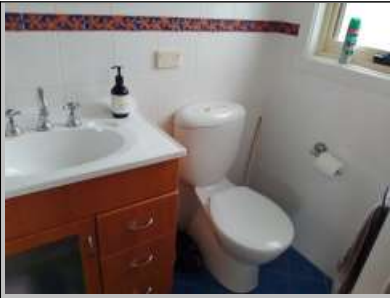
Level one.

The shower recess was tested and there was no visible water penetration to surrounding areas. IMPORTANT NOTE: This test may not reveal water leaks until the shower is put into constant use and surrounding areas monitored over a period of time.

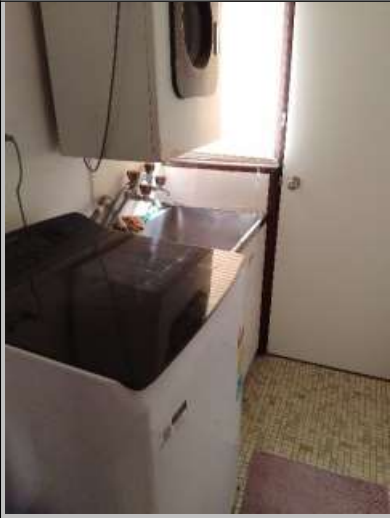
Ground floor.

The tub and taps appear serviceable. Drain appears serviceable.

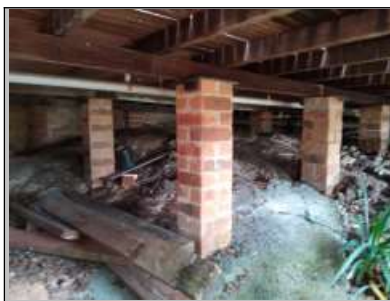
The building is constructed on a combination of strip footings, piers and concrete slab. The footings appear to be generally sound.
