Building Inspection Report

Inspection Date: Mon, 13 May 2024

Property Address: 35 Parni Pl, Frenchs Forest NSW 2086,
Australia

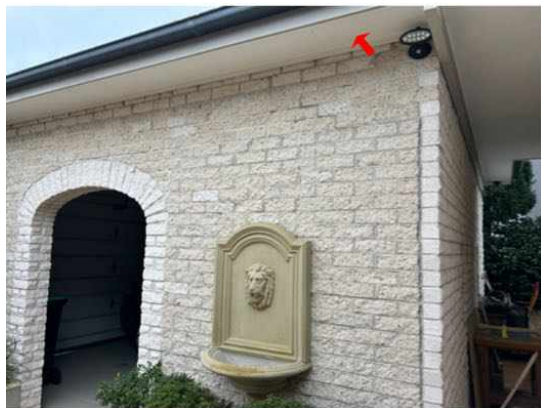
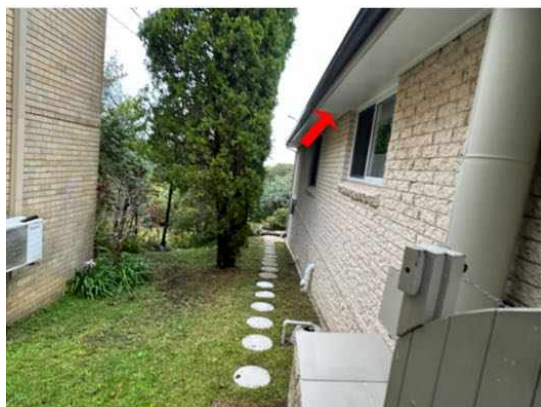
Defects 1.01

Building:	Building 1
Location:	All Areas
Finding:	Asbestos - Suspected ACM Identified on Site
Information:	Reporting on Asbestos is outside the Scope of this Report. This suspected defect is highlighted as a caution only. We suspect, based on our experience in the building industry, that there is a higher risk of the identified building element containing asbestos.

As Asbestos Reporting is outside the scope of this report, we advise that you consider a separate Asbestos Inspection and Condition Audit, which can include the taking of samples for definitive confirmation of the presence of Asbestos.

In the interim, the client is advised to act with caution, especially when considering any damage to building materials general wear and tear renovations extensions demolition and general maintenance activities due to the suspected presence of Asbestos.

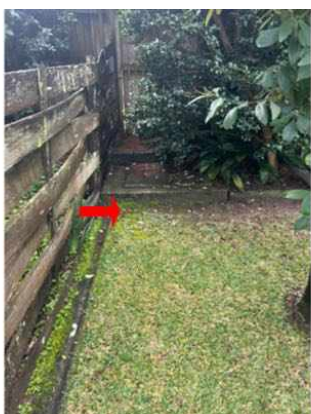
Defects 3.01

Building: Building 1
 Location: All Areas
 Finding: Evidence of excessive moisture was present at the time of inspection
 Information: Excessive moisture is generally caused by deteriorated inadequate or missing roof drainage leaking plumbing pipes or fixtures poorly plumbed HWS overflows or condenser units and poor site drainage.

Excessive moisture can attract termites and produce conditions that promote termite attack fungal growth and wood decay.

It is recommended that all plumbing and drainage fixtures and fittings be maintained regularly in order to prevent excessive moisture being present in the external / internal property.

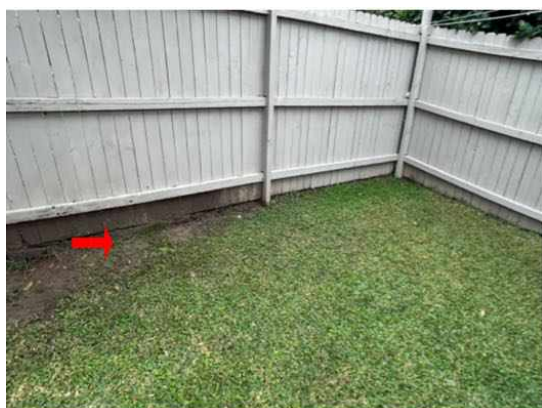
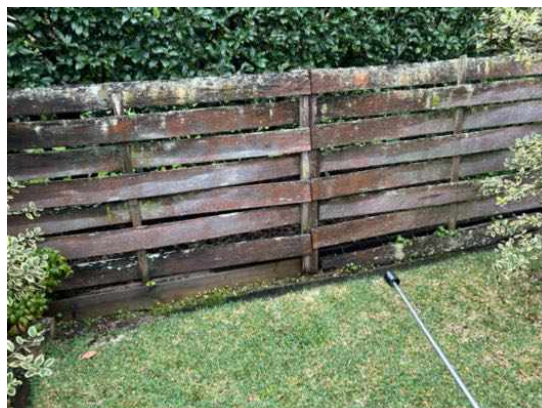
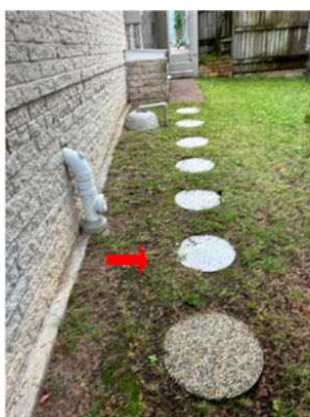
Defects 3.02

Building: Building 1
 Location: All Areas
 Finding: Site drainage - suspected Inadequate
 Information: The site drainage in this area was found to be inadequate at the time of inspection, creating potential for subsequent water damage to associated building elements.

It is important that water does not lie against the base of walls; surrounding paths and ground levels should be sloped to drain water away from walls. Downpipes should not discharge stormwater onto lower walls or plinths. Stormwater should be carried away by large, regularly cleaned drains. Ground levels may need to be lowered to expose a buried DPC.

Where site drainage is inadequate, installation of an Agricultural (Aggie) Drain may be required. A qualified plumber should be appointed to further inspect the property and perform any remedial works as necessary. Water damage and secondary defects are likely to occur if left unmanaged.

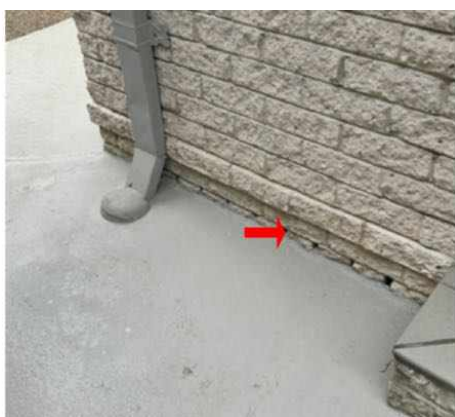
Defects 3.03

Building: Building 1
 Location: All External Areas
 Finding: Weep holes - particularly obstructed
 Information: It was noted during the time of inspection that some of the weep holes to the

brickwork were particularly obstructed. Weep holes are designed to allow water from leaks or seepages in brickwork to be directed to the external environment, prior to entering the wall cavity or associated building materials. Weep holes should therefore be kept clean and free of debris or blockages.

Particular obstruction weep holes are likely to result in the presence of excessive moisture within the brickwork and associated structures, creating potential for water damage and moisture problems.

Depending on the nature of the blockage, the homeowner may be able to undertake remedial works.

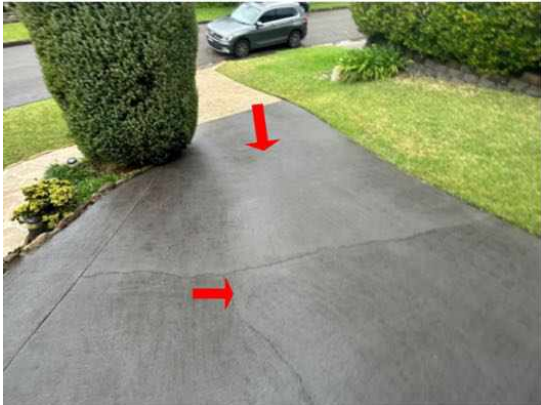
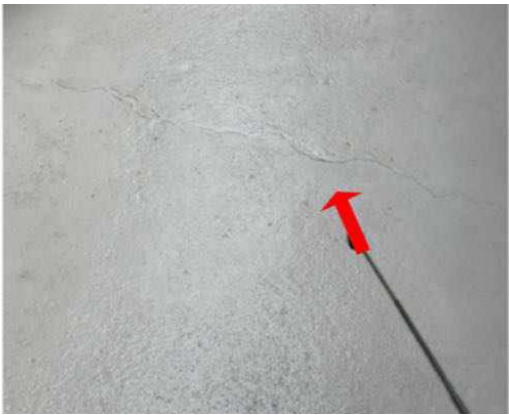
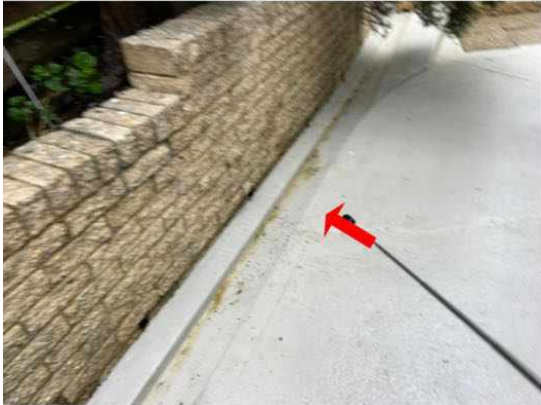
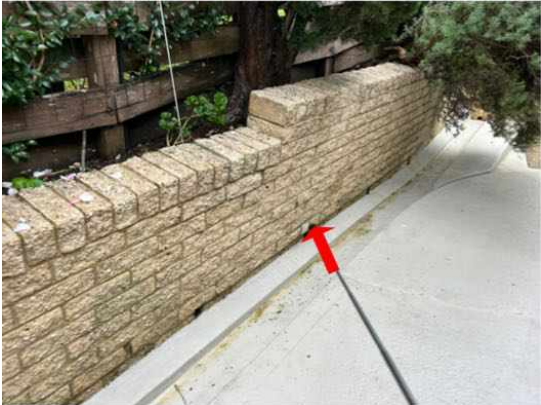
Defects 3.04

Building:	Building 1
Location:	All External Areas
Finding:	Crack in concrete slab - Category 1
Information:	A crack coded as Category 1 was identified in the slab. A Category 1 crack is described as a fine but noticeable crack, with the slab at an otherwise reasonable level.

Category 1 cracks should be monitored for a period of 12 months. At the end of the monitoring period, identified cracks that are rated greater than Category 2 are considered defects, and require rectification.

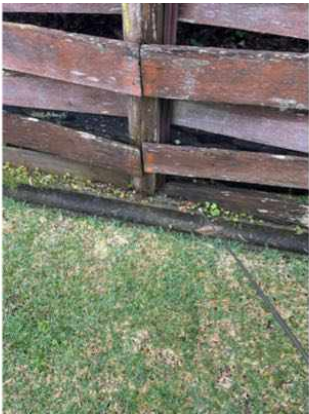
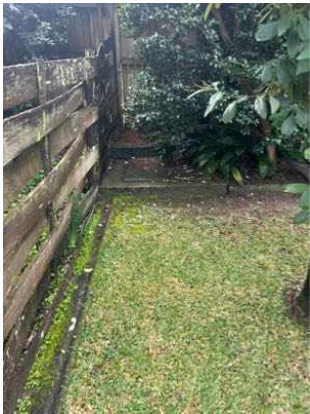
Defects 3.05

Building: Building 1
Location: All External Areas
Finding: Fencing - Deteriorated
Information: It was noted at the time of inspection that sections of the fencing throughout the property have deteriorated. Typically fencing deteriorates due to age and or wear, rot and or rust which is generally expected for a structure of this age, due to prolonged exposure to weather conditions.

If left unattended, it is may develop further damage will occur.

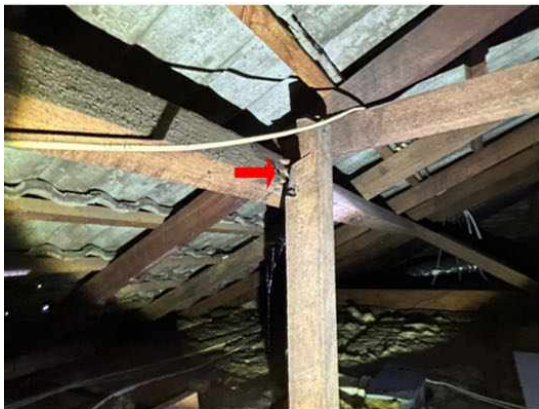
Defects 3.06

Building: Building 1
Location: Roof Void
Finding: Roof structure - repair required
Information: Upon inspection of the roofing structure a timber was observed to need re fastened.

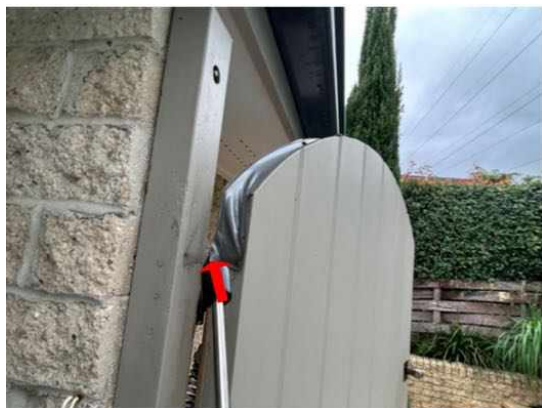
Defects 3.07

Building: Building 1
Location: All Areas
Finding: Incomplete works
Information: The works to this area appear to be incomplete at the time of inspection.

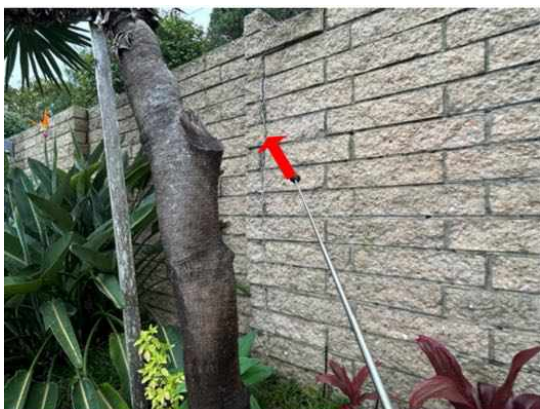
Defects 3.09

Building:	Building 1
Location:	Pool Area
Finding:	Brickwork - Cracking noticeable
Information:	There were several cracks and or crack repairs evident to external brickwork.

Noticeable cracks are a common occurrence in external brickwork and are a likely result of age expected building movement, general expansion, and/or contraction of building materials in different weather conditions. Noticeable cracks in brickwork may develop if left unattended, with potential for necessitating major remedial works or replacement of the brickwork.

It is highly advised that a qualified bricklayer be appointed to provide necessary works to cracked brickwork to prevent any further damage. Such works should be conducted as soon as possible.

Always monitor these cracks and contact a building inspector should cracks widen, lengthen, or become more numerous.

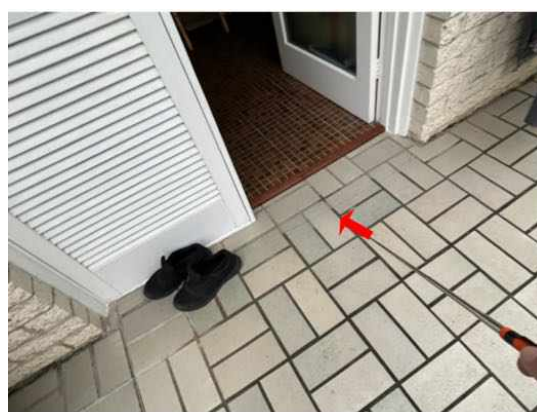
Defects 3.10

Building:	Building 1
Location:	All Areas

Finding: Floor tiles - Cracked

Information: Cracking in the floor tiles was evident in this area at the time of inspection. It is suspected that this cracking has occurred as a result of the floor being uneven and lacking a solid or suitable foundation for the tiles to be laid on. Settlement in the floor foundations may also have caused movement and resulted in the cracking of tiles in this area.

Cracked tiles throughout the household detract from the overall appearance of the affected areas, as well as creating potential for water penetration to adjoining building elements. If left unmanaged, water damage may occur as a result of constant water penetration over a prolonged period of time.

While not considered a matter of urgency, replacement of cracked floor tiles is advised as a solution. A tiling contractor or general handyperson may be appointed to perform these works at client discretion. Where cracks become more numerous, consultation with a registered builder specialising in re-stumping may be required.

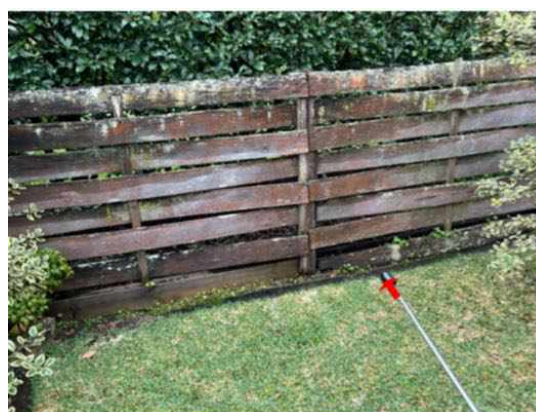
Defects 3.11

Information: Where evidence of growth was noted, there may be environmental, biological or health

Generally, the client is advised to ensure that the general environment is free of moisture and humidity to aid in the prevention of mould formation and development. Any mould found during the inspection should be cleaned immediately by a cleaning contractor or the homeowner as applicable.

Please note that severely affected building elements may require replacement by a registered builder or qualified carpenter.

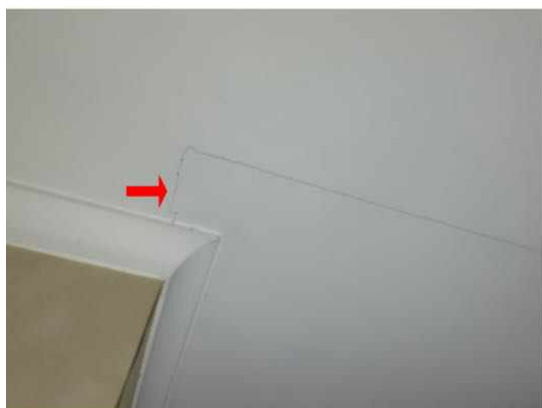
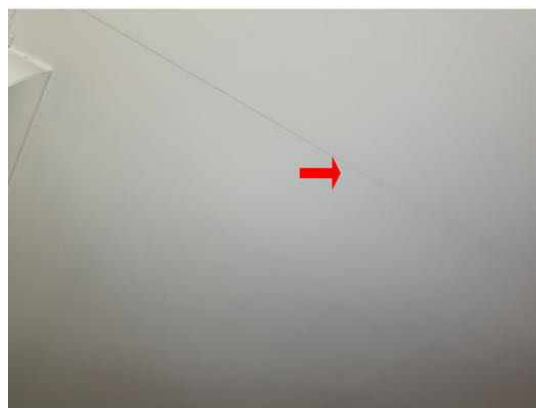
Defects 3.12

Building:	Building 1
Location:	Lounge Room
Finding:	Cracking Ceilings - Minor
Information:	Cracking which are evident at cornices/wall and/or ceiling junctions are common and usually occur due to separation of the building material due to changes in moisture levels or timber frame shrinkage as part of the drying process.

Although cracks are noticeable, they are often only considered to be an appearance defect and usually do not indicate any structural damage but may be as a result of impact damage which will require rectification works to be conducted.

Cracking of this nature can generally be repaired with minor sanding, filling and/or repainting. Such works should be performed by a qualified painter or a general handyman.

Monitoring of all cracking should be conducted frequently. Always contact a builder should cracks widen, lengthen, or become more numerous

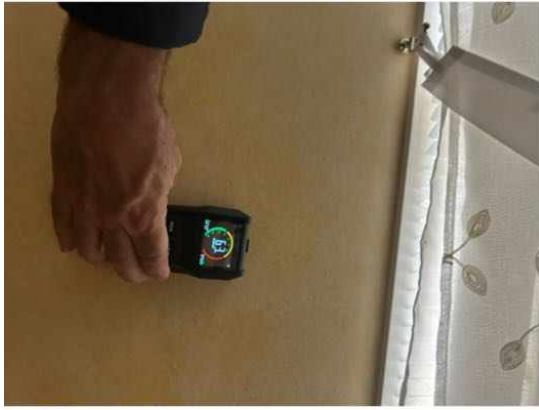
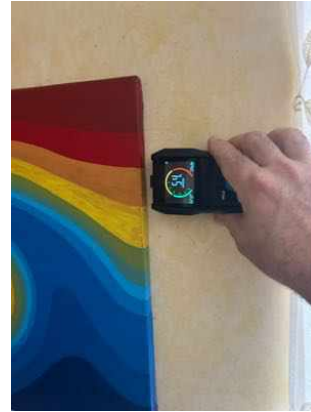
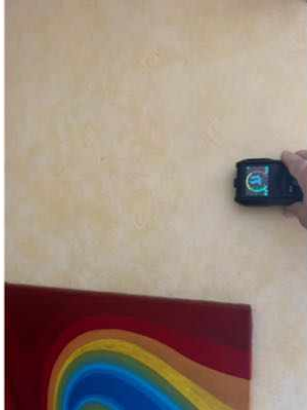
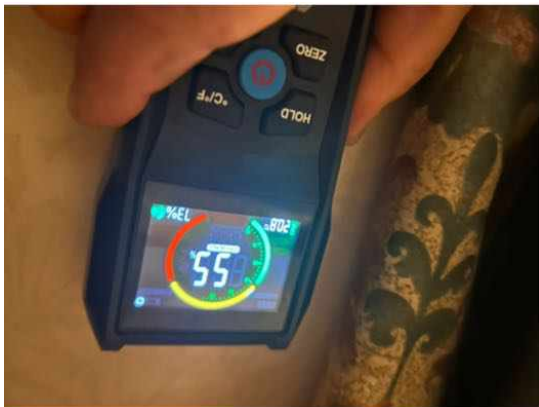
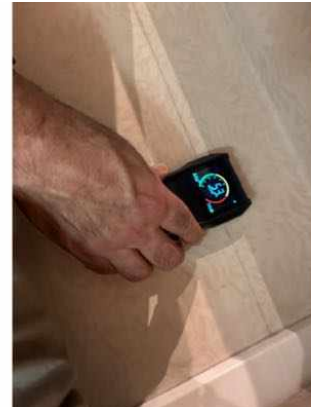
Defects 3.13

Building:	Building 1
Location:	Bedroom 2
Finding:	Moisture meter readings - medium to high
Information:	The moisture meter result for the areas inspected were medium to high at the time of inspection.

The moisture reading of 0-15% is quite normal and gives no cause for concern. However, moisture readings in excess of 15% indicate the need for further inspection.

Excessive moisture is generally caused by deteriorated inadequate or missing roof drainage leaking plumbing pipes or fixtures poorly plumbed HWS overflows or condenser units and poor site drainage.

Excessive moisture - medium to high moisture reading found in the internal wall of one of the bedrooms at the time of inspection and may require further invasive inspection.

It is highly recommended that all plumbing and drainage fixtures and fittings be maintained regularly in order to prevent excessive moisture being present in the external / internal property.

Monitoring of the area should be done over the near future to look for any indication the moisture content has changed.

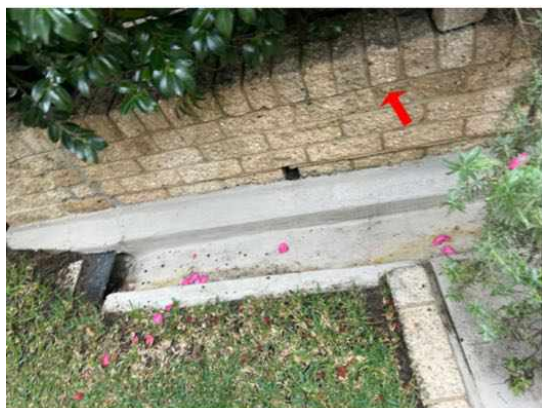
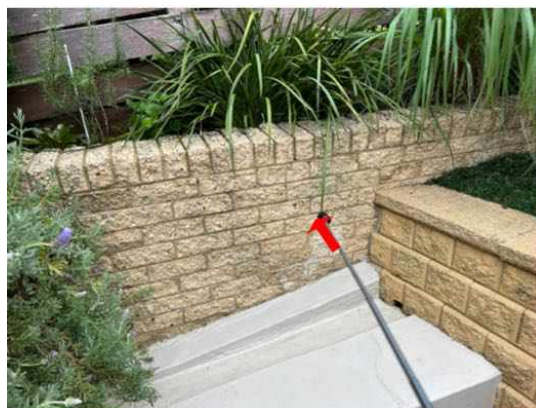
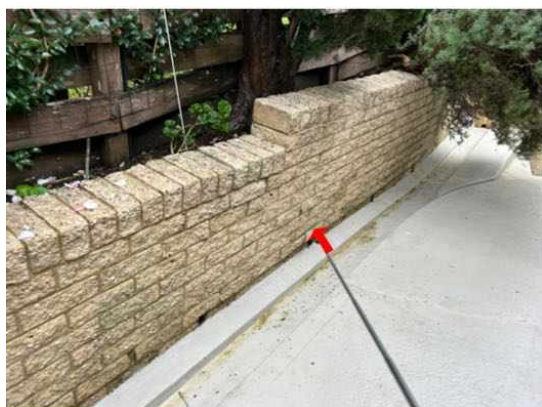
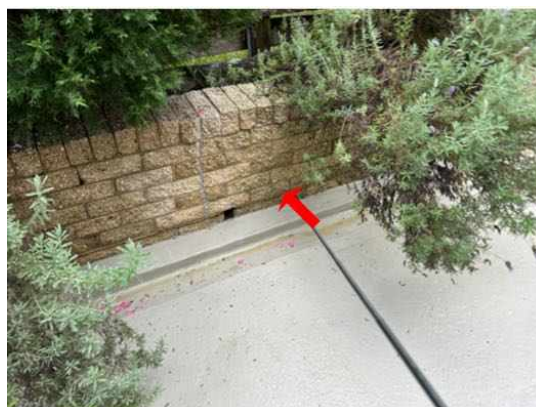
Defects 3.14

Building:	Building 1
Location:	Yard - Side
Finding:	Retaining wall - Defective
Information:	The retaining wall in this area was found to be defective at the time of inspection. Generally, defective retaining walls are caused by poor original design or material use. However, deteriorated retaining walls may also be a result of substandard construction, poor site drainage or unmanaged stormwater flows.

If left unmanaged, the retaining wall may become a safety hazard if it continues to destabilise.

Where retaining walls are considered structural walls, a structural engineer / surveyor should be consulted regarding required remedial works. Otherwise, a landscaper or retaining wall installer may be appointed to repair or replace the wall, at the discretion of the client.

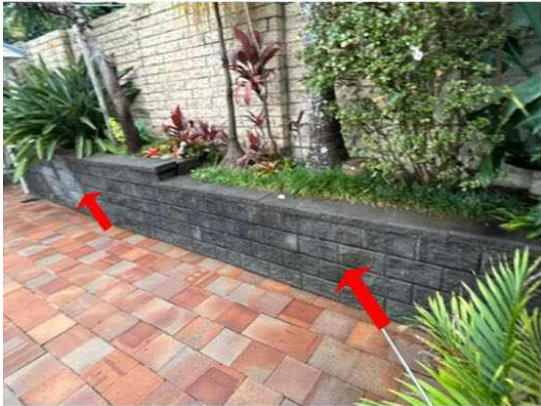
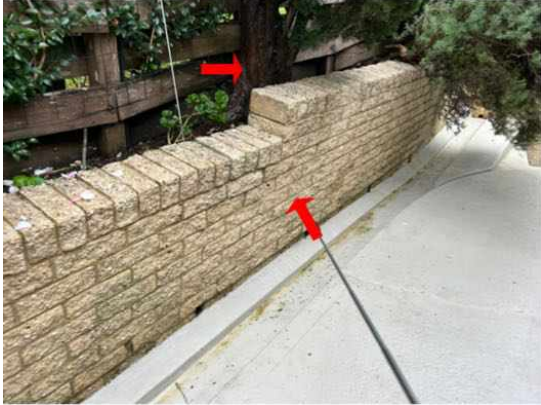
Defects 3.15

Building:	Building 1
Location:	All Areas
Finding:	Subsidence - Local trees and vegetation
Information:	Trees and other vegetation can have a significant local effect on drying of soils. Over a number of years, especially during drought conditions, adjacent trees and vegetation may draw excessive moisture from the soils. The opposite may also occur, where swelling of the soil results when the trees decline or are removed.

As the cumulative moisture deficient is reversed, the surface level around the tree (and adjoining subfloor) will rise and expand laterally. This is often damaging to buildings unless the foundations have been strengthened or designed to cope with the effect.

Subsidence can have complex and varying causes, which will influence the required remedial works. It is advised to begin by consulting a structural engineer to determine the required scope of works. This generally includes some form of underpinning, as well as addressing the underlying cause. Consultation with a geotechnical engineer

may also be necessary.

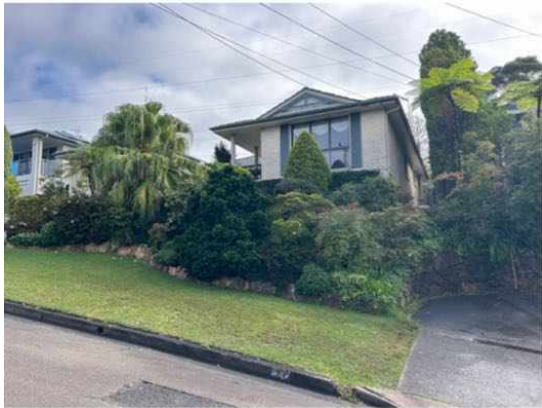
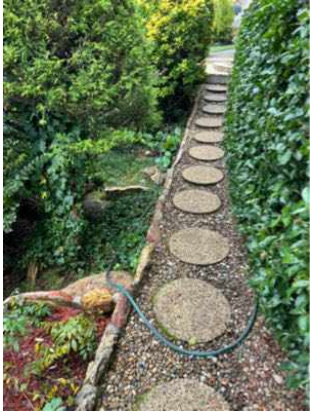
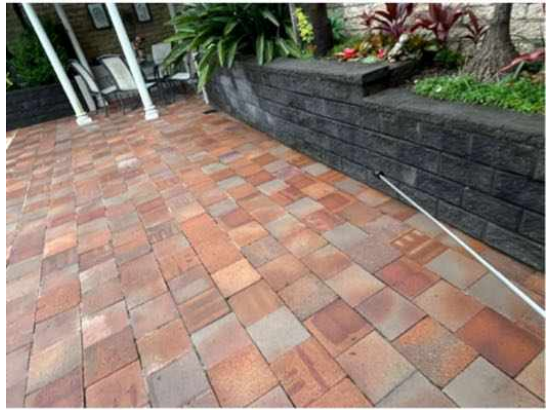
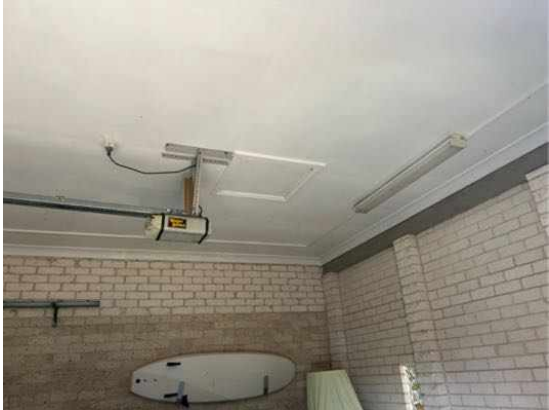
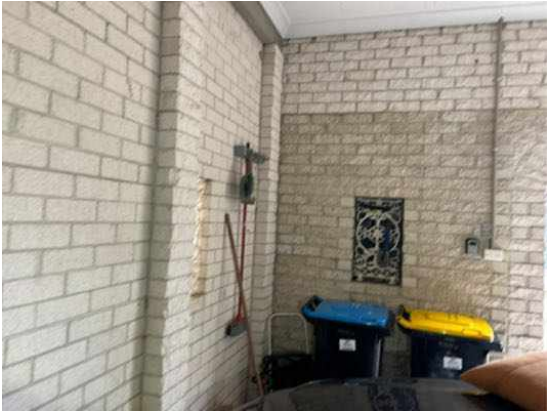
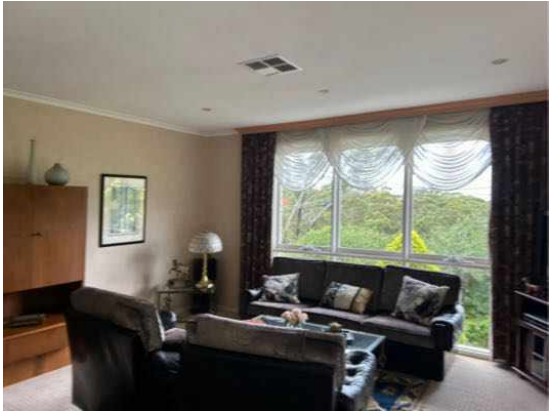
Noted Item

Building: Building 1
Location: All Areas
Finding: Additional Photos - Obstructions and Limitations
Information: These photographs are an indication of the obstructions and limitations which impeded full inspection of the property at the time of inspection. These obstructions can hide an array of defects and should be removed to allow full inspection to be carried out.

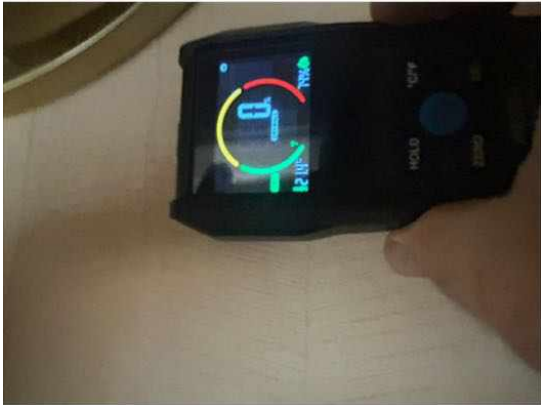
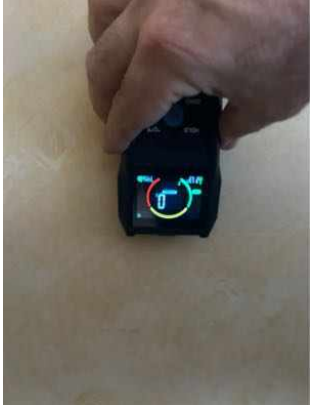
Building: Building 1
Location: All Areas
Finding: Moisture meter readings - low
Information: The moisture meter result for the areas inspected.

The moisture reading of 0-15% is quite normal and gives no cause for concern. However, moisture readings in excess of 15% indicate the need for further inspection.

Levels between 25-30% indicate that there may be water ingress, meaning that remedial work could be required.

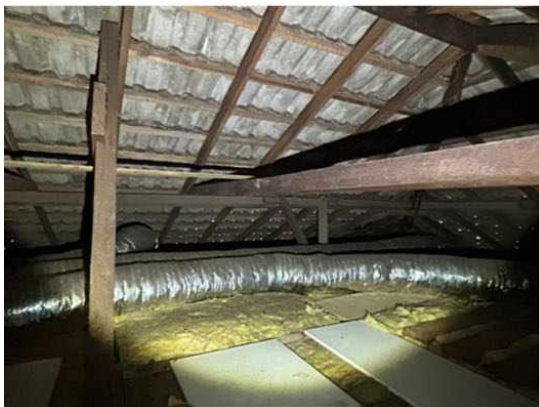
Building: Building 1
 Location: Roof Void
 Finding: Sarking - Not installed
 Information: Sarking is missing under the roof sheeting. Sarking acts as an insulator that helps with noise reduction and protects against water penetration. Sarking plays a key role in the operation and function of the overall roofing structure and its performance.

Although not a requirement at the time of construction, replacement of any missing building element is advisable (although this can be quite expensive to do after the time of construction). Where sarking is missing, regular inspections of the roof tiles for cracking and potential moisture penetration is required.

Sarking may be retrospectively fitted by a registered builder at the discretion of the client.

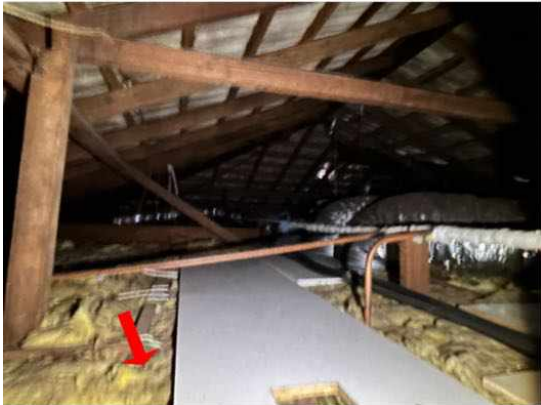
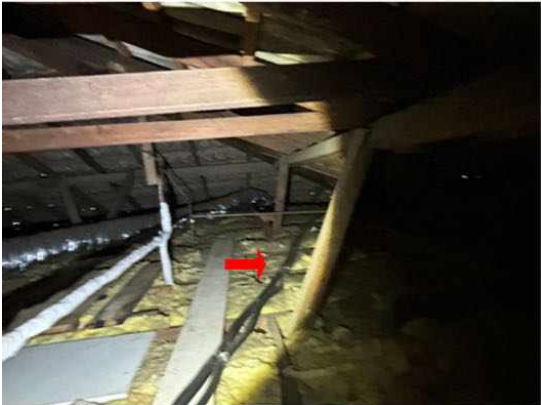
Building: Building 1
Location: Roof Void
Finding: Insulation- installed
Information: Insulation was evident in the ceiling void at the time of inspection. Insulation acts as an insulator that helps with heat reduction.

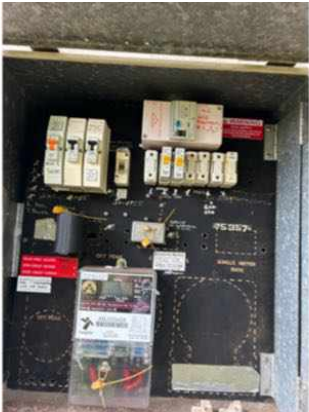
Building: Building 1
 Location: All Areas
 Finding: Plumbing and Electrical
 Information: Plumbing and electrical inspections are outside the scope of the building inspection and must be conducted by a Licensed and registered Trades person.

Whilst we note and comment of visually apparent defects that present during the building inspection, legislation requires the checking and documenting of compliance for plumbing and electrical requirements be done by licensed electrician and plumbers respectively to ensure they are functioning correctly.

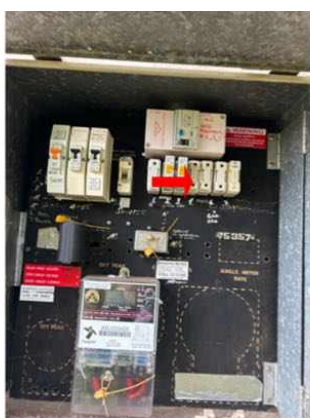
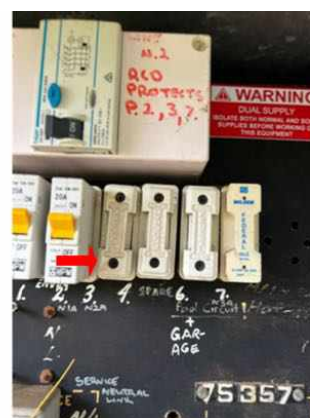
Building:	Building 1
Location:	Meter Box
Finding:	Electrical switchboard - Old ceramic fuses
Information:	The electrical switchboard while appearing to have adequate safety switches installed has old ceramic fuses in place.

While this on its own on is not considered a defect it is noted for the clients consideration that a switchboard upgrade may be required in the short to mid term to improve the functionality of the electrical system. A licensed electrician could be appointed to provide quotation for the works at the client's discretion which may in turn expose other required works to bring the system up to a compliant state.

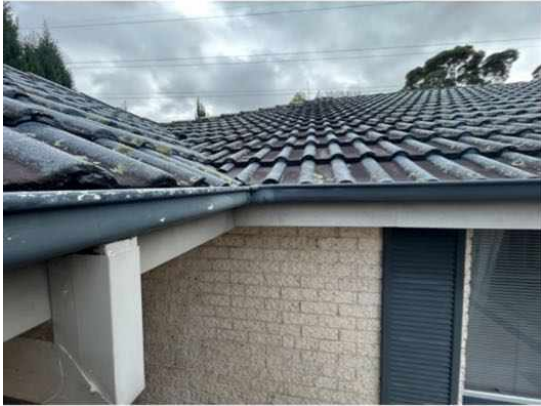
Building:	Building 1
Location:	Roof Exterior
Finding:	Roof tiles - Weathered
Information:	Upon inspection of the exterior roofing, the majority of roof tiles were considered to be in a fair condition. While weathering of the tiles is consistent with the age of the property, maintenance works are required.

Where left unmanaged, deteriorating roof tiles are likely to lead to a number of secondary defects, including minor water leaks and weather exposure to internal roofing structures.

Consultation with a roofing contractor is highly advised to gain advice on cost of remedial works that may be required in the short to medium term. Remedial works are likely to increase the longevity of the exterior roofing structure.
