Building Inspection Report

Inspection Date: Thu, 16 Mar 2023

Property Address: 17 Kurrajong Rd, Frenchs Forest NSW
2086, Australia

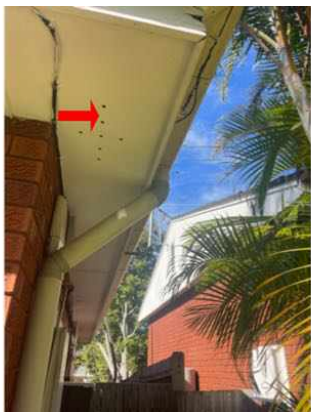
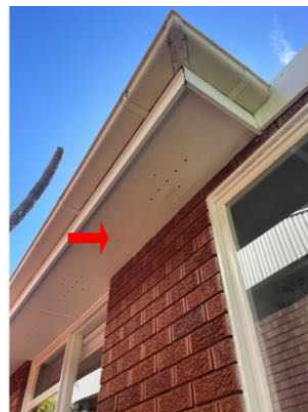
Defects 1.02

Building:	Building 1
Location:	All Areas
Finding:	Asbestos - Suspected ACM Identified on Site
Information:	Reporting on Asbestos is outside the Scope of this Report. This suspected defect is highlighted as a caution only. We suspect, based on our experience in the building industry, that there is a higher risk of the identified building element containing asbestos.

As Asbestos Reporting is outside the scope of this report, we advise that you consider a separate Asbestos Inspection and Condition Audit, which can include the taking of

samples for definitive confirmation of the presence of Asbestos.

In the interim, the client is advised to act with caution, especially when considering any damage to building materials general wear and tear renovations extensions demolition and general maintenance activities due to the suspected presence of Asbestos.

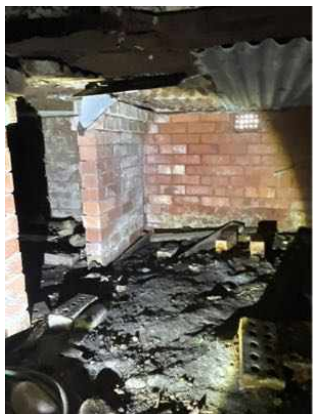
Defects 1.03

Building:	Building 1
Location:	Subfloor
Finding:	Mould - Present
Information:	Where evidence of mould growth was noted, there may be environmental, biological or health issues associated with the report. A specialist inspection by a suitably qualified environmental health inspector is warranted, where mould is extensive or where any queries regarding air quality spores or other related issues apply.

Generally, the client is advised to ensure that the general environment is free of moisture and humidity to aid in the prevention of mould formation and development. Any mould found during the inspection should be cleaned immediately by a cleaning contractor or the homeowner as applicable.

Please note that severely affected building elements may require replacement by a builder or carpenter.

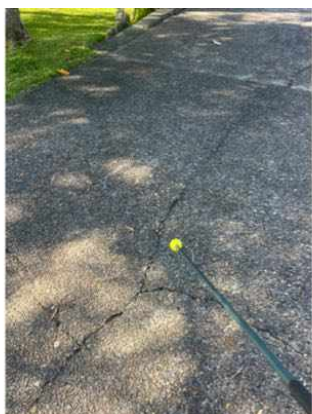
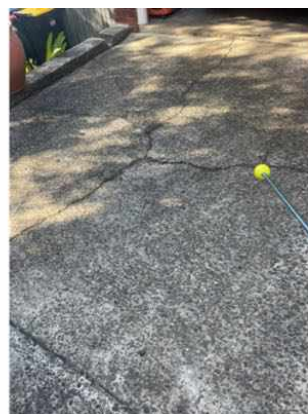
Defects 3.01

Building:	Building 1
Location:	All External Areas
Finding:	Cracking - External Concrete Paving Damage Category 3 - Wide Cracks (2mm - 4mm)
Information:	Wide cracks were identified in external concrete paving Wide cracks are significant and are likely to lead to the development of safety hazards and secondary defects if left unmanaged.

General age and expected deterioration of the paved areas is a common cause of this type of cracking. However, expansion and contraction of the slab may also have occurred due to environmental factors. Such factors include variable moisture and weather conditions, the presence of trees and their roots having a settling or lifting affect on the soil, or the effect of load bearing, e.g. heavy vehicles over a sustained period of time.

Cracking to this degree may also be due to poor original installation of the concrete. Factors such as poor compaction of the sub surface and/or inadequate reinforcing of the slab may create cracking and other secondary defects. Wide cracks may also have a more significant structural cause, such as subsidence of soils.

Where the crack is located adjacent to structural elements of the building, the advice of a Structural Engineer is advisable before undertaking repairs. Significant repair and likely replacement of the concrete paving is probable.

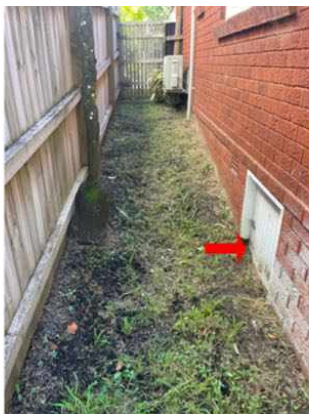
Defects 3.05

Building:	Building 1
Location:	All Areas
Finding:	Brickwork - Efflorescence
Information:	Efflorescence appears to be affecting the brickwork, concrete or tiles in this area. Efflorescence typically occurs when excess salts within the concrete or cement mortar is leached to the surface due to water transfer.

It is typically seen as white salt deposits on the surfaces of concrete pavement or mortar between bricks or tiles. While detracting from the overall appearance of the affected area, efflorescence is not likely to develop into secondary damage if left unmanaged.

Generally, soluble salt deposits can be removed by dry brushing with a stiff-bristled brush. Repeated dry brushing is an ideal treatment for eliminating this forming of efflorescence. A cleaning contractor or general handyperson may be appointed to perform these works at the discretion of the client.

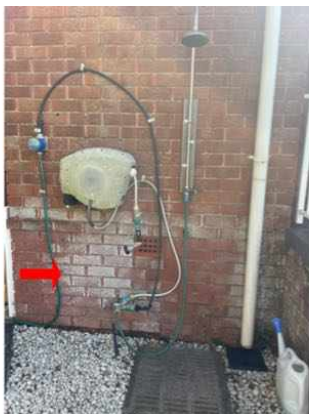
Defects 3.06

Building:	Building 1
Location:	All Areas
Finding:	Brickwork - Deteriorated mortar
Information:	Mortar, or 'bedding', is the material which fills joins and intersections between bricks in masonry walls and structures. Sections of mortar in this brickwork were identified as having deteriorated, which is generally expected for a property of this age and condition.

Mortar may deteriorate as a result of age of building materials, minor movement of bricks, or frequent exposure to weathering. Mortar should be replaced to ensure that bricks remain in their intended location and to prevent gaps, which would allow water or moisture ingress and secondary damage as a result.

Mortar deterioration can be addressed by a bricklayer where areas of deterioration are localised and easily accessible. Alternatively, appointment of a registered builder is advised, to repoint large areas of decaying mortar. Where secondary structural defects have become evident, consultation with a structural engineer may be required.

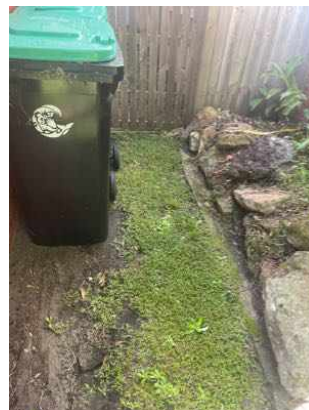
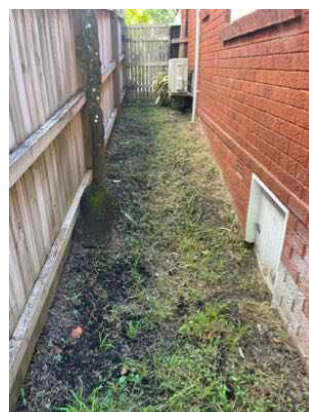
Defects 3.11

Building:	Building 1
Location:	Subfloor
Finding:	Subfloor ventilation - Inadequate
Information:	Adequate subfloor ventilation aids in preventing excessive moisture wood rot and termite activity by ensuring a dry subfloor environment.

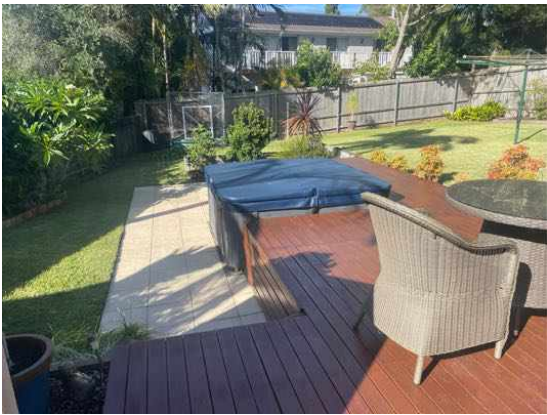
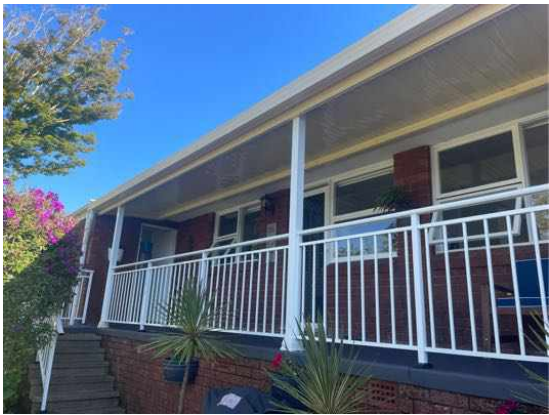
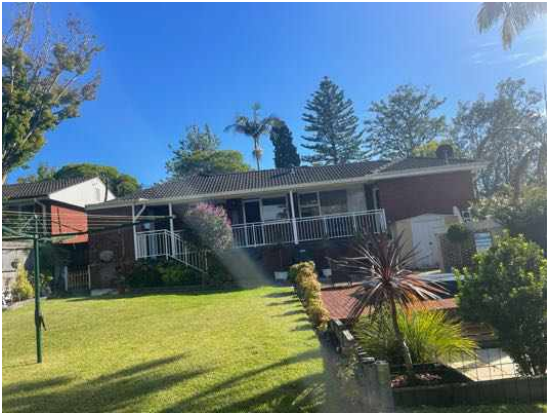
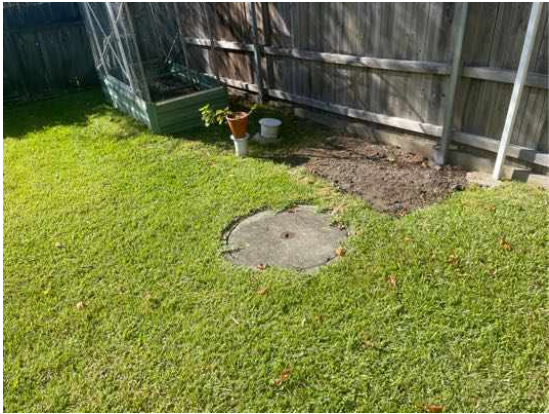
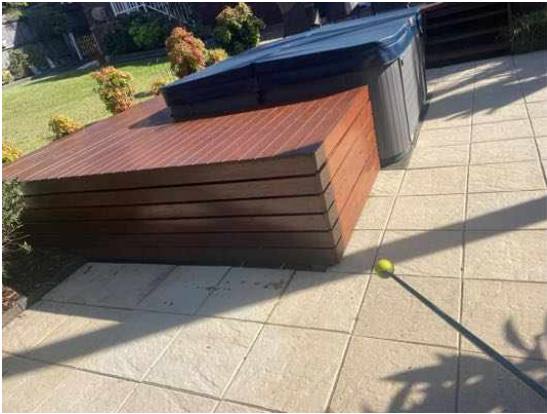
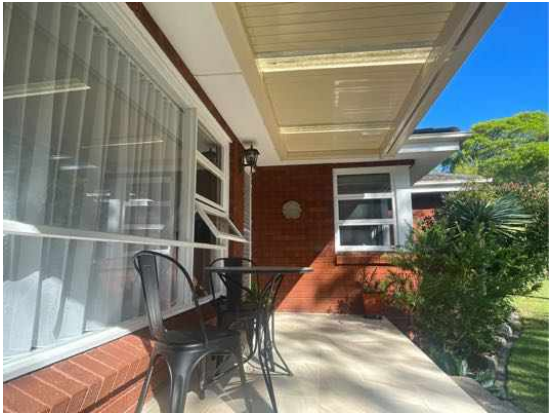
Building:	Building 1
Location:	All Areas
Finding:	Additional Photos - Obstructions and Limitations
Information:	These photographs are an indication of the obstructions and limitations which impeded full inspection of the property at the time of inspection. These obstructions can hide an array of defects and should be removed to allow full inspection to be carried out. A re-inspection is recommended once the areas are made accessible.

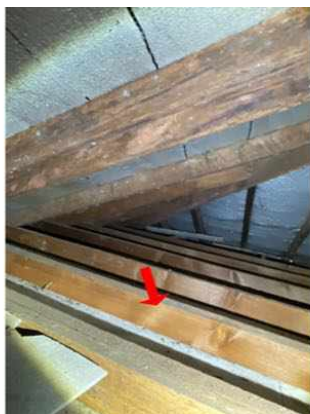
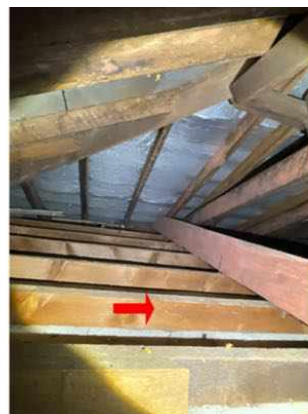
Building: Building 1
 Location: Roof Void
 Finding: Insulation - not present
 Information: Upon inspection of the roof void it was noted that there is was no insulation.

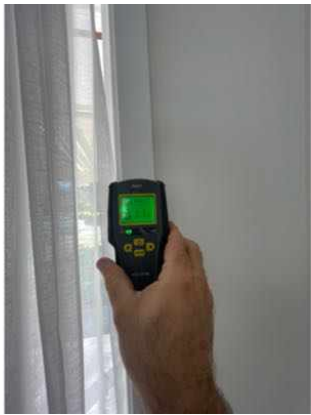
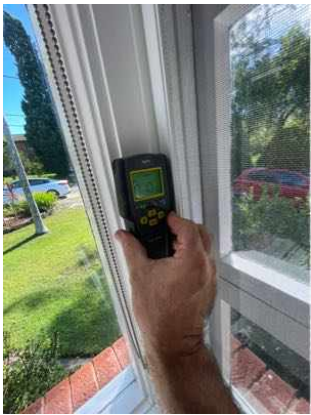
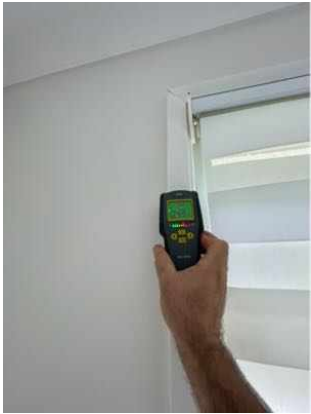
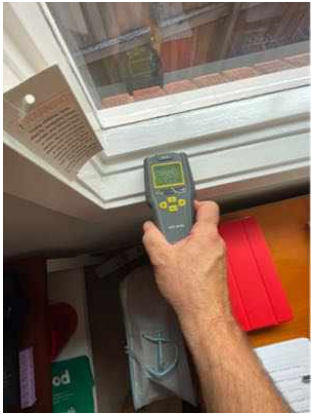
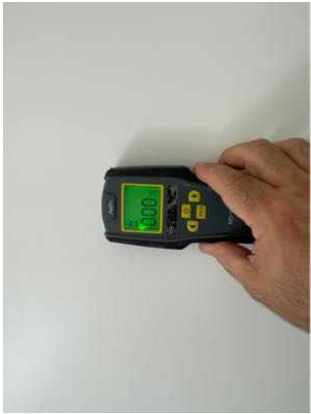
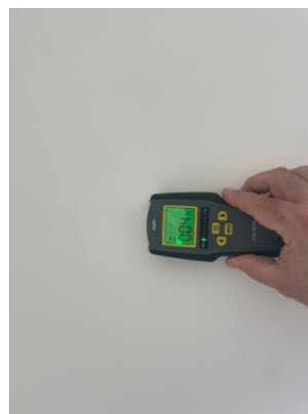
Building: Building 1
 Location: All Areas
 Finding: Moisture meter readings - low
 Information: The moisture meter result for the areas inspected.

The moisture reading of 0-15% is quite normal and gives no cause for concern. However, moisture readings in excess of 15% indicate the need for further inspection.

Levels between 25-30% indicate that there may be water ingress, meaning that remedial work could be required.

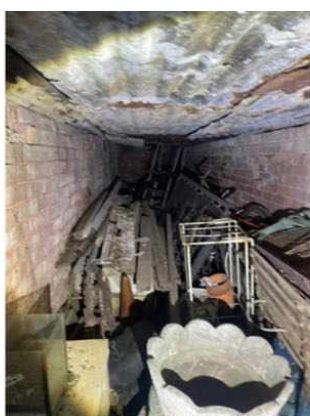
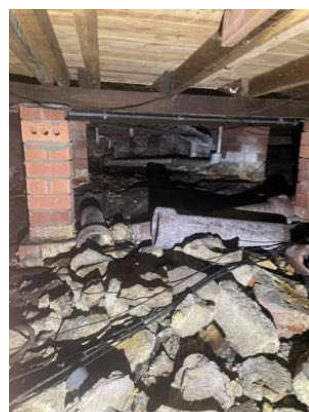
Information: An array of debris was found in the subfloor area at the time of inspection. Debris in this area restricts subfloor ventilation and creates potential for concealed pest entry. Stored timbers and other materials may also make the area susceptible to termite activity and wood rot.

A clear and empty subfloor will be better ventilated and easier to maintain in a dry condition. The removal of any timber debris is vital in minimising the risk of termite or wood borer activity.

Debris in the subfloor should be removed as soon as possible. Depending on the location and amount of debris and stored items, the homeowner may elect to undertake this task. Alternatively there are a large number of rubbish removal subcontractors that could undertake these works.

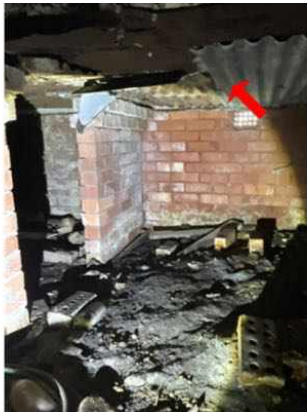
Building: Building 1
Location: Subfloor
Finding: Formwork timber and corrugated iron - removal
Information: Sometime formwork material is not removed during construction which increases the risk of termite activity, wood rot and corrosion being present.

It is recommended that formwork to be removed from these areas.
