Timber Pest Inspection Report

Inspection Date: Sat, 25 Jul 2020

Property Address: 25 Dareen St, Beacon Hill NSW 2100, Australia

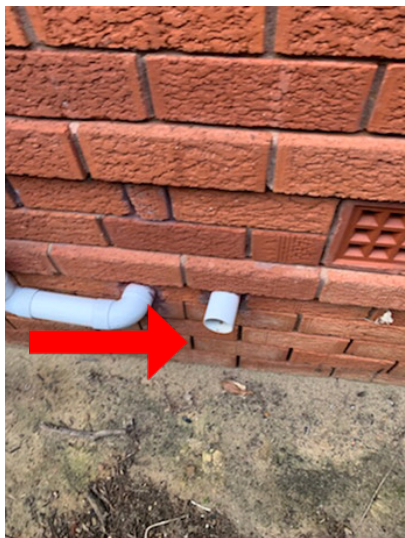
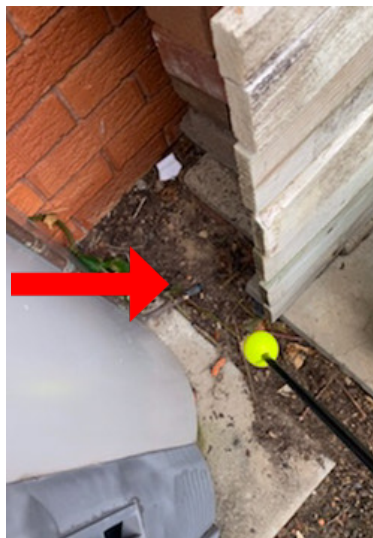
Building:	Building 1
Location:	Yard - Side
Finding:	Evidence of excessive moisture was present at the time of inspection
Information:	Excessive moisture can attract termites and produce conditions that promote termite attack fungal growth and wood decay.

Excessive moisture is generally caused by deteriorated inadequate or missing roof drainage leaking plumbing pipes or fixtures poorly plumbed HWS overflows or condenser units and poor site drainage.

These damp conditions can lead to secondary defects such as rot, rust or corrosion of associated building elements, the formation of fungal decay, or even the creation of potential slip hazards. When coupled with poor site drainage, pooling of water may also attract termite activity to this area.

It is highly recommended that all plumbing and drainage fixtures and fittings be maintained regularly in order to prevent excessive moisture being present in the external / internal property.

It is highly recommended that a qualified plumber be appointed to install adequate drainage to the overflow. These works will ensure that the area remains dry and free of any secondary defects.
