Timber Pest Inspection Report

Inspection Date: Thu, 6 Oct 2022

Property Address: 7 Trigalana Pl, Frenchs Forest NSW 2086,
Australia

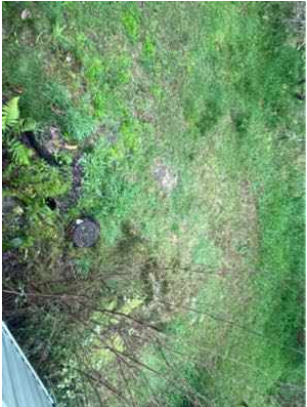
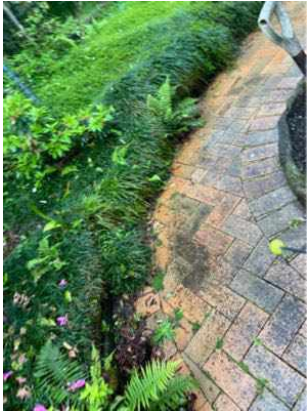
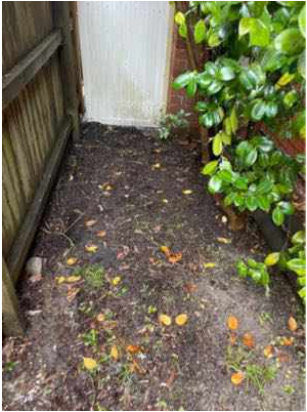
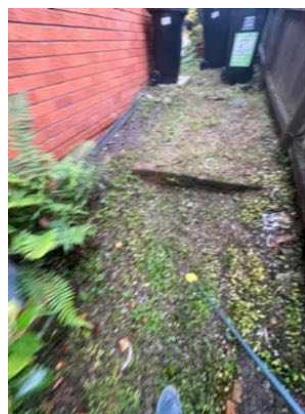
Building:	Building 1
Location:	All External Areas
Finding:	Evidence of excessive moisture was present at the time of inspection
Information:	Excessive moisture can attract termites and produce conditions that promote termite attack fungal growth and wood decay.

Excessive moisture is generally caused by deteriorated inadequate or missing roof drainage leaking plumbing pipes or fixtures poorly plumbed HWS overflows or condenser units and poor site drainage.

It is highly recommended that all plumbing and drainage fixtures and fittings be maintained regularly in order to prevent excessive moisture being present in the external / internal property.

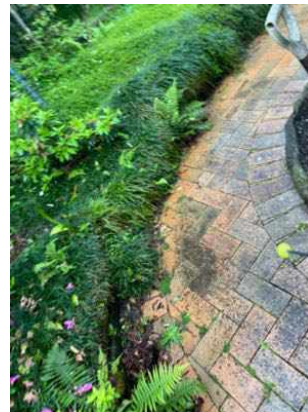
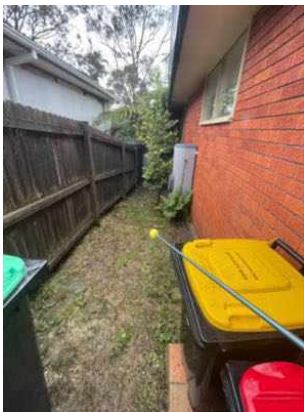
Building:	Building 1
Location:	All External Areas
Finding:	Site drainage - suspected Inadequate
Information:	The site drainage in this area was found to be suspected inadequate at the time of inspection, creating potential for subsequent water damage to associated building elements.

It is important that water does not lie against the base of walls; surrounding paths and ground levels should be sloped to drain water away from walls. Downpipes should not discharge stormwater onto lower walls or plinths. Stormwater should be carried away by large, regularly cleaned drains. Ground levels may need to be lowered to expose a buried DPC.

Where site drainage is inadequate, installation of an Agricultural (Aggie) Drain may be required. A qualified plumber should be appointed to further inspect the property and perform any remedial works as necessary. Water damage and secondary defects are likely to occur if left unmanaged.

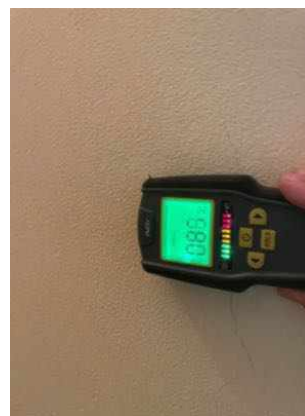
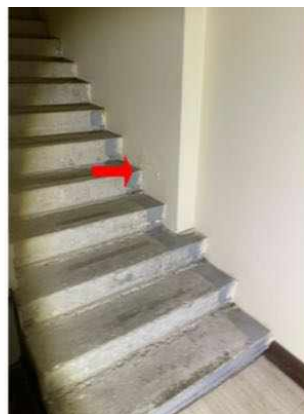
Building: Building 1
Location: Basement
Finding: Evidence of excessive moisture was present at the time of inspection
Information: Excessive moisture can attract termites and produce conditions that promote termite attack fungal growth and wood decay.

Excessive moisture is generally caused by deteriorated inadequate or missing roof drainage leaking plumbing pipes or fixtures poorly plumbed HWS overflows or condenser units and poor site drainage.

It is highly recommended that all plumbing and drainage fixtures and fittings be maintained regularly in order to prevent excessive moisture being present in the external / internal property.

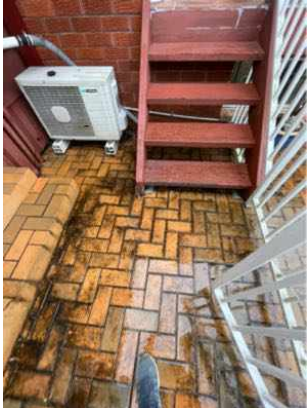
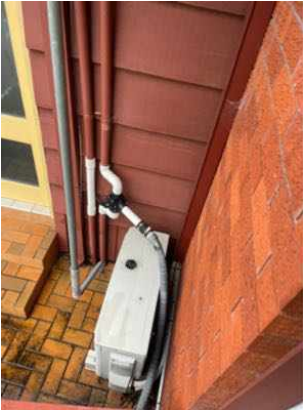
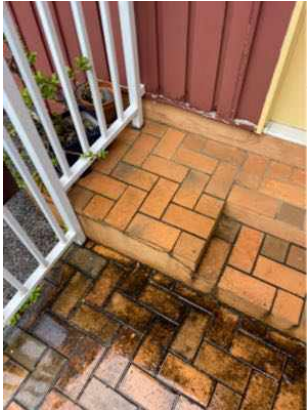
Building:	Building 1
Location:	All Areas
Finding:	Building materials in direct ground contact - conducive to termites
Information:	Where timber elements are in direct contact with the ground and consequently moisture or dampness they become conducive to termite activity.

When met with excessive moisture timber begins to decay and develop wood rot. Any timbers that are in direct contact with external grounds especially if left untreated or non- durable also provide ingress for subterranean termites into that particular element.

The removal of any such materials that may be conducive to termite activity should be removed as soon as possible to minimise the risk of termite attack.

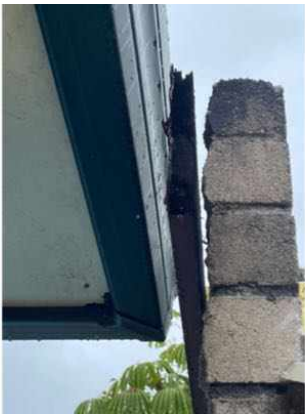
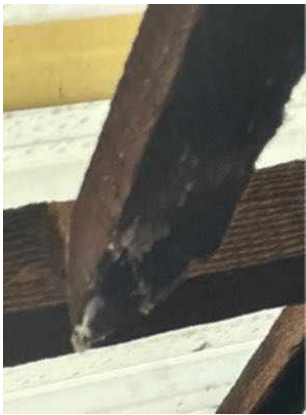
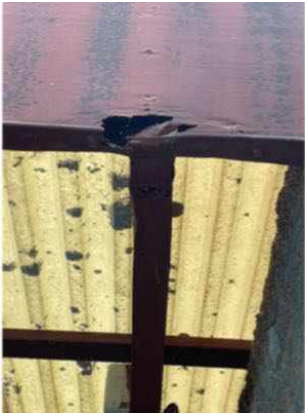
Building:	Building 1
Location:	All External Areas
Finding:	Wood rot
Information:	This building element shows evidence of wood rot. Wood rot, also known as Fungal Decay, occurs when timbers and other cellulose building materials are exposed to damp conditions on an ongoing basis. This could be the result of exposure to weathering over a prolonged period of time, or the attraction of excessive moisture from other abutting building materials. Contributing factors also include poor air ventilation in the area.

Early intervention and regular maintenance, particularly of exterior timbers, will prolong the useful life of these building elements. Prior to any works being performed, the cause of the moisture that has created the visible wood rot should be identified and addressed in a suitable manner.

A carpenter may also be required to replace affected building materials.

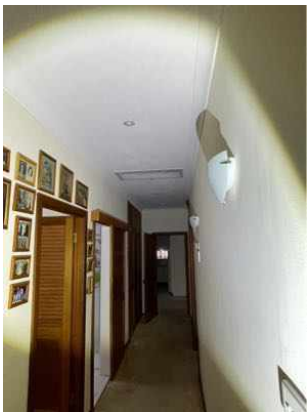
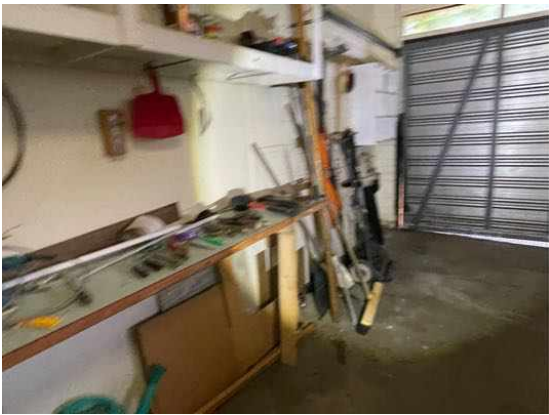
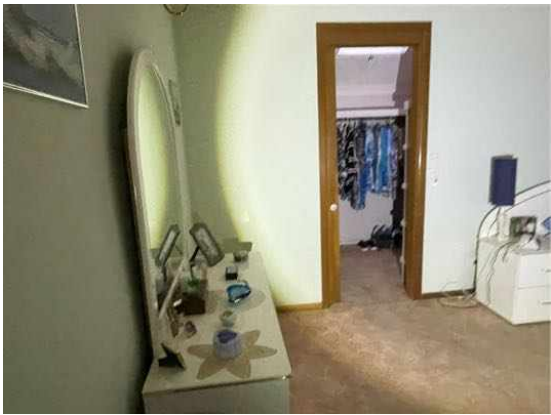
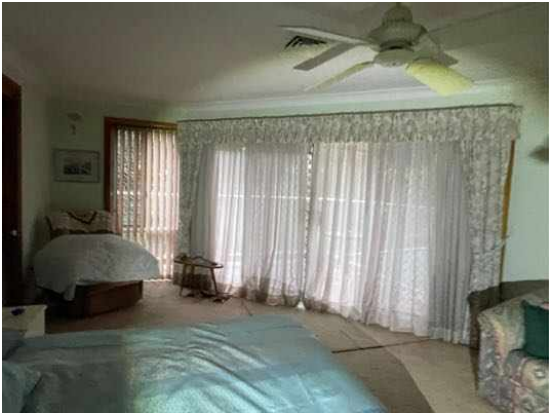
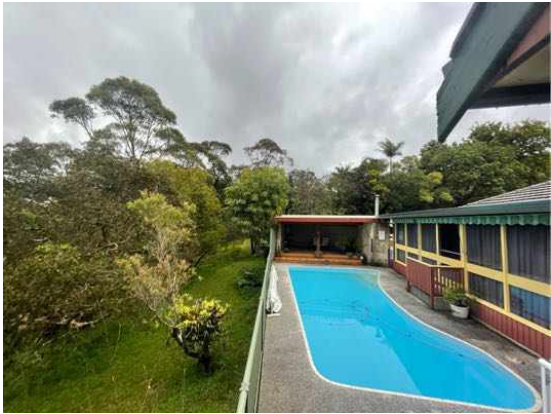
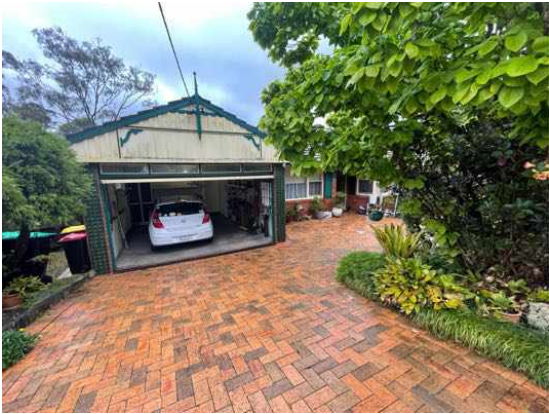
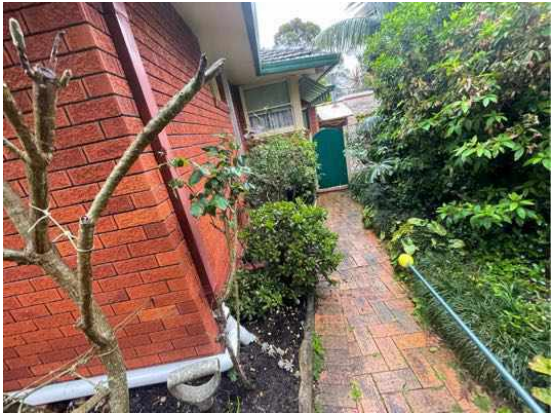
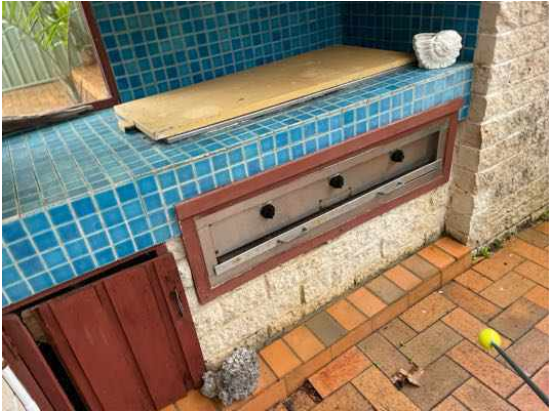
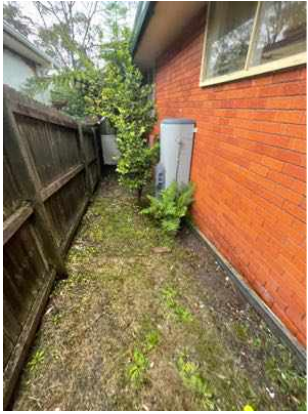
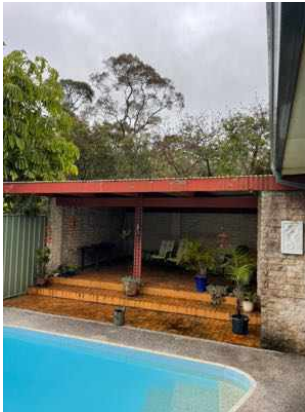
Building: Building 1
 Location: All Areas
 Finding: Additional Photos - Obstructions and Limitations
 Information: These photographs are an indication of the obstructions and limitations which impeded full inspection of the property at the time of inspection. These obstructions can hide an array of defects and should be removed to allow full inspection to be carried out.
