## **VISUAL BUILDING & PEST INSPECTION REPORT**

Complies with Australian Standard 4349.1 & 4349.6

### Vendor Report

Inspected Property:  
7 Towarri Place Belrose

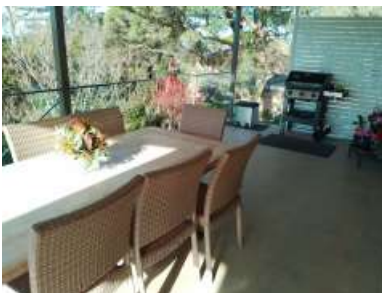
Eastern elevation.

Constructed from concrete or masonry. The condition of the structure is generally acceptable.

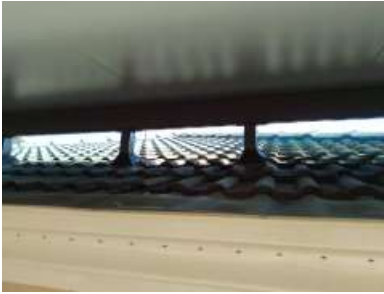
The roof is of pitched construction.

No access was possible to part of the external roof area due to the roof not being accessible from a 3.6 meter ladder.

The overall condition of the roof coverings is fair.

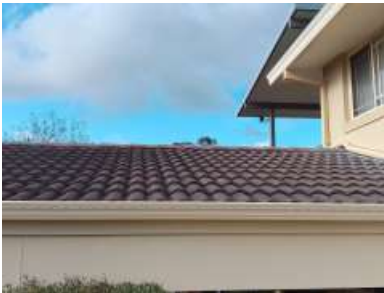
The roof is of pitched style construction.

The overall condition of the roof coverings is fair.

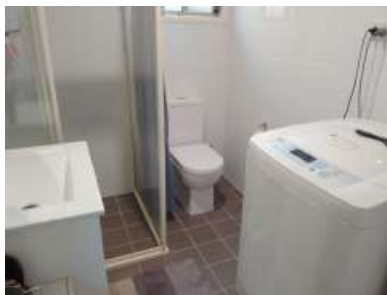
Rear.

The shower recess was tested and there was no visible water penetration to surrounding areas. **IMPORTANT NOTE:** This test may not reveal water leaks until the shower is put into constant use and surrounding areas monitored over a period of time.

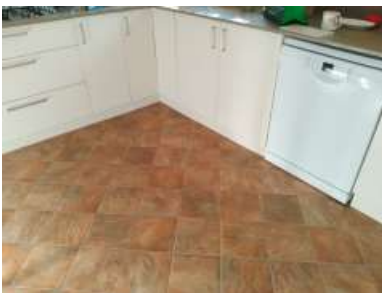
The condition of the fixtures is generally good, A glass splashback is located over the benchtop area. Glass appears to be in serviceable condition.

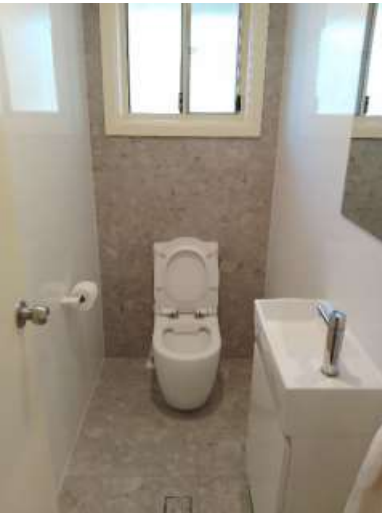
Level one.

The toilet appears to be in working order.

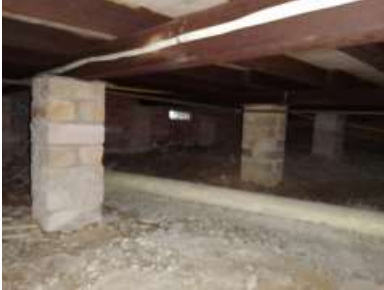
The building is constructed on a combination of strip footings and piers. The footings appear to be generally sound.

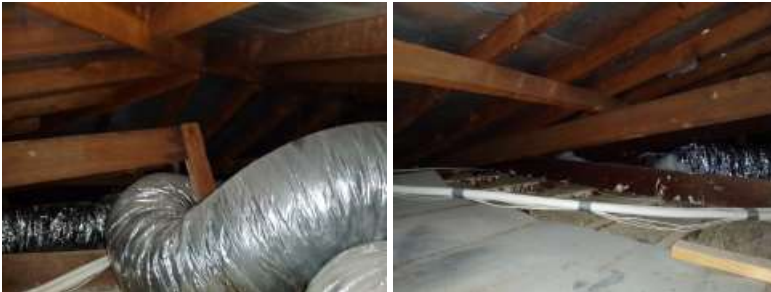
Body access into the roof void was restricted and access was not gained to any areas beyond the roof access hole.

A comment is not made where access was unable to be gained. Damage and or defects may be present and not detected in areas where inspection was limited, obstructed or access was not gained. If restrictions are noted we STRONGLY recommend access be gained to enable a full inspection inaccessible areas.

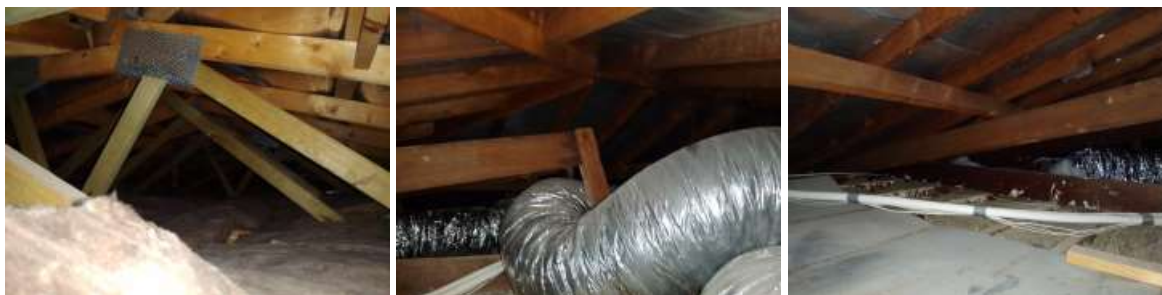
Body access into the roof void was restricted and access was not gained to any areas beyond the roof access hole.

A comment is not made where access was unable to be gained. Active termites or other timber damaging pests may be present and not detected in areas where inspection was limited, obstructed or access was not gained. Timbers above the areas nominated were not accessed and not able to be inspected. Recommend access be gained to allow a full inspection of inaccessible areas.
