Building and Timber Pest Inspection Report

Inspection Date: Wed, 17 Feb 2021

Property Address: 13 Bluegum Cres, Frenchs Forest NSW 2086, Australia

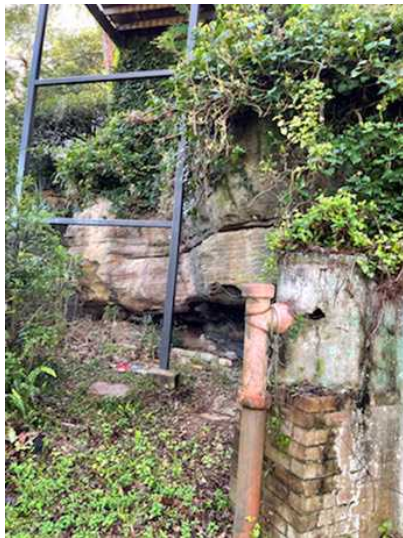
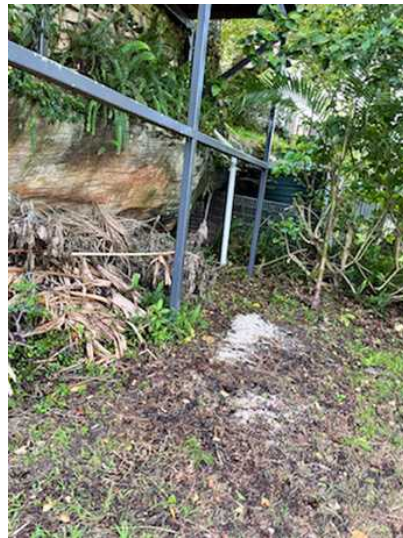
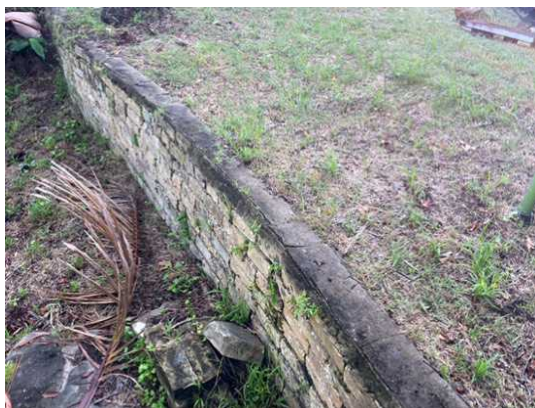
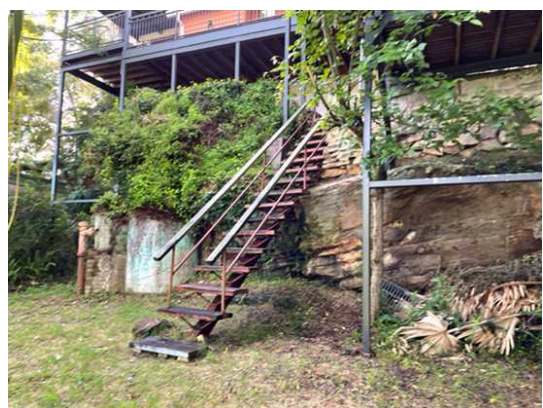
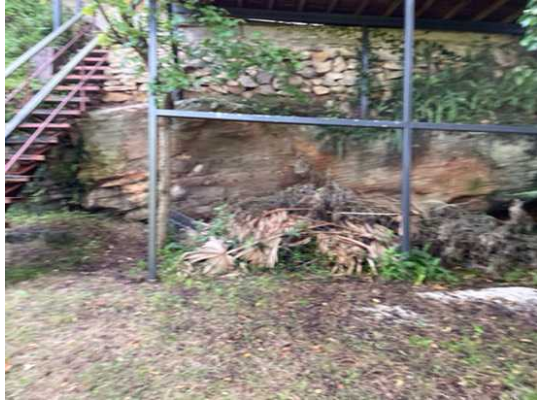
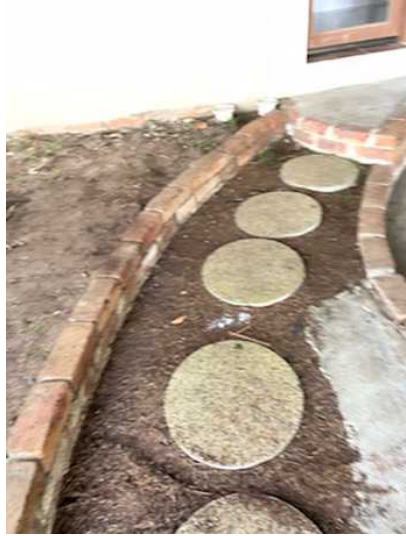
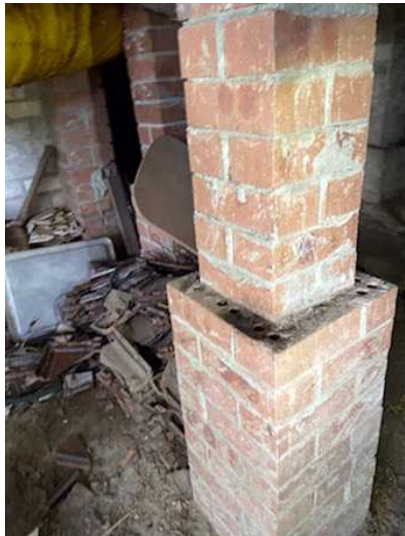
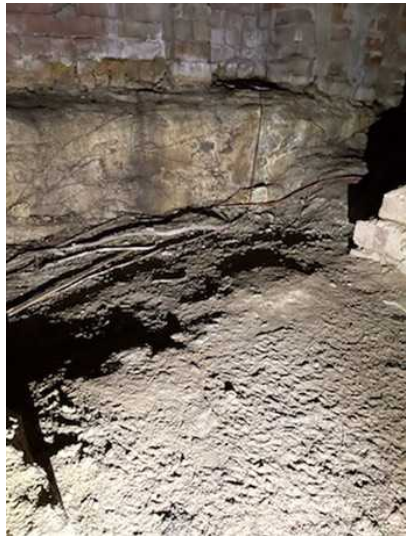
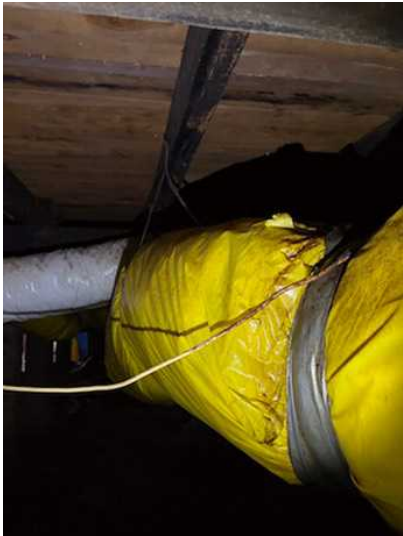
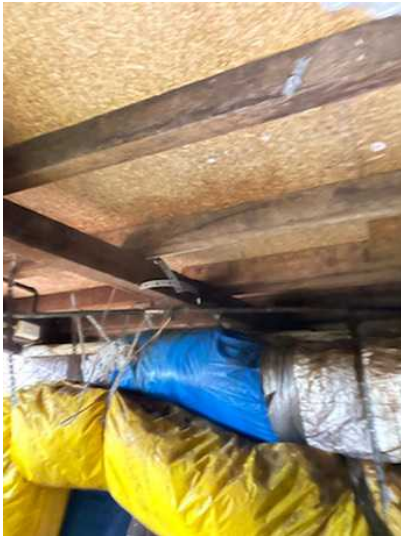
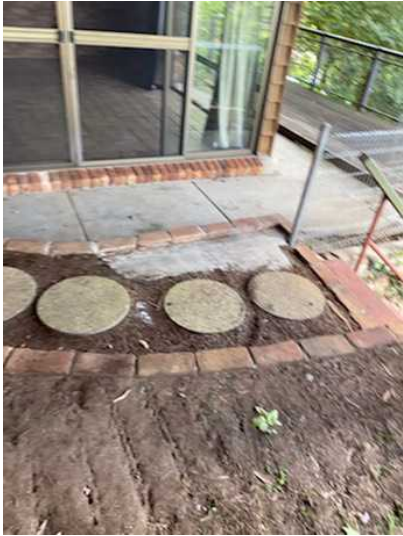
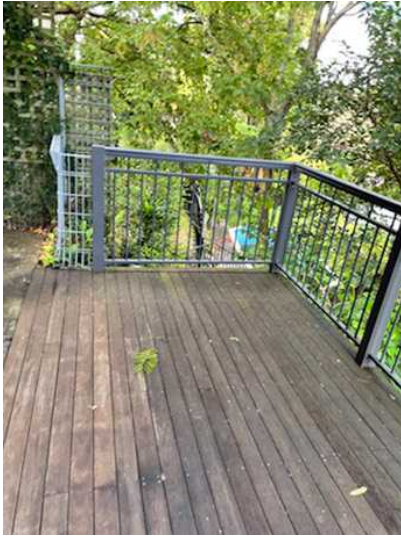
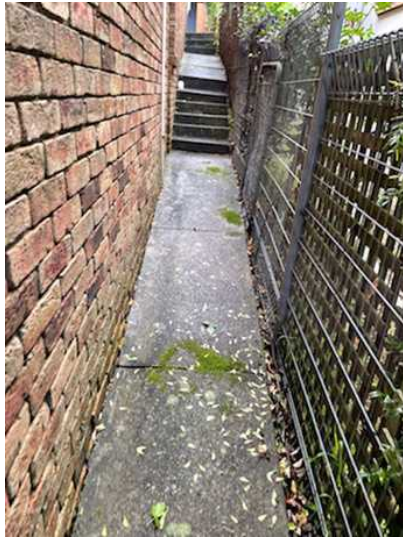
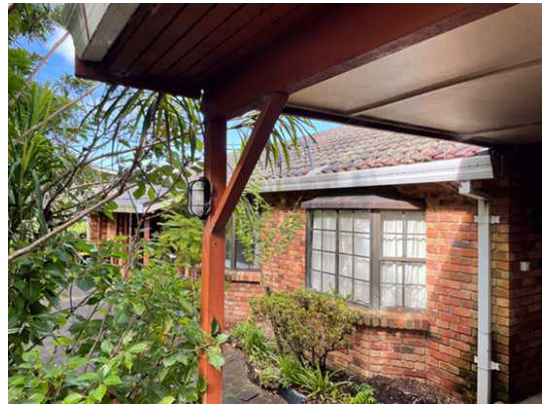
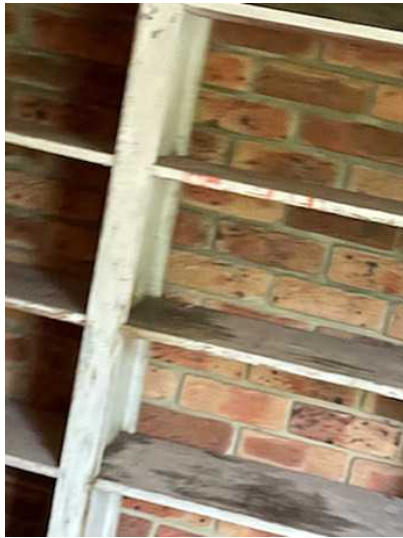
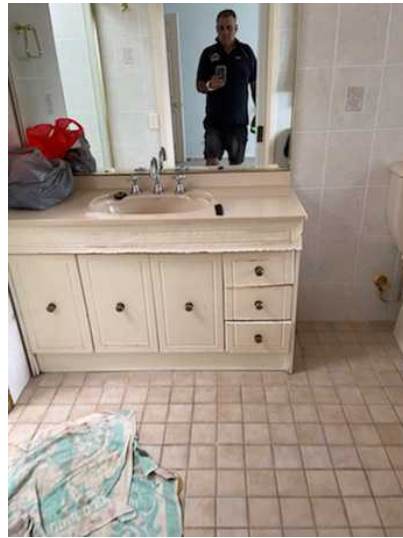
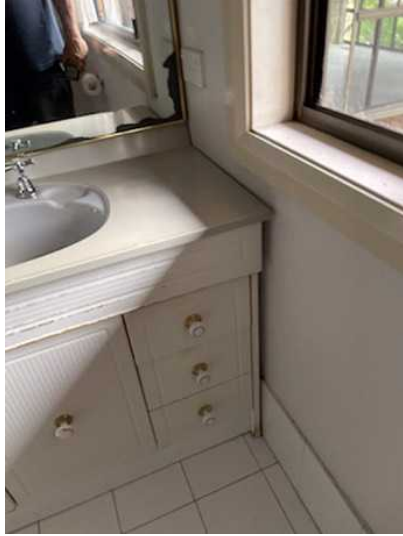
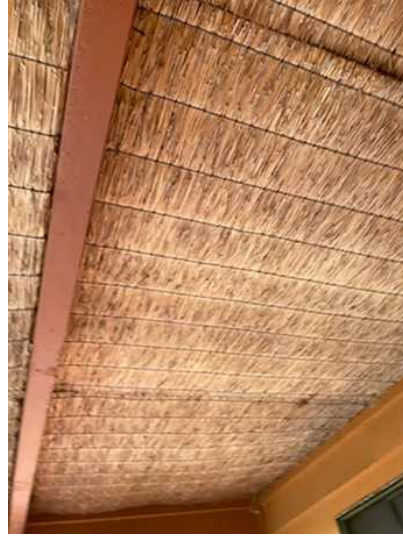
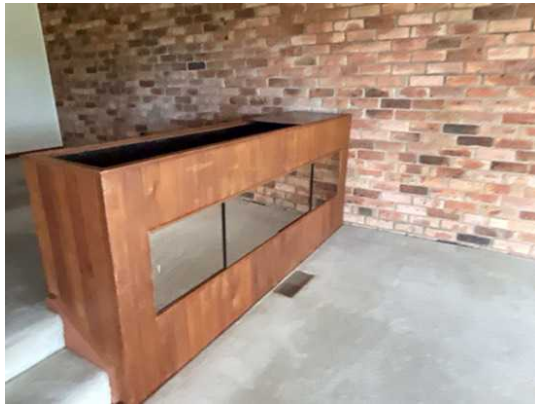
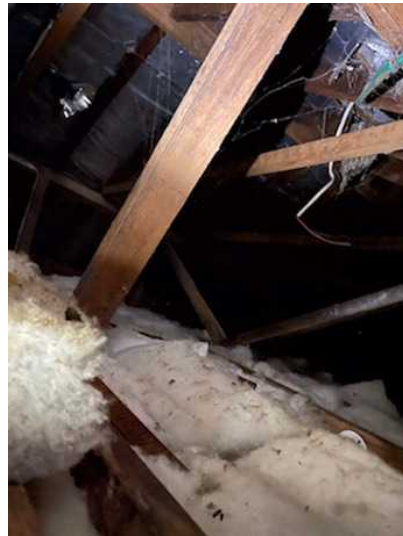
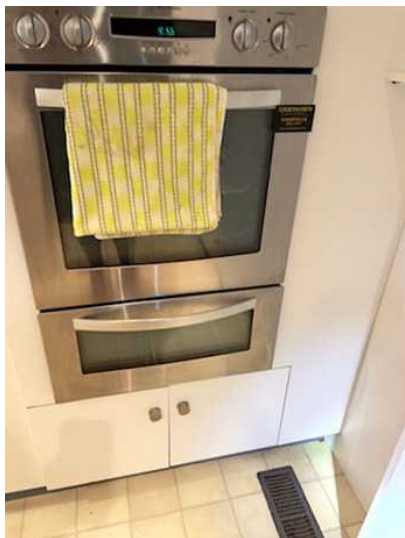
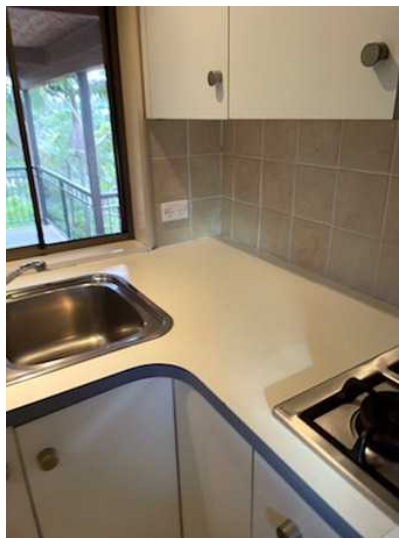
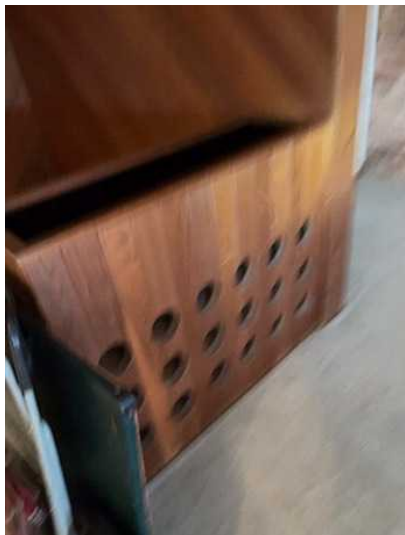
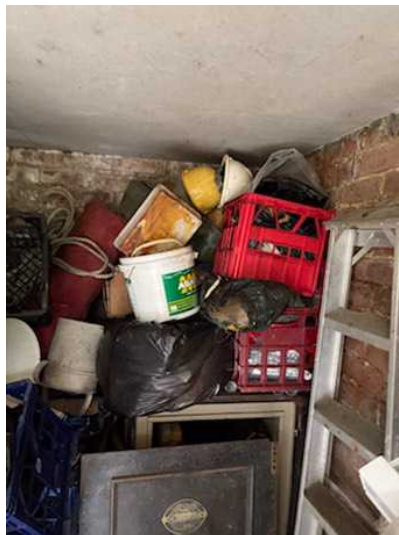
Finding 3.13

Building: Building 1
Location: All Areas
Finding: Additional Photos - Obstructions and Limitations
Information: These photographs are an indication of the obstructions and limitations which impeded full inspection of the property at the time of inspection. These obstructions can hide an array of defects and should be removed to allow full inspection to be carried out.

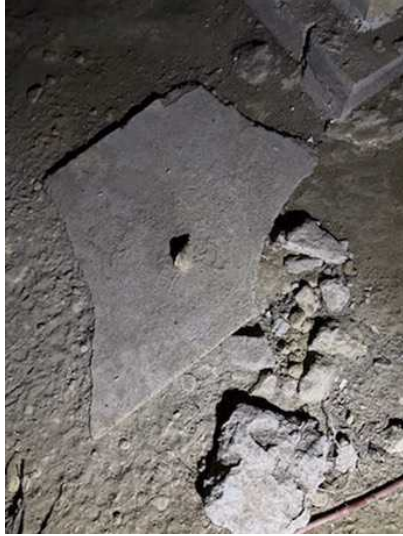
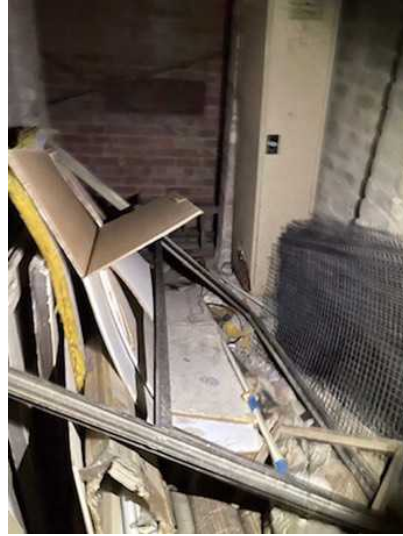
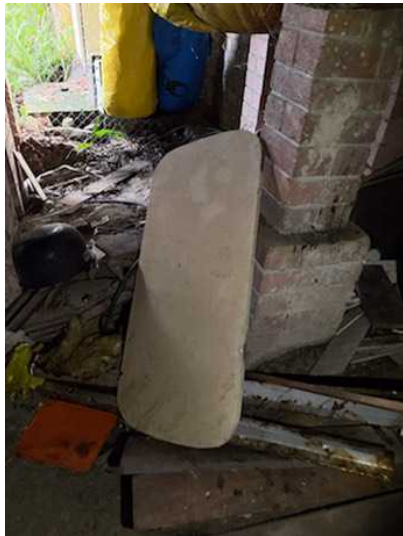
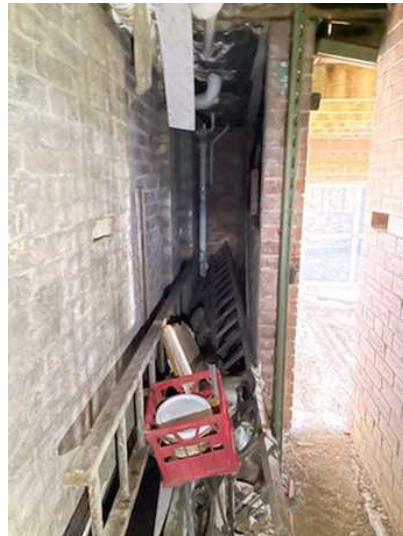
Finding 6.04

Building: Building 1
Location: Subfloor
Finding: Evidence of excessive moisture was present at the time of inspection
Information: Excessive moisture can attract termites and produce conditions that promote termite attack fungal growth and wood decay.

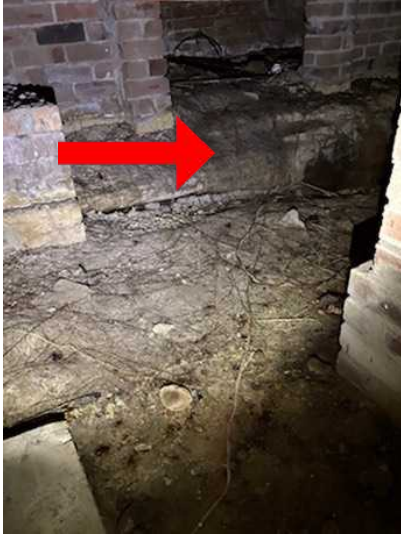
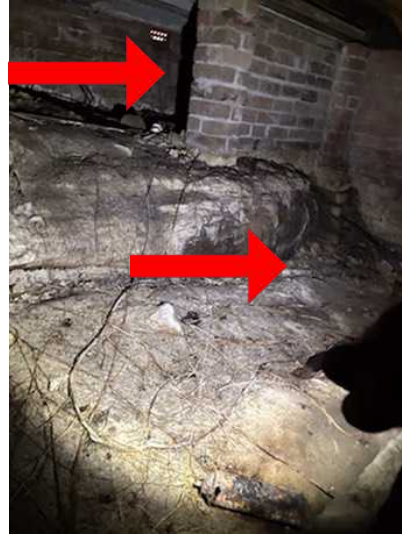
Finding 6.05

Building: Building 1

The client may consider gaining further advice from a pest controller as to the costs and procedures involved with this application. It is recommended that obtaining such advice be a short-term priority.
