## Building and Timber Pest Inspection Report

Inspection Date: Thu, 22 Apr 2021

Property Address: 60 Romford Rd, Frenchs Forest NSW 2086,  
Australia

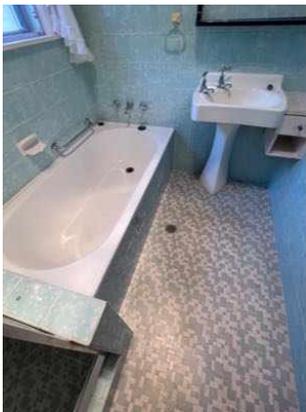
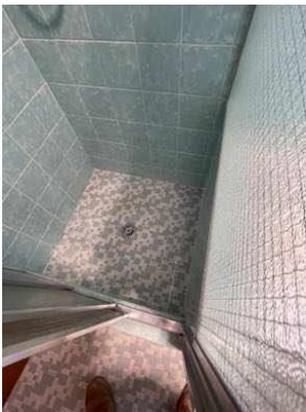
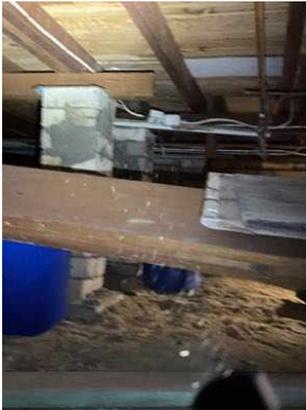
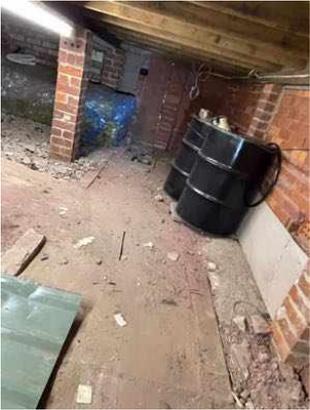
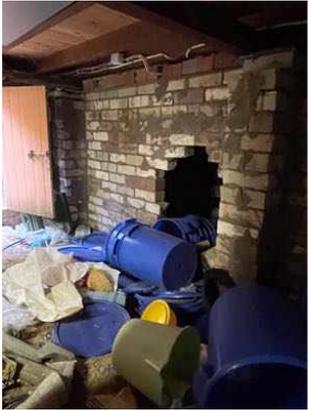
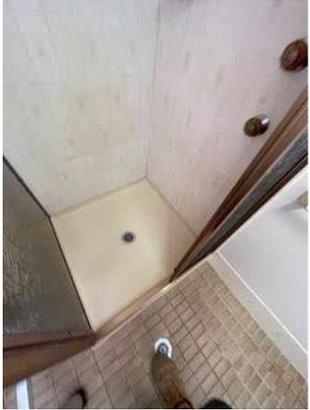
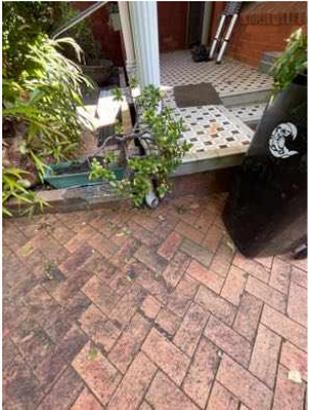
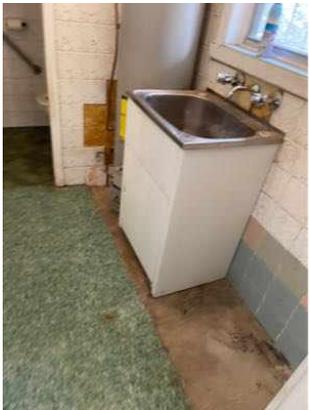
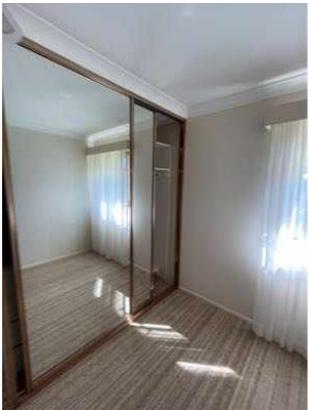
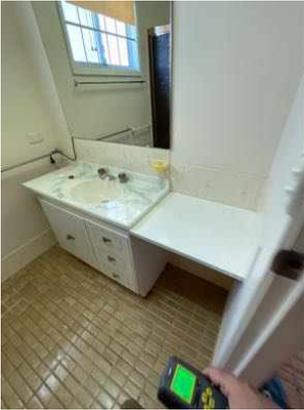
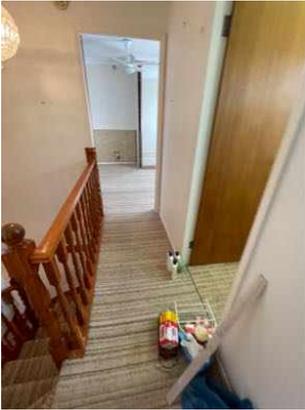
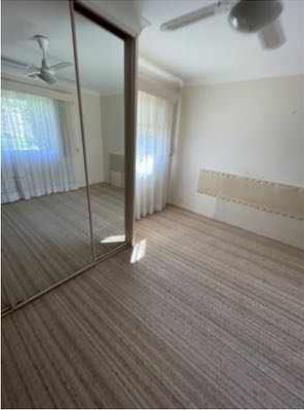
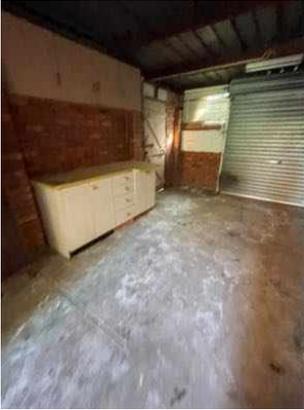
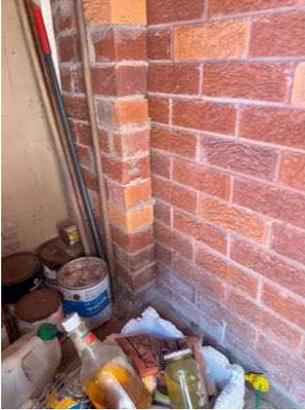
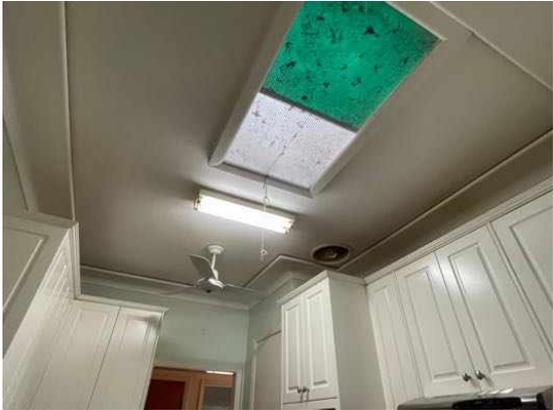
Building: Building 1  
 Location: All Areas

Finding: Additional Photos - Obstructions and Limitations  
Information: These photographs are an indication of the obstructions and limitations which impeded full inspection of the property at the time of inspection. These obstructions can hide an array of defects and should be removed to allow full inspection to be carried out.
