Building and Timber Pest Inspection Report

Inspection Date: Thu, 4 Nov 2021

Property Address: 44 Grace Ave, Frenchs Forest NSW 2086,
Australia

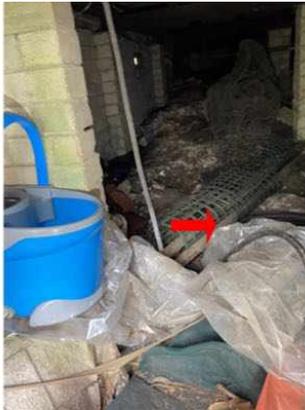
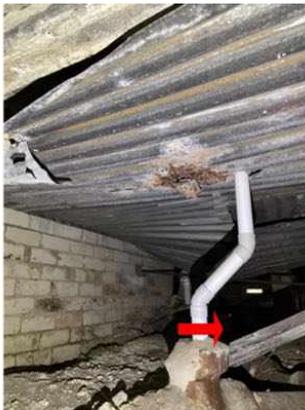
Defects 1.05

An array of debris was found in the subfloor area at the time of inspection. Debris in this area restricts subfloor ventilation and creates potential for concealed pest entry. Stored timbers and other materials may also make the area susceptible to termite activity and wood rot.

A clear and empty subfloor will be better ventilated and easier to maintain in a dry condition. The removal of any timber debris is vital in minimising the risk of termite or wood borer activity.

Debris in the subfloor should be removed as soon as possible. Depending on the location and amount of debris and stored items, the homeowner may elect to undertake this task. Alternatively there are a large number of rubbish removal subcontractors that could undertake these works.

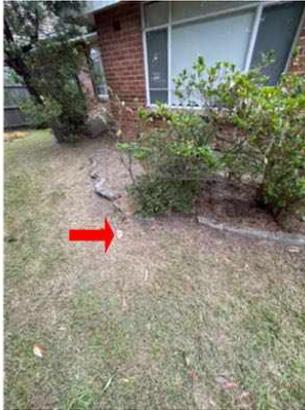
Defects 3.03

ground levels should be sloped to drain water away from walls. Downpipes should not discharge stormwater onto lower walls or plinths. Stormwater should be carried away by large, regularly cleaned drains. Ground levels may need to be lowered to expose a buried DPC.

Where site drainage is inadequate, installation of an Agricultural (Aggie) Drain may be required. A qualified plumber should be appointed to further inspect the property and perform any remedial works as necessary. Water damage and secondary defects are likely to occur if left unmanaged.

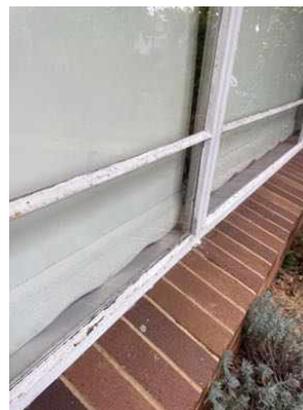
Building: Building 1
Location: All Areas
Finding: Windows - Rusted or corroded
Information: This building element shows evidence of rusting and corrosion, which is likely to have developed as a result of excessive exposure to moisture and or inadequate coatings.

Rusting and corrosion should be managed by ideally removing or limiting the affected surface from exposure to moisture. A registered builder may be appointed to replace any building elements that have been severely affected by rust or water damage.

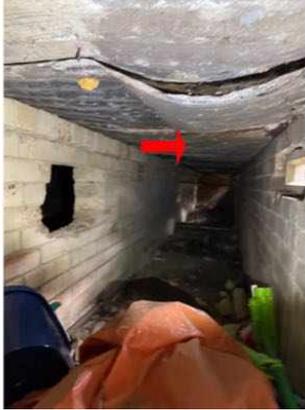
Defects 3.11

Building:	Building 1
Location:	Subfloor
Finding:	Building element - Rusted or corroded
Information:	This building element shows evidence of rusting and corrosion, which is likely to have developed as a result of excessive exposure to moisture and or inadequate coatings.

Where possible, the use of galvanized (treated) metals or aluminium coated metals aid in rust prevention, as does regular general maintenance. Rust formation can be controlled with coatings, such as paint, that isolate the iron from the environment.

Rusting and corrosion should be managed by ideally removing or limiting the affected surface from exposure to moisture. A registered builder may be appointed to replace any building elements that have been severely affected by rust or water damage.

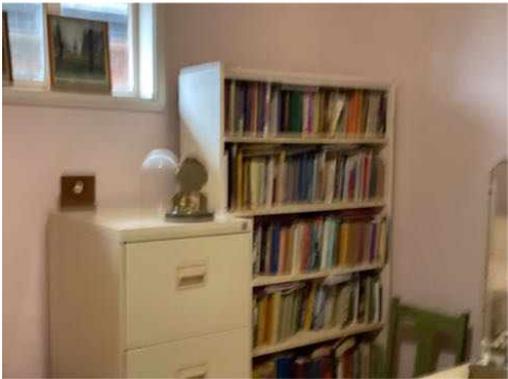
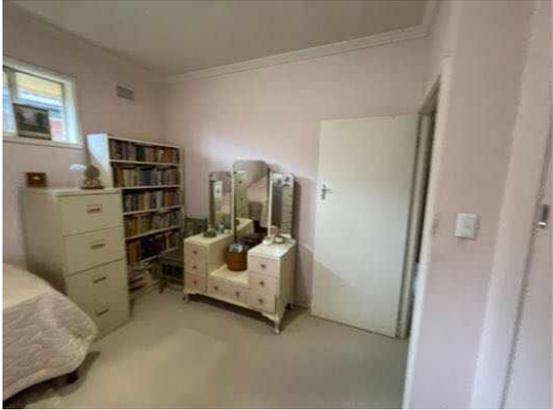
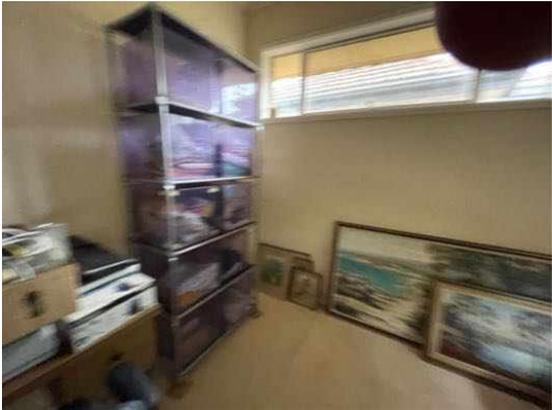
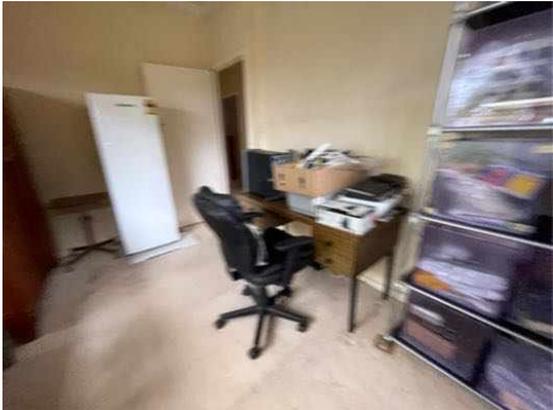
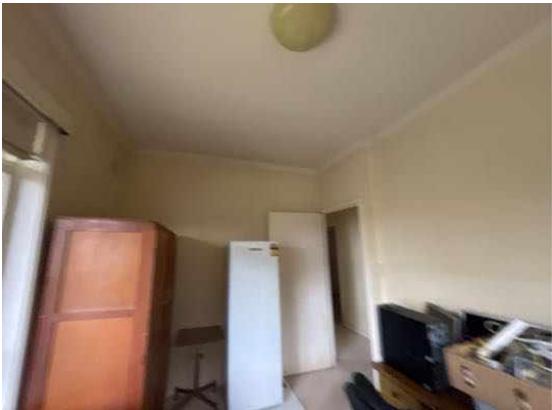
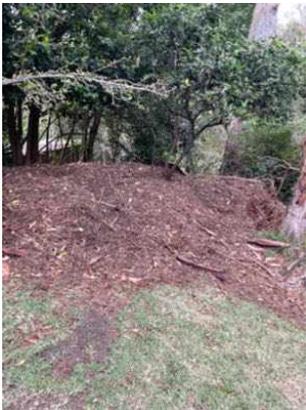
Building: Building 1
Location: All Areas
Finding: Additional Photos - Obstructions and Limitations
Information: These photographs are an indication of the obstructions and limitations which impeded full inspection of the property at the time of inspection. These obstructions can hide an array of defects and should be removed to allow full inspection to be carried out. A re-inspection is recommended once the areas are made accessible.

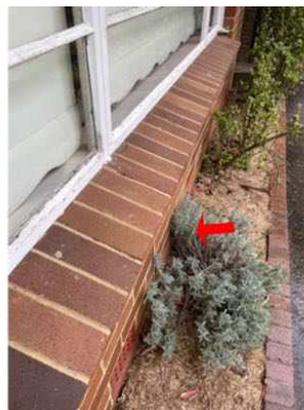
Noted Item

Building: Building 1
 Location: All External Areas
 Finding: Garden Beds - Conditions Conducive to Termites
 Information: Garden beds were found to be evident in the garden area. These garden beds can include untreated timber, and with a combination of moisture from watering hosing can make conditions conducive to termite activity and termite ingress.
